OFFICE OF ENVIRONMENTAL SUSTAINABILITY

INSPECTOR'S REPORT ON AN APPLICATION FOR A CERTIFICATE OF AUTHORISATION FOR A CLOSED LANDFILL				
TO:	Dr Eimear Cotter, Director			
FROM:	Ewa Babiarczyk, Inspector, Environmental Licensing Programme			
DATE:	3 September 2019			
RE:	Application by Limerick City & County Council for a Certificate of Authorisation for a closed landfill at Knocknacarriga, Cappamore, County Limerick. Certificate of Authorisation Register Number H0277-01.

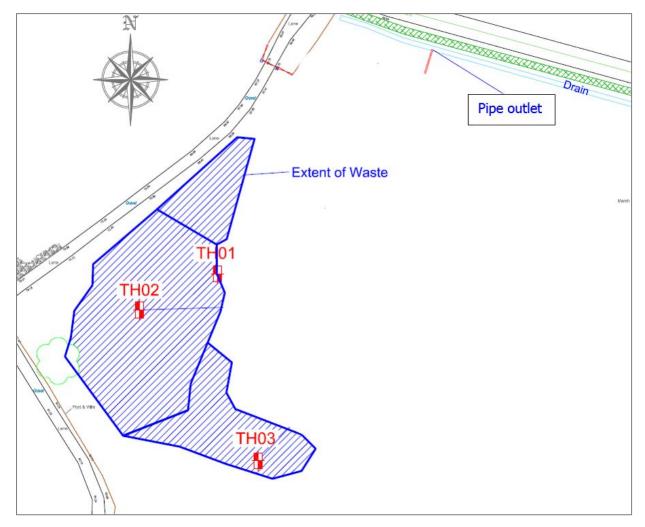
Figure 2: Extent of the Landfill Site

The local landowner indicated that during the operation of the site in the 1980's, Limerick County Council laid a small drainage pipe from the quarry floor to this surface water drainage ditch (see Figure 2). In May 2013, the pipe was discharging into the ditch at a rate of less than 0.008 l/s. A discharge from the drainage pipe into a dry drainage ditch was observed by the applicant on 21st November 2018. The flow rate of this discharge was recorded at 0.004 l/s. A small amount of water (no exact measurement of the flow provided) was observed in this ditch during the site investigation on 22nd May 2019.
Hydrogeology	The site overlies a poorly productive bedrock groundwater body. The bedrock beneath the landfill site consist of limestone Ballysteen formation. No karst features were detected during the geophysical survey of the site. The groundwater body is Slieve Phelim (Code: IE_SH_G_213). Its status is good and this groundwater body is not at risk. The groundwater body beneath the site is designated a locally important gravel aquifer (Lg). The aquifer vulnerability is classified as Extreme. The hydrogeological gradient follows the general topography.

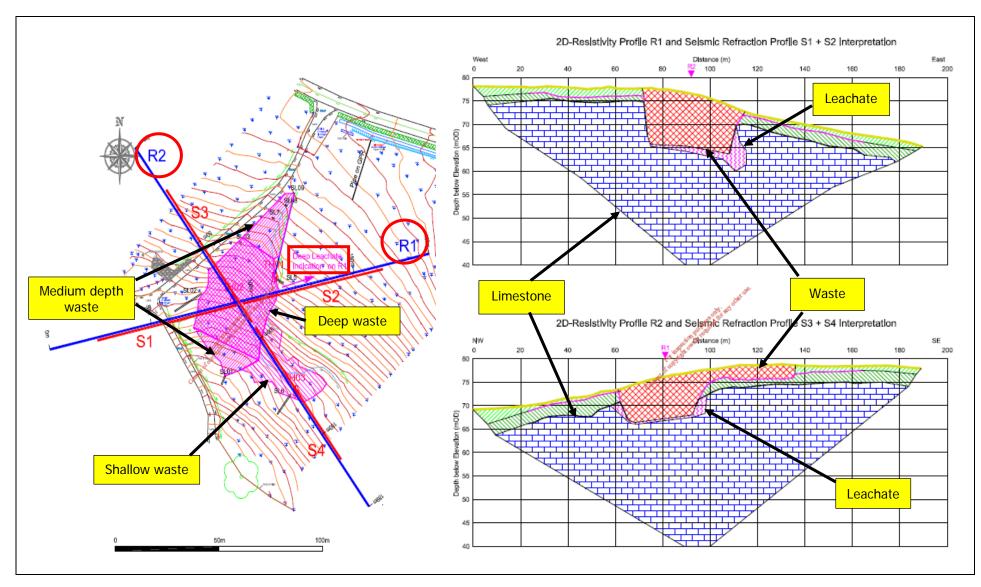
Figure 3: Interpretation of the Geophysical Survey

The geophysical survey carried out as part of the risk assessment indicates a small amount of leachate outside the waste body, as shown in Figure 3. The Geophysical Survey Report states that this is likely to be caused by a small amount of groundwater flowing along a hydrogeological gradient. The site investigation further showed that the upper 4m of the waste body was dry with no seepages or perched leachate. Sampling of discharge from the said pipe was carried out in 2013 and November 2018. The results show that the discharge contains low levels of contamination and is consistent with leachate produced from a highly decomposed waste body. The result recorded for Nitrates in 2018 sample (135.7 mg/l) is much higher than the 2013 sample results (28 mg/l). The Tier 2 Report states that this would be expected in methanogenic leachate and may be originating from fertiliser spreading on these lands. An additional sample was taken from the pipe on the 5th February 2019. Ammonia as N was recorded at 18.3 mg/l and Nitrate (NO₃) was recorded at 6.817 mg/l. Tier 2 Report states that these varying results for Nitrate indicate this Nitrate is originating not from the deposited waste but rather from spreading of artificial fertiliser. Condition 3.5 requires monitoring of the discharge from the pipe and the receiving surface water drain at locations upstream and 500m downstream of the discharge from the pipe. There is a risk of landfill gas migration to nearby houses. The most Landfill gas: likely pathway for the migration of the landfill gas is through the underlying bedrock. There are four houses, a farmyard and a commercial building located within 250 metres of the landfill site. No landfill gas or odours were detected during the site walkover survey and no facilities were provided to contain landfill gas. The trial holes and the spoil heap were monitored for landfill gas. No landfill gas was detected during the excavation of the trial holes although slight transient odours were detected when the waste body was disturbed. Condition 3.1 requires installation of three gas monitoring boreholes within the waste body and Condition 3.5 requires monitoring to detect the presence and concentration of landfill gas on a quarterly basis. Conceptual site model: The conceptual site model developed in 2013 identified the following pollutant linkages: human health exposure and emission into buildings due to off-site migration of landfill gas;

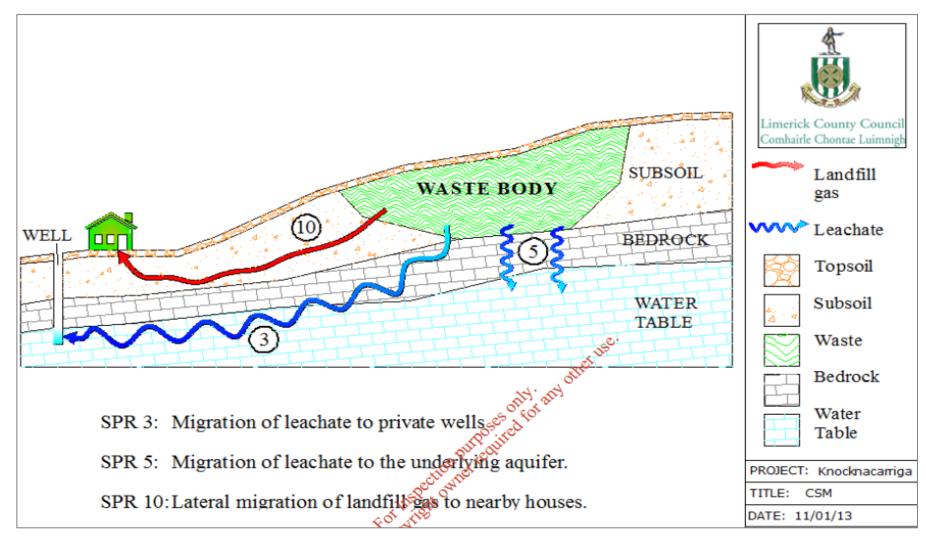
Figure 4: Conceptual site model for the landfill site

The conceptual site model is shown in Figure 4. The source, pathways and receptors can be described as follows:

- Rainfall on the landfill will preferentially percolate through the cap and into the waste.
- Leachate is generated in the waste.
- Gas is generated at the landfill.

- Leachate migration from the site through the bedrock into the locally important aquifer.
- Leachate can migrate through the base of the landfill into underlying aquifer beneath and discharge to the adjoining surface water body (drain) and private wells.
- Gas migration can occur through the permeable cap and through fractured bedrock beneath the waste.
- Gas migration beyond the site boundary.

- the underlying bedrock and locally important aquifer;
- houses and private wells outside the site;
- The Lower River Shannon SAC located 600 m to the north of the site;
- Surface water bodies between 250m and 1km of the site.

The proposed remedial actions are intended to break the SPR linkages by preventing:			
	- potential migration of leachate to groundwater; and			
	- migration of landfill gas to off-site locations.			
	The proposed capping will also prevent any waste materials from appearing on the surface of the landfill site.			
	The draft Certificate of Authorisation allows for the importation and use of soil and stone to complete the works.			
	Condition 3.15 of the recommended certificate of authorisation provides for a communications programme directed at the occupiers of buildings adjacent to deposited waste (the site). The communications programme will inform the relevant occupiers of what they should be doing to protect their property, health and well-being, and members of the public from the risk of an incident involving landfill gas.			
Proposed aftercare monitoring and	Monitoring as specified in Condition 3.5 of the recommended certificate of authorisation.
