<b>Figure Title</b>	Site Location Knockcronaghan
<b>Figure No.</b>	2.1
<b>Project</b>	Tier 1 Assessment of Historical Landfills in Monaghan
<b>Client</b>	Monaghan County Council
<b>Scale</b>	1:25,000
<b>Page Size</b>	A3
<b>Revision</b>	A
<b>Date</b>	15/06/2018

## Killicronaghan Walkover Survey Checklist – 12<sup>th</sup> June 2018

## Photos from Recent Site Walkovers

Site Location: Killycronaghan

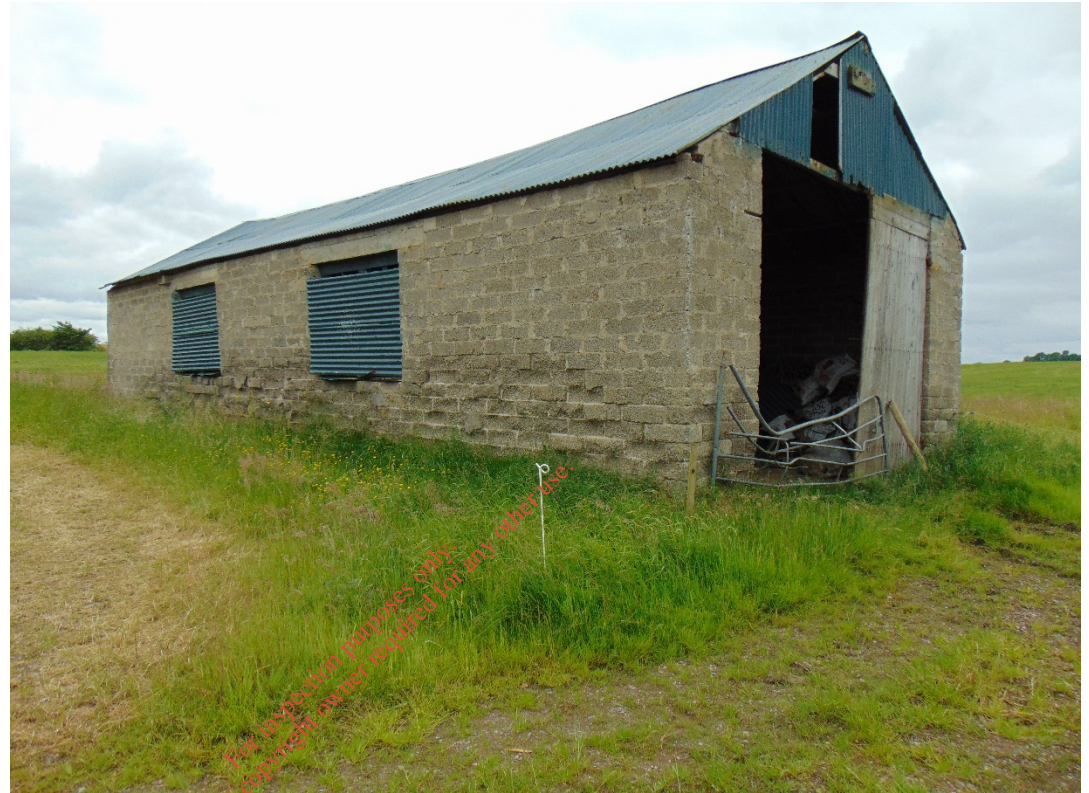
1

Farm building near  
site entrance

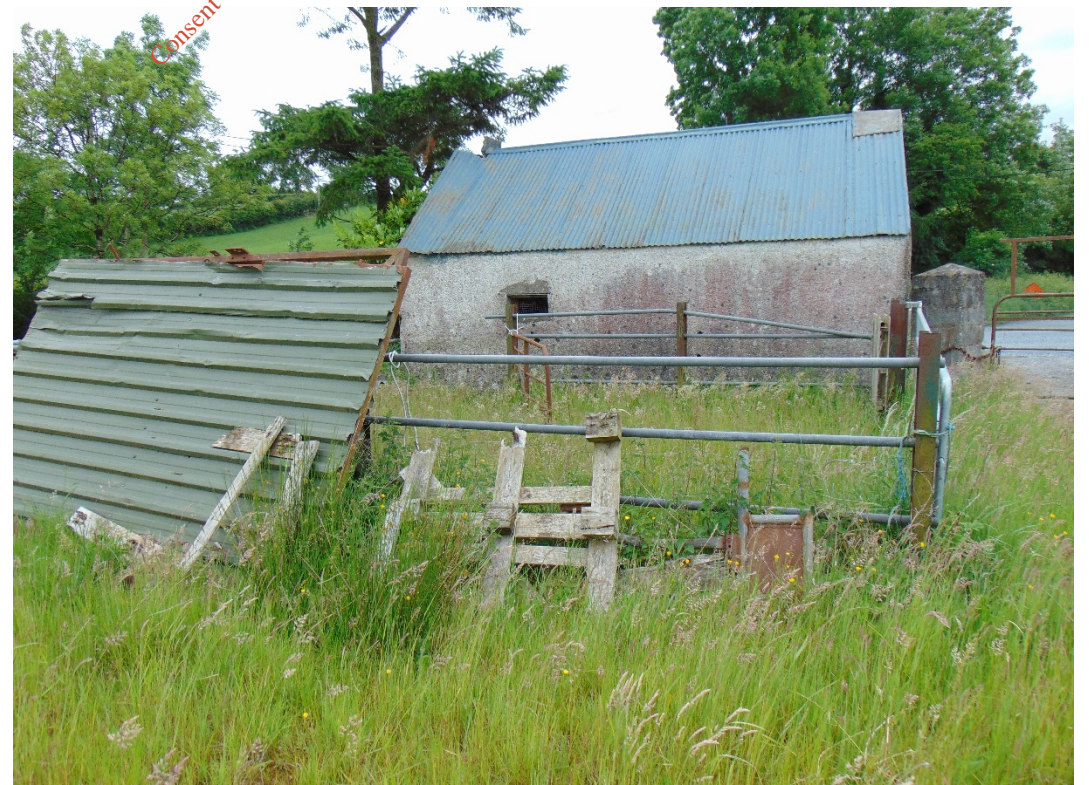
2

Farm building near  
site entrance

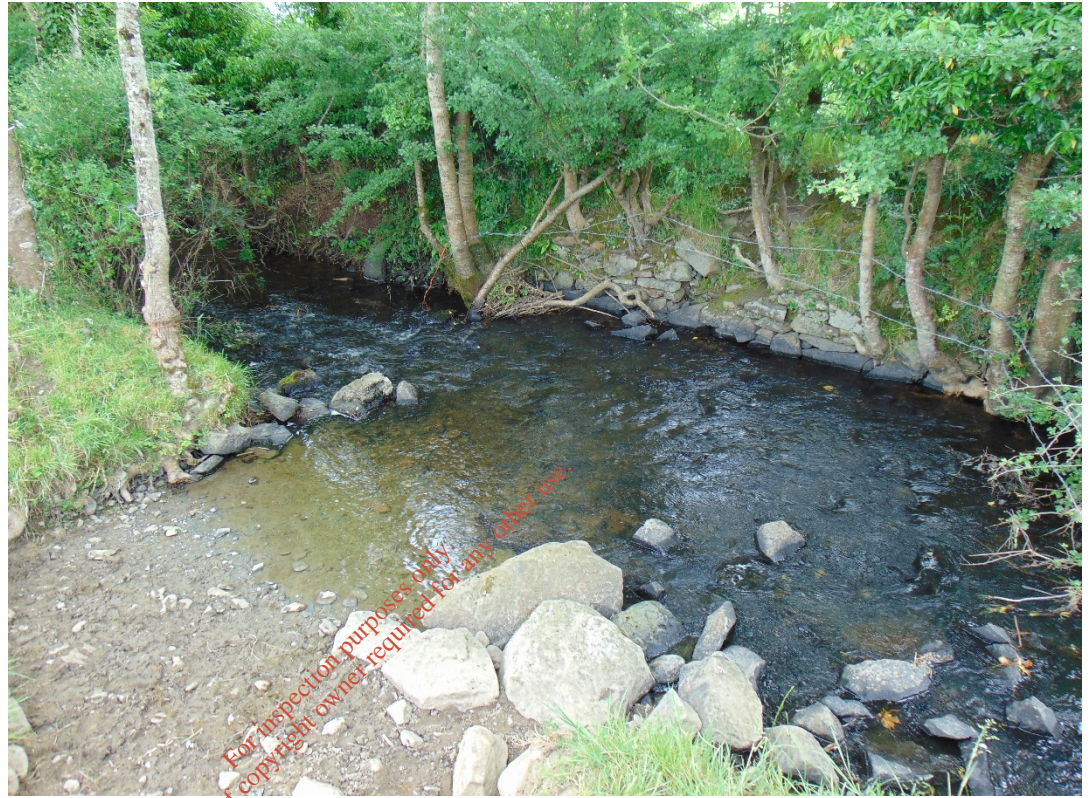
3

Kilgormly river at  
eastern site  
boundary

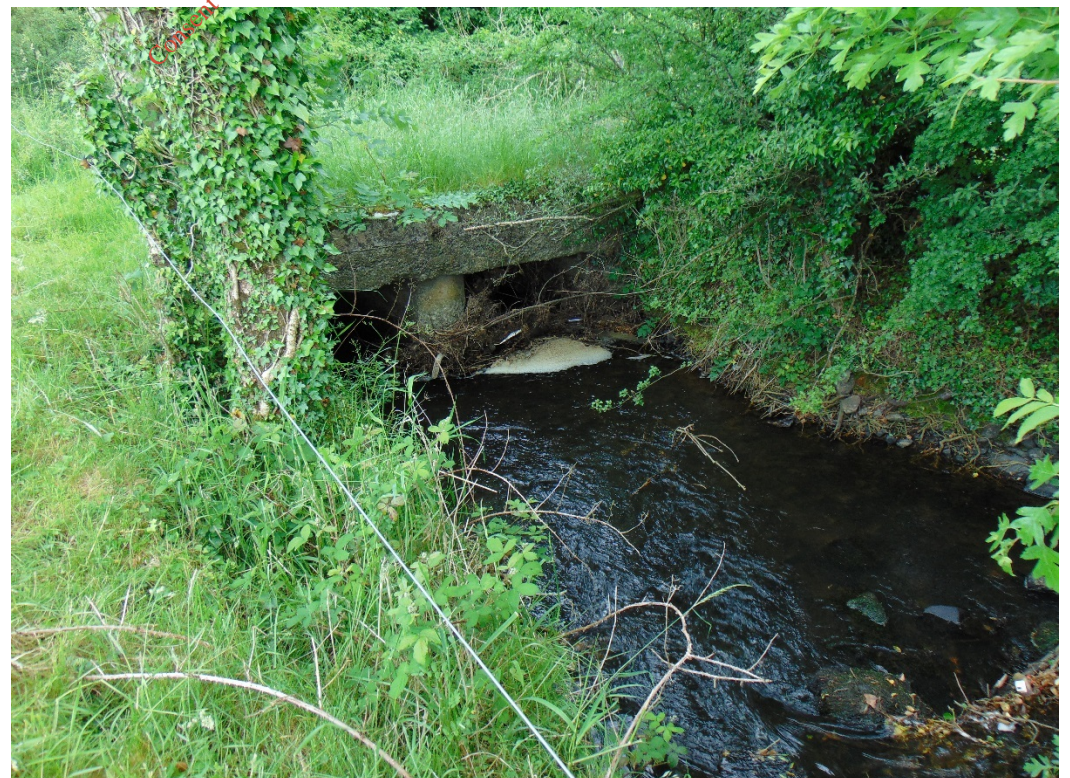
4

Old concrete bridge over  
Kilgormly river along  
eastern site boundary

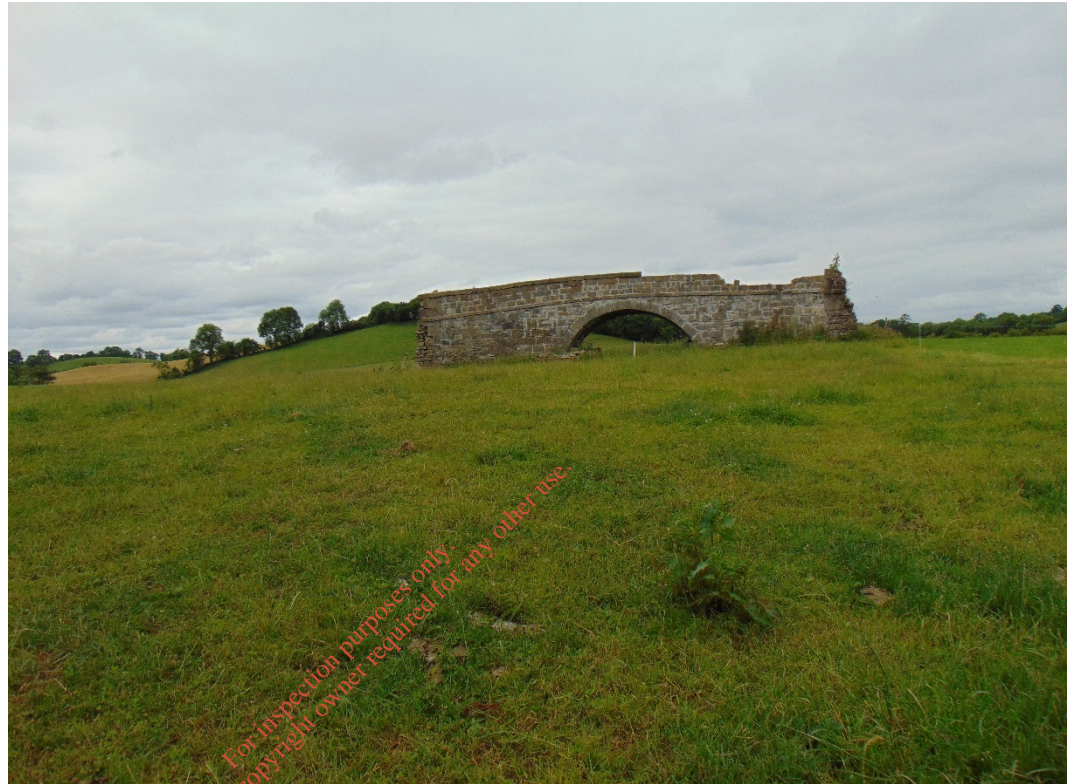
5

Derelict Lemmon's  
Bridge over old canal  
towards northern  
end of the site

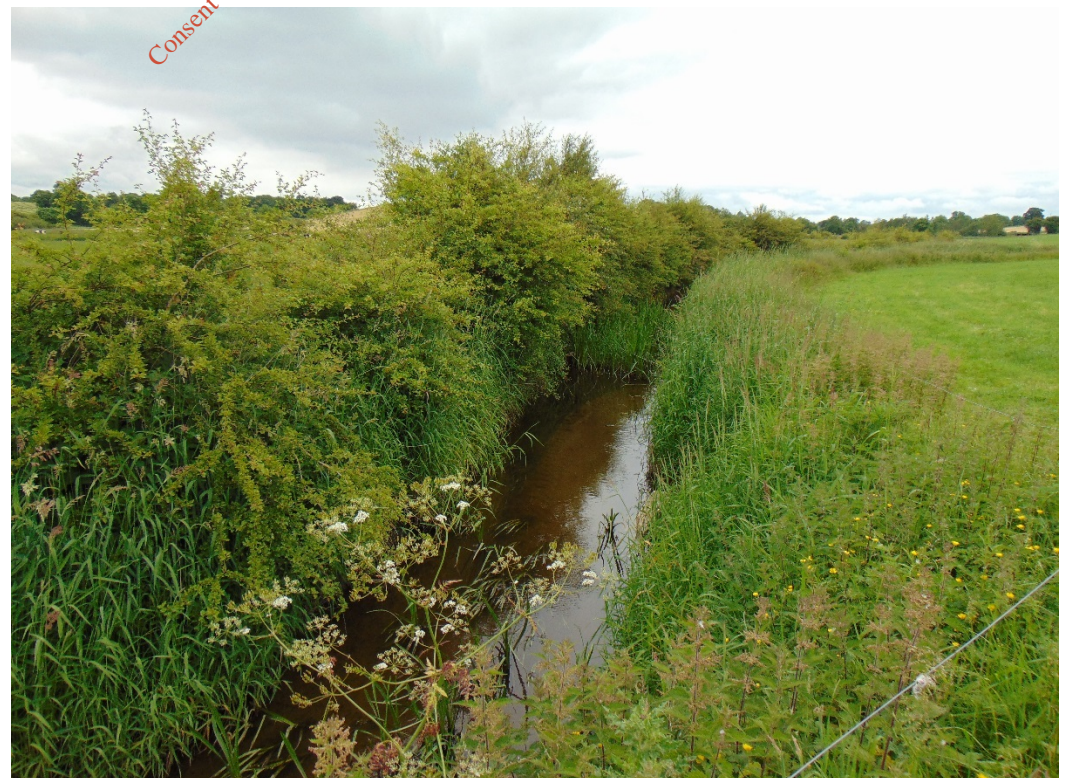
6

Kilgormly river along  
northern site boundary

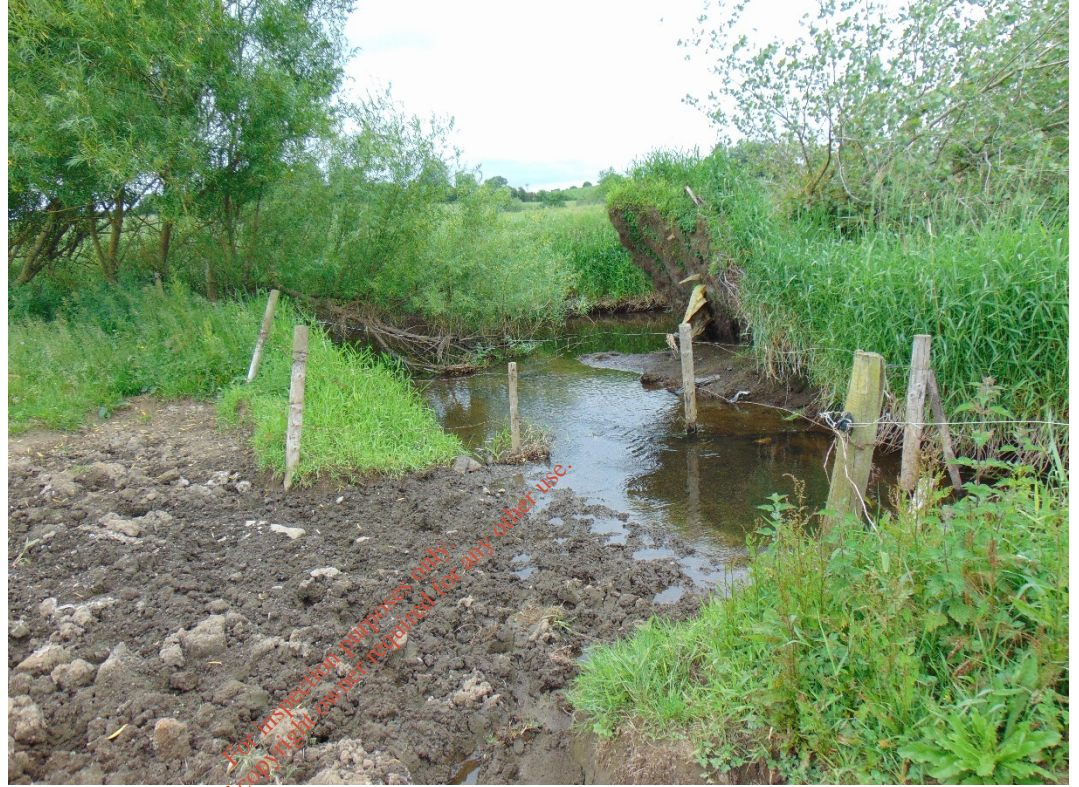
7

Confluence of  
Kilgormly river and  
Ulster canal

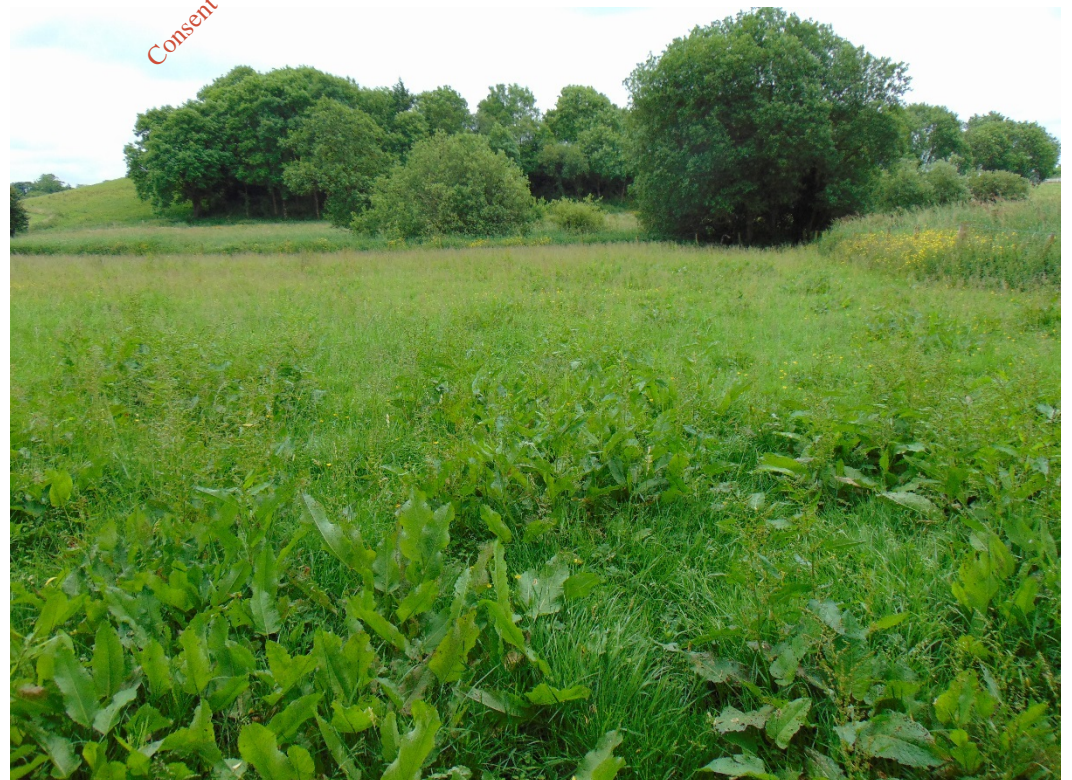
8

View of western section of  
site.

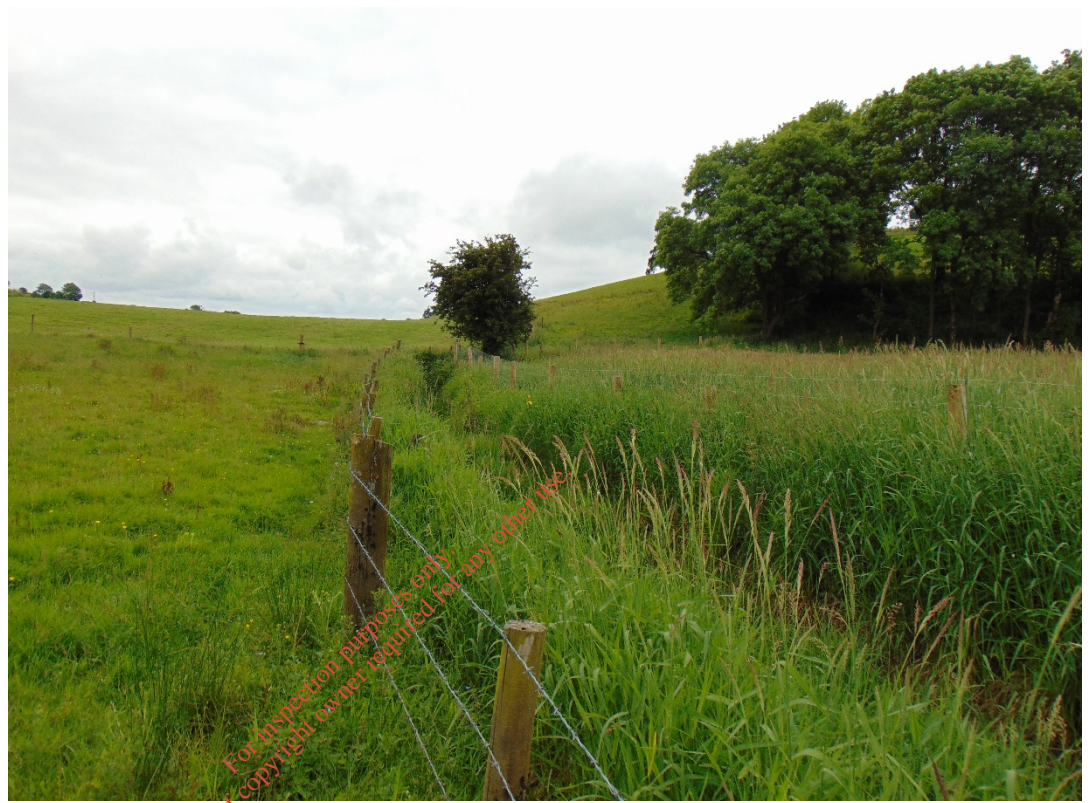
9

Surface water ditch  
along southwestern  
site boundary

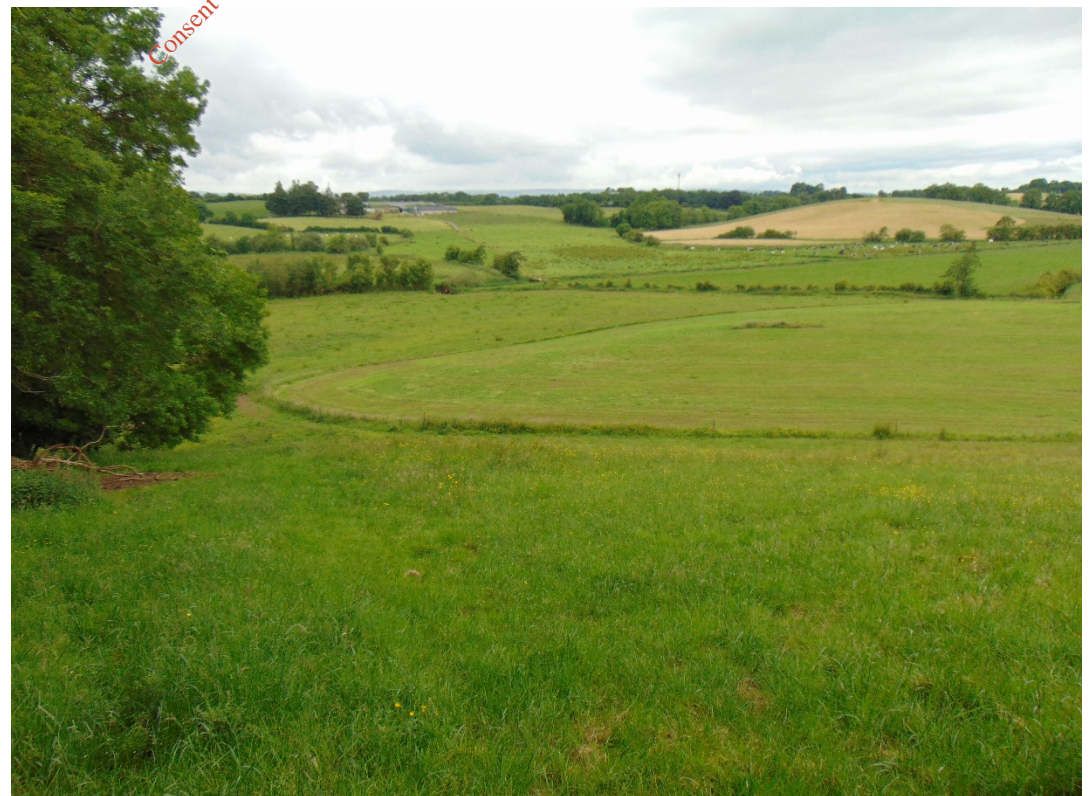
10

View northwards from top  
of hill at southern section  
of site

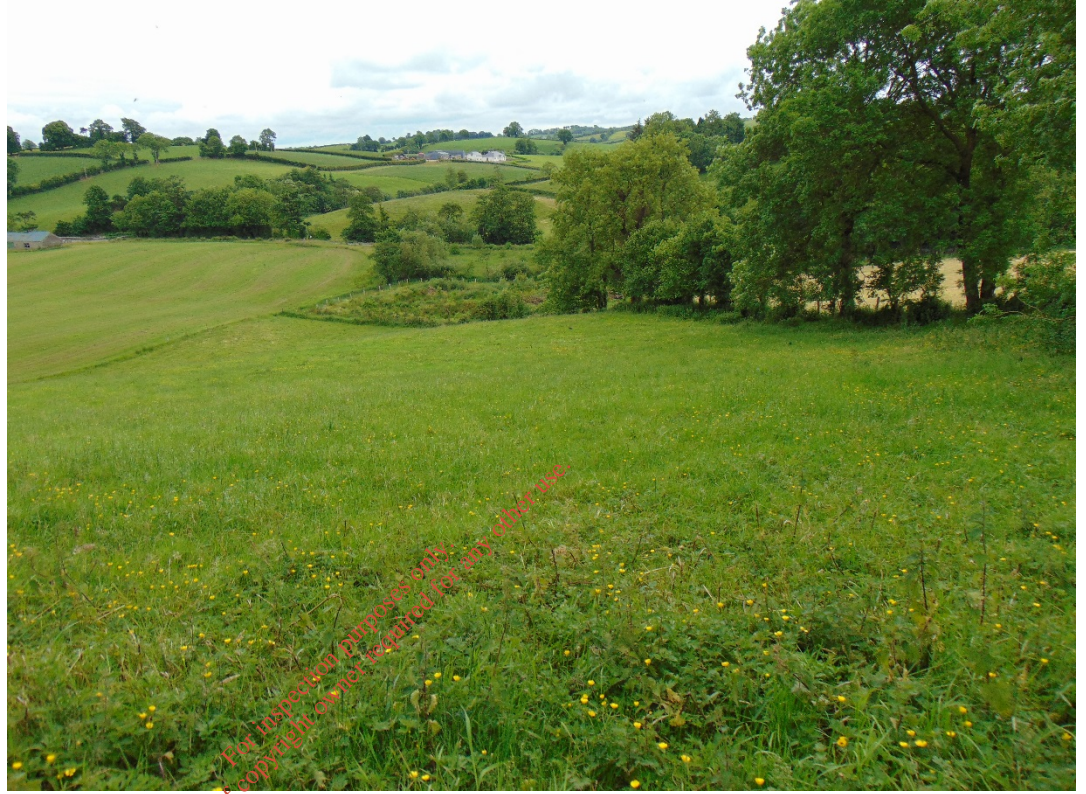
11

View of southern and eastern sections of site

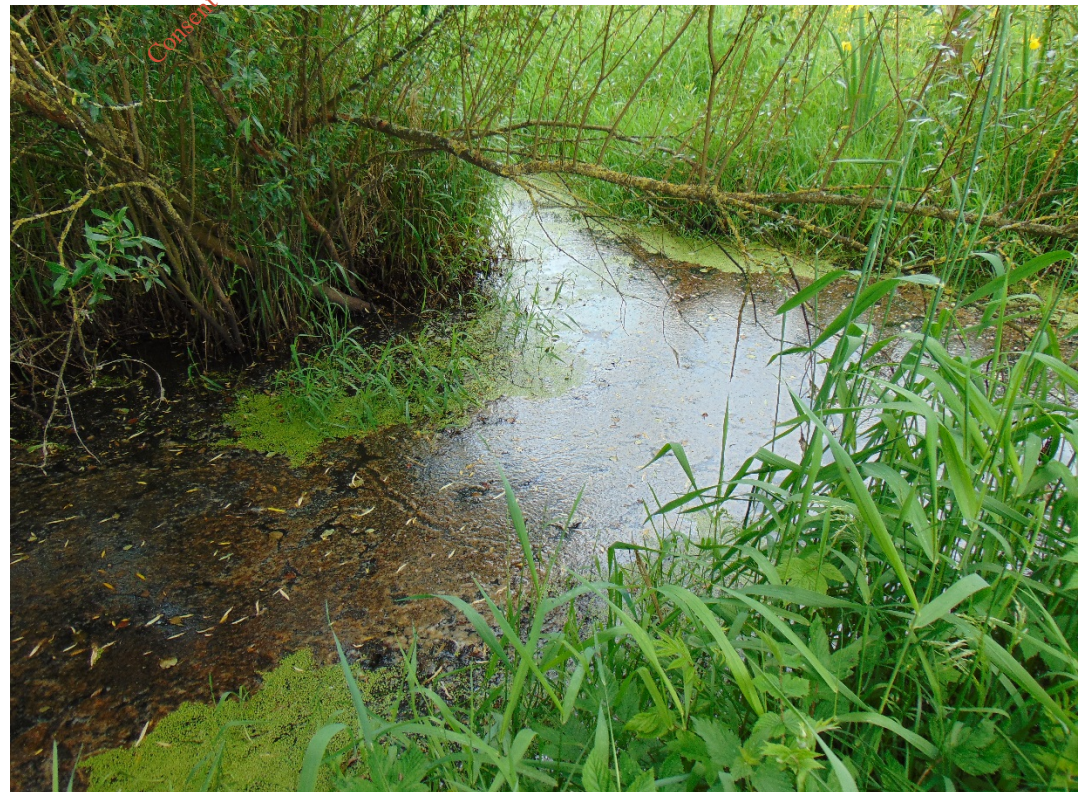
12

Surface water ditch to southeast of site

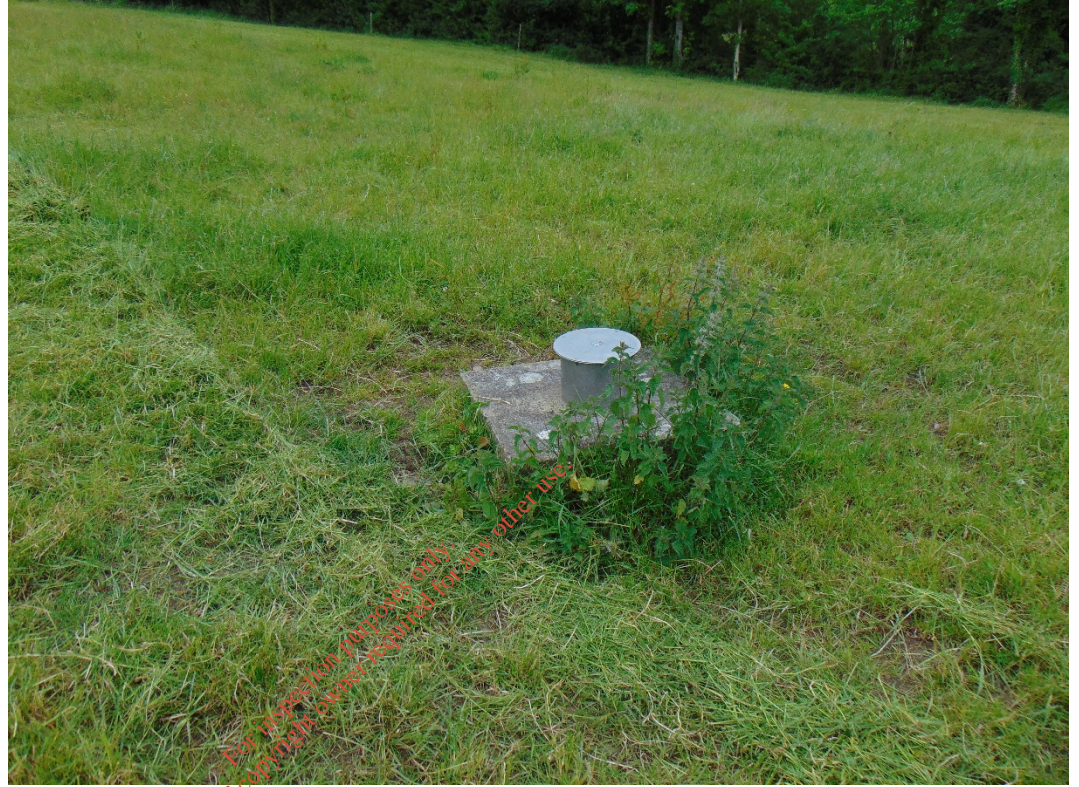
13

9. Are there any indications of remedial measures? (Provide details)	√	No, 6 inches of soil cover placed over waste body upon closure
Capping	√	No
Landfill gas collection	√	No, 2 disused methane wells present onsite
Leachate collection	√	No

Old methane well  
toward northern  
section of the site

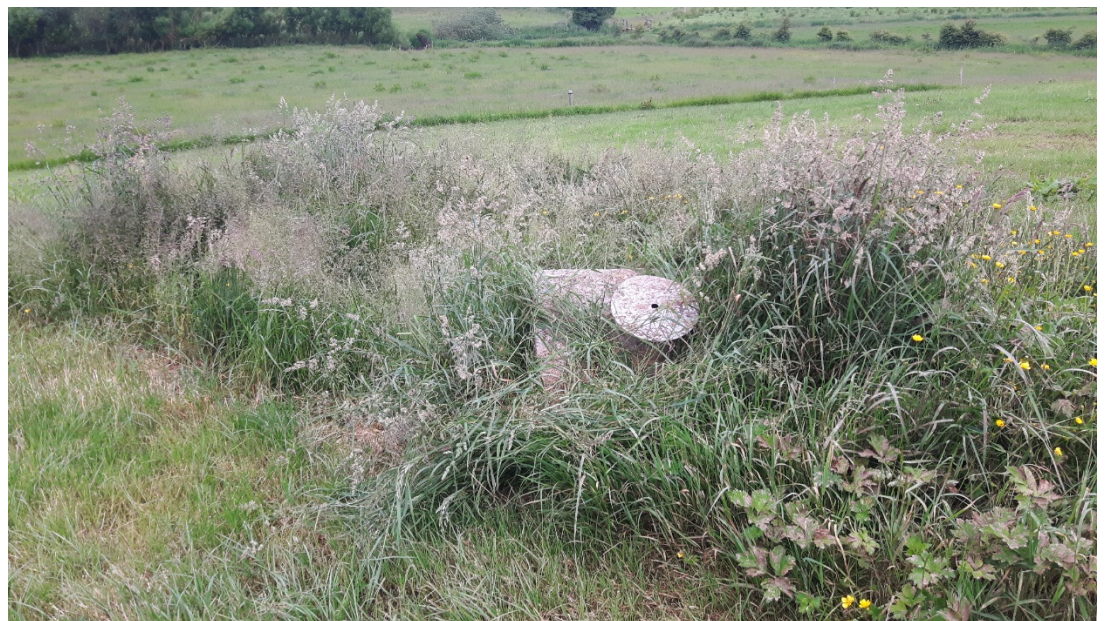
14

Second old methane well  
towards the western  
section of the site

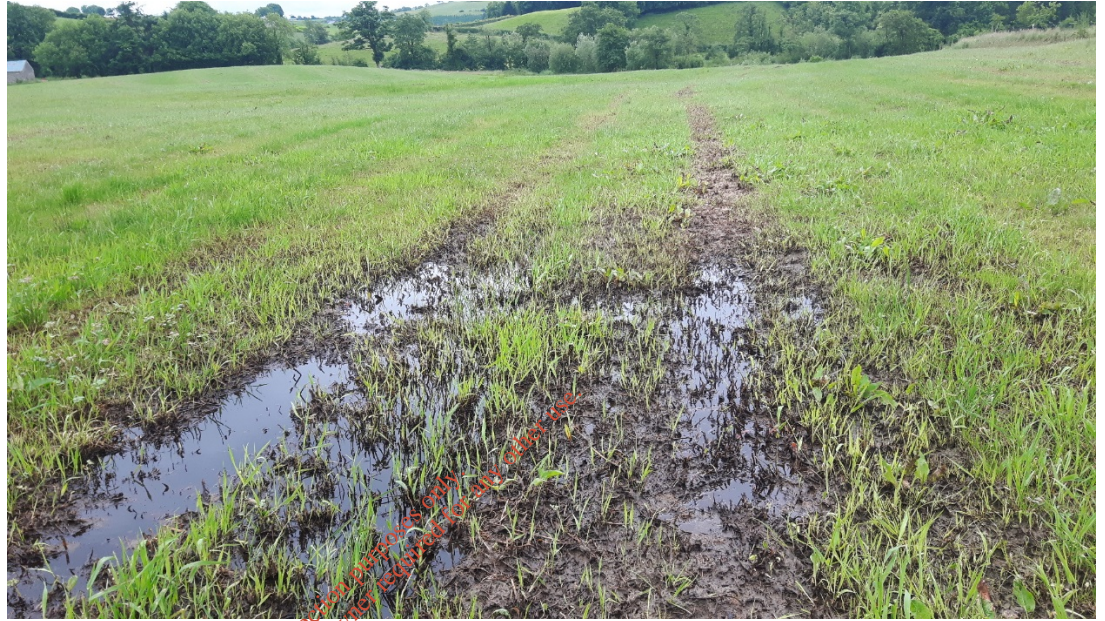
15

Section of water  
logged area near the  
centre of the site

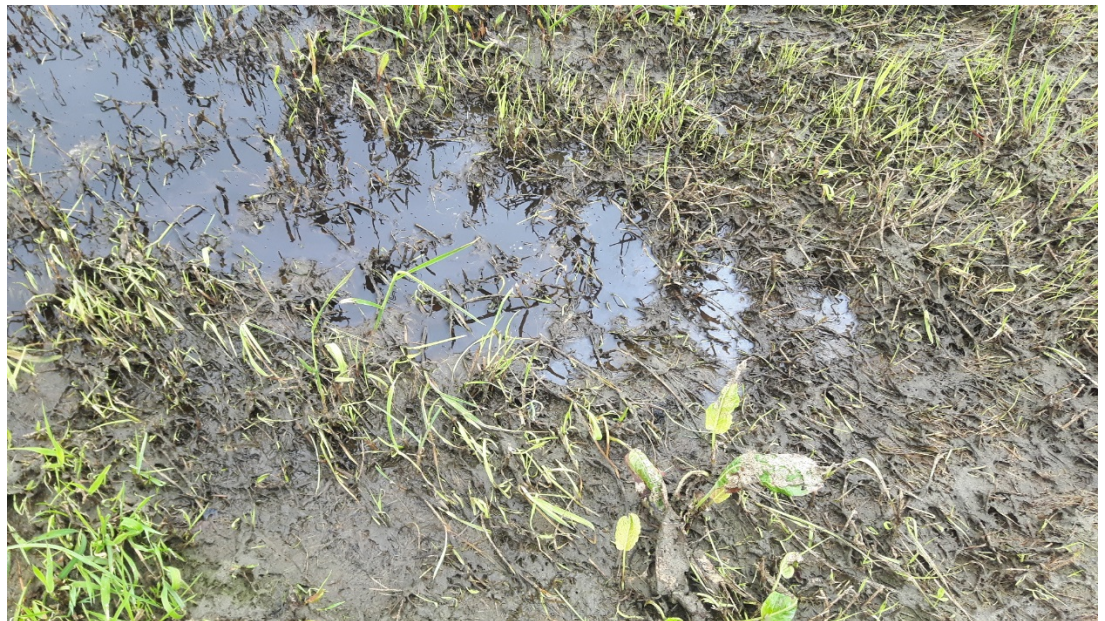
16

6. Are there any potential sources of contamination (if yes, give details)?	√	Yes, waste from former landfill
Surface waste (if yes, what type?)	√	No
Surface ponding of leachate	√	No
Leachate seepage	√	Some evidence of leachate seepage in one area of field
Landfill gas odours	√	No

Information	Checked	Comment (include distances from site boundary)
8. Are there any signs of impact on the environment? (If yes, take photographic evidence)	√	Yes
Vegetation die off, bare ground	√	No
Leachate seepages	√	Some evidence of leachate seepage in one area of field
Odours	√	No
Litter	√	No
Gas bubbling through water	√	No
Signs of settlement	√	No
Subsidence, water logged areas	√	No
Drainage or hydraulic issues	√	Blocked surface water ditch to the southeast of the site from roadworks - stagnant water in ditch
Downstream water quality appears poorer than upstream water quality	√	No clear evidence

Evidence of leachate  
seepage at waterlogged  
section
