# Appendix III

Photos from Recent Site Walkovers

Monaghan Co. Council

Site Location: Killycard

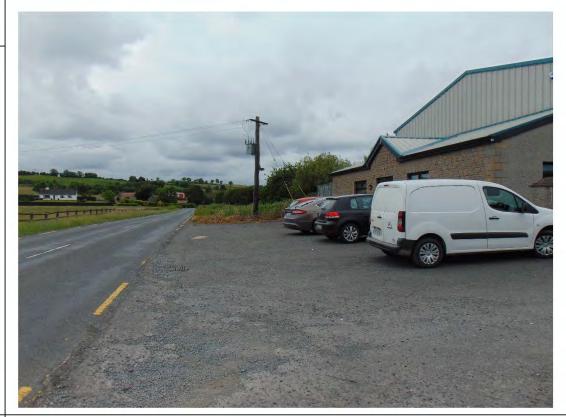
Site entrance to industrial units

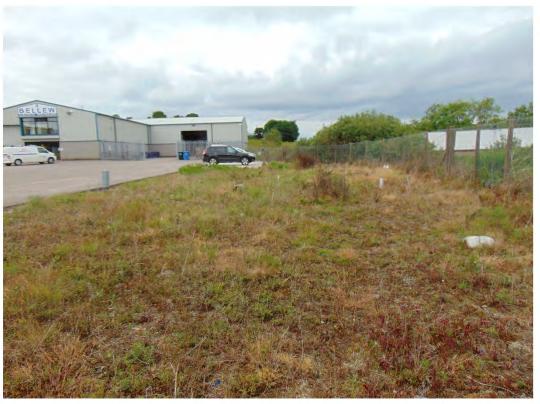
Grassed areas near industrial units carpark

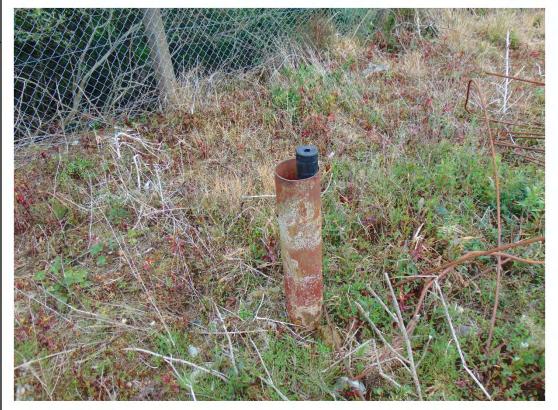
Old gas well near industrial unit carpark

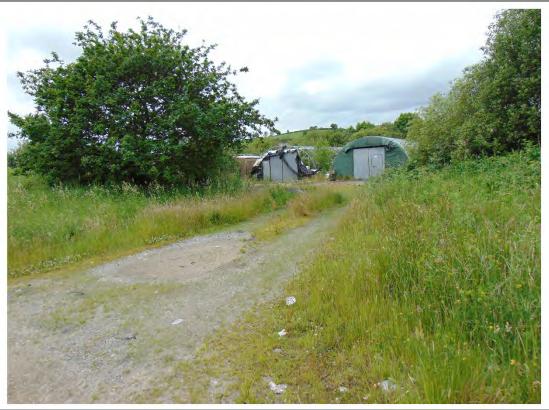
Site entrance to derelict mushroom buildings

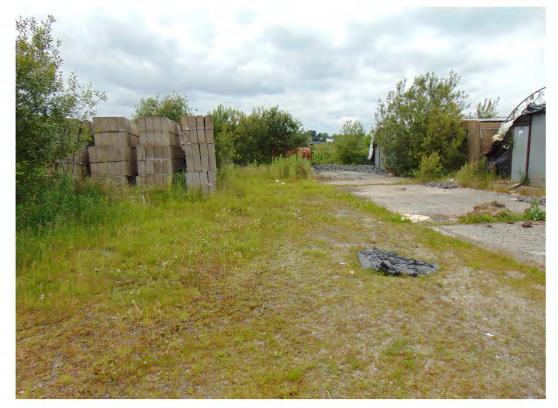
Area in front of derelict mushroom buildings

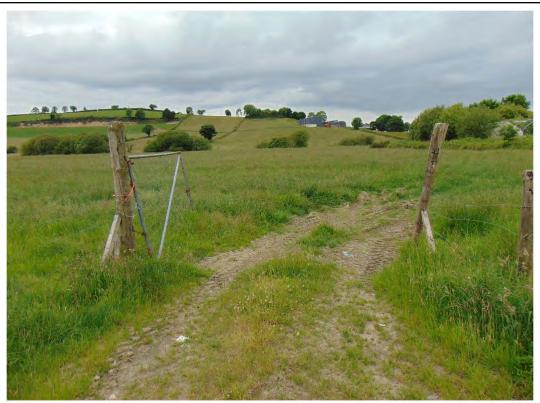
Site entrance to vegetated field

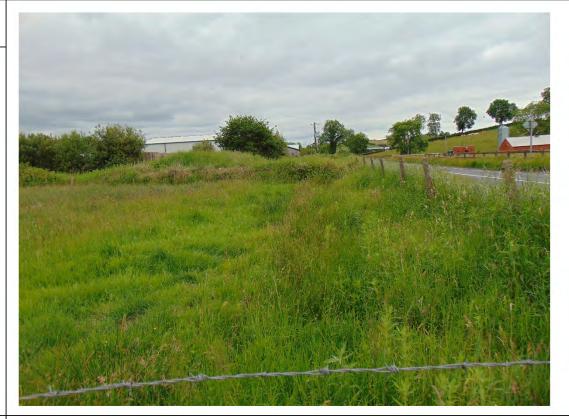
Southern section of vegetated field

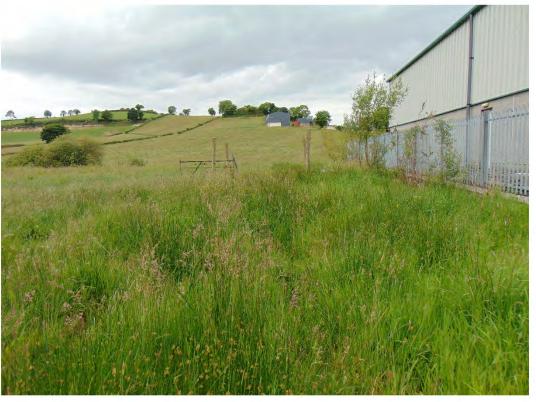
Area west of industrial units, north of derelict mushroom buildings

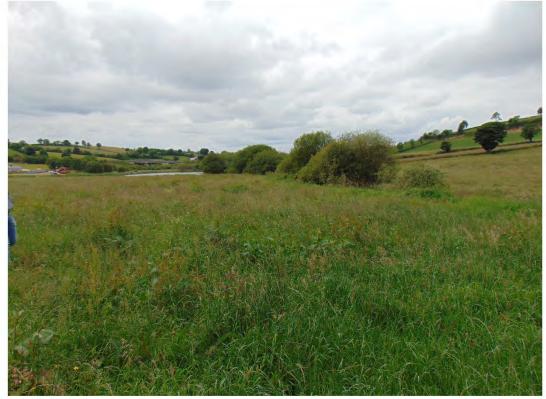
9

Northern section of site, looking westwards

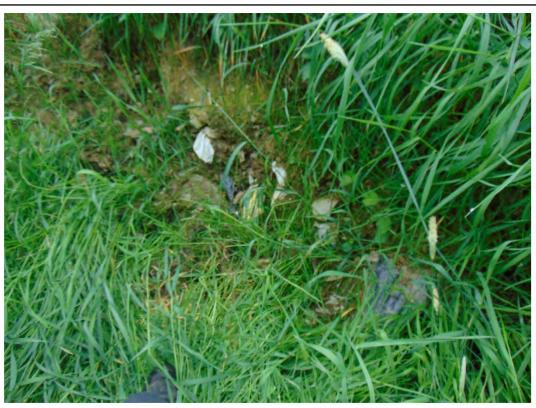
Waste material protruding from northern boundary adjacent to surface water ditch

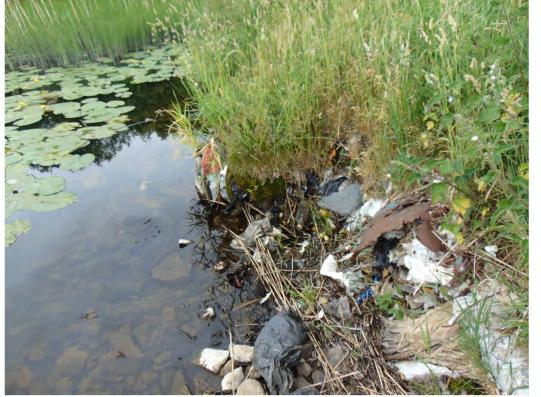
11

Exposed waste material at western boundary of Corrinshigo lake

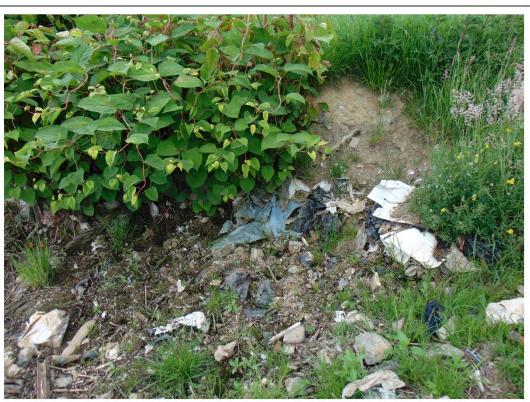
12

Exposed waste material at western boundary of Corrinshigo lake

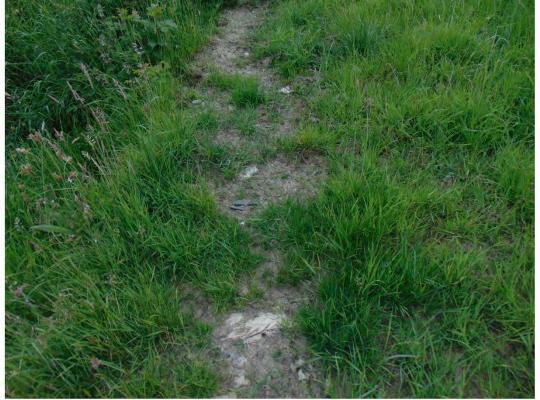
13

Waste material protruding from soil surface

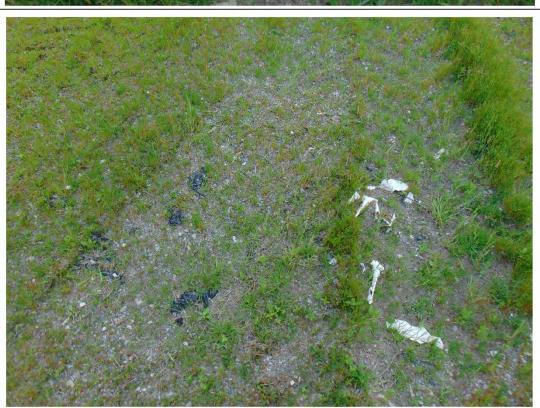
Waste material protruding from soil surface
