OFFICE OF ENVIRONMENTAL SUSTAINABILITY

INSPECTOR'S REPORT ON AN APPLICATION FOR A CERTIFICATE OF AUTHORISATION FOR A CLOSED LANDFILL					
TO:	Dr. Eimear Cotter, Director				
FROM:	Ewa Babiarczyk, Inspector, Environmental Licensing Programme				
DATE:	24 th January 2020				
RE:	Application by Cavan County Council for a Certificate of Authorisation for a closed landfill at Dunaree , Kingscourt , County Cavan . Certificate of Authorisation Register Number H0016-01 .

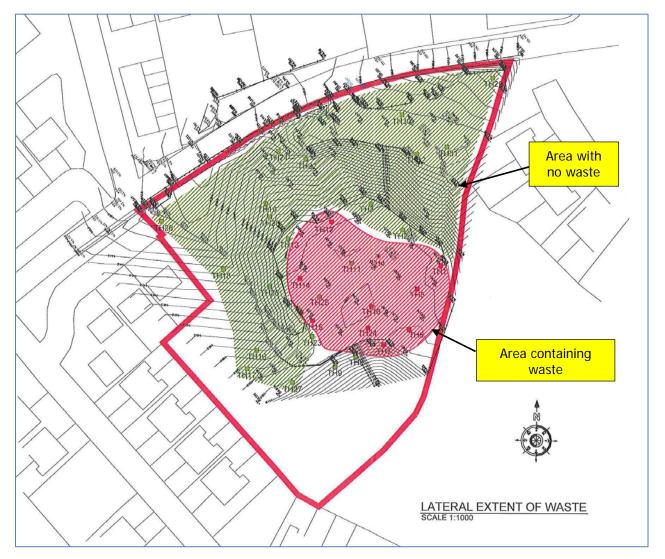
Figure 3: Approximate extent of deposited waste

Location of facility	The closed landfill is located 0.6km from Kingscourt town, in the townland of Dunaree, Co. Cavan, at the L35360 Road.		
	The location of the landfill site is shown in Figure 1.		
Period of landfilling	1970 to 1991		
Surrounding area	The use of the surrounding land is predominantly residential and industrial. Apart from the south-eastern site boundary which borders with an undeveloped construction site, the closed landfill is surrounded by housing estates and other buildings as shown on Figure 2.		
Area of the closed landfill	The landfill covers an area of 1.2 ha.		
Quantity of waste at the facility	Approximately 6,000 tonnes.		
Characterisation of waste deposited	The waste body comprises of municipal solid waste (MSW) ar construction & demolition (C&D) waste. The deposited was includes plastic, paper, glass, metal and textiles. There is also stony clay matrix. The approximate extent of the deposited waste shown in Figure 3.

The majority of the buried waste was found on the higher ground in the South-eastern part of the site. Waste was encountered in trial holes TH1, TH4, TH5, TH6, TH7, TH10, TH12, TH14, TH15, and TH24.

- (a) install of a low permeability landfill cap, minimum 1m, with 1mm thick low permeability geomembrane having a hydraulic conductivity of less than or equal to 1x10-9m/s;
- (b) install passive gas venting system. The gas vent pipes shall not be perforated above the ground level;
- (c) install additional gas monitoring wells as recommended in Tier 3 Assessment;
- (d) regrade the landform of the closed landfill; and
- (e) reseed grass within the site.

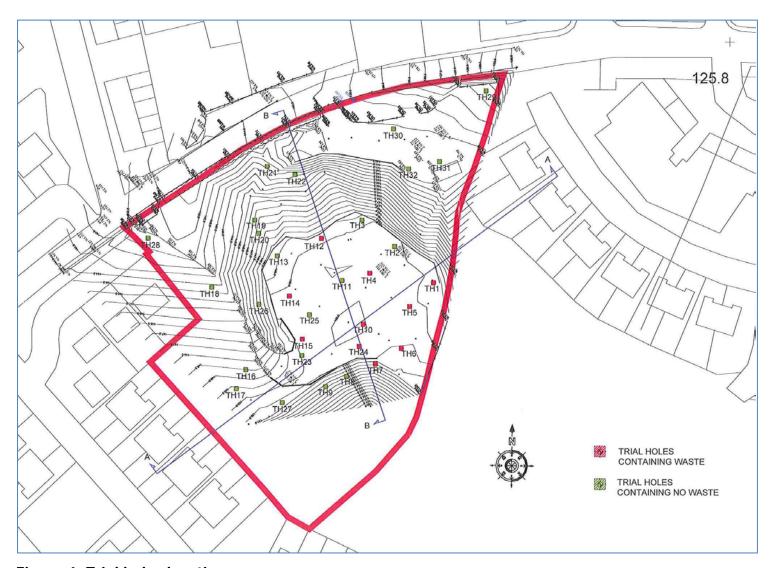
Figure 4: Trial holes location

- waste material was encountered in 10 (TH1, TH4, THS TH6, TH7, TH10, TH12, TH14, TH15, and TH24) of the 32 trial holes excavated, shown in Figure 4. The most extensive quantities of waste were encountered towards the South East of the site on the upper level. The waste extends from the eastern boundary (TH 6) to the top of the slope (TH 12) in a northerly direction towards the Council's storage yard. Negligible quantities of waste were found outside this area;
- no groundwater or leachate was encountered in any of the trial holes;
- landfill gas was being generated within the waste body;
- the closed landfill is capped with a thin layer of soil/aggregate, through which precipitation is freely entering the waste body.

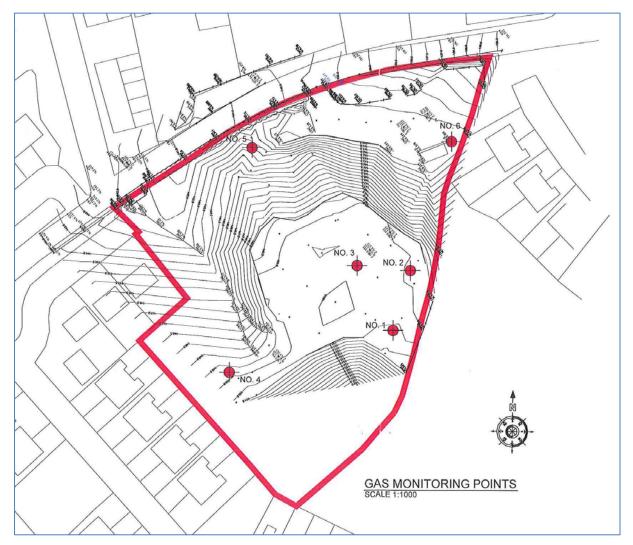
Figure 5: Gas monitoring locations

Landfill gas:	There is a risk of landfill gas migration to nearby houses. The most likely pathway for the migration of the landfill gas is through the underlying bedrock and existing landfill cap.		
	The most recent gas monitoring was carried out at six monitoring locations MW1 to MW6 (as shown in Figure 5) on 17^{th} October 2019. The monitoring results show that Methane (CH ₄) concentrations varied from 1 to 1.1 % v/v at MW1, MW2, MW4 and MW6. Carbon dioxide (CO ₂) varied from 0.1 to 1.7 % v/v with 1.7 % v/v recorded at MW2 and 0.1 % v/v recorded at MW4, MW5 an MW6. The amount of gas generated at the closed landfill is insufficient for utilisation or flaring.		
	The findings of the Tier 2 and Tier 3 Environmental Risk Assessment gas monitoring established that the majority of gas being generated at the former landfill is most likely escaping through the surface, due to the shallow depth of the landfill and the composition of the existing landfill cap. However, the findings further state, the lateral migration of landfill gas cannot be disregarded given the subsurface rock, fill material and as both Methane and Carbon Dioxide are heavier than air. Condition 3.1 requires a landfill cap, to include a 1mm thick low permeability geomembrane and a passive gas venting system. Additionally, Condition 3.8(c) requires monitoring to detect the presence and concentration of landfill gas on a quarterly basis.

There are six gas monitoring wells currently installed at the site. As part of a continued programme of monitoring it is proposed to install three additional gas monitoring wells at the site. In combination with the existing six gas monitoring locations the new gas monitoring locations will be positioned on both sides of the passive gas venting system in order to show whether gas is breaching the gas venting barrier and to test the effectiveness (or otherwise) of the gas venting system.

Additionally, Condition 3.8(c) requires monitoring to detect the presence and concentration of landfill gas on a quarterly basis.

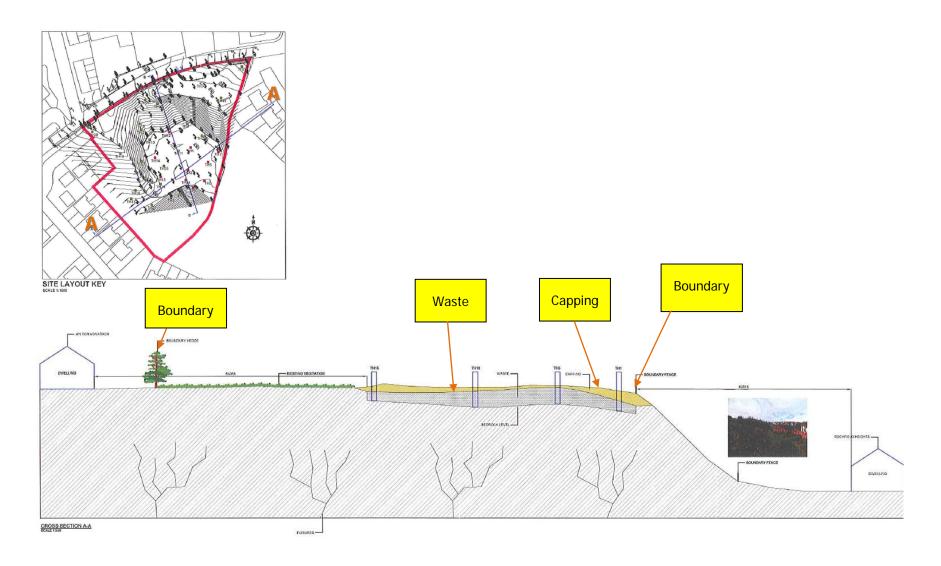
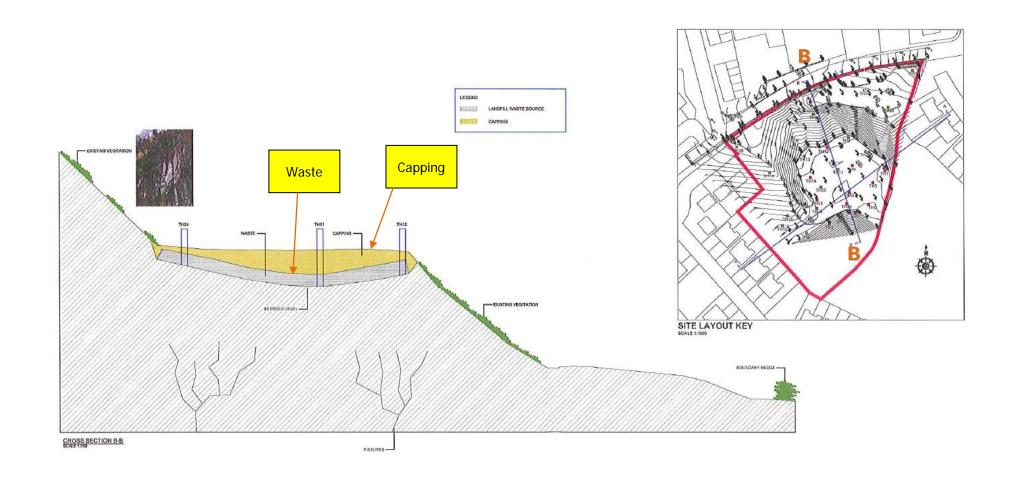
Conceptual site model:	Trial hole investigations carried out as part of Tier 2 revealed that the extent of the deposited waste was significantly smaller than it had been initially thought after Tier 1 Risk Assessment. This resulted in the change of a number of SPR linkages and the reduction of overall risk rating of the site from High Risk (class A) down to Moderate Risk (class B).		
	The conceptual site model is shown in Figures 6(a) and Figure 6(b).

Figure 6(a): Conceptual site model for Kingscourt Landfill site – Cross section A-A

Figure 6(b): Conceptual site model for Kingscourt Landfill site – Cross section B-B
