**Project**  
Tier 1 Assessment of Historical  
Landfills in Monaghan

## Killycard Walkover Survey Checklist – 12<sup>th</sup> June 2018

# PHOTOGRAPHIC LOG

**Project Number:** P1655

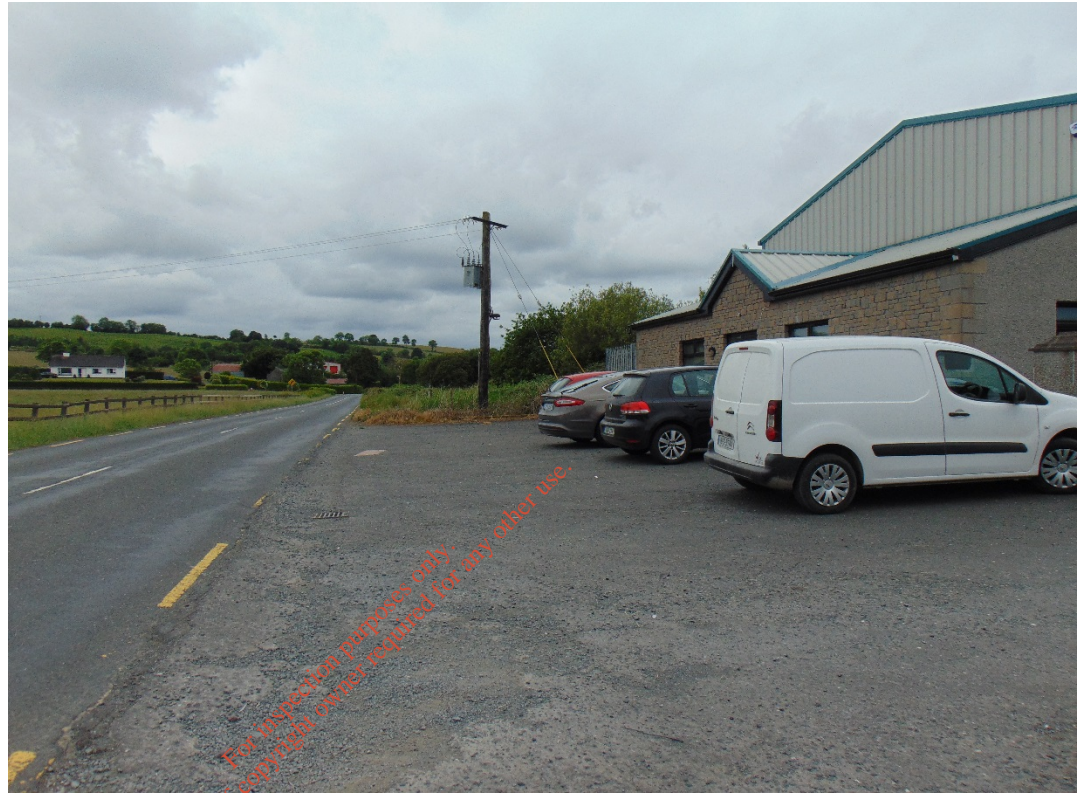
1

Site entrance to  
industrial units

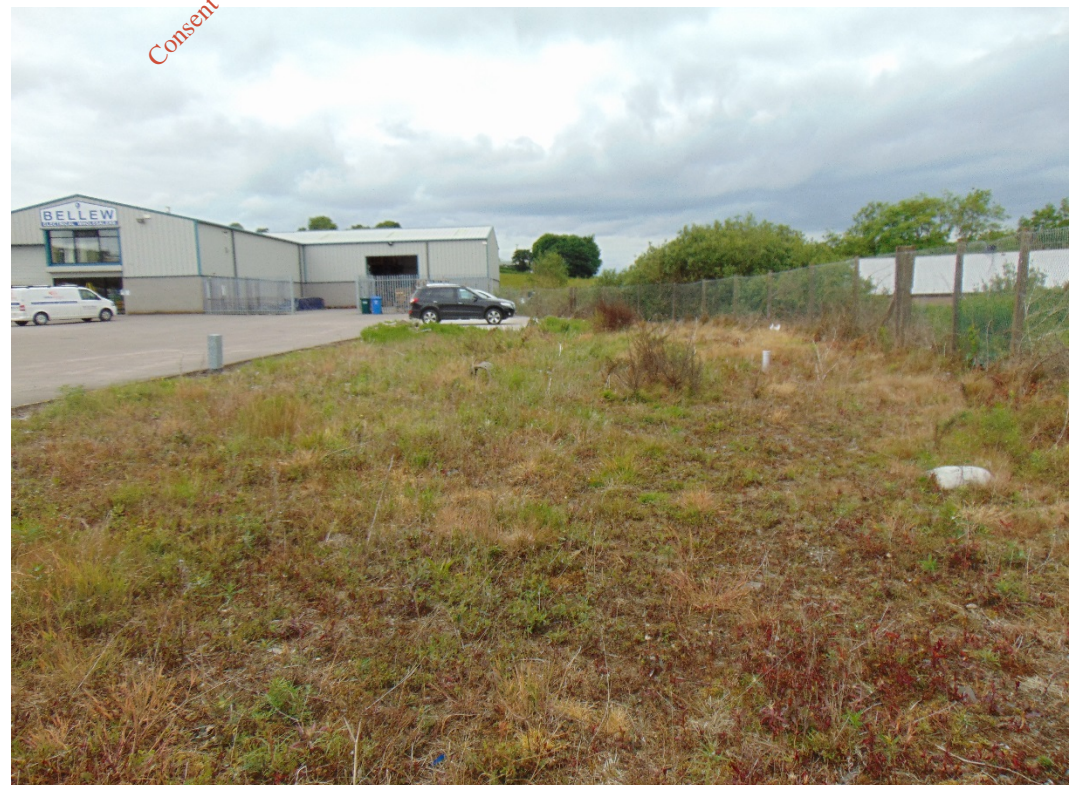
2

Grassed areas near  
industrial units carpark

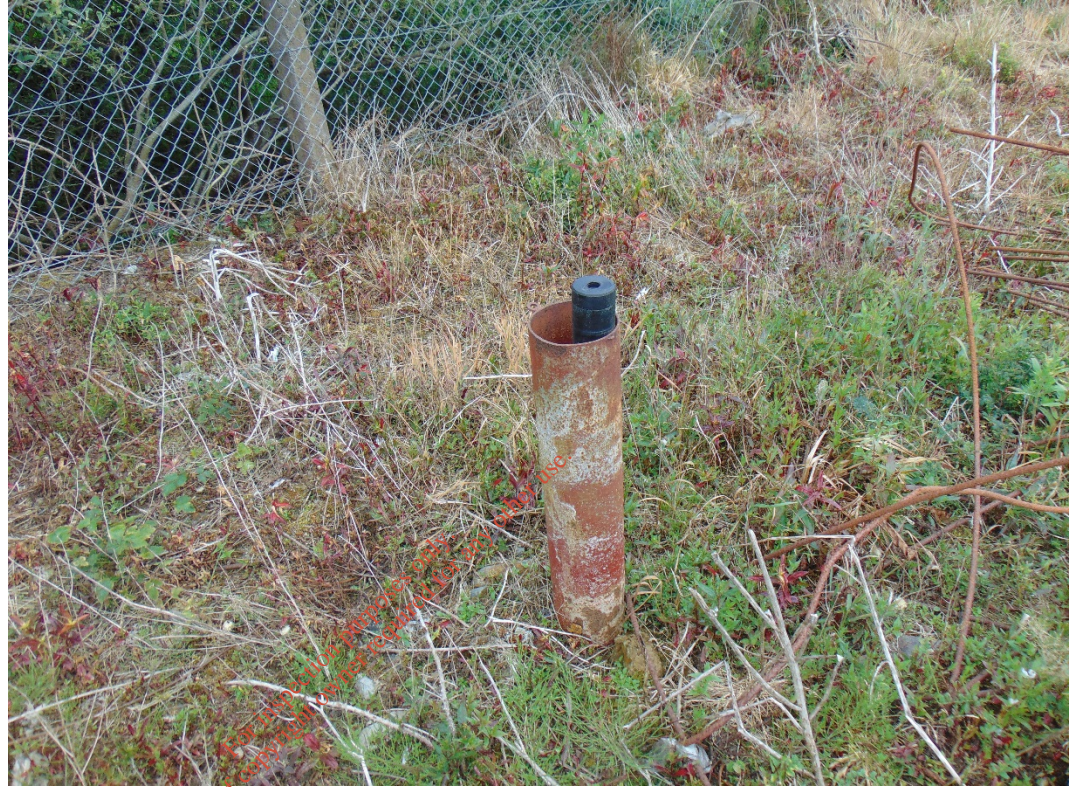
**Photo No.**  
3

Old gas well near industrial unit carpark

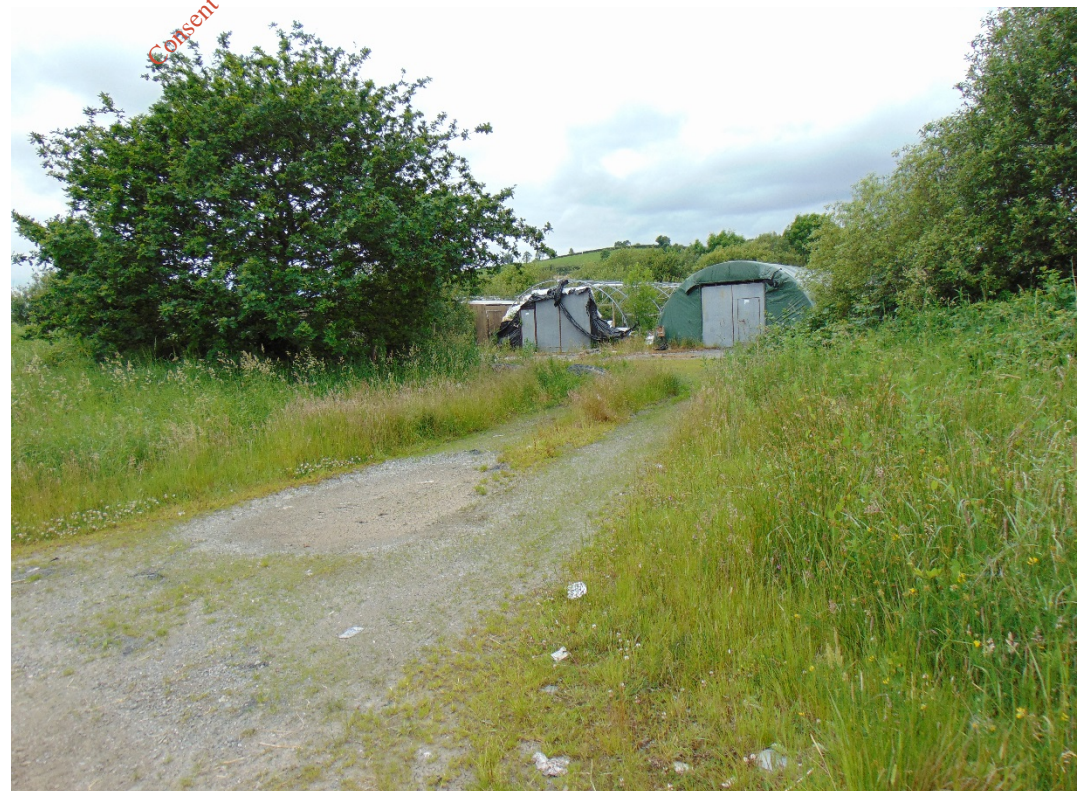
**Photo No.**  
4

Site entrance to derelict mushroom buildings

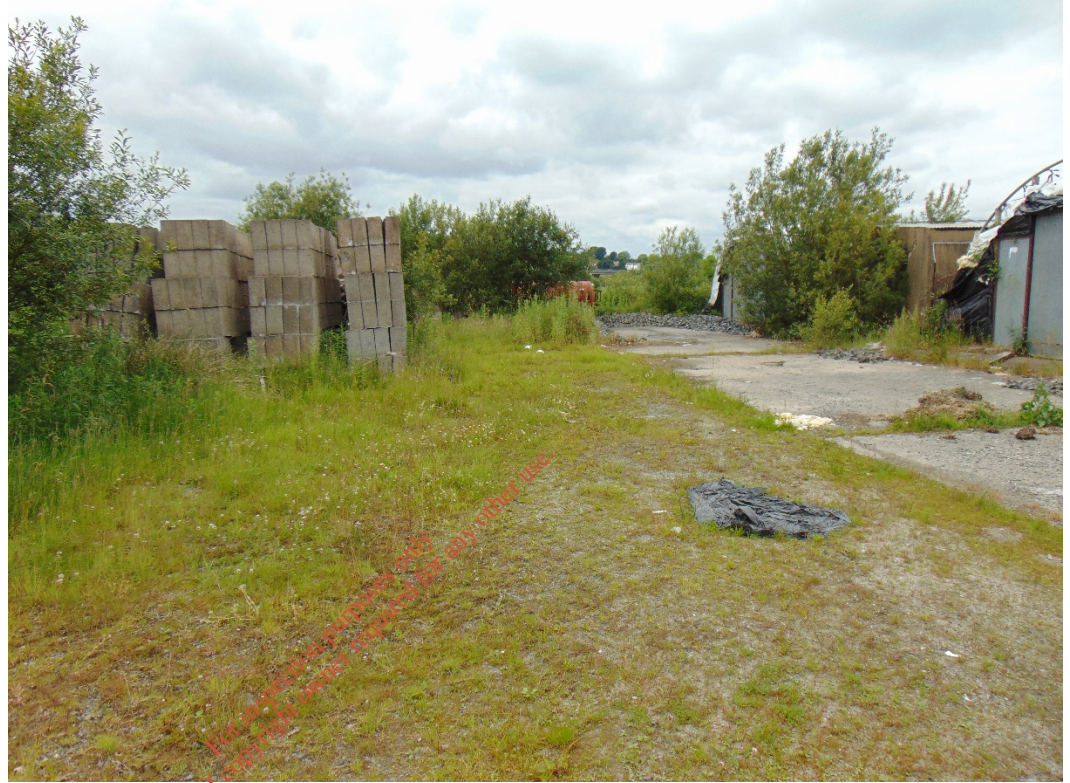
**Photo No.**  
5

Area in front of  
derelict mushroom  
buildings

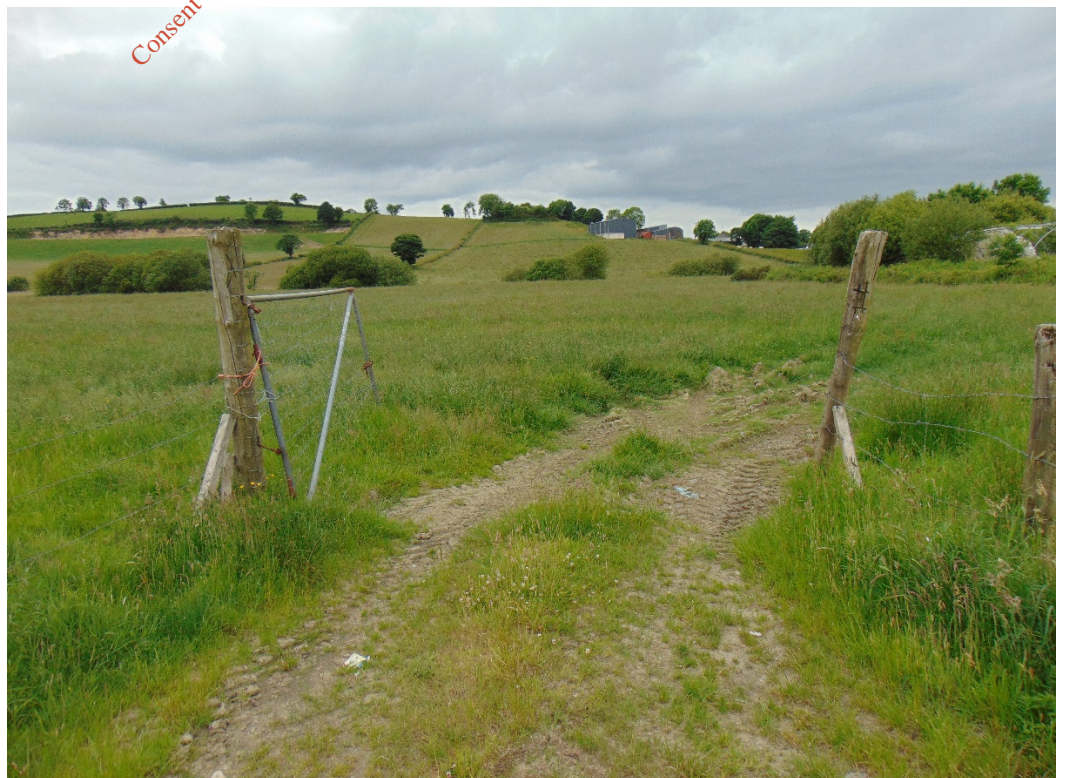
**Photo No.**  
6

Site entrance to  
vegetated field

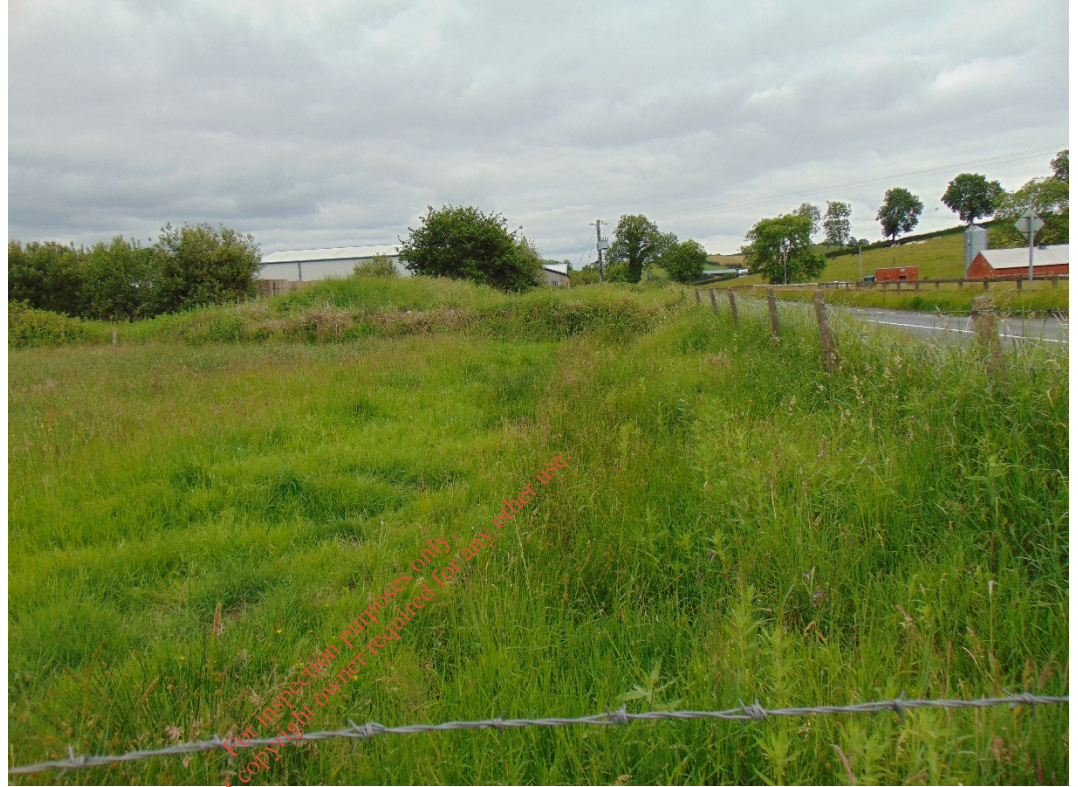
**Photo No.**  
7

Southern section of vegetated field

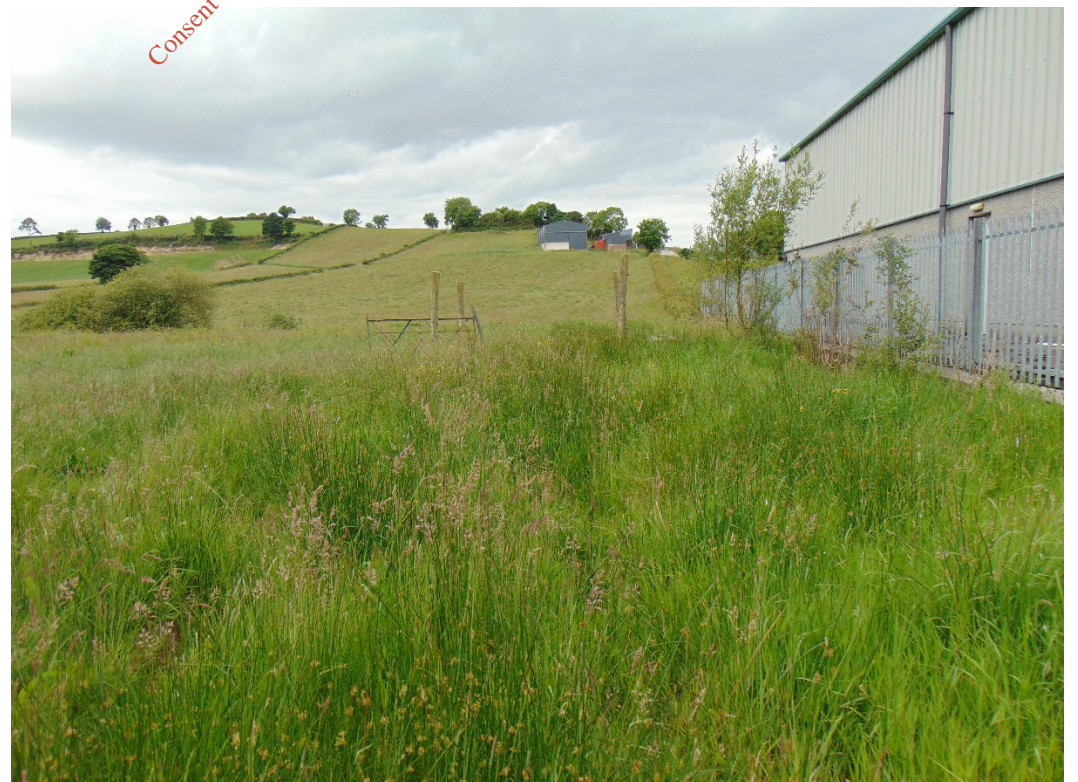
**Photo No.**  
8

Area west of industrial units, north of derelict mushroom buildings
