Project
Tier 1 Assessment of Historical
Landfills in Monaghan

Client
Monaghan County Council

Killycard Walkover Survey Checklist – 12th June 2018

Project Number: P1655

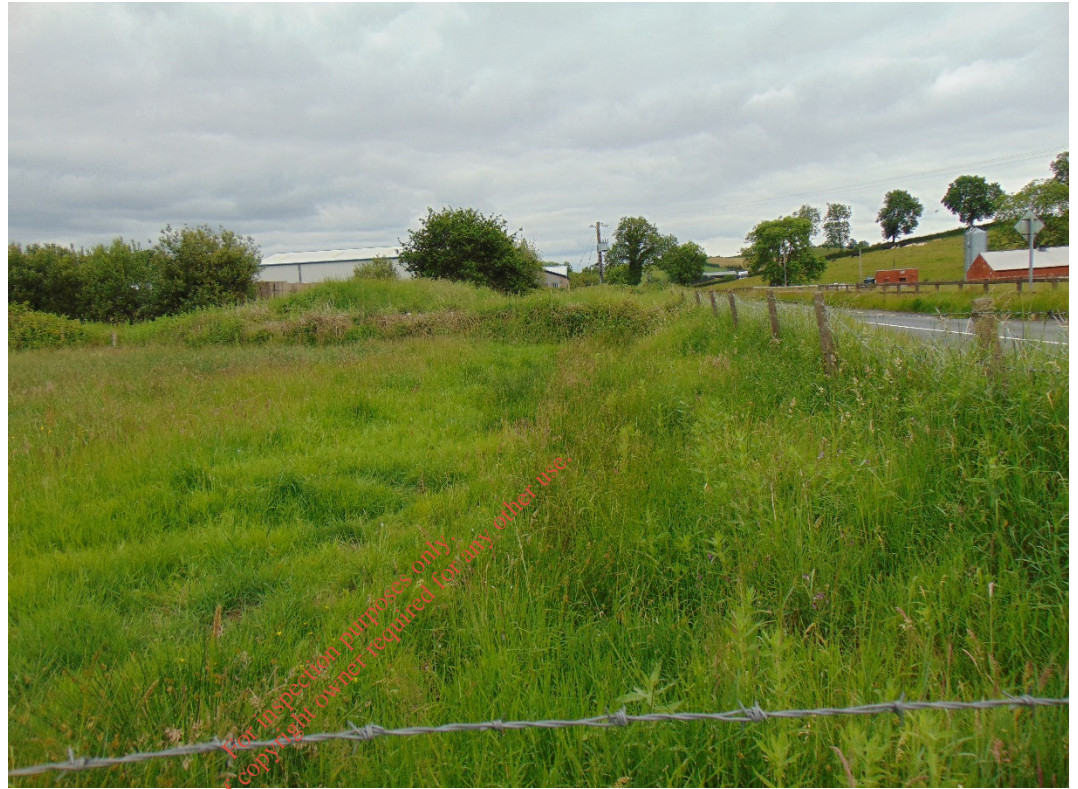
Photo No.
7

Southern section of vegetated field

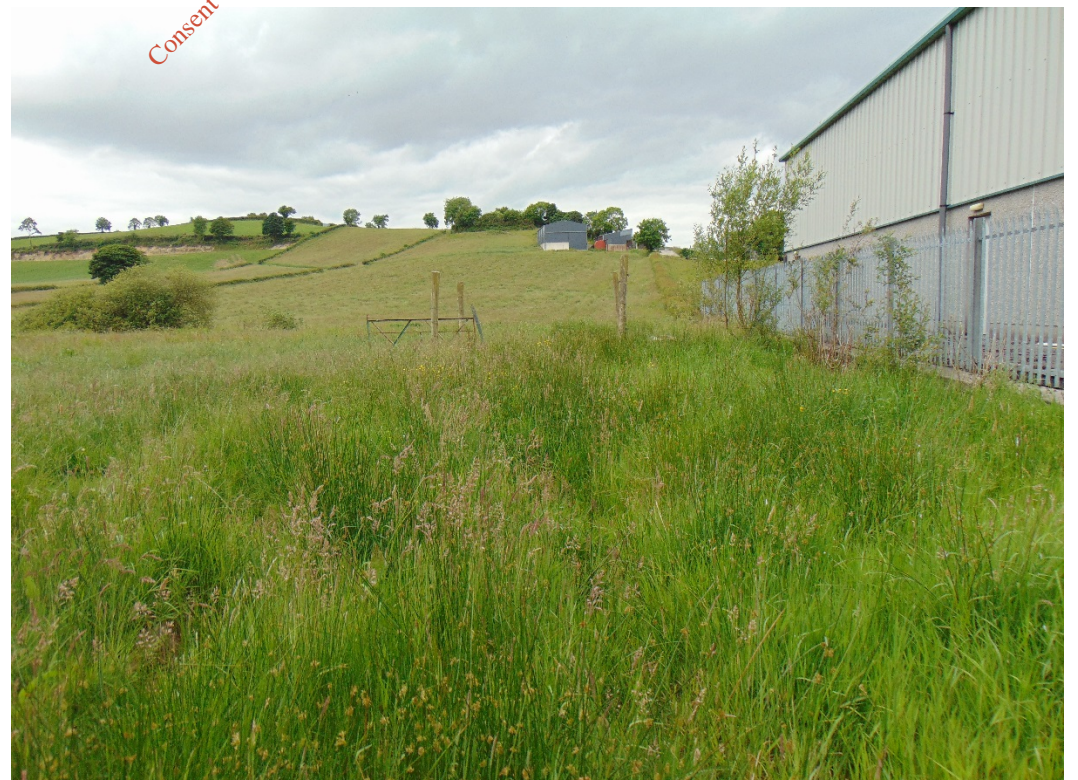
Photo No.
8

Area west of industrial units, north of derelict mushroom buildings
