APPENDIX 2

WWTP PIPELINE REPORTS

600MM Ø RISING MAIN PIPE FAILURE THROUGH LANDFILL 20-
06-06

**Site Investigation for a Proposed
Pipeline through a Lanfill Site at Skerries.**

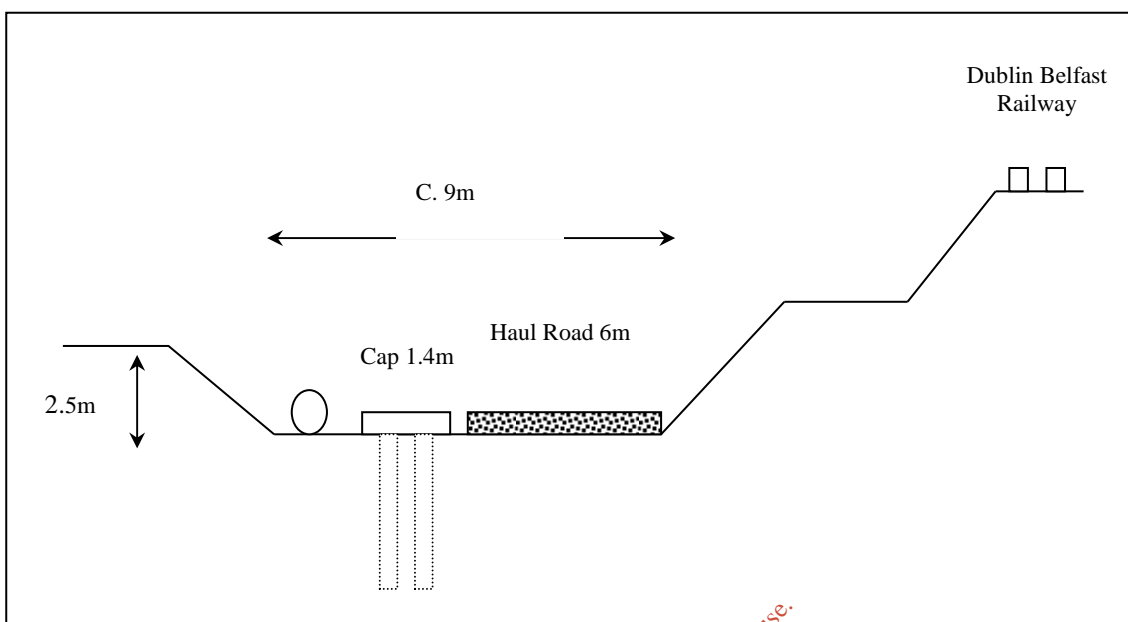
FIGURE 2 - TYPICAL CROSS SECTION THROUGH WORKS

- All excavation works are currently complete (circa 9m wide by 2.5m deep).
- 12 of the 18 pile caps are complete.
- 11 of the 17 support beams are in place.
- The pipe has been placed in protective wrapping and is ready to be placed.

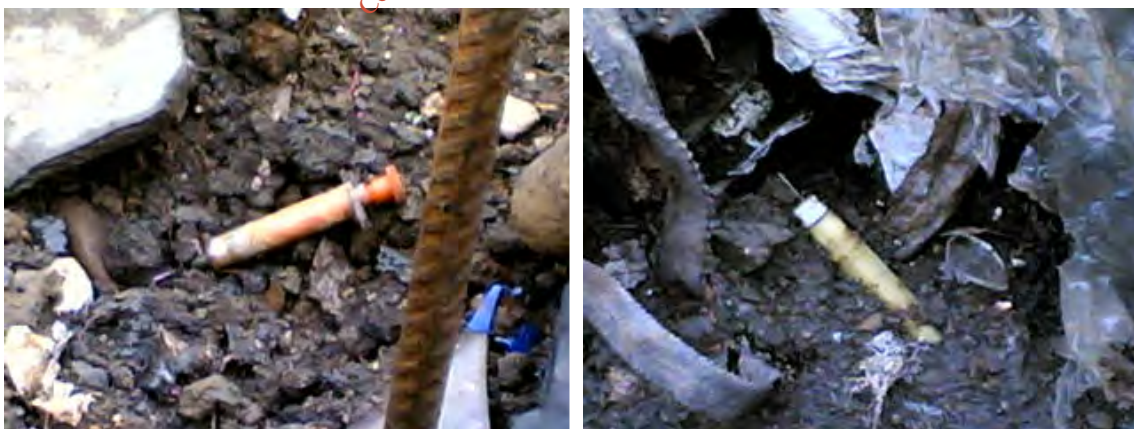
FIGURE 3 - CLINICAL WASTE FOUND 23/03/06

On Thursday March 23rd, site personnel noticed syringes and other clinical or veterinary waste through the sides of the excavations. On closer examination similar hazardous waste was discovered strewn along the excavated material. Work was suspended and the hazardous material marked. Figure 3 shows photos of some of the material found.

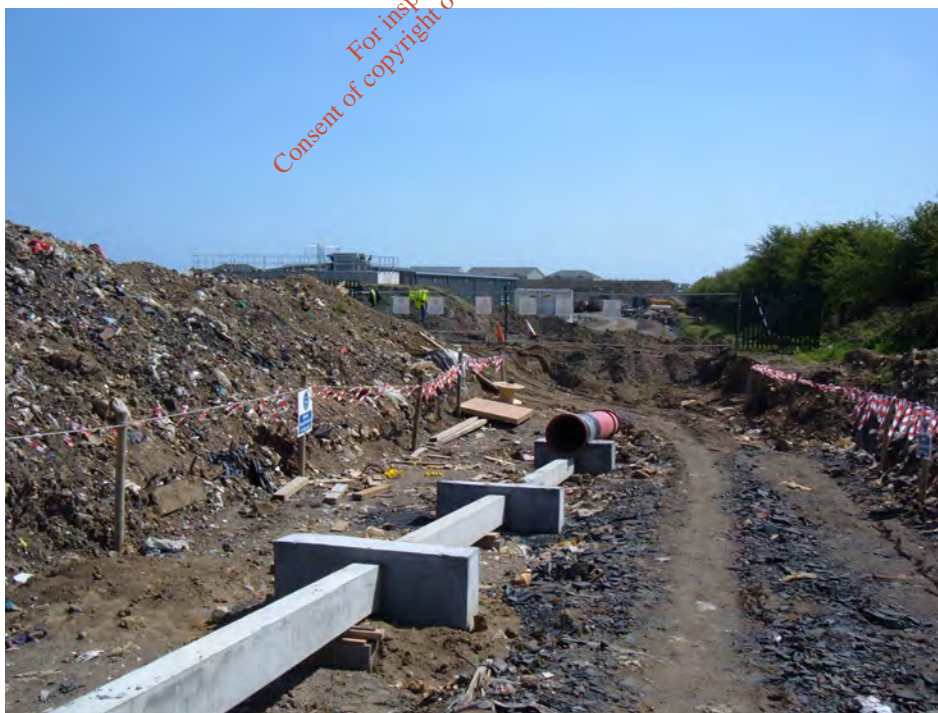
Photo No. 1 taken 28/04/06.

The section of pipeline between Ch 3210m and 3312m had been piled with 18 No. sets of piles at 6m centres with pile caps poured on top of each set tied together laterally with tie beams at a level of 150mm approx. below pile caps and then the pipe laid to rest only on the pile caps themselves as can be seen from photograph 1 & 2. Pipes were backfilled as can be seen from Photographs 3,4 & 5 and no plant traversed the pipeline during this backfilling operation.

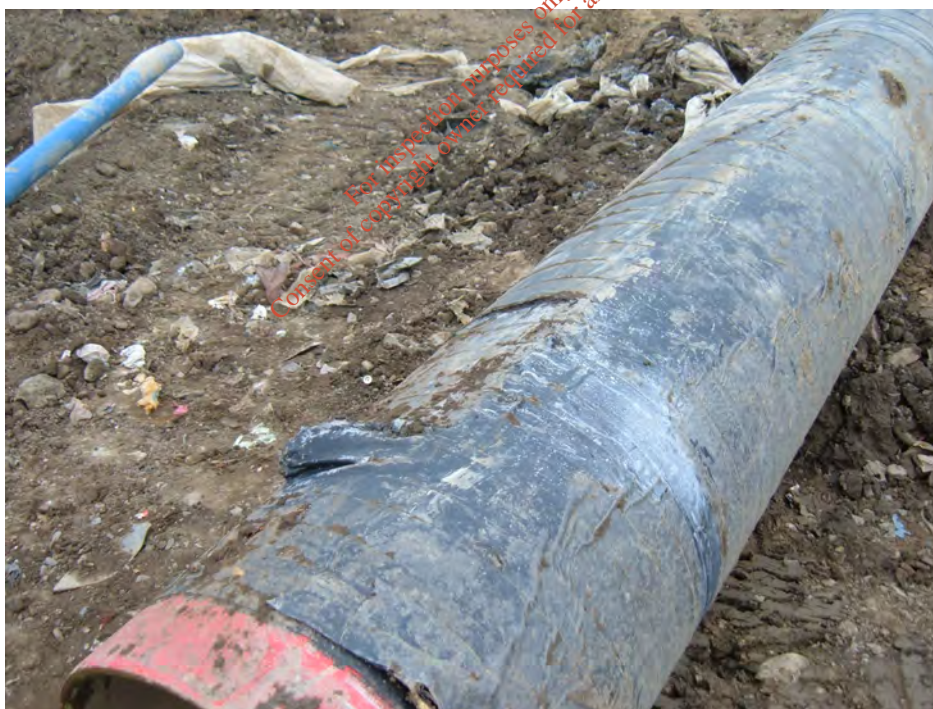
Photo No. 6 taken 20/06/06.

A major leak was detected after excavating a trial hole at Ch 3261m at a joint between 2 pipes, it was noted that the material underneath the mid section of the pipes (between the pile caps) had either settled away from the pipe due to the nature of the ground or had not been compacted correctly around and over the tie beams.

SIAC stated that they would remove any damaged pipes through this area and would have their consultants Nicolas O'Dwyers assess the situation and rectify the design accordingly. Pipe testing would continue on the remainder of the 600mm Ø pipeline despite these events.

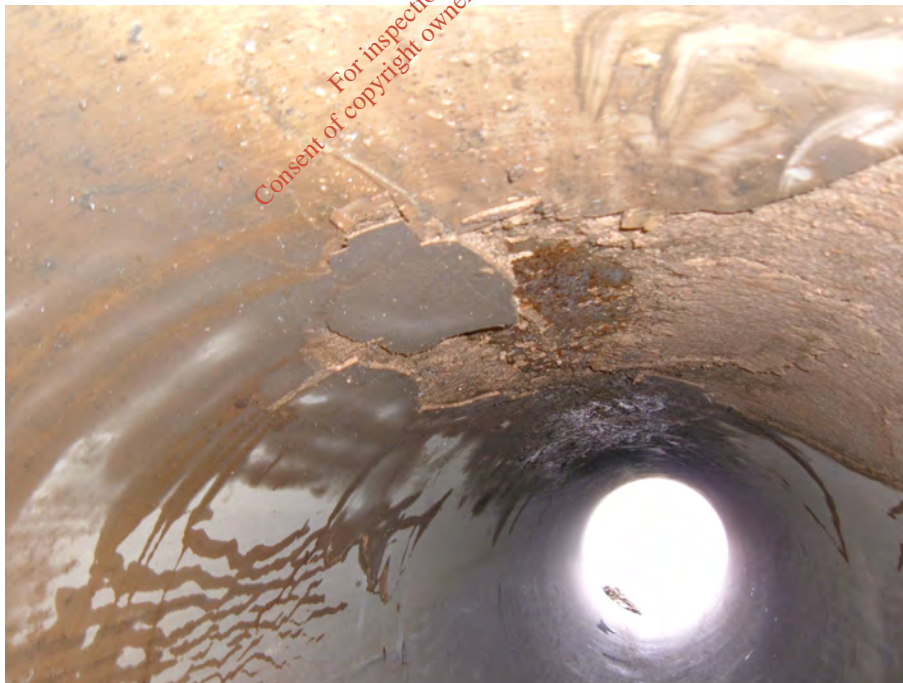
Photo No. 8 taken 20/06/06.

This had the effect of causing a point load to be applied to the pipes at each pile cap over a small bearing area as the pile caps were rectangle in shape and the pipe round. The pipe between Ch3255 & Ch3261m was cut and a section near the failed joint removed. When the interior of the pipe was inspected the pipe had deformed (see Photographs 6 & 7) and broke the cement lining off the inside of the pipes at the location of the pile caps (see photographs 8-10).
