## OFFICE OF ENVIRONMENTAL SUSTAINABILITY

### INSPECTOR'S REPORT ON AN APPLICATION FOR A CERTIFICATE OF AUTHORISATION FOR A CLOSED LANDFILL

**RE:** Application by **Roscommon County Council** for a Certificate of Authorisation for a closed landfill at **Cloondacarra Beg, Castlerea, County Roscommon**.

Certificate of Authorisation Register Number **H0394-01**.

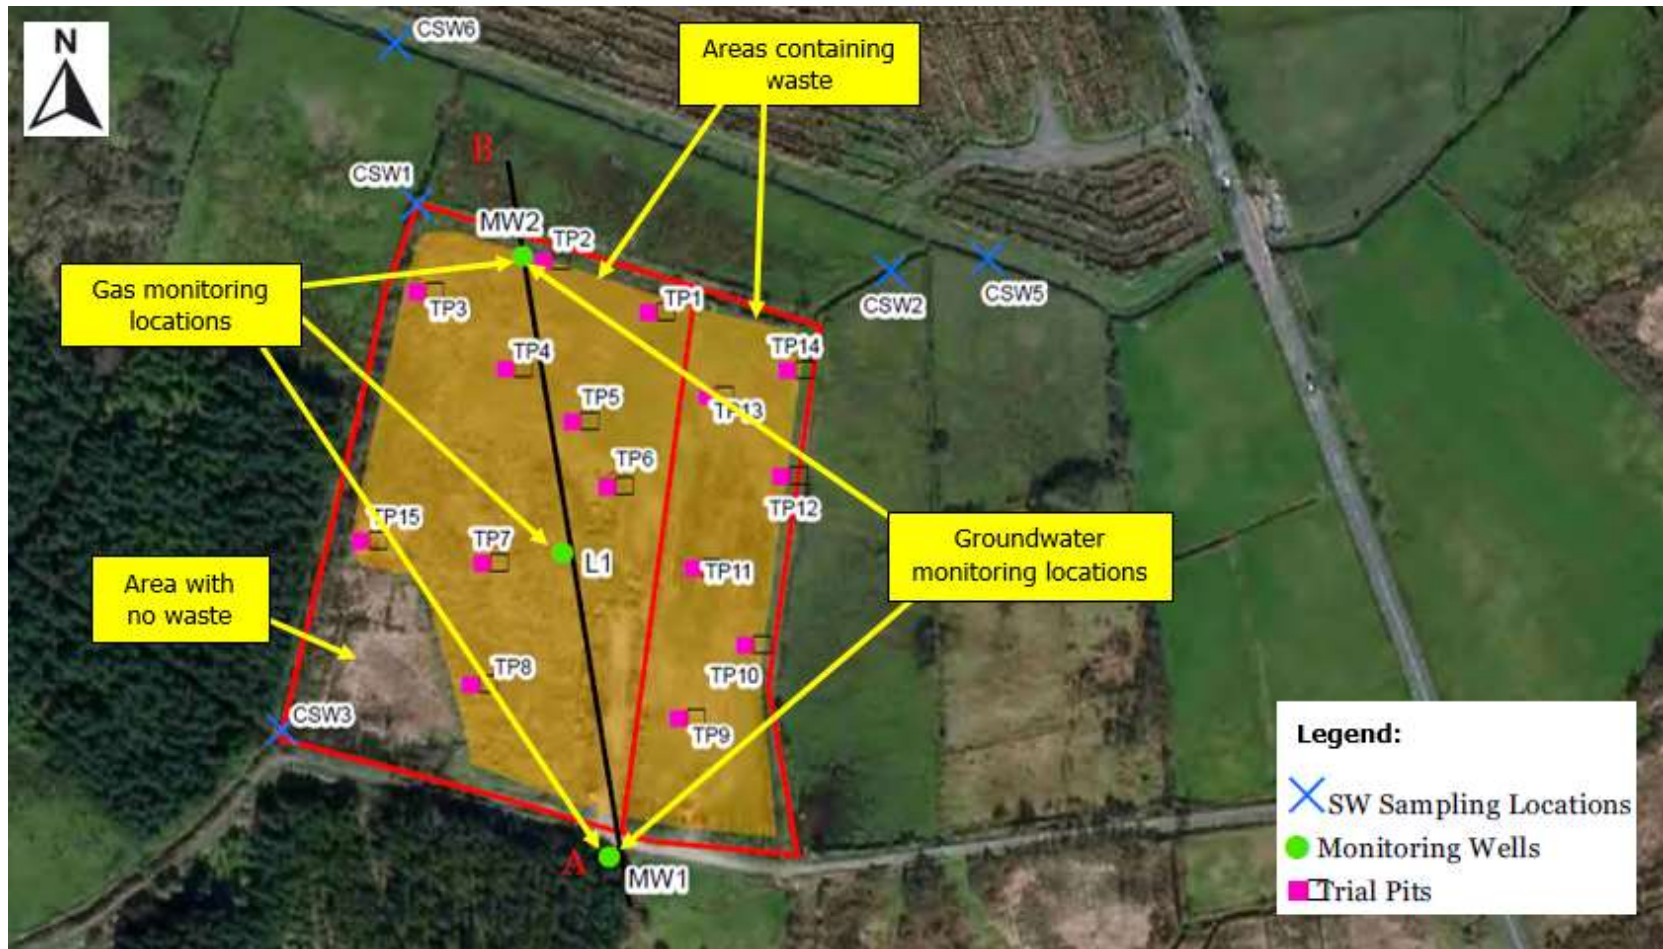
**Figure 3: Approximate extent of deposited waste and monitoring locations**

Quantity of waste at the facility	Approximately 41,500 tonnes. 83,000m <sup>3</sup>
Characterisation of waste deposited	The waste body comprises of municipal and commercial waste and sewage treatment sludge. The deposited waste includes organic material, paper, plastic, cinders, glass, metal, nappies, textiles and dog carcasses from a local pound.  The approximate extent of the deposited waste is shown in Figure 3.

<p>The surface water monitoring was carried out on 27<sup>th</sup> November 2017 and 8<sup>th</sup> August 2019 at five locations CSW1, CSW2, CSW3, CSW5 and CSW6, as shown in Figure 3.</p> <p>The 2017 monitoring results show exceedances of BOD at monitoring location CSW3, which is located upstream of the landfill in the land drain which flows along the western site boundary and discharges into the Harristown Stream. While the standard for BOD is 2.6 mg O<sub>2</sub>/l (95%ile flow) as set out in European Communities Environmental Objectives (Surface Waters) Regulations 2009, as amended, the recorded concentrations of this parameter was 3 mg/l. Also, the 2019 monitoring results shows exceedances of this parameter at CSW2, which is located downstream of the landfill on the land drain which runs along the eastern site boundary. The recorded concentration at CSW2 was 3 mg/l.</p> <p>The 2017 monitoring results also show exceedances of ammonia at all monitoring locations. While the standard for total ammonia is 0.140mg/l (95%ile flow) as set out in European Communities Environmental Objectives (Surface Waters) Regulations 2009, as amended, the recorded concentrations were: 0.37mg/l at CSW1, 17.86mg/l at CSW2, 0.23mg/l at monitoring locations CSW3 and CSW4, and 1.11mg/l at CSW6. Ammonia concentrations recorded in 2019 exceeded the said standard at CSW1 and CSW2 and were recorded at, respectively, 0.61mg/l and 7.77mg/l. CSW1 is located downstream of the landfill on the same land drain as CSW3. The 'Updated Tier 2 and Tier 3 Environmental Risk Assessment' (hereafter referred to as 'The risk assessment') submitted by the applicant states that the elevated ammonia levels in the upgradient monitoring locations may be associated with run-off from the surrounding lands and the local peat environment. However, there was no difference in the concentration of ammonia recorded at CSW5 and CSW6 in 2019. CSW5 is located on the Harristown Stream upstream of the discharge locations from the two land drains, while CSW6 is located on the Harristown Stream, downstream of the discharge locations from the two land drains. Ammonia at 0.09mg/l was recorded at each of these two locations.</p> <p>The monitoring results also show exceedance of the standard for orthophosphate in 2019. While the standard for this parameter is 0.075mg/l (95%ile flow), as set out in European Communities Environmental Objectives (Surface Waters) Regulations 2009, as amended, the recorded concentration of this parameter at CSW1 was 0.08mg/l.</p> <p>Furthermore, the monitoring results show exceedance of total cyanide in 2019. While the standard for this parameter is 0.01 mg/l (mean concentration) as set out in European Communities Environmental Objectives (Surface Waters) Regulations 2009, as amended, the recorded concentration of this parameter at CSW1 was 0.16mg/l.</p> <p>The monitoring results also show that in both monitoring rounds the concentrations of ammonia, chloride and potassium and manganese</p>

<p>were significantly higher at the downstream monitoring location CSW2 compared with the concentrations of these parameters recorded at the upstream monitoring location CSW3.</p> <p>The 2017 monitoring results further show that concentrations of sulphate, chloride, total oxidised nitrogen, BOD, COD, potassium, sodium and ammonia at the monitoring location CSW5 (upstream) were higher than the concentrations of these parameters at the monitoring location CSW6 (downstream). For example, concentration of ammonia at CSW5 was 0.23mg/l and 1.11 mg/l at the CSW6. The 2019 monitoring results show however, that the concentrations of most of the monitored parameters at CSW6 were the same, or less than the concentrations recorded at CSW5.</p> <p>The difference in water quality upstream and downstream of the site demonstrates that water quality in the Harristown Stream is being impacted by the closed landfill. However, the 2019 monitoring results show that this impact is not significant.</p> <p>Condition 3.8(d) requires monitoring of surface water at the locations upstream and downstream of the closed landfill on a quarterly basis.</p>

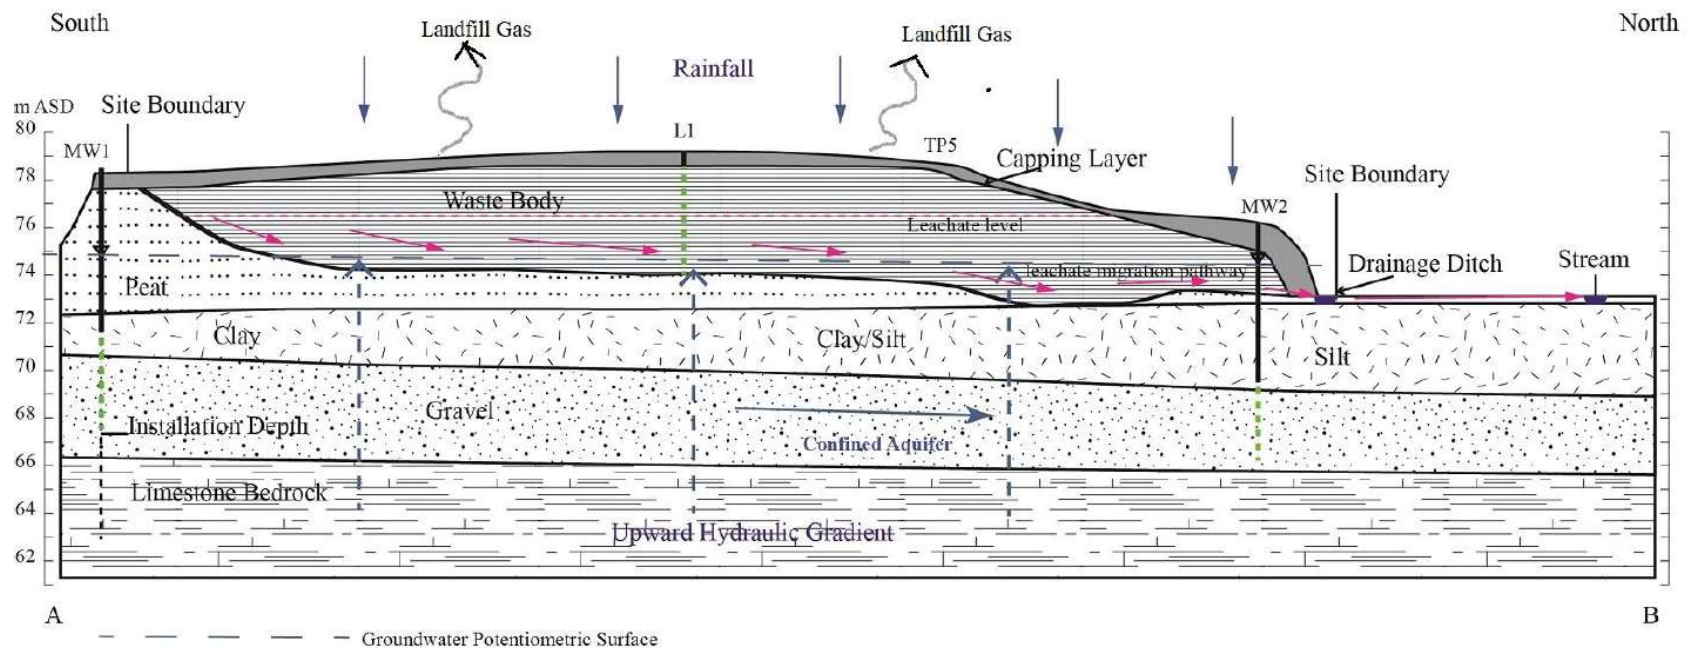
**Figure 4: Conceptual site model for Castlereas Landfill – cross section from South to North of the site**

Conceptual site model:	<p>The overall risk rating of the site is High Risk (class A) due to leachate migration to the surface waters.</p> <p>The conceptual site model is shown in Figure 4.</p>
