**SHORE ROAD HISTORIC LANDFILL,
CLIFDEN, CO. GALWAY**

**APPLICATION TO EPA
FOR
CERTIFICATE OF AUTHORISATION**

***TIER 2 SITE INVESTIGATION & RISK ASSESSMENT
OF SHORE ROAD LANDFILL REPORT
(16th May 2014)***

**TIER 2 SITE INVESTIGATION & RISK ASSESSMENT
OF
FORMER SHORE ROAD LANDFILL,
CLIFDEN, CO. GALWAY**

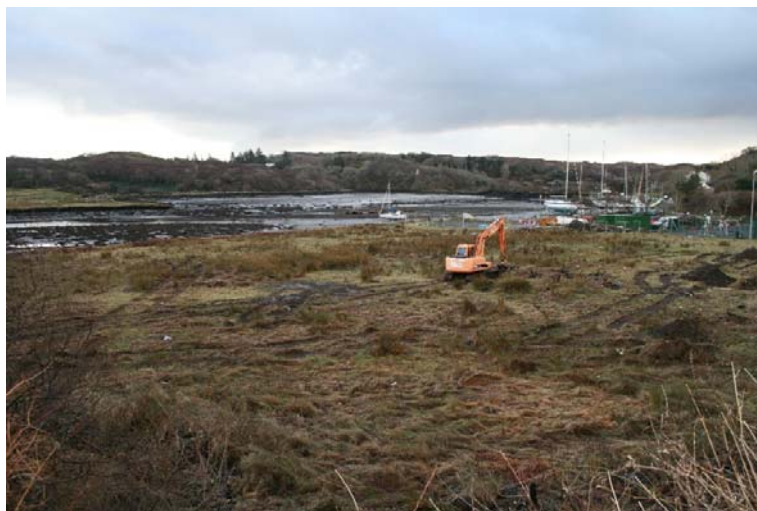
Plate 1. View of former Shore Road Landfill from north-eastern corner facing southeast

The site was wet under foot during the site investigation with rushes the predominant vegetation on site.

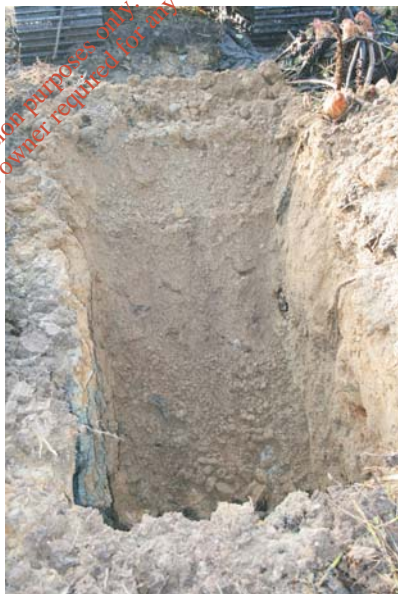
DESCRIPTION	COMMENTS	
			0	Soft light brown sandy SILT	Green color on wall of pit	0
			0.5	Soft yellow/light brown sandy gravelly CLAY with boulders and cobbles	No evidence of contamination	0.5
			1.0	indigenous soil	Indigenous Mottling	1.0
			1.5	Gray/ white coarse sandy GRAVEL with cobbles	Water ingress at 1.5m bgl	1.5
			2.0	Terminated at 1.55m bgl - hit weathered bedrock		2.0
			2.5

<u>LOCATION / NOTES:</u> NE corner. Some inflow of ponded water top of pit. Water rose to approximately 1m bgl.	<u>LEGEND</u> <input checked="" type="checkbox"/> Disturbed Sample <input type="checkbox"/> Undisturbed Sample * Headspace Analysis

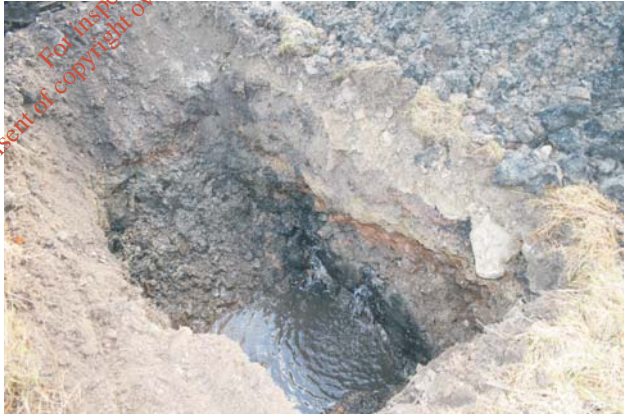
DESCRIPTION	COMMENTS	
			0	Soft dark brown sandy CLAY (MADE GROUND/LANDFILL CAP)		0
			0.5	Yellow/ light brown gravelly CLAY (MADE GROUND) with boulders and cobbles- rounded, sub rounded and sub-angular		0.5
			1.0	Some timber, occasional pods of peat		1.0
			1.5	Loose clayey gravelly COBBLES/ BOULDERS (MADE GROUND)	Possible stone drain	1.5
			2.0	Terminated at 1.82m bgl - hit weathered bedrock	At 1.5m bgl very strong inflow of clean water	2.0
			2.5			2.5
			3.0			3.0
			3.5			3.5
			4.0			4.0
			4.5			4.5
			5.0			5.0

<u>LOCATION / NOTES:</u> Located at the edge of the car park.	<u>LEGEND</u> <input checked="" type="checkbox"/> Disturbed Sample <input type="checkbox"/> Undisturbed Sample * Headspace Analysis † Down Borehole Analysis Groundwater Table Perched Water Table	TRIALPIT LOG	
		JOB TITLE	SHORE ROAD SITE INVESTIGATION
		LOCATION	CLIFDEN, CO. GALWAY
		CLIENT	GALWAY C.C.

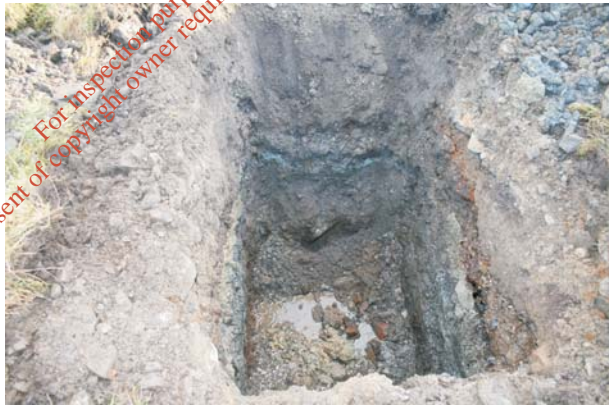
DESCRIPTION	COMMENTS	
			0	Soft light brown sandy CLAY (MADE GROUND/LANDFILL CAP)		0
			0.5	Soft yellow/ light brown gravelly CLAY with boulders and cobbles (rounded)	Iron mottling, black staining	0.5
			1.0	Loose angular clayey COBBLES (MADE GROUND) with boulders	Strong water inflow at 0.8m bgl	1.0
			1.5	clayey GRAVEL with cobbles		1.5
			2.0	Terminated at 2.10m bgl - hit weathered bedrock		2.0
			2.5

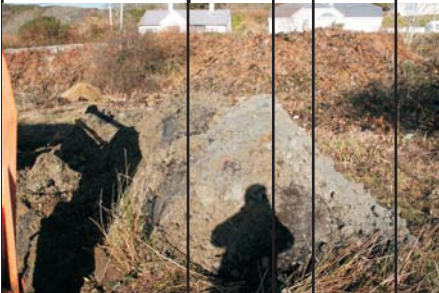
0		Soft light brown sandy CLAY (MADE GROUND/LANDFILL CAP)		0
				0.5		Soft light gravelly CLAY (MADE GROUND) with boulders	Trapped clay pipe with water	0.5
				1.0		Soft/firm yellow brown gravelly CLAY		1.0
				1.5		Soft gray gravelly CLAY with cobbles/boulders interspersed	No evidence of contamination Mottling	1.5
				2.5		Soft gray sandy gravelly SILT with rounded boulders and cobbles	Collapsing sides	2.5
				3.5		Coarse gray sandy GRAVEL with boulders and cobbles	Water ingress at 3.5m bgl	3.5
				4.0				4.0
				4.5		Terminated at 3.9m bgl- hit weathered bedrock		4.5

LOCATION / NOTES: Near shallow land drain. Noticeable drop off in depth to bedrock.	LEGEND

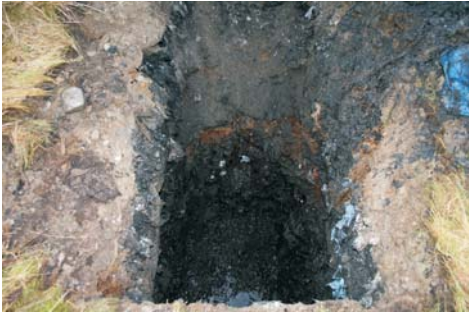
DEPTH (m)	GEOLOGY	DESCRIPTION	COMMENTS	
				0		Soft light brown sandy CLAY (MADE GROUND/LANDFILL CAP)		0
				0.5		soft yellow/light brown gravelly CLAY with boulders and cobbles- rounded, sub-rounded, sub-angular etc some builders blocks		0.5
				1.0				1.0
				1.5				1.5
				2.0				2.0
				2.5		soft black/dark gray gravelly sandy SILT with boulders	Sulphide odor/brackish smell Strong water ingress	2.5
				3.0				3.0
				3.5		End of hole at 3.5m bgl - hit weathered bedrock		3.5
				4.0

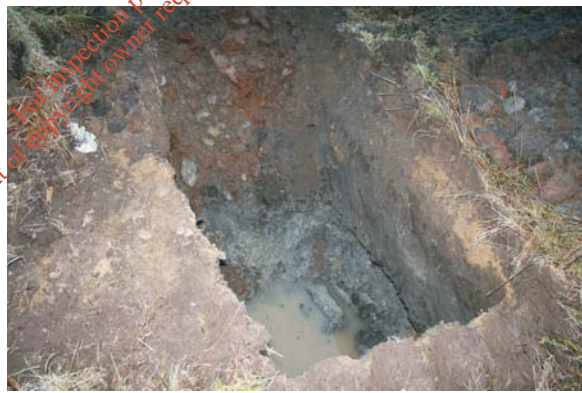
Drainage pipe at 0.5m bgl Strong inflow	0.5
	1.0	Mixed WASTE (DOMESTIC/COMMERCIAL/C&D)	Slight Sulphide odor	1.0
	1.5	Black plastic bin bag waste/ plastics, skip waste, residential renovation waste, electric cables, timer shards, plastic & glass bottles, ash and cinder, rubber hosing, car parts, inflow from perched water table into overlying plastic sheeting.		1.5
	2.0			2.0
	2.5			2.5
	3.0		Collapsing pit walls	3.0
	3.5		No sheen on water.	3.5
	3.9		Strong inflow	3.9
	4.0	Terminated at 3.9m bgl - hit weathered bedrock or very large boulder.		4.0
	4.5			4.5
	5.0			5.0

LOCATION / NOTES: East of helepad	LEGEND

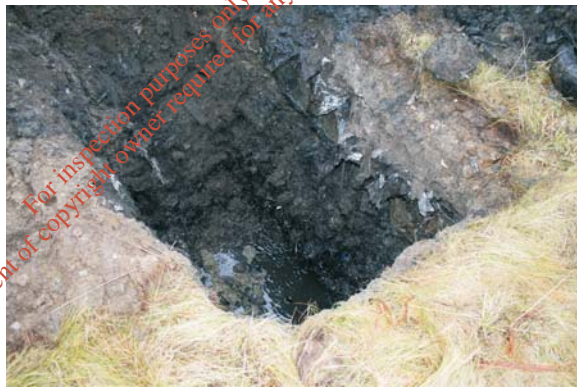
DEPTH (m)	GEOLOGY	DESCRIPTION	COMMENTS	
				0		Soft light brown sandy CLAY (MADE GROUND/LANDFILL CAP)		0
				0.5				0.5
				1.0				1.0
				1.5		Mixed WASTE (DOMESTIC/COMMERCIAL/C&D) skip waste, residential renovation waste, electric cables, timer shards, masonry, plastic & glass bottles, ash and cinder, rubber hosing, car parts, inflow from perched water table into overlying plastic sheeting.	No evidence of Contamination	1.5
				2.0				2.0
				2.5				2.5
				3.0				3.0
				3.5				3.5
				4.0		Terminated at 3.95m bgl - hit weathered bedrock.		4.0
				4.5				4.5
				5.0				5.0

LOCATION / NOTES: East of helipad	LEGEND <input checked="" type="checkbox"/> Disturbed Sample <input type="checkbox"/> Undisturbed Sample * Headspace Analysis † Down Borehole Analysis Groundwater Table Perched Water Table	TRIALPIT LOG	
		JOB TITLE	SHORE ROAD SITE INVESTIGATION
		LOCATION	CLIFDEN, CO. GALWAY
		CLIENT	GALWAY C.C.

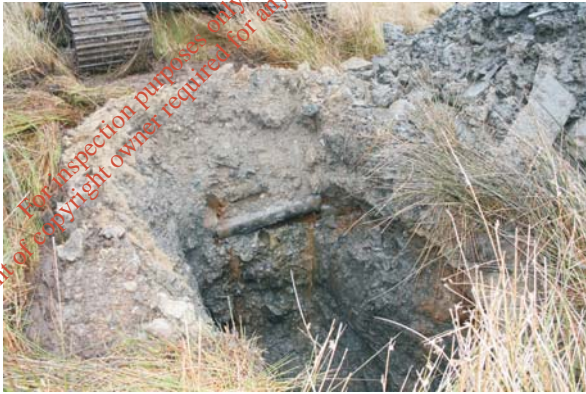
Inflow from pipe, possibly an old foul sewer	0.5
			1.0	Large amount of boulders and rubble		1.0
			1.5	Some pipes		1.5
			2.0	Pockets of Peat, low percentage domestic waste		2.0
			2.5

Collapsing sides	2.5
			3.0			3.0
			3.5			3.5
			4.0	Terminated at 3.75m bgl - hit weathered bedrock		4.0
			4.5			4.5
			5.0			5.0

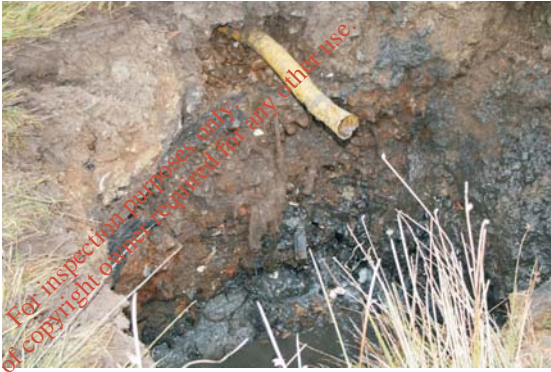
DEPTH (m)	DESCRIPTION	COMMENTS	
		0	Soft light brown sandy CLAY (MADE GROUND/LANDFILL CAP)	Land Drain	0
		0.5	Soft light brown/green gravelly CLAY		0.5
		1.0	C&D WASTE (MADE GROUND)	No odor	1.0
		1.5	Boulders, bricks, blocks, ash, timber, some glass, metal, some plastics	Strong inflow from N face and S face	1.5
		2.0	Mottling around waste		2.0
		2.5

2.5
		3.0			3.0
		3.5	soft brown gravelly CLAY with cobbles	Indigenous	3.5
		4.0	Terminated at 3.85m bgl - hit weathered bedrock		4.0
		4.5			4.5
		5.0			5.0

LOCATION / NOTES: Located beside helipad.	LEGEND
