TIER 3

ENVIRONMENTAL RISK ASSESSMENT

FORMER MUNICIPAL LANDFILL

WHITEGATE

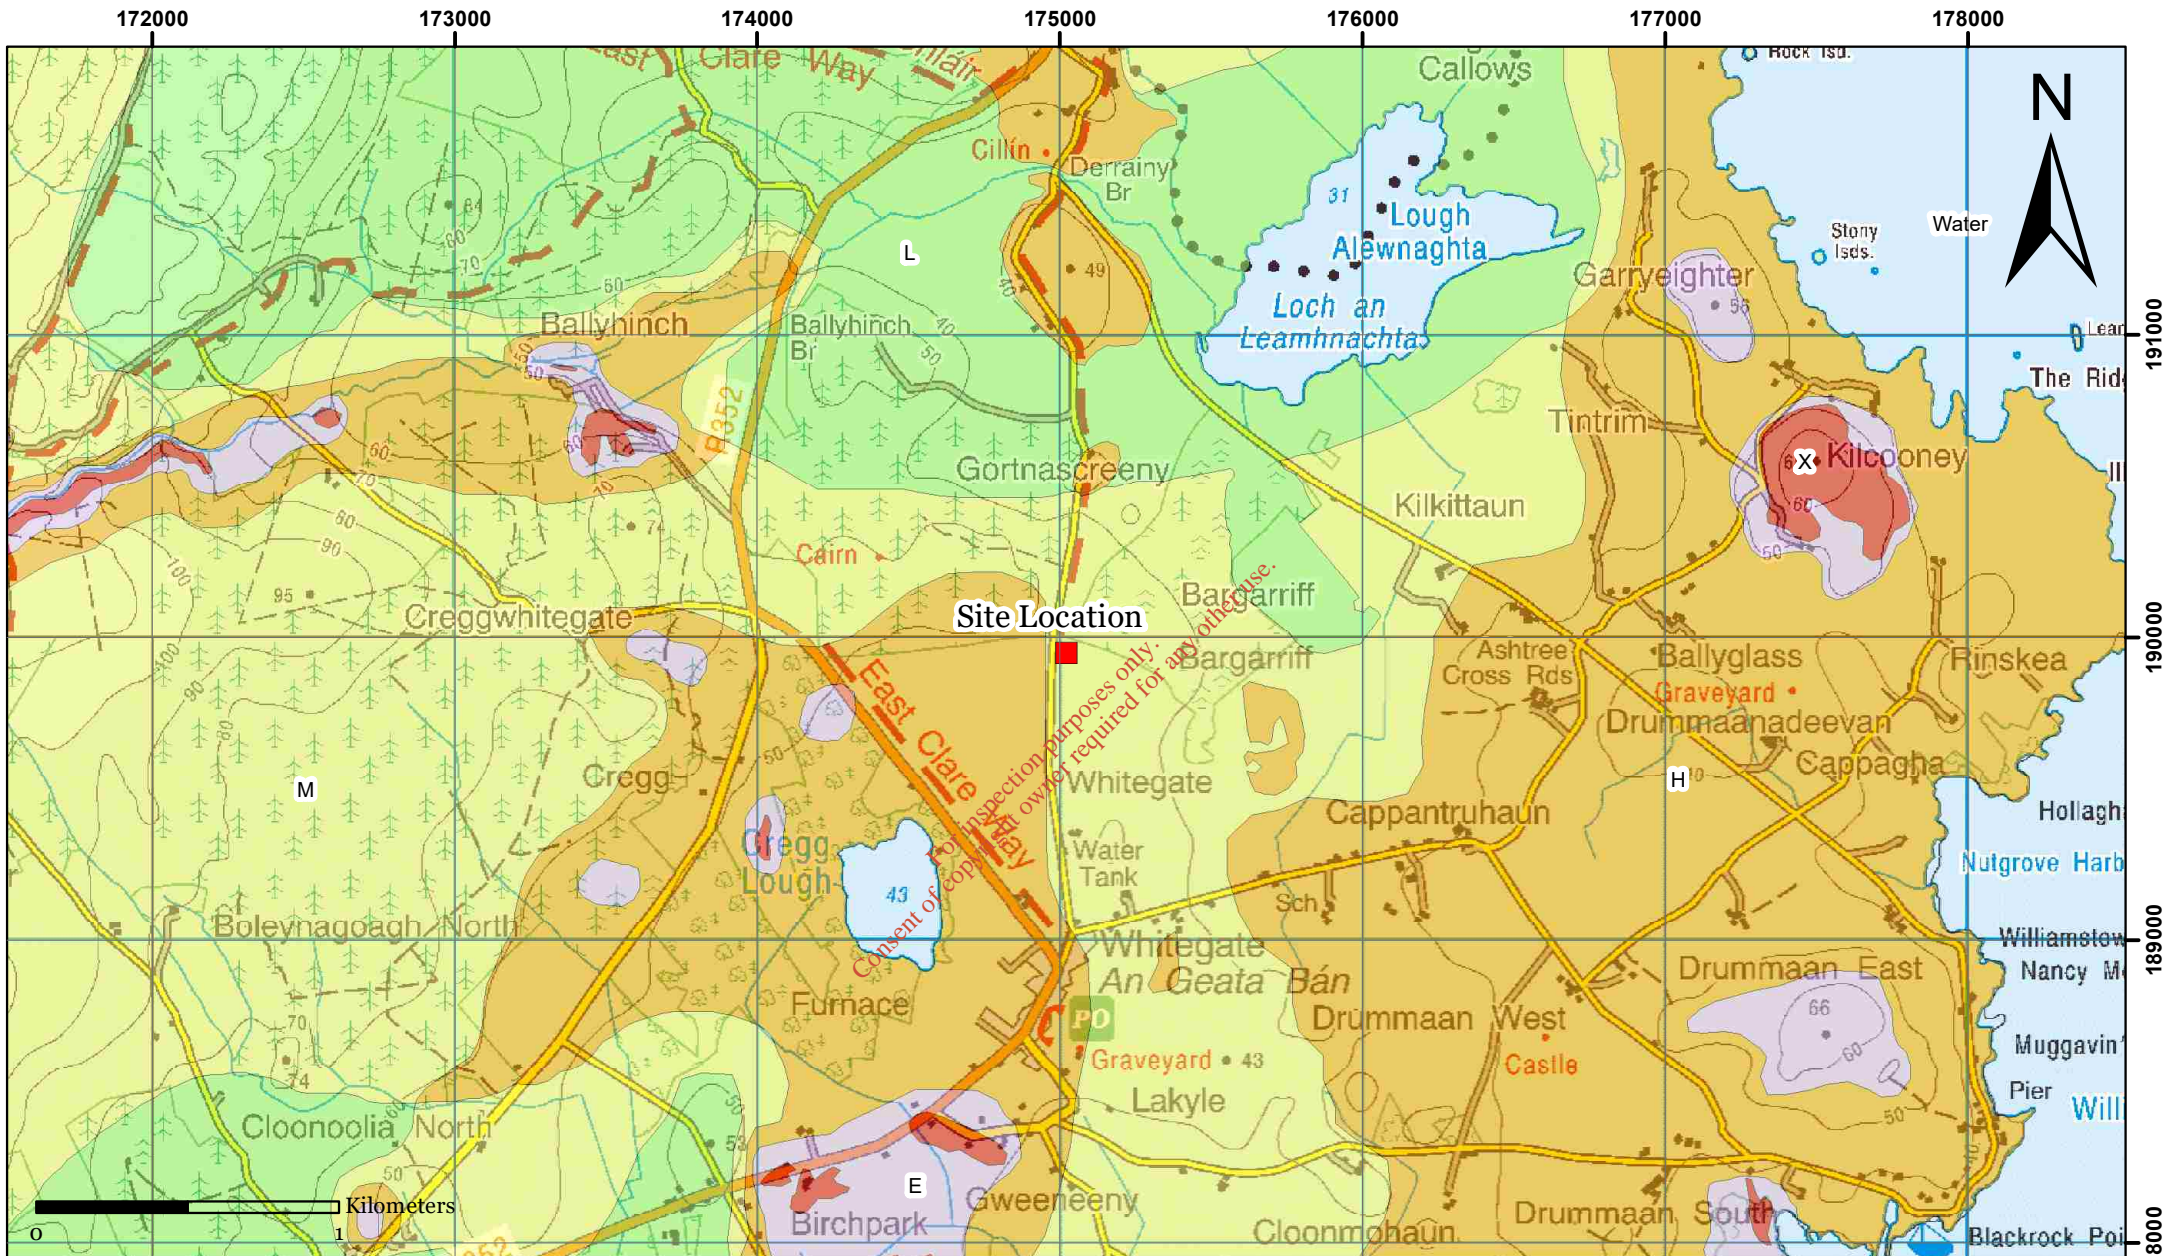
Figure 2.8

The vulnerability rating for the bedrock aquifer underlying the peat in the area is classified as Moderate indicating the presence of up to 5m of subsoils above the bedrock (Figure 2.8) however the harvesting of peat has reduced the vulnerability rating and the trial pit excavations indicates that the vulnerability in T-6 and T-8 is Extreme. .

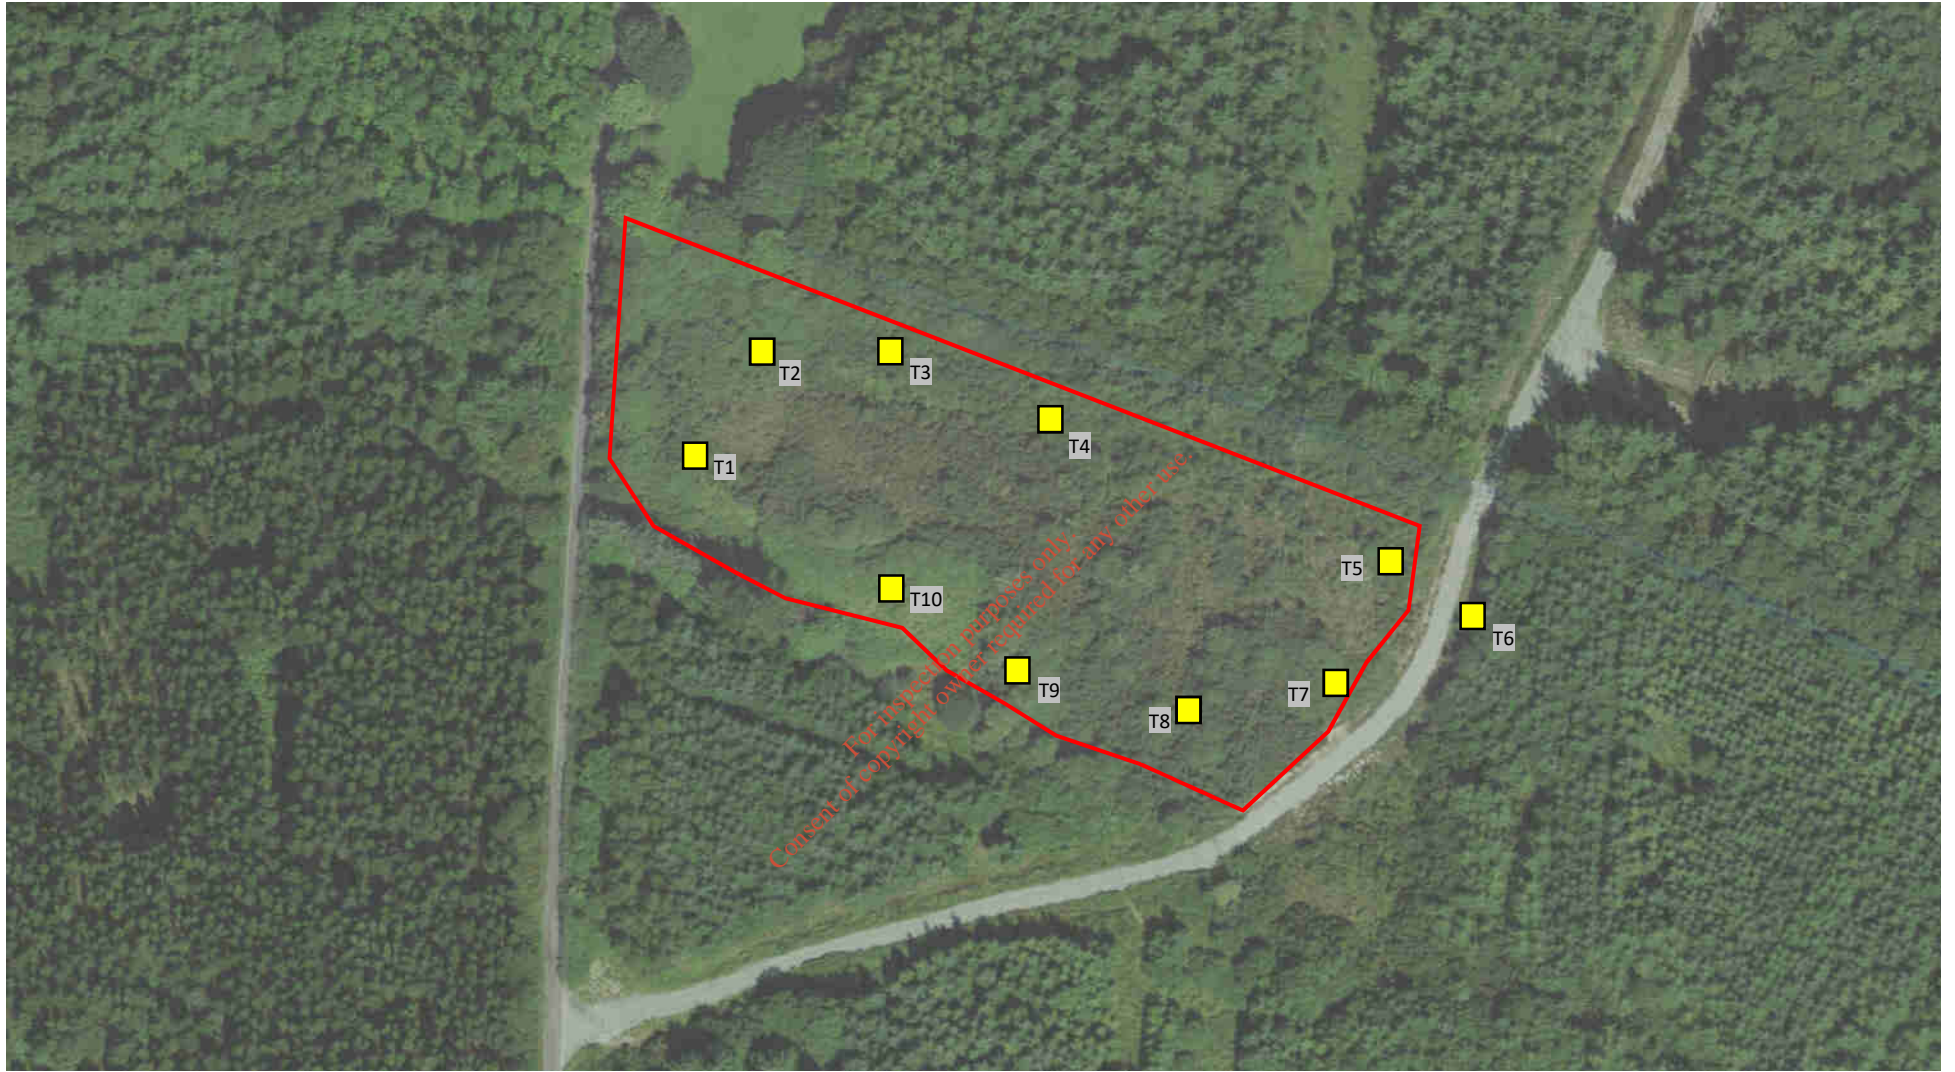
Title:
 Figure 3.1 Trial Pit Location

Ten trial pits (T-1 T-10) were opened across the site which confirmed the presence of c200 – 700mm capping layer comprising top soil. Waste is present across the entire site with a thickness of between 4-5m. The waste footprint covered 1.19 ha. It is underlain in all trial pit locations by peat. It is noted that water inflows were observed in the trial pit and is indicated as the water table. However given the nature of the site it is more likely that the water in the trial pits is perched water in the waste mass and not groundwater.

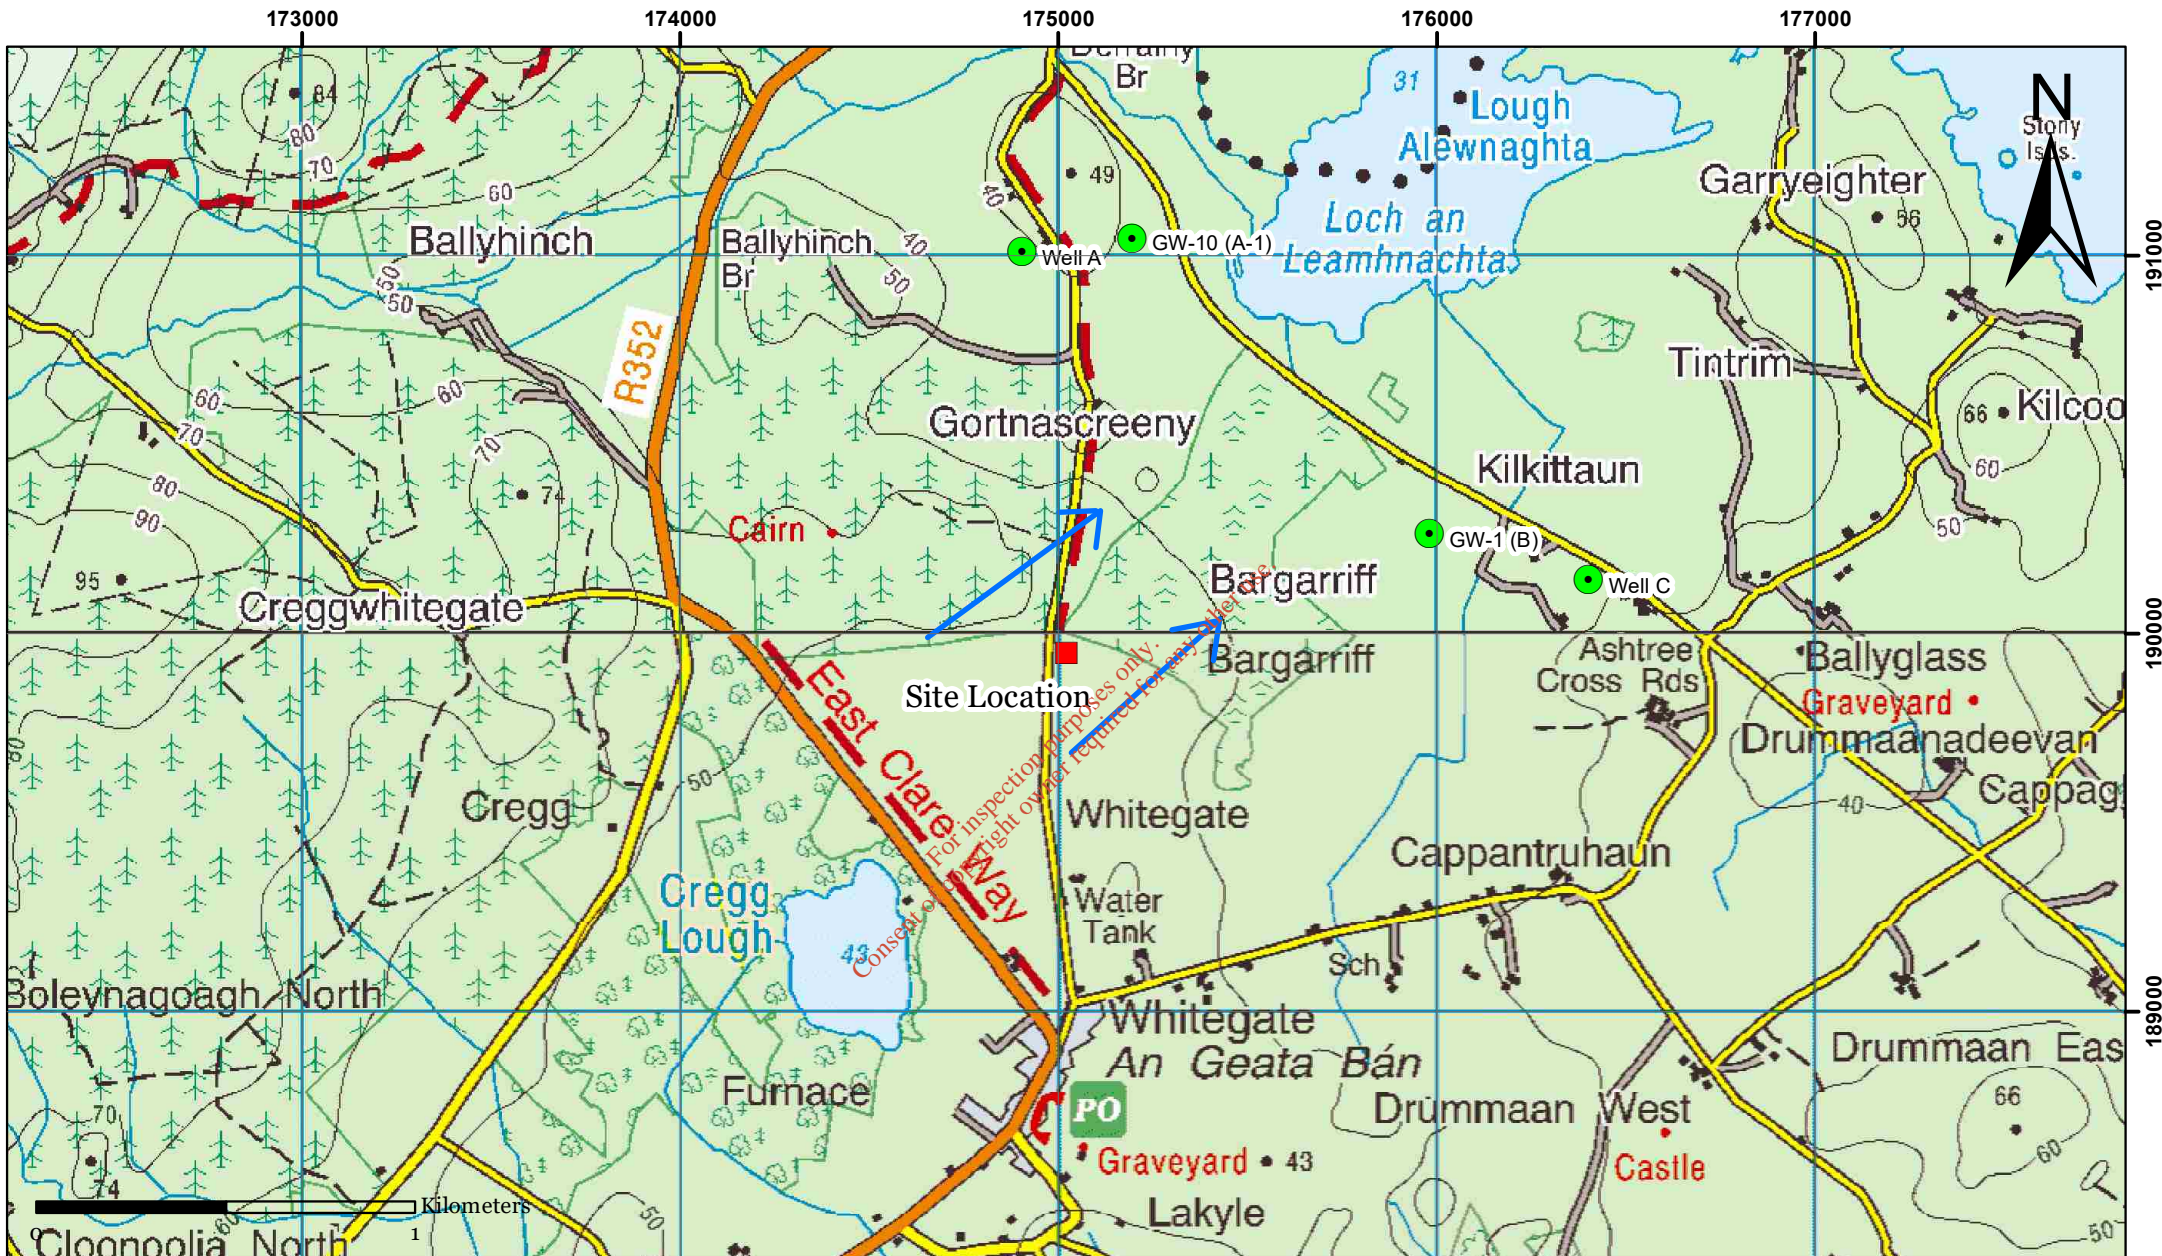
Figure 3.2

Based on the local topography and site drainage the groundwater flow direction is considered to be from the high ground to the west where the highest elevation locally is c95mOD to the east and north east toward Lough Alwenaghta c31mOD.

The well locations and groundwater flow direction is shown on Figure 3.2.

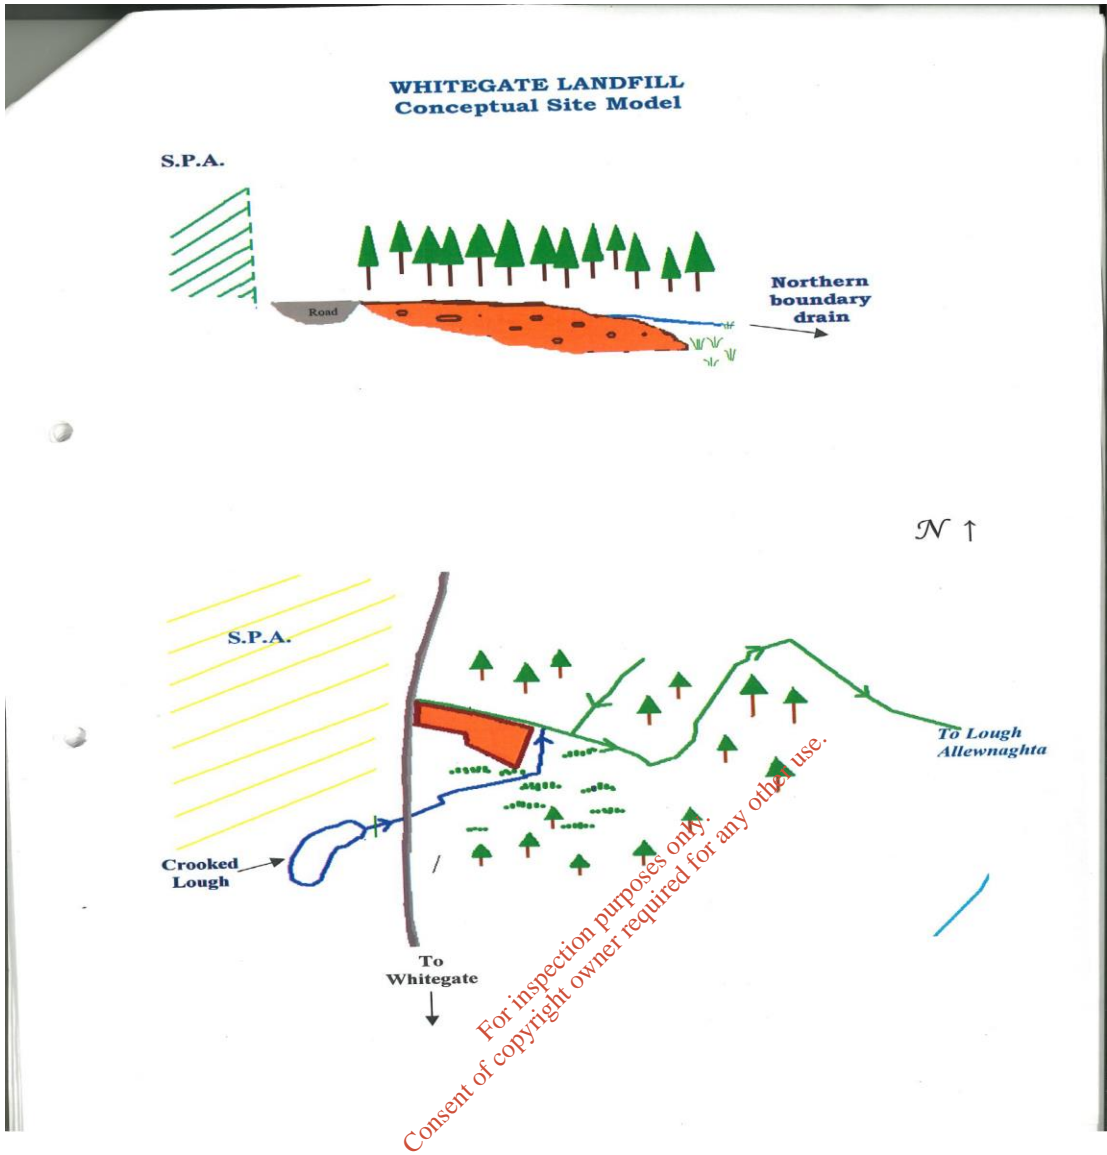
Figure 4.1 Tier 1 Conceptual Site Model

The Tier 1 Conceptual Site Model (CSM) is shown in Figure 4.1. It shows the waste mass on the underlying peat with waste filled close to the road to the west of the landfill with the Special Protection Area further west and the drain to the north of the landfill into which leachate is migrating.
