Tier 1 Environmental Risk Assessment

Unlicensed Landfill

Whitegate

Clare County Council

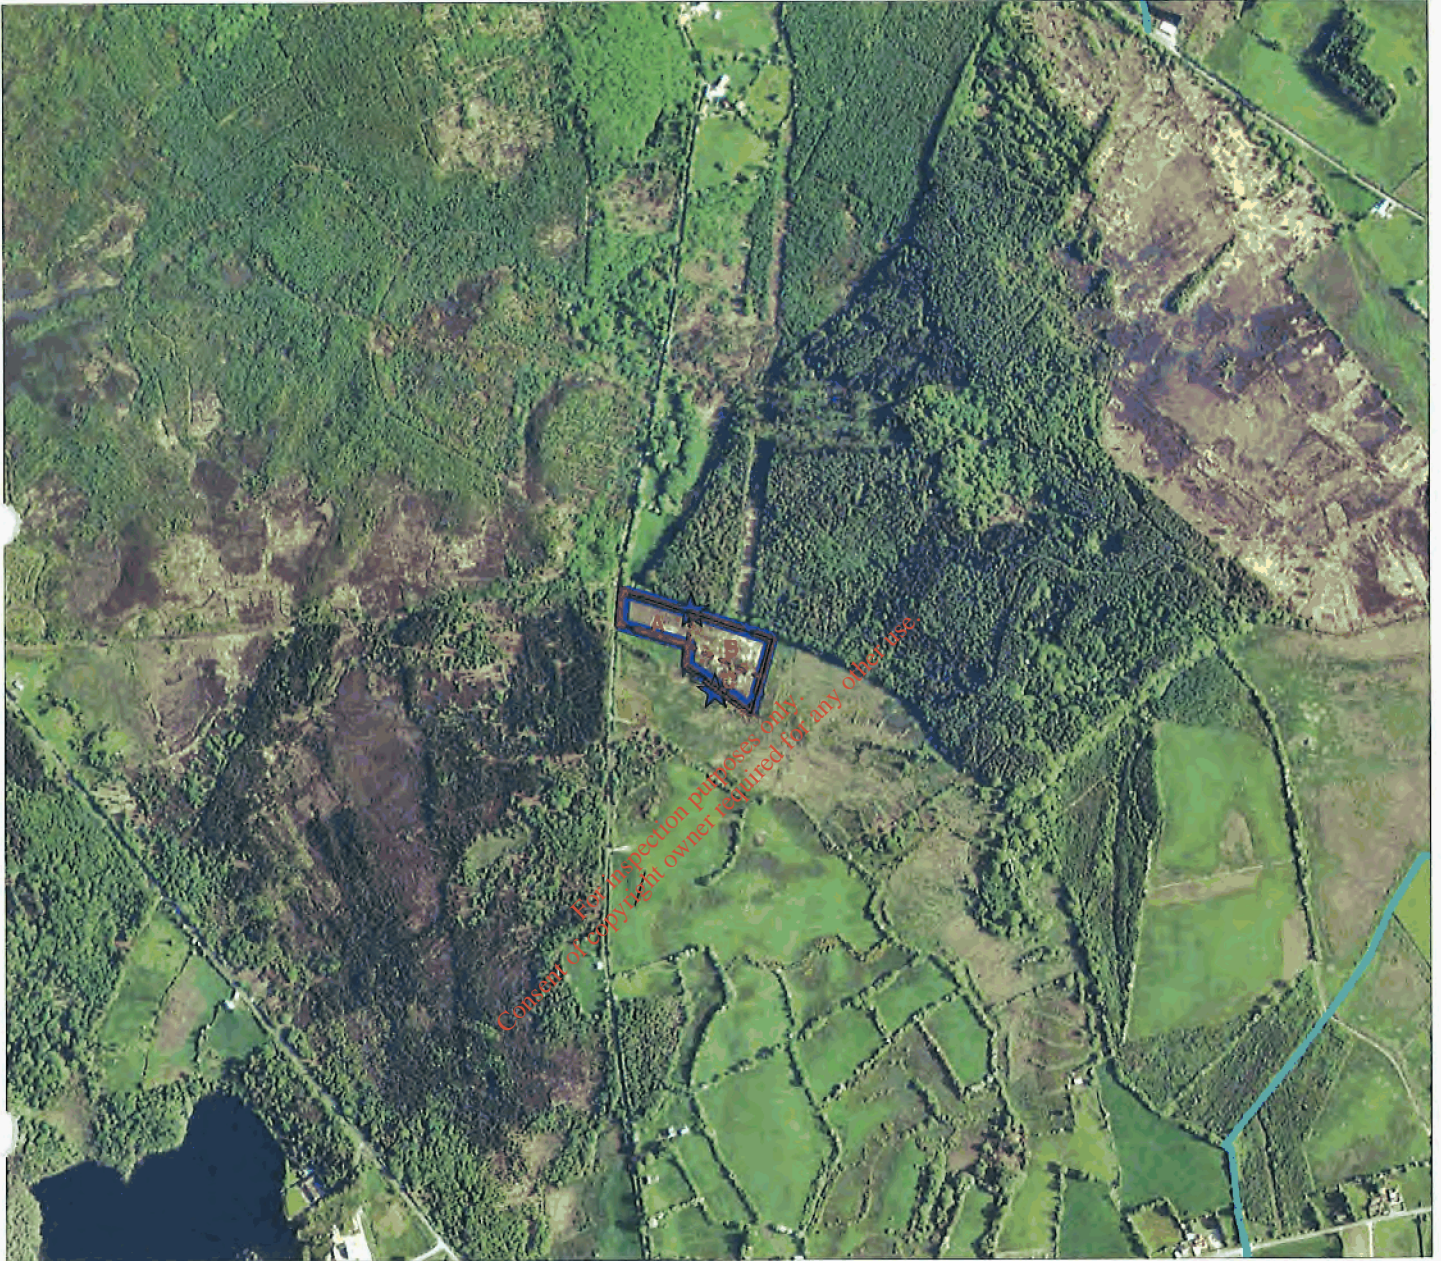
WHITEGATE LANDFILL

Area A: Entrance area. No waste visible except on northern side slope

Area B: C&D appears to have been placed waste here

Area C: Some waste visible on southern side slope

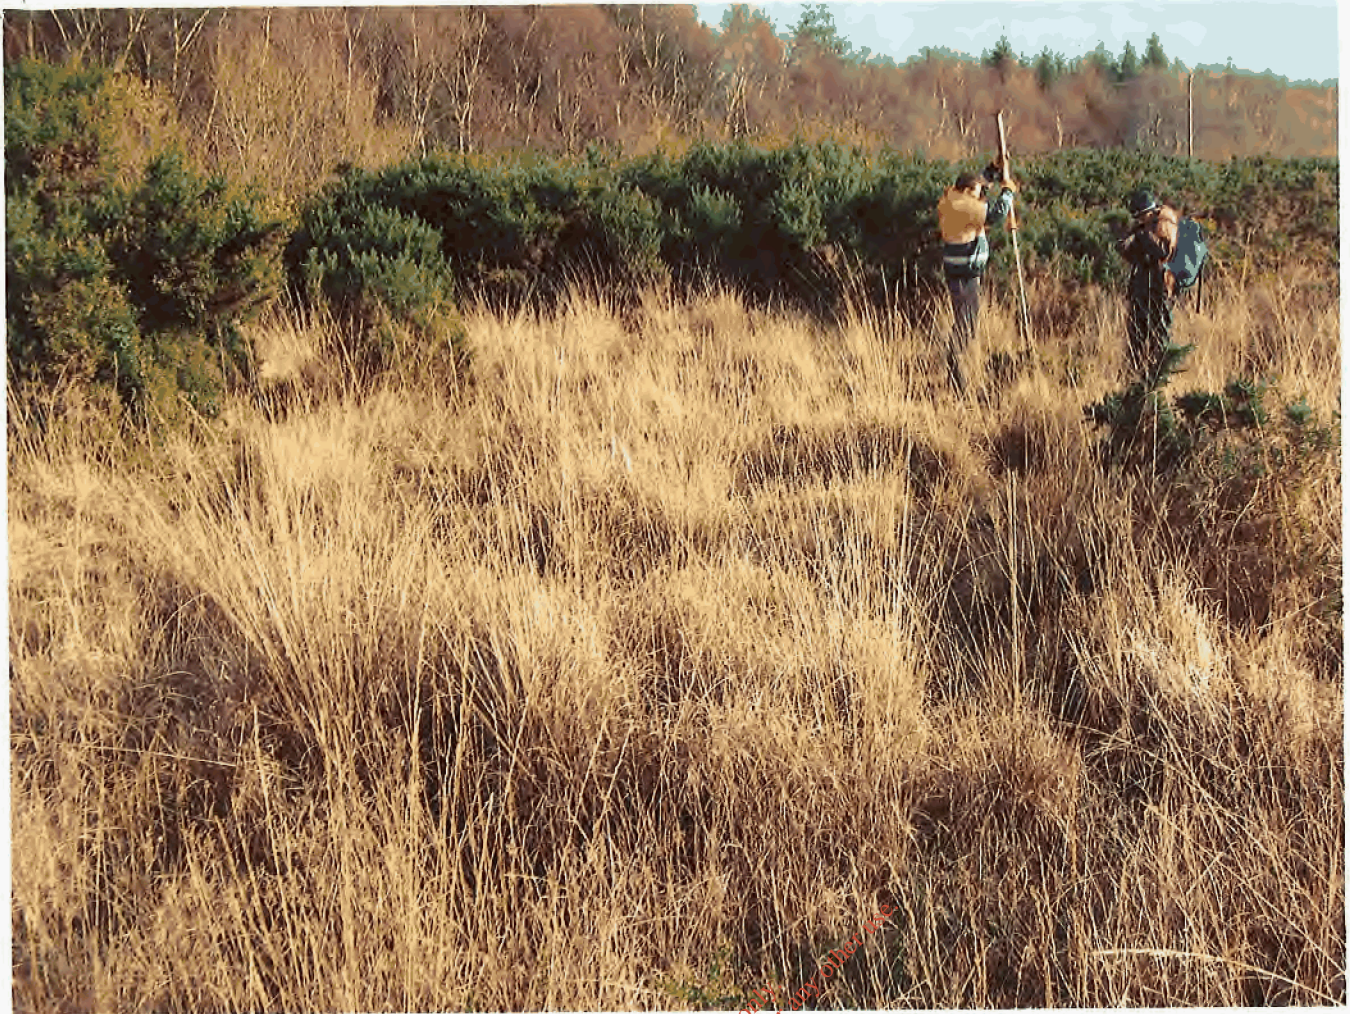
testing for gas.JPG

Impact searcher bars were used to measure gas levels at 0.5m to 1m depths at suitable locations on the site. It was only possible to measure at six locations due to the ground being water-logged. No methane was detected at any location. CO₂ levels were low, ranging from 0.1 to 1.7%v/v. Detailed results are attached in Appendix III. Sample locations are shown on a map attached in appendix III.

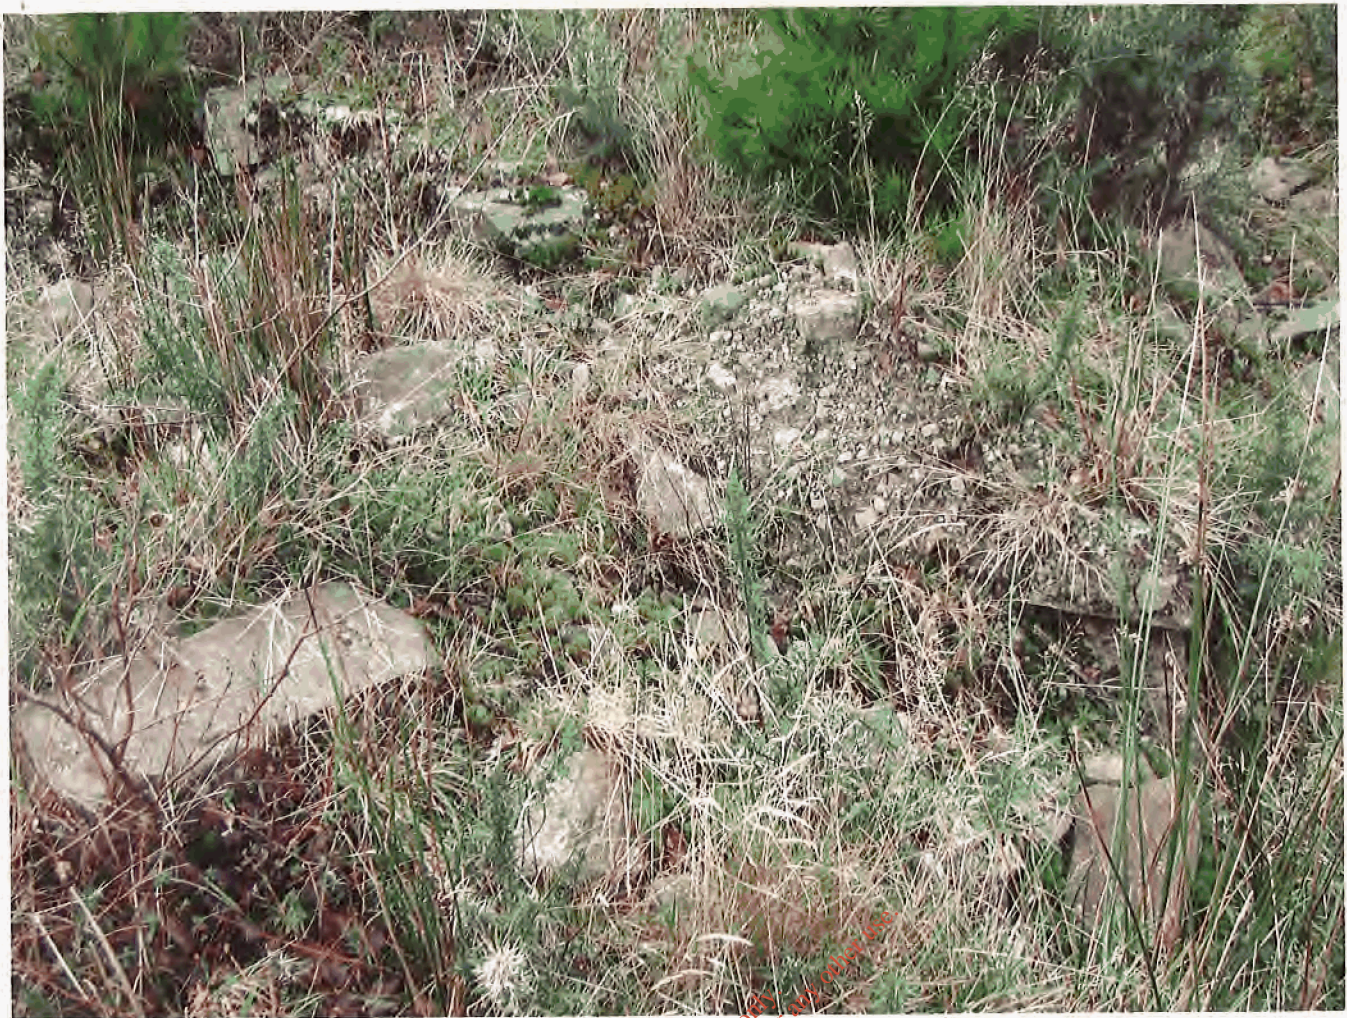
view of Construction material to north boundary.JPG

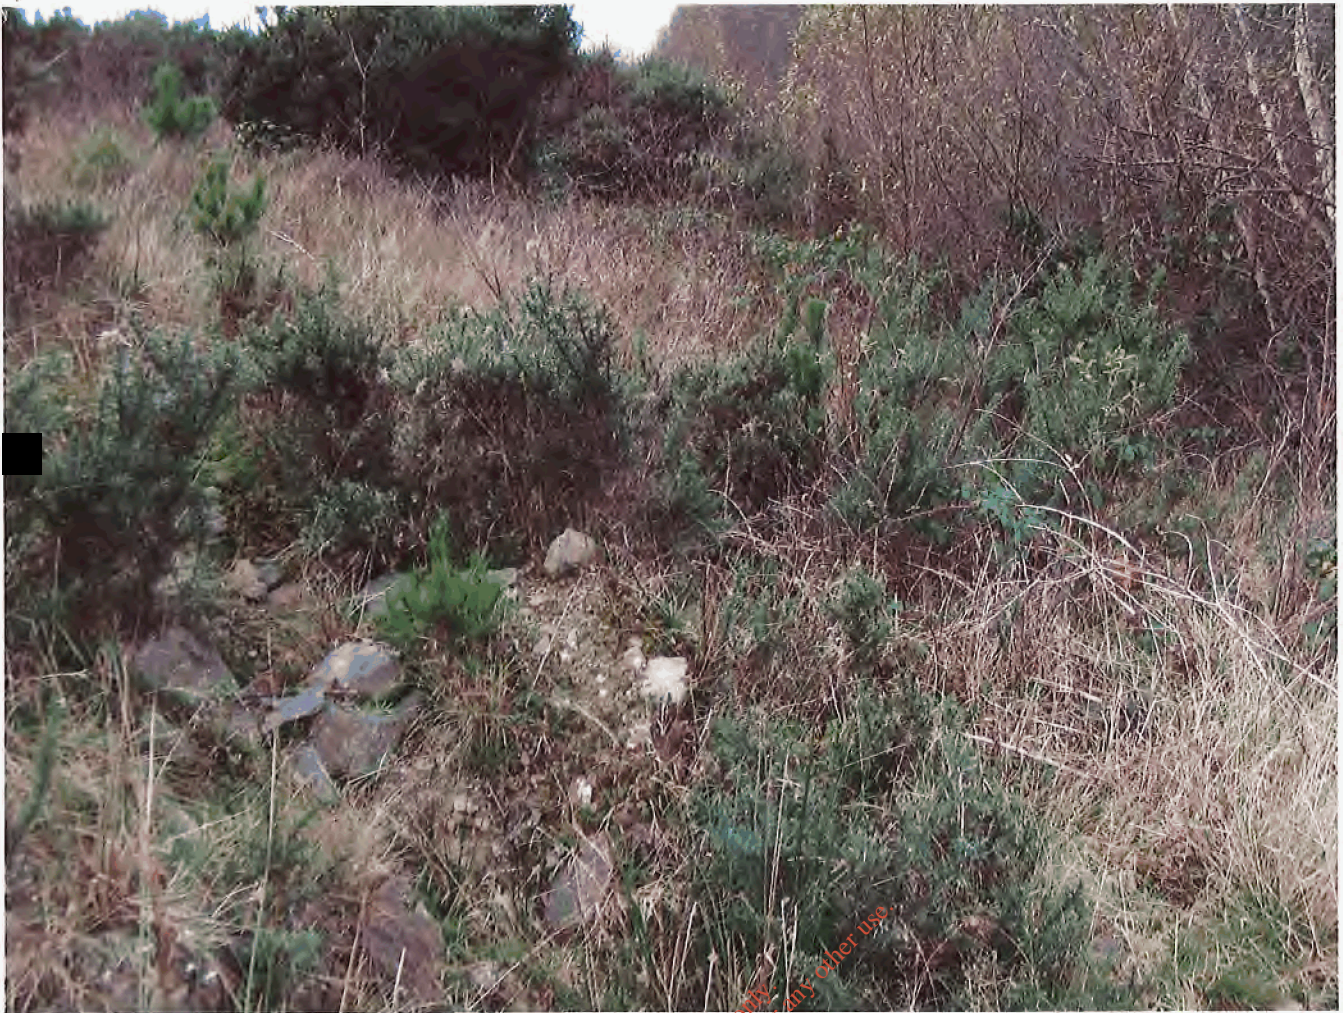
view of placed material, boulders, at north boundary.JPG

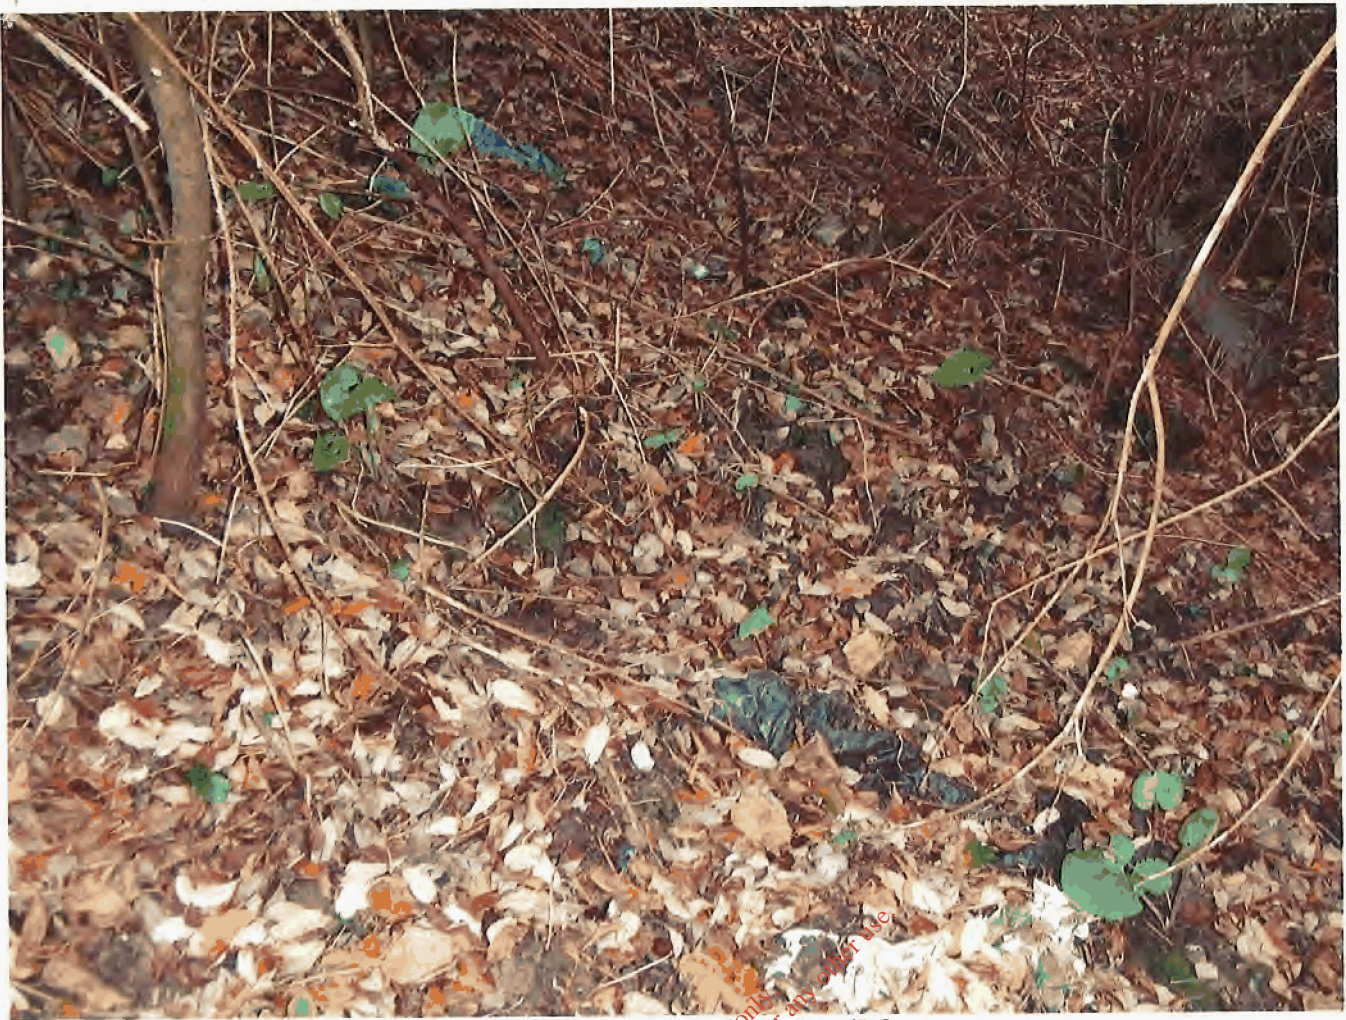
3. Results of follow-up investigations indicate that the surface water downstream of the site is uncontaminated.
4. The landfill has been well covered except on the northern and southern perimeters, where exposed waste is visible on the side slopes.

side slope on northern boundary.JPG

5. While the theoretical SPR9 linkage does not exist in reality, the exposed waste must be addressed, particularly in view of the proximity of the site to the SPA.

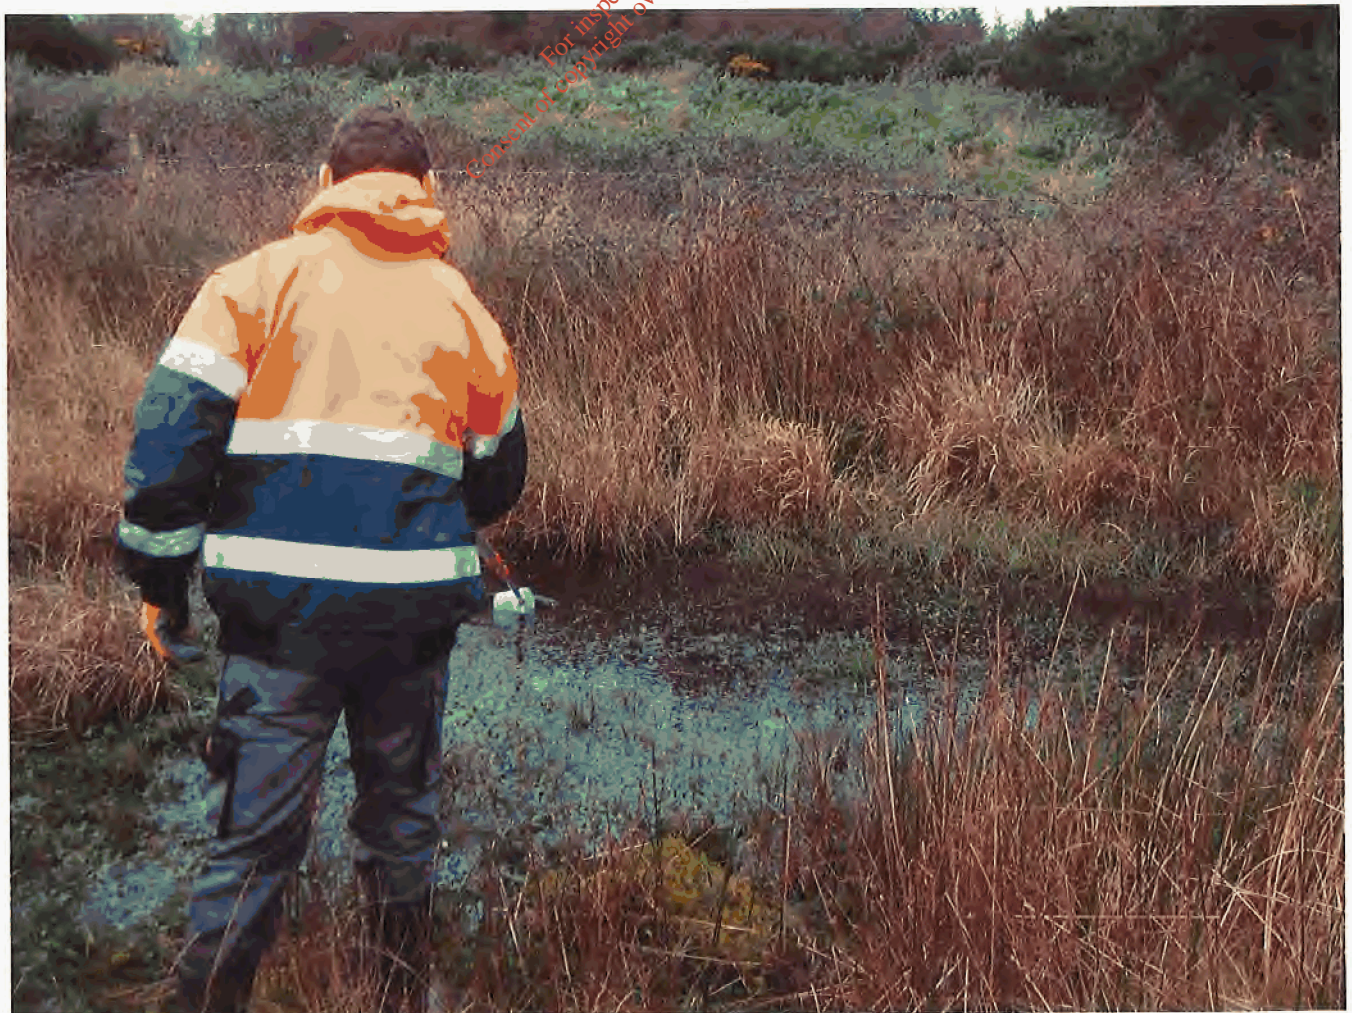
SW sample location, outside southern boundary.JPG

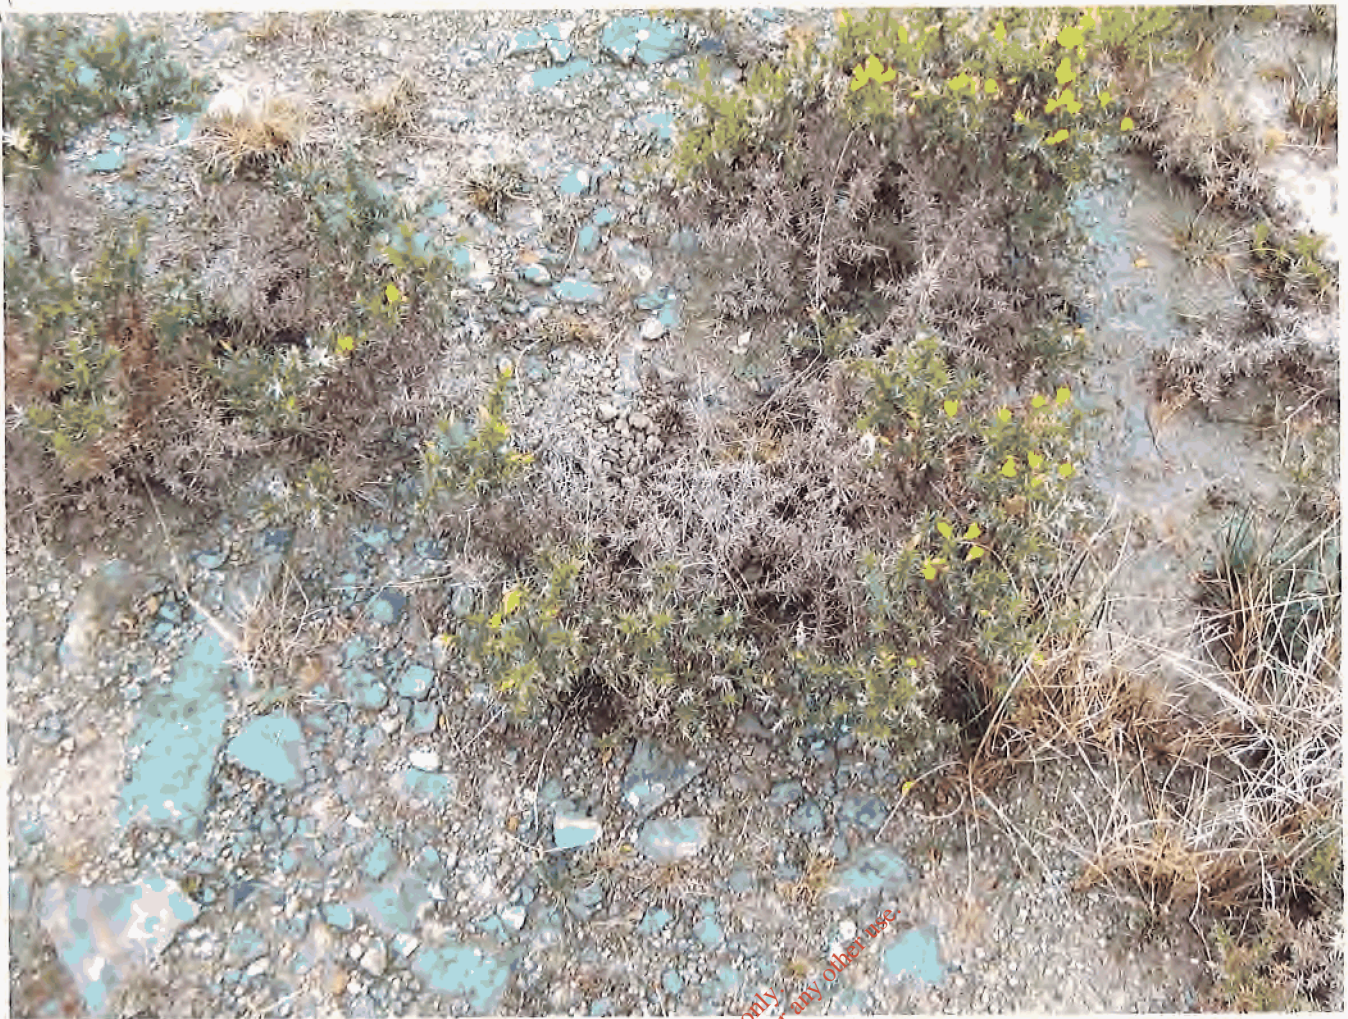
bare ground, no top soil looking east.JPG

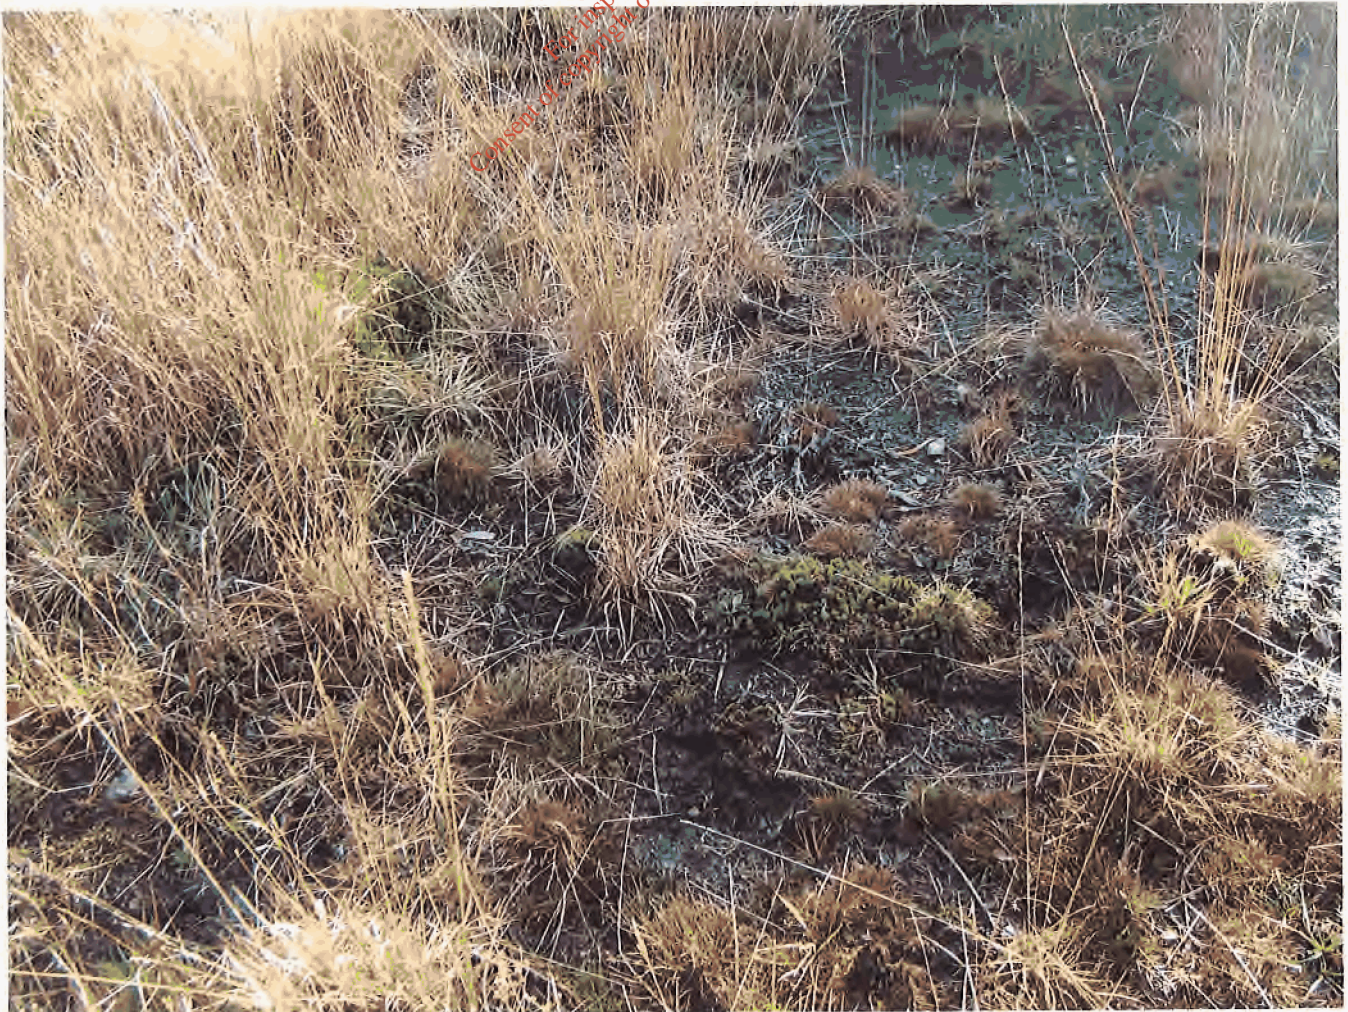
bare ground, no topsoil, looking east.JPG

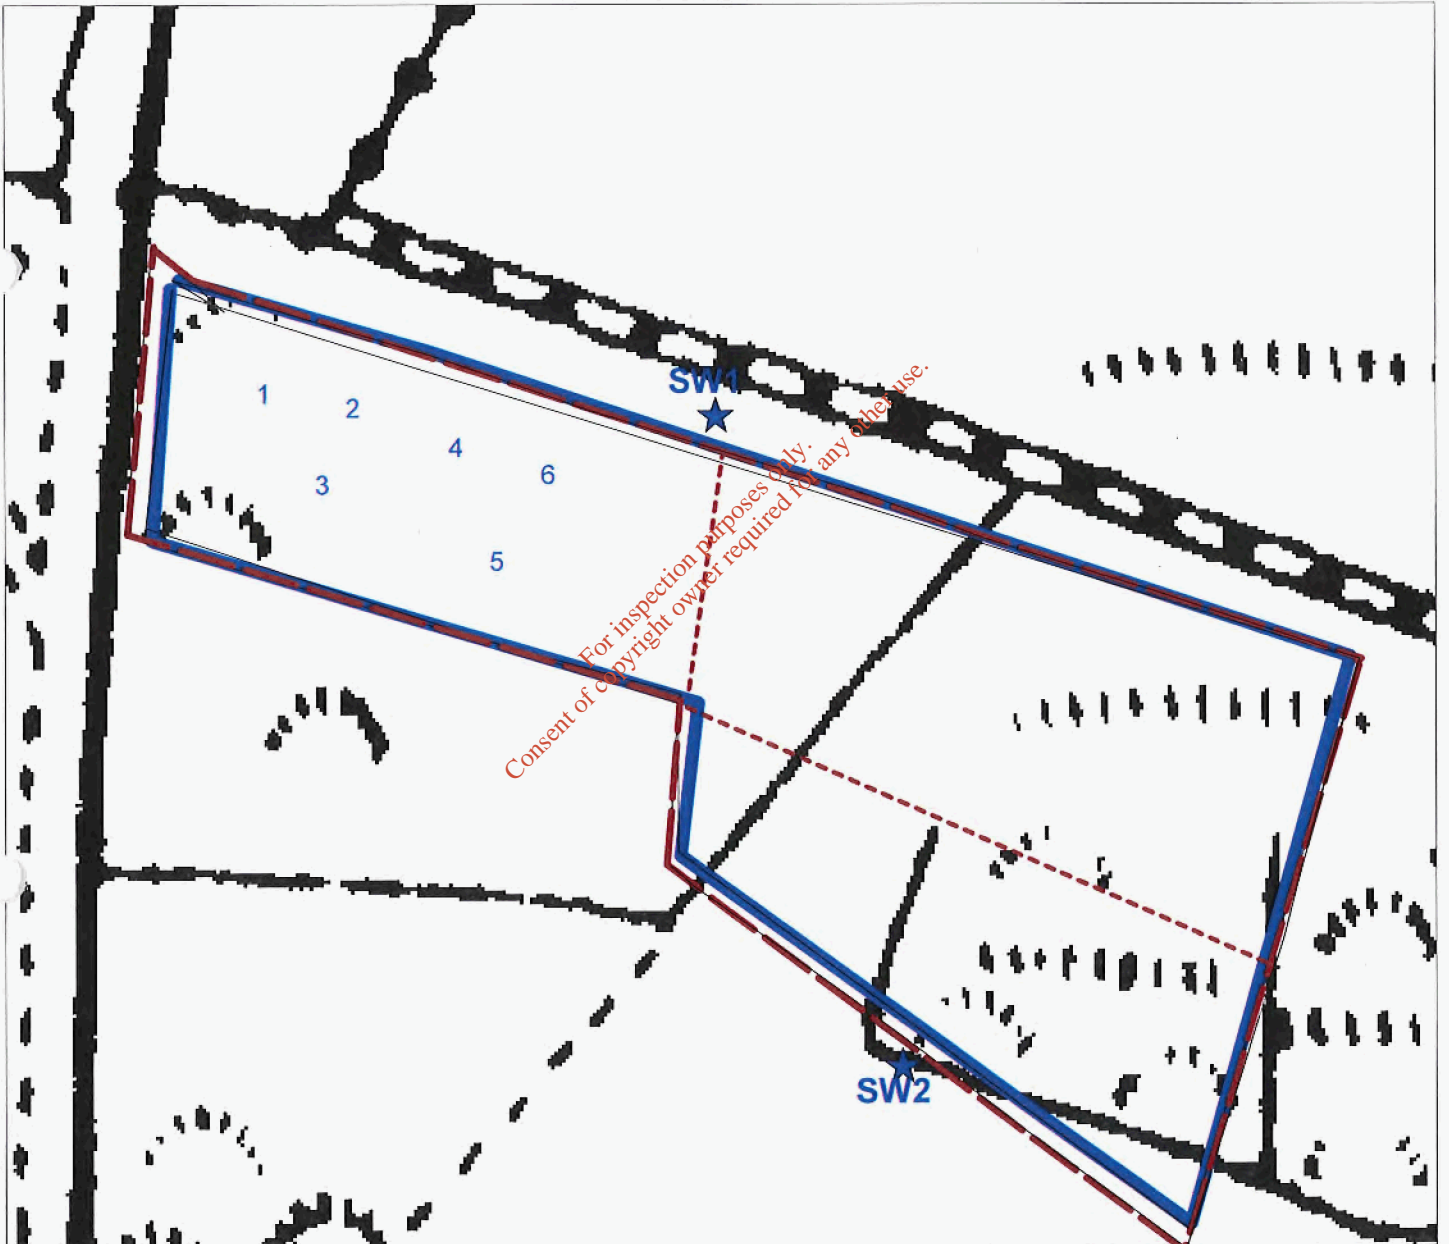
Gas and Surface Water Monitoring Locations

Sample locations are shown on the drawing attached in appendix III.
