# Cartron Big Landfill

## Datagap Analysis & Tier 1 Assessment

### Longford County Council

22 November 2017

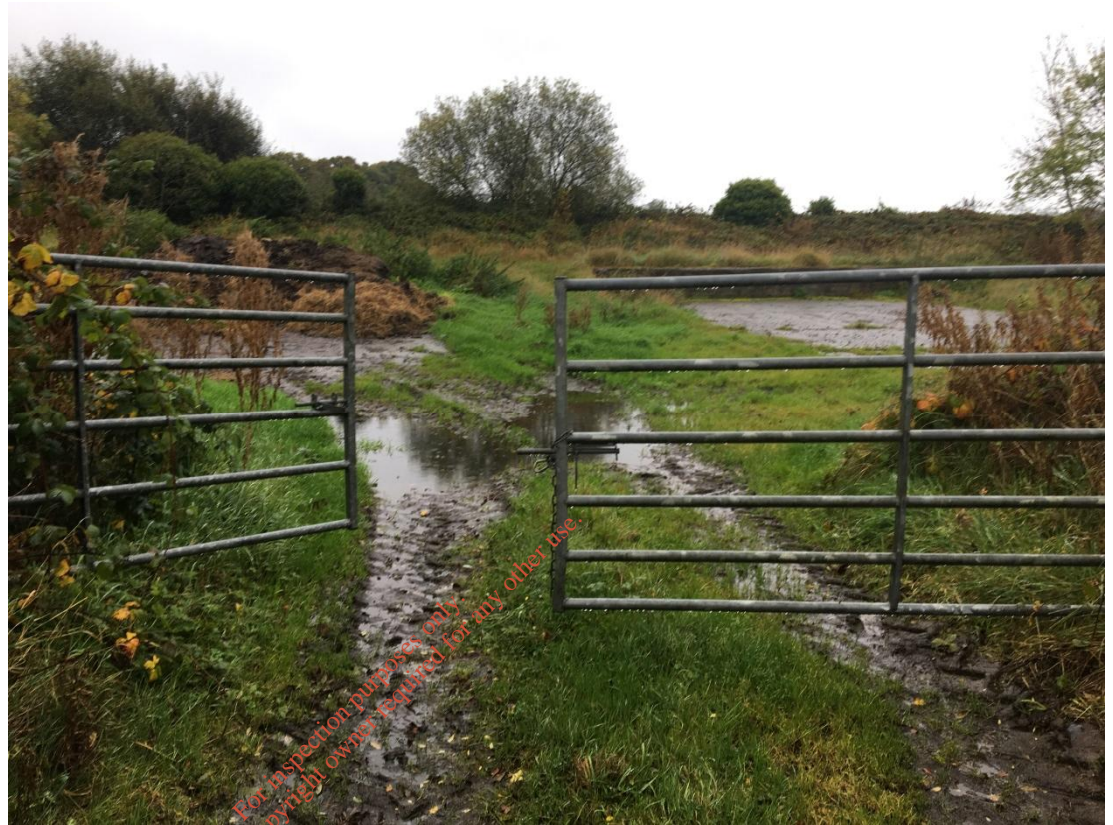
Main access gate to site from L3538 roadway.

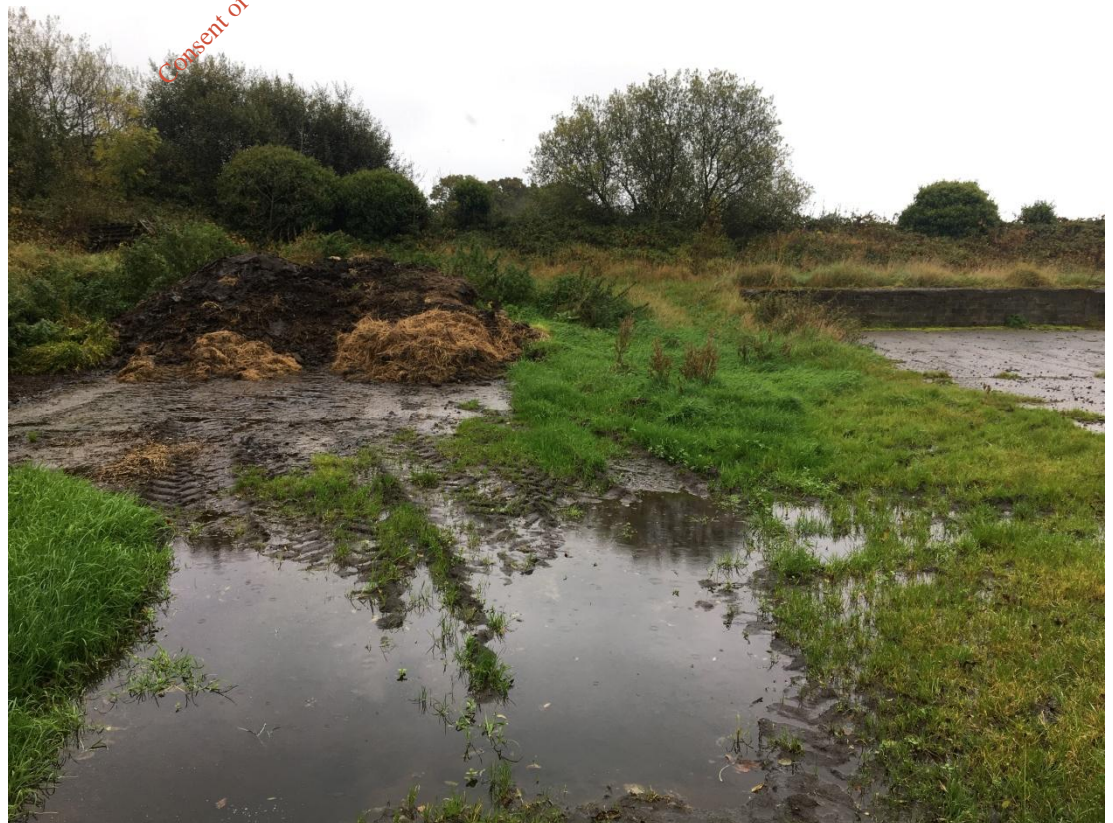
Concrete hardstand adjacent to main entrance gate, with surface ponding and farmyard manure.

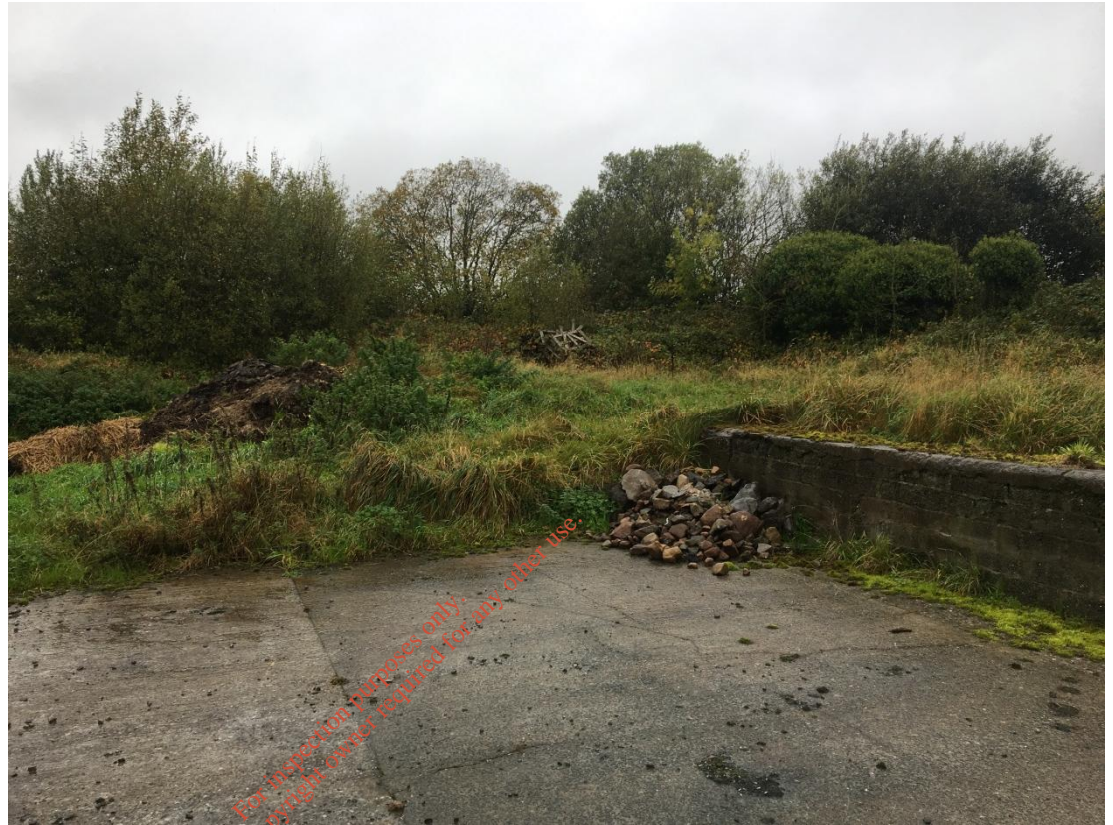
Debris and old wooden pallets adjacent to concrete hardstand.

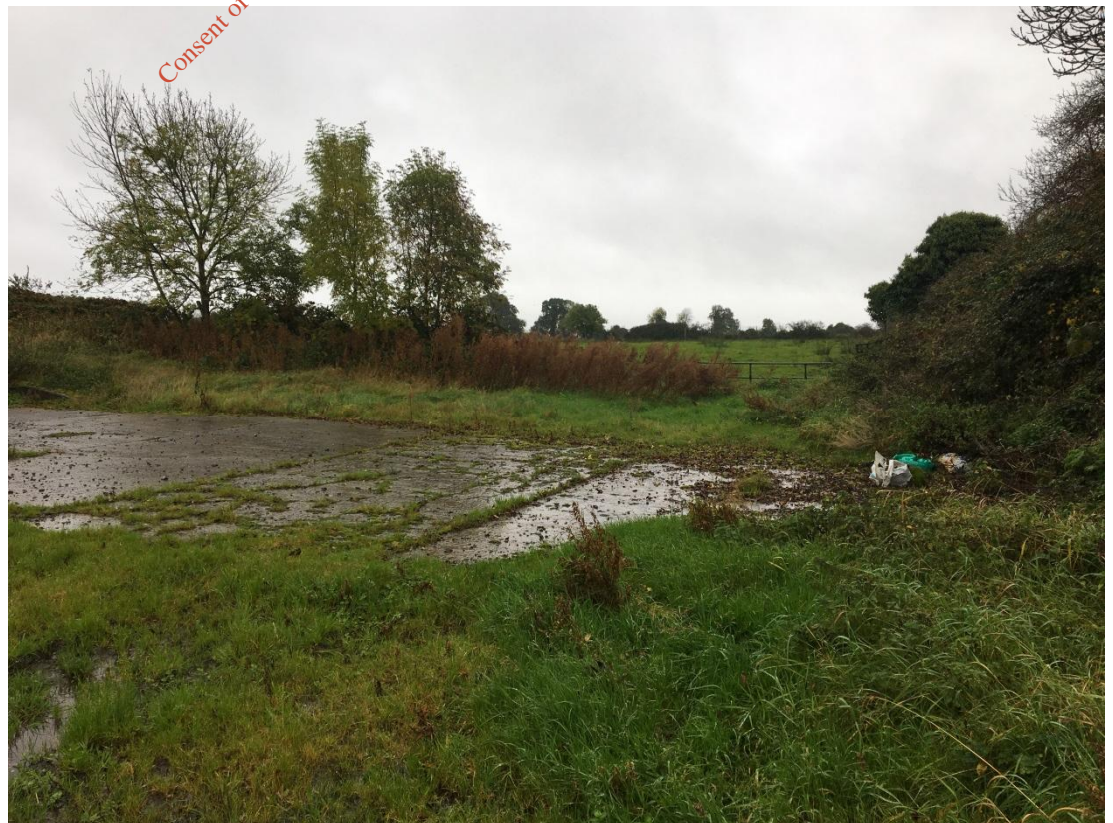
Rubbish bags adjacent to concrete hardstand.

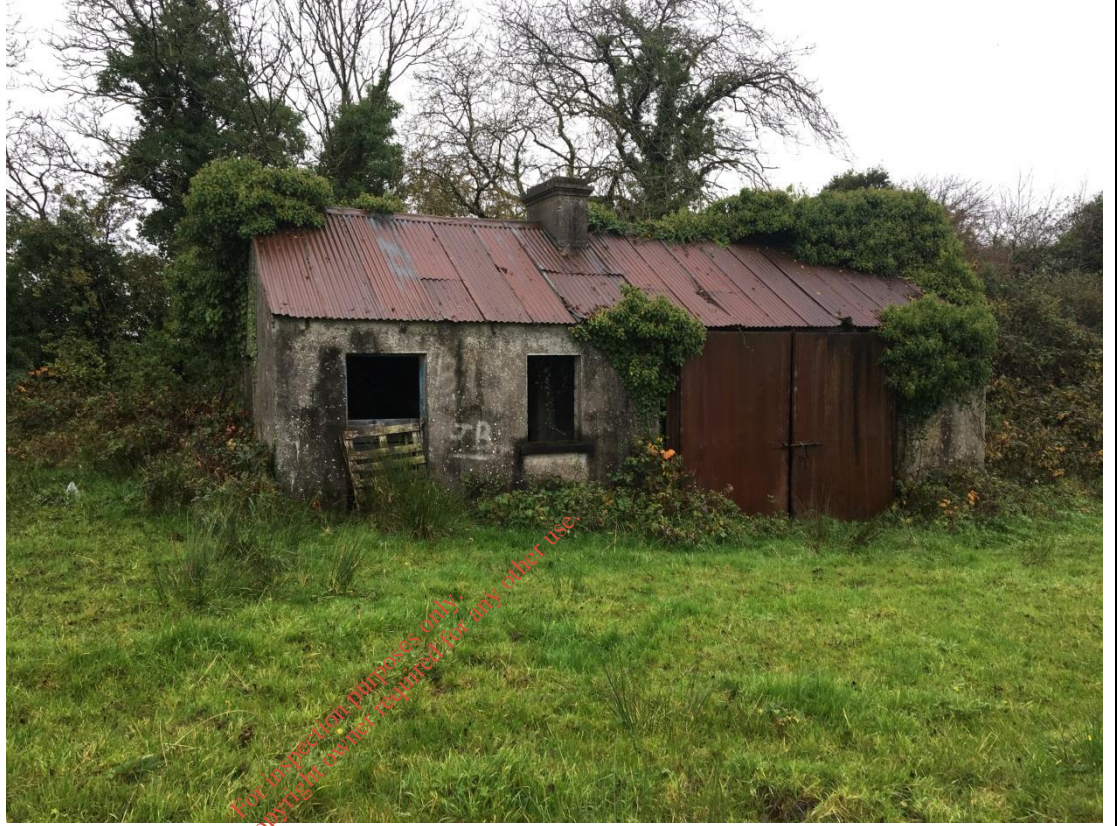
<b>Photo No.</b> 5	<b>Date:</b> 13/10/2017
-----------------------	----------------------------

**Description:**  
Derelict building adjacent to main entrance.

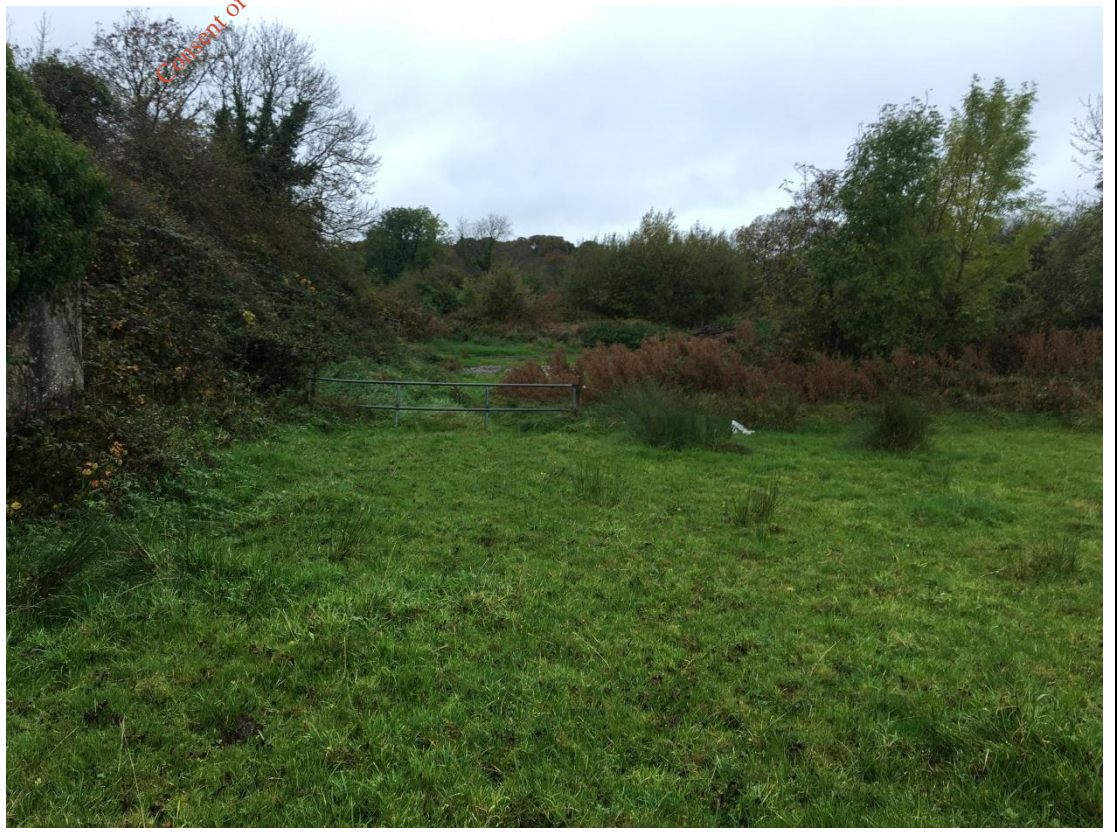
<b>Photo No.</b> 6	<b>Date:</b> 13/10/2017
-----------------------	----------------------------

**Description:**  
Internal access gate from concrete hardstand to the field.

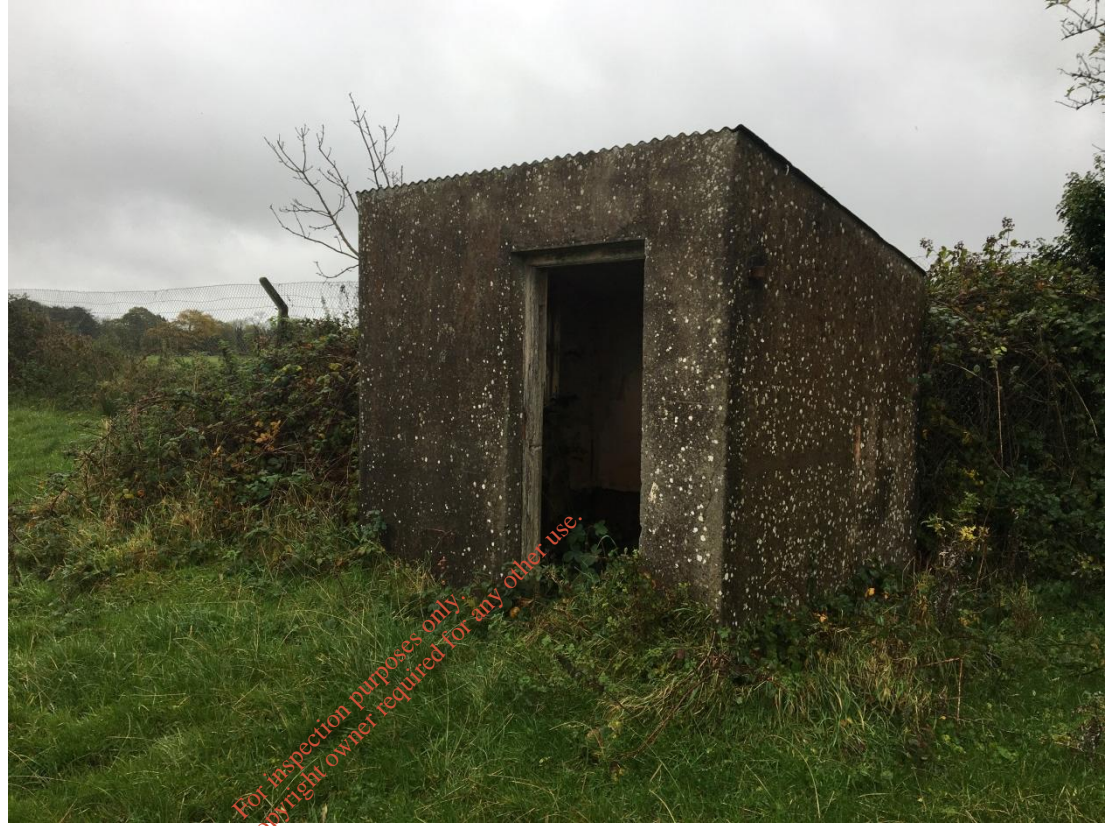
Derelict shed by second entrance in south-western corner.

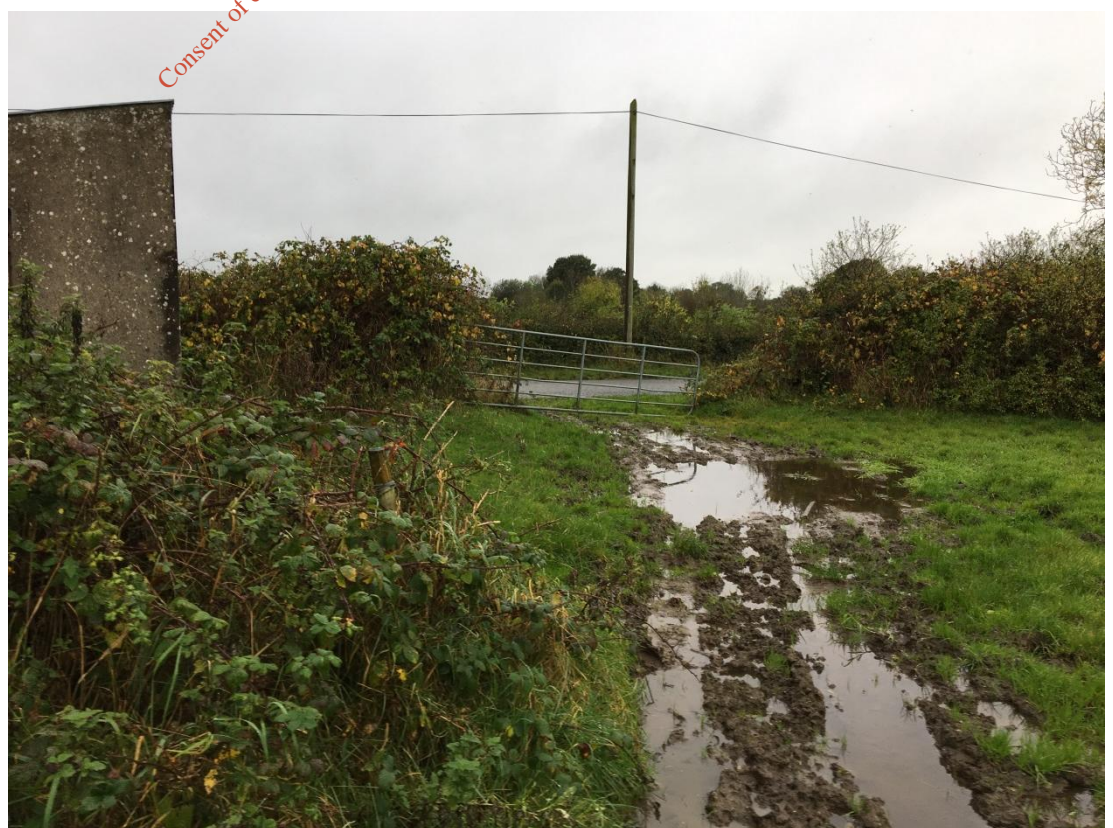
Entrance in south-western corner from L3538.

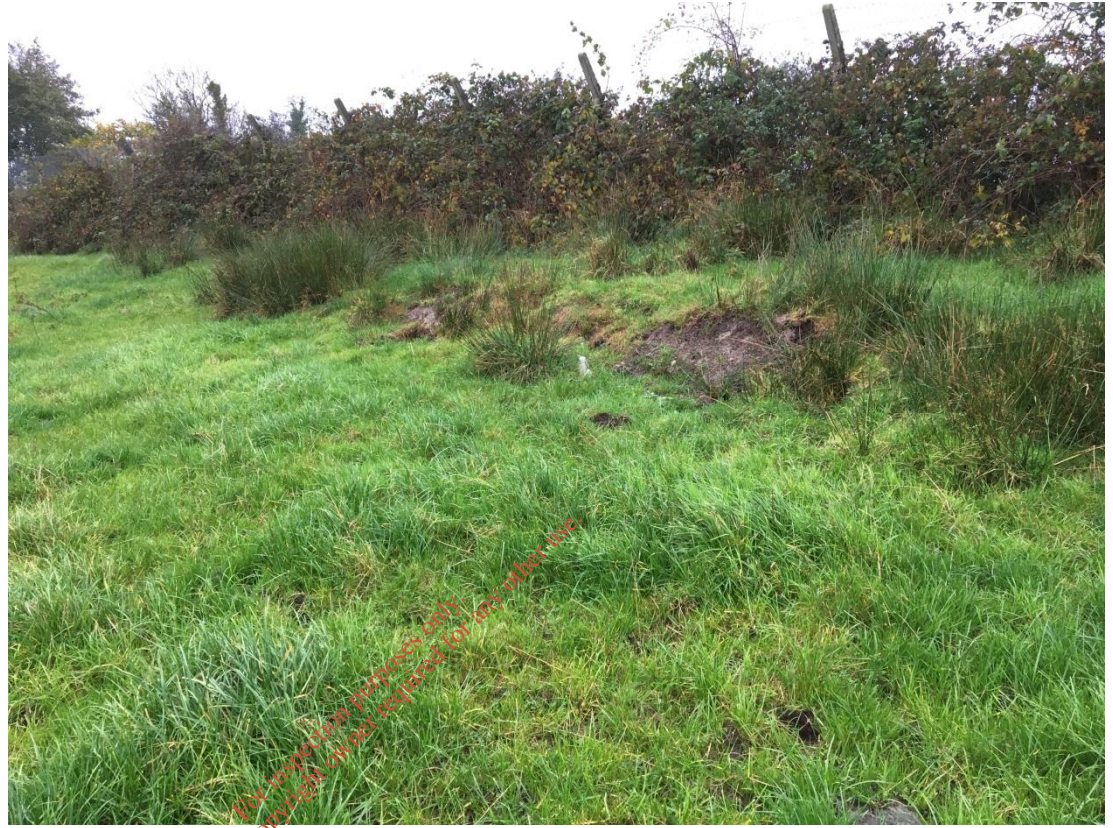
Evidence of subsidence along southern site boundary.

Given that the above assessment indicates that the most sensitive SPR linkage is high risk, due to the seepage of leachate to the adjacent surface water stream, the apparent lack of adequate capping, leachate collection and drainage, and the presence of zones of subsidence, AECOM recommends:

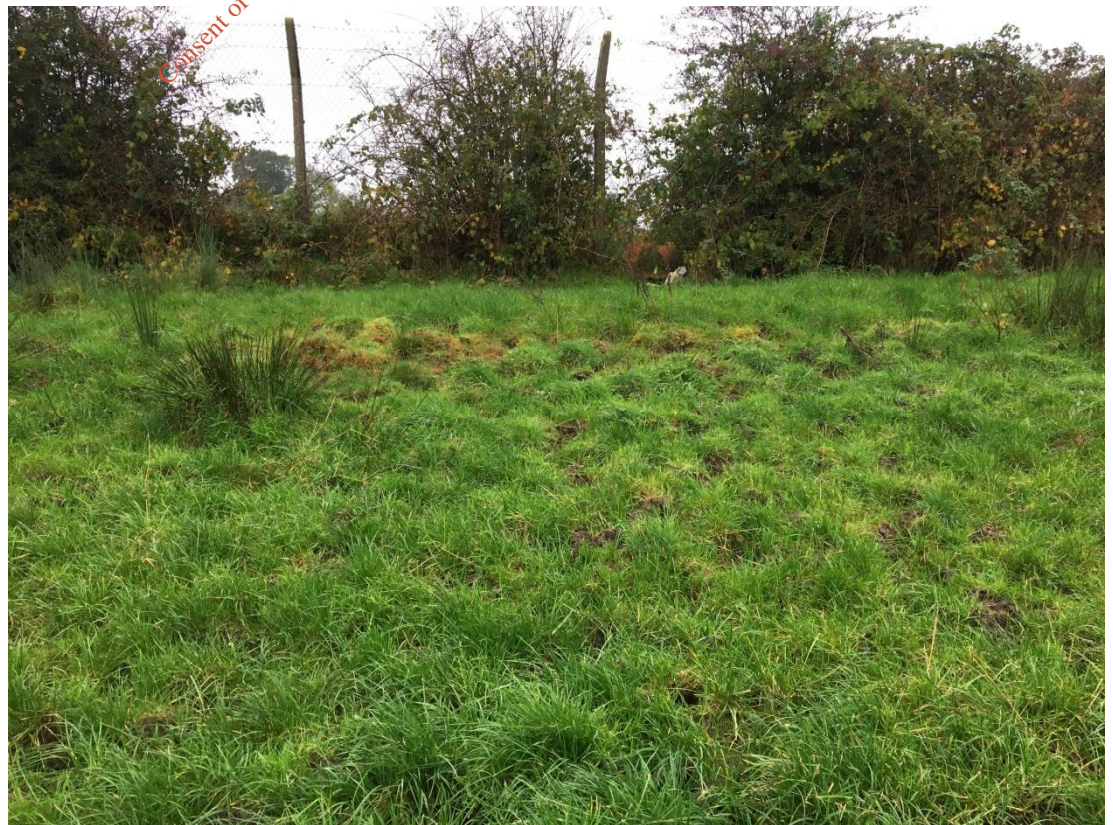
Evidence of subsidence along southern site boundary, 2 m high chainlink boundary fence.

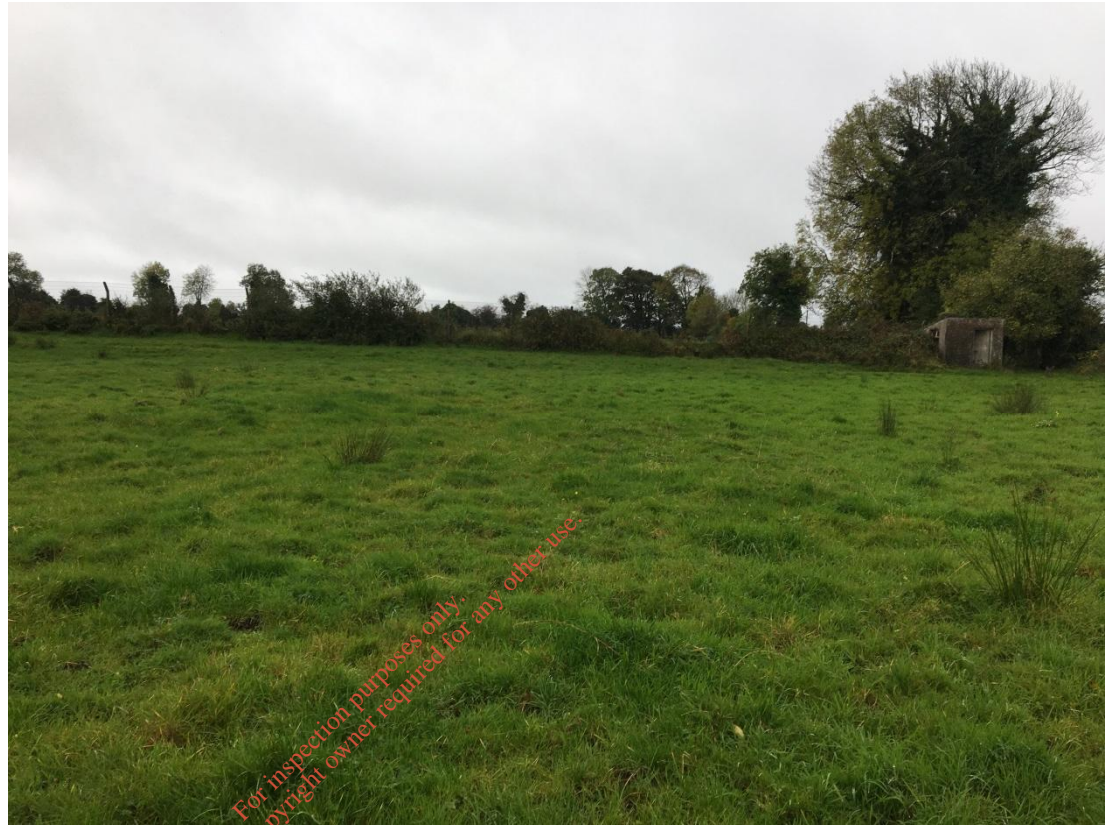
View of south-eastern corner of field and southern site boundary.

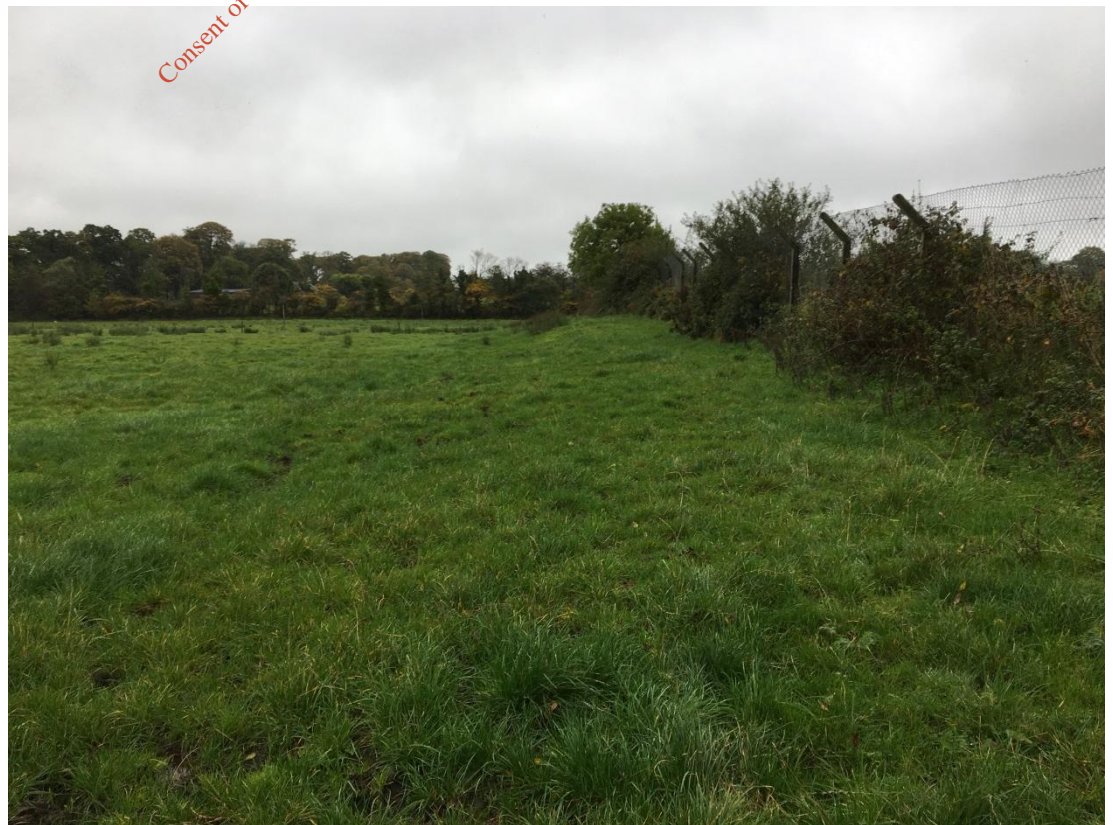
View along southern boundary.

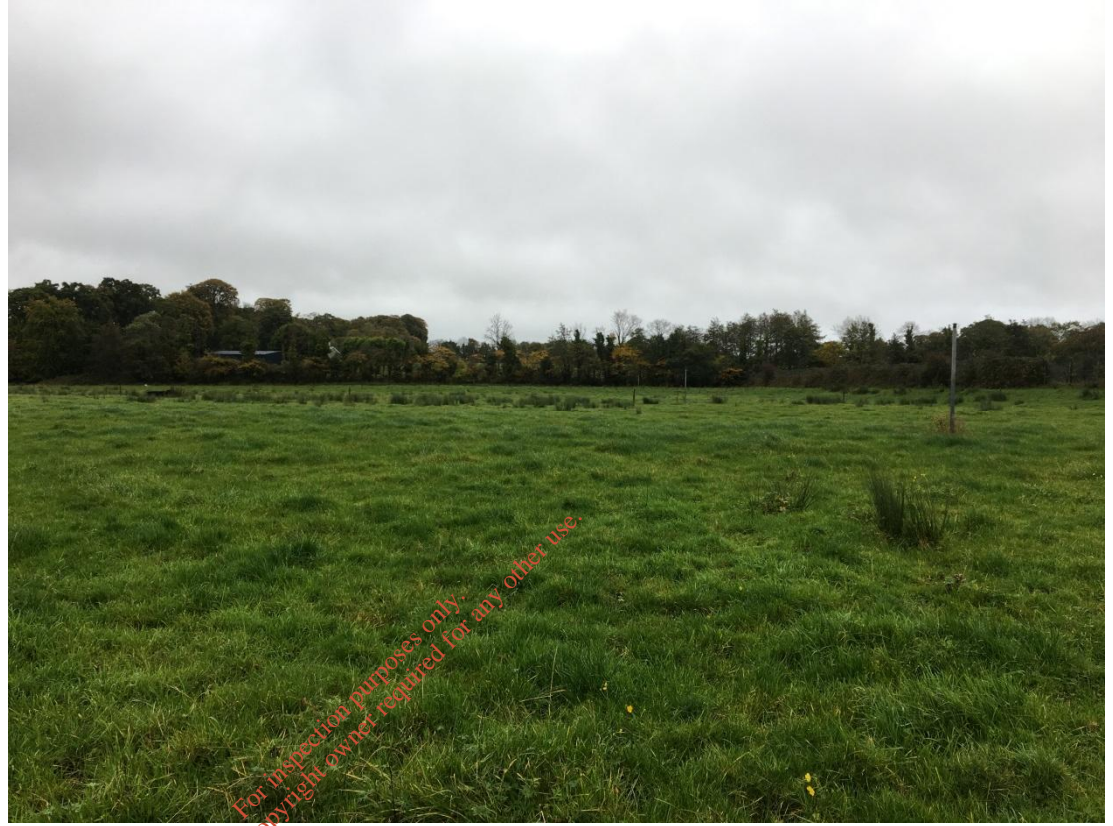
View across site from the east with landfill gas vent pipes visible.

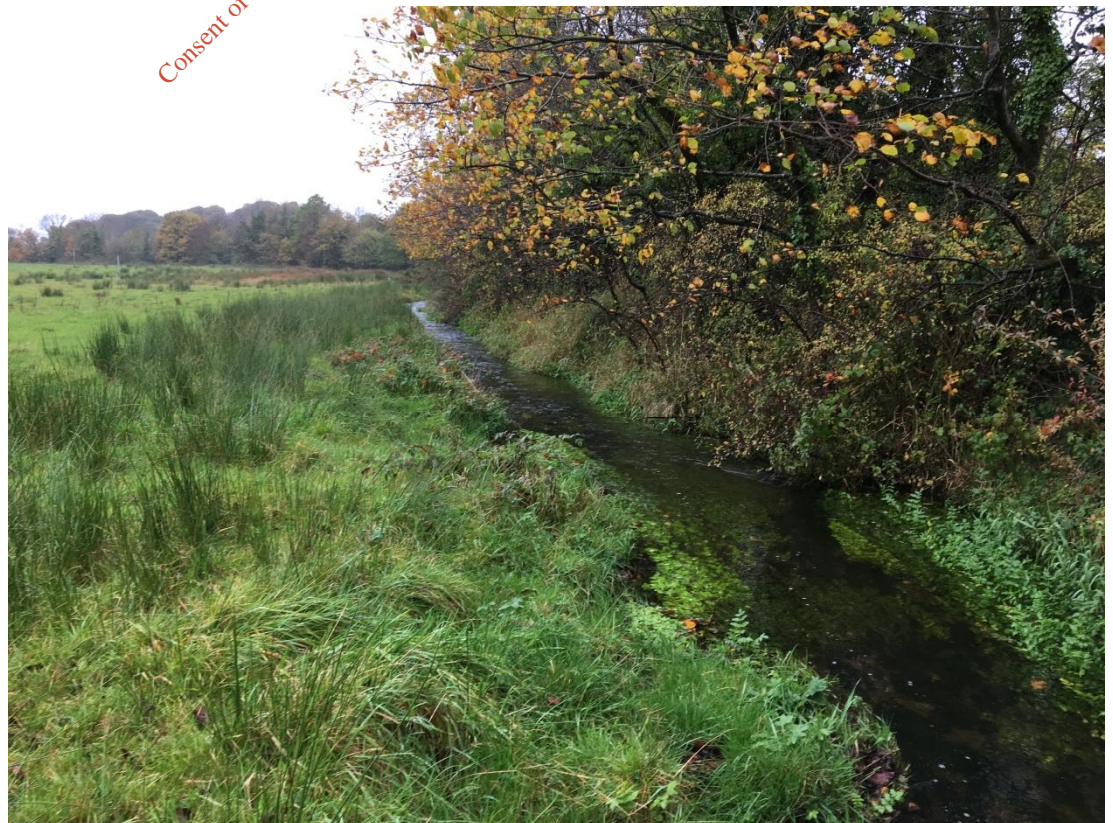
Clooncoose stream flowing along eastern boundary from south-east corner of site.

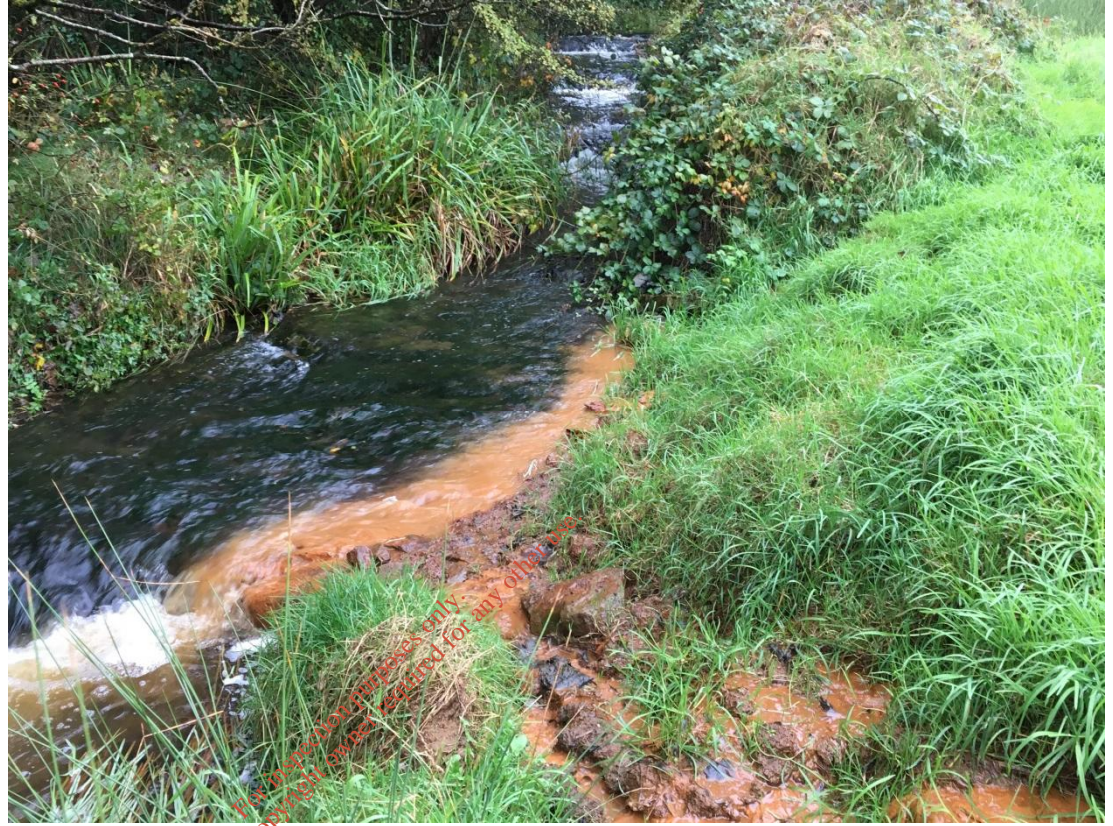
<b>Photo No.</b> 15	<b>Date:</b> 13/10/2017
------------------------	----------------------------

**Description:**  
Leachate entering the stream, evidence of iron precipitate forming.

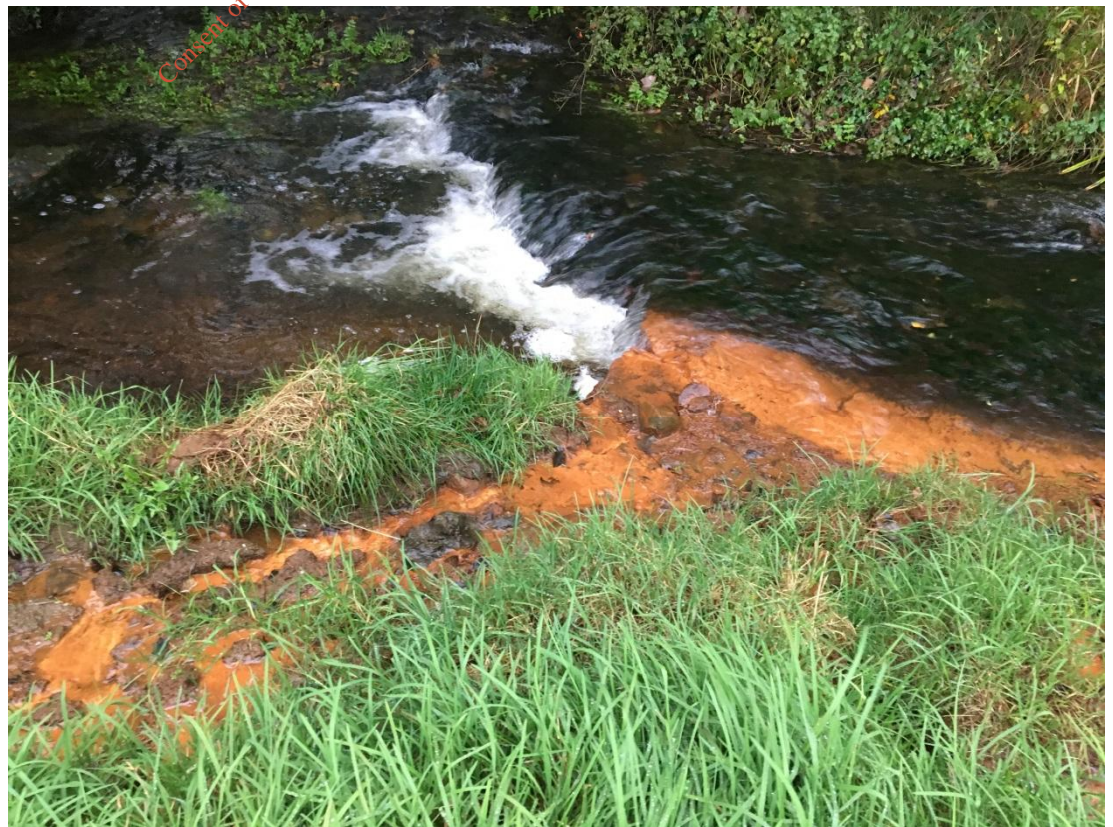
<b>Photo No.</b> 16	<b>Date:</b> 13/10/2017
------------------------	----------------------------

**Description:**  
Leachate entering the stream, evidence of iron precipitate forming.

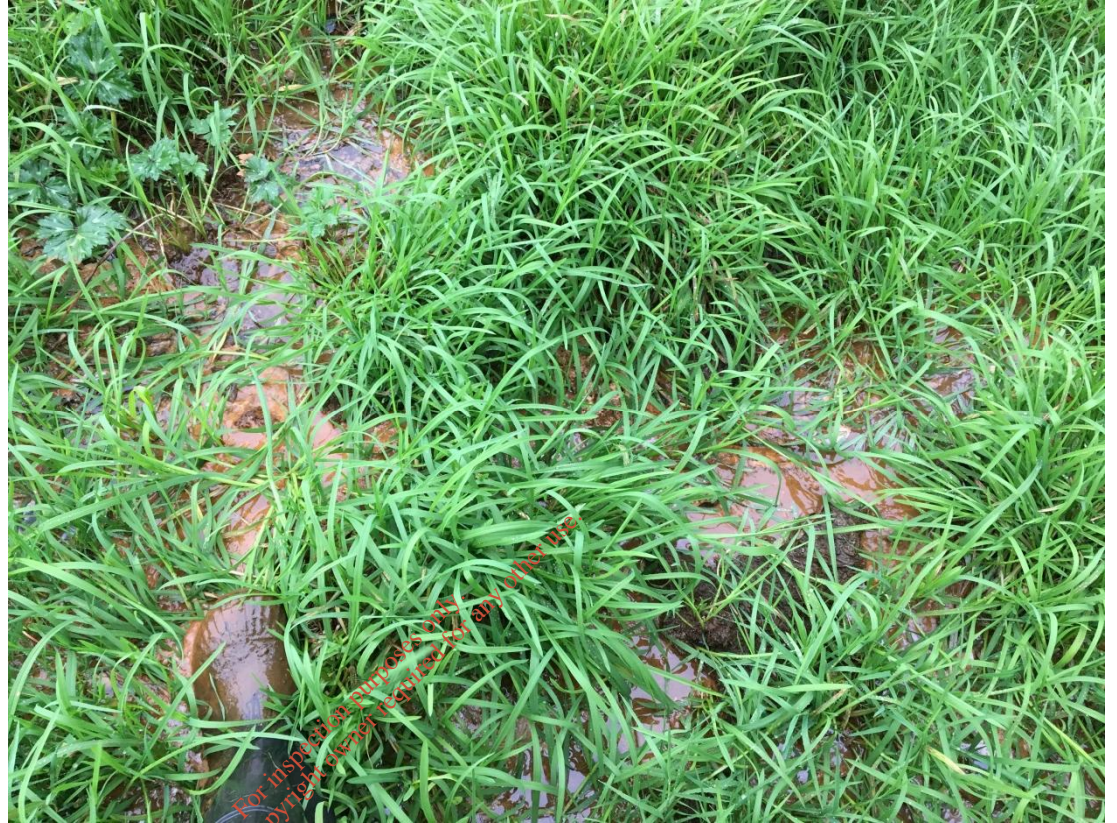
Waterlogged ground.

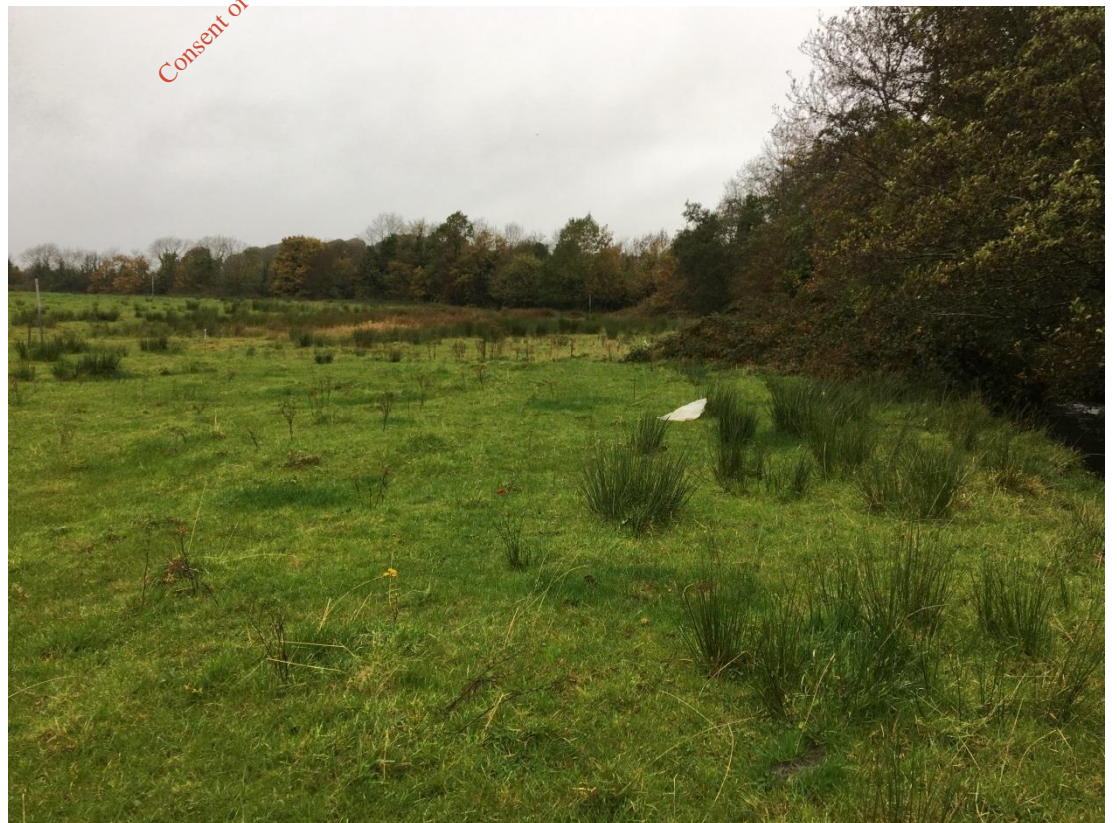
Change in vegetation where ground is waterlogged and leachate enters the stream.

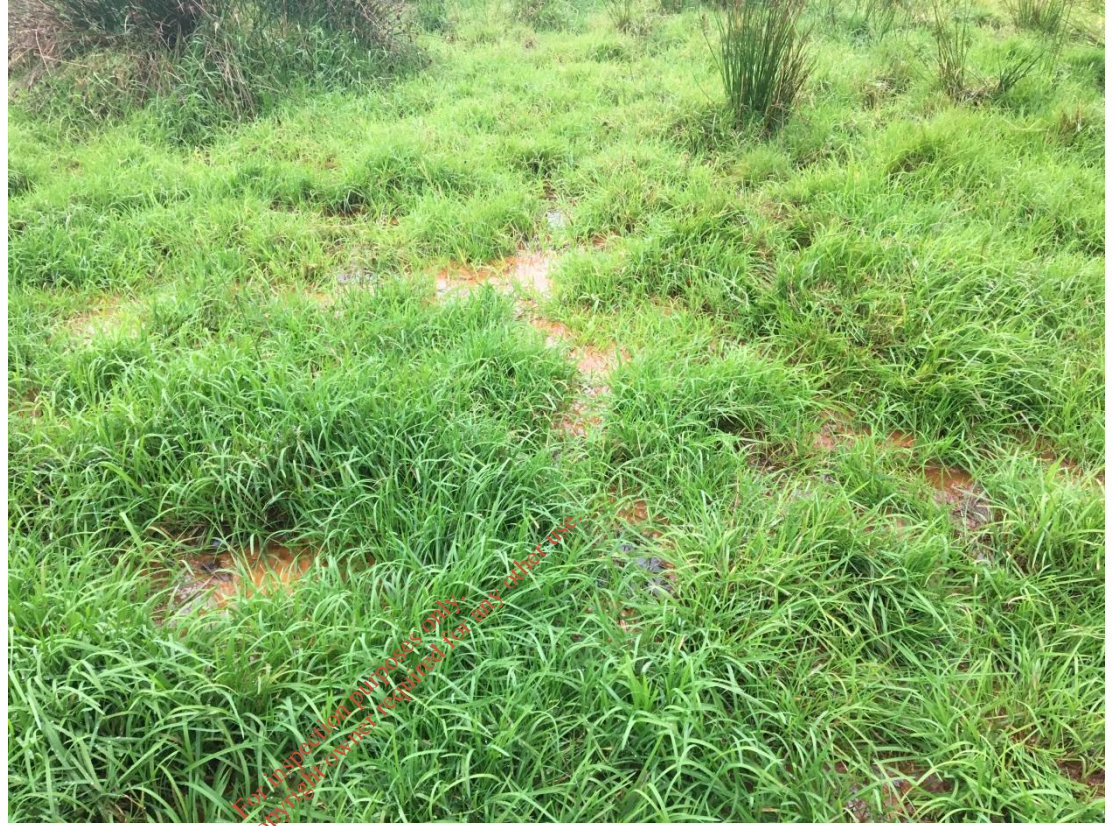
Waterlogged and boggy ground with leachate.

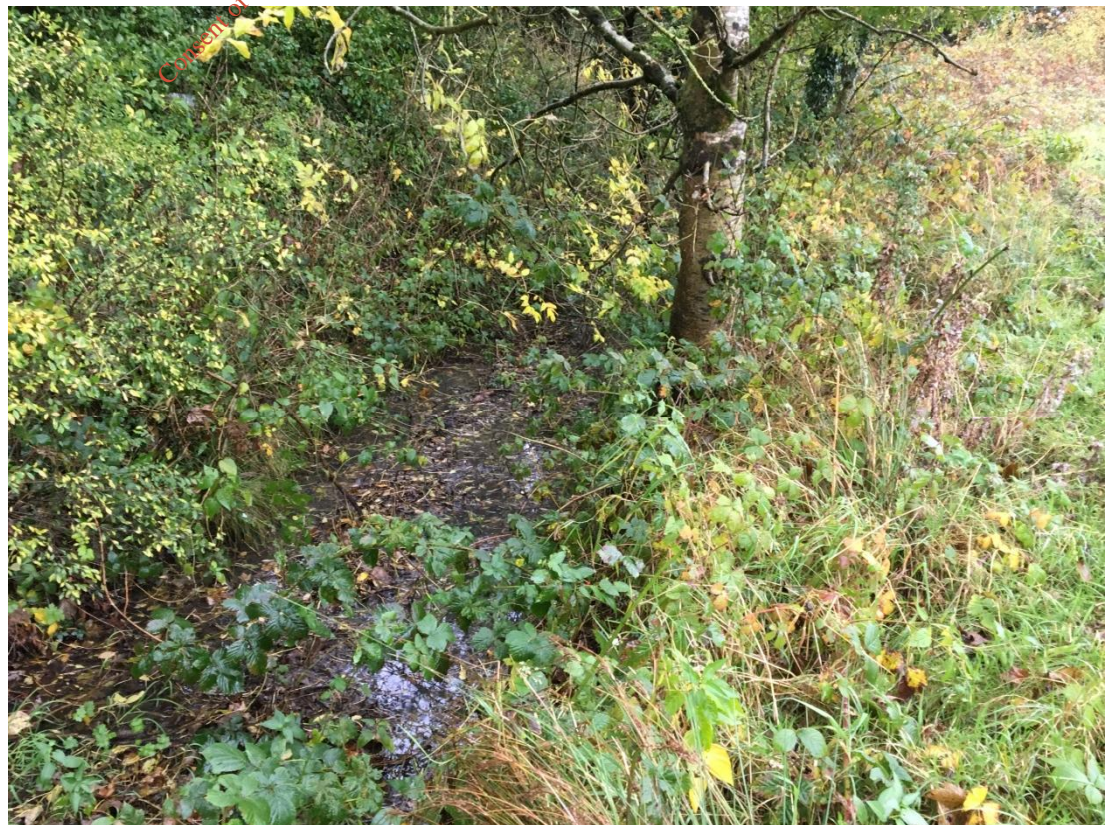
Drain along northern site boundary, low flow, and milky water.

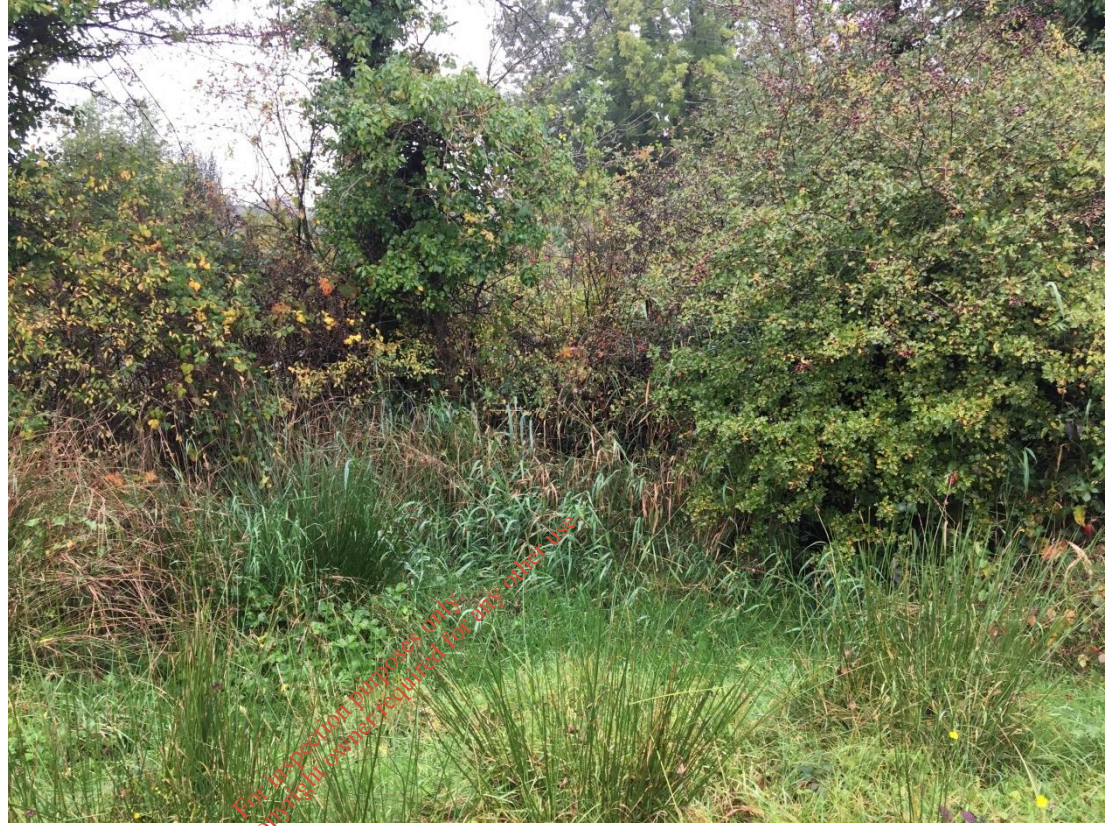
Boggy ditch in north-west  
corner of site.

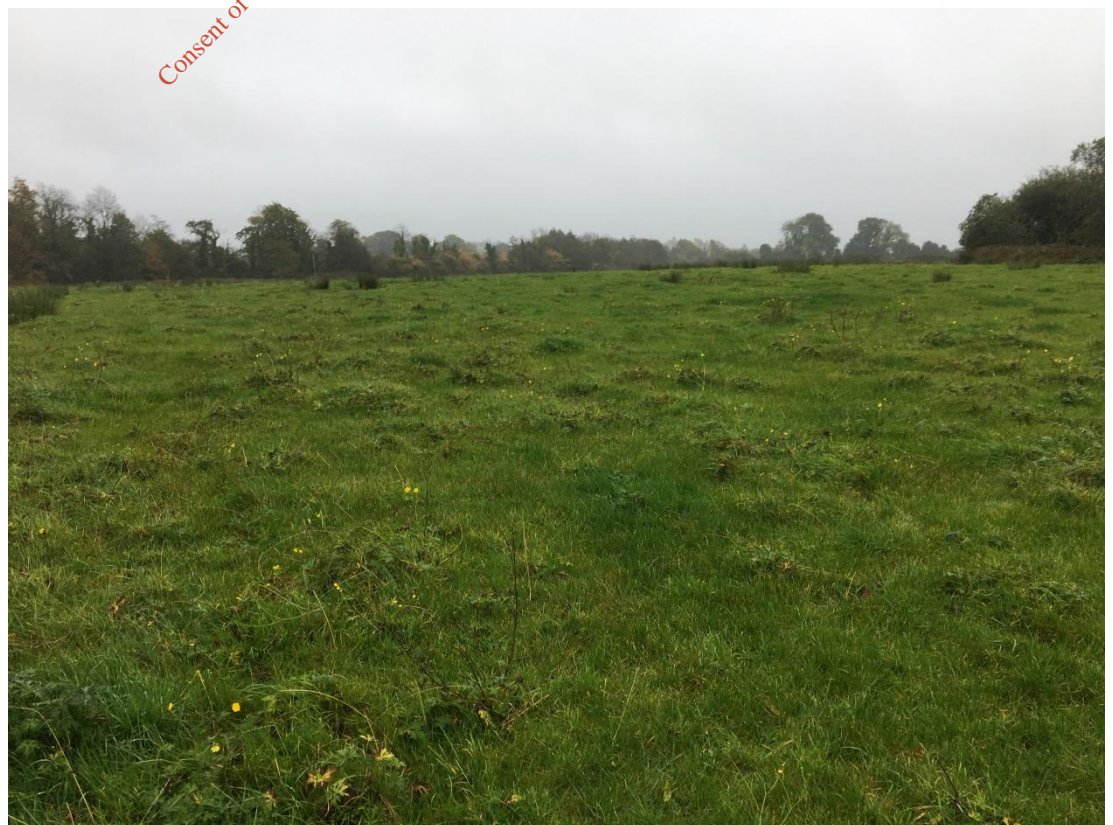
View of site from north-west  
corner.
