Site Walkover Checklist & Photographs

Cartron Big Walkover Survey Checklist – 26th June 2018

Site Location: Cartron Big Landfill

Project Number: P1444

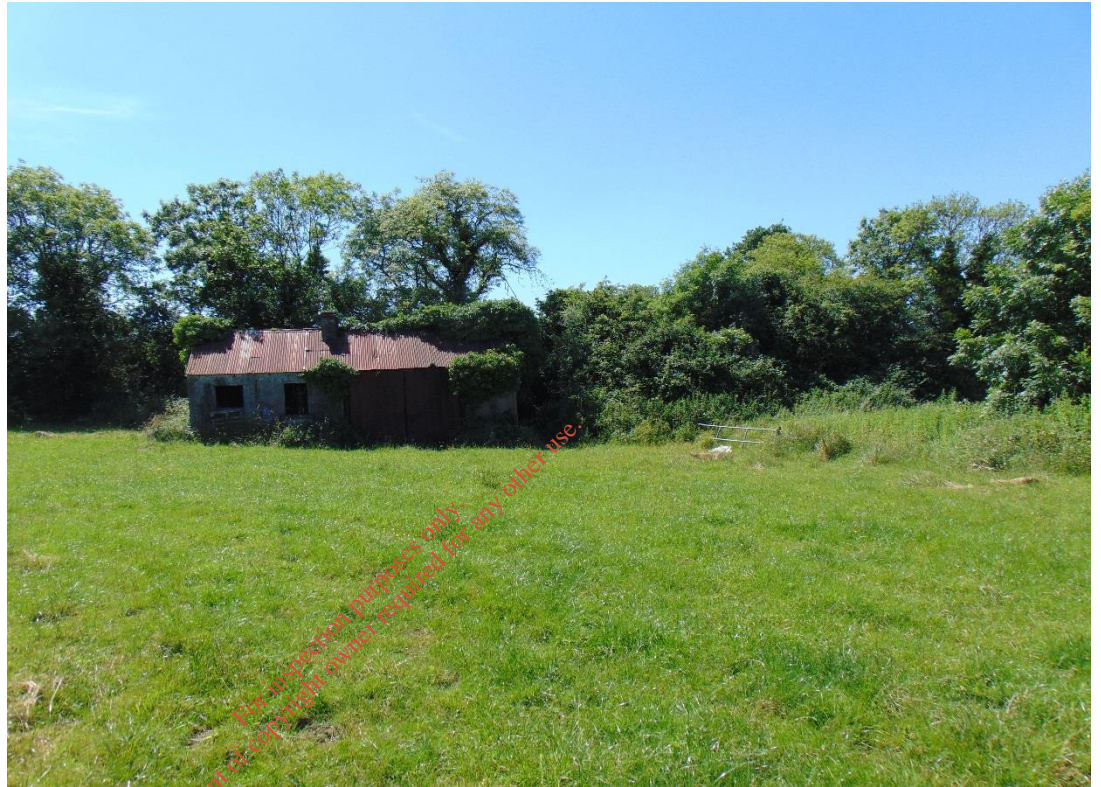
Photo No. 3
Date: 26-06-18

Description:
Derelict building
along western
boundary and near
to concrete
hardstand area.

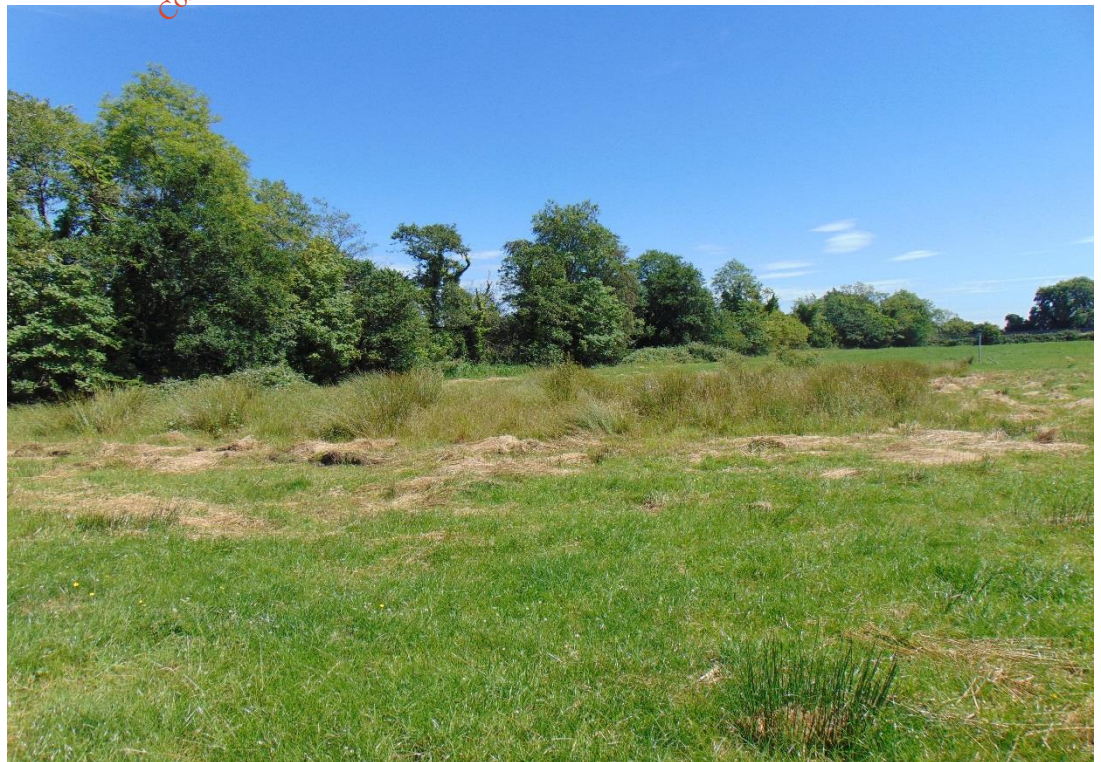
Photo No. 4
Date: 26-06-18

Description:
View showing poorly
draining grassland
conditions prone to
waterlogging along
the eastern side of
the site.

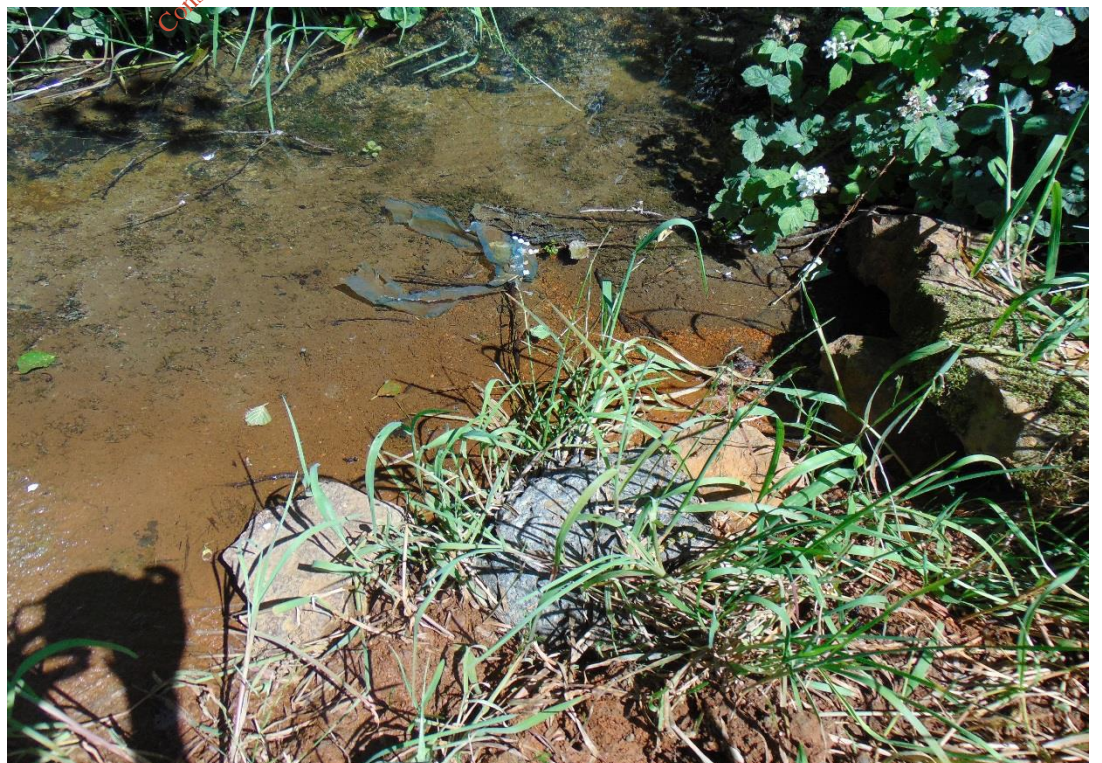
Photo No.
6

Another view discoloration (red staining) to the Clooncoose Stream near the eastern portion of the landfill (possible evidence of leachate seepage from the landfill)
