# Appendix 1

Site Walkover Photos Taken during Tier 2 and 3 Assessments of the historic landfill site.

# PHOTOGRAPHIC LOG

**Site Location:** Cartron Big Landfill

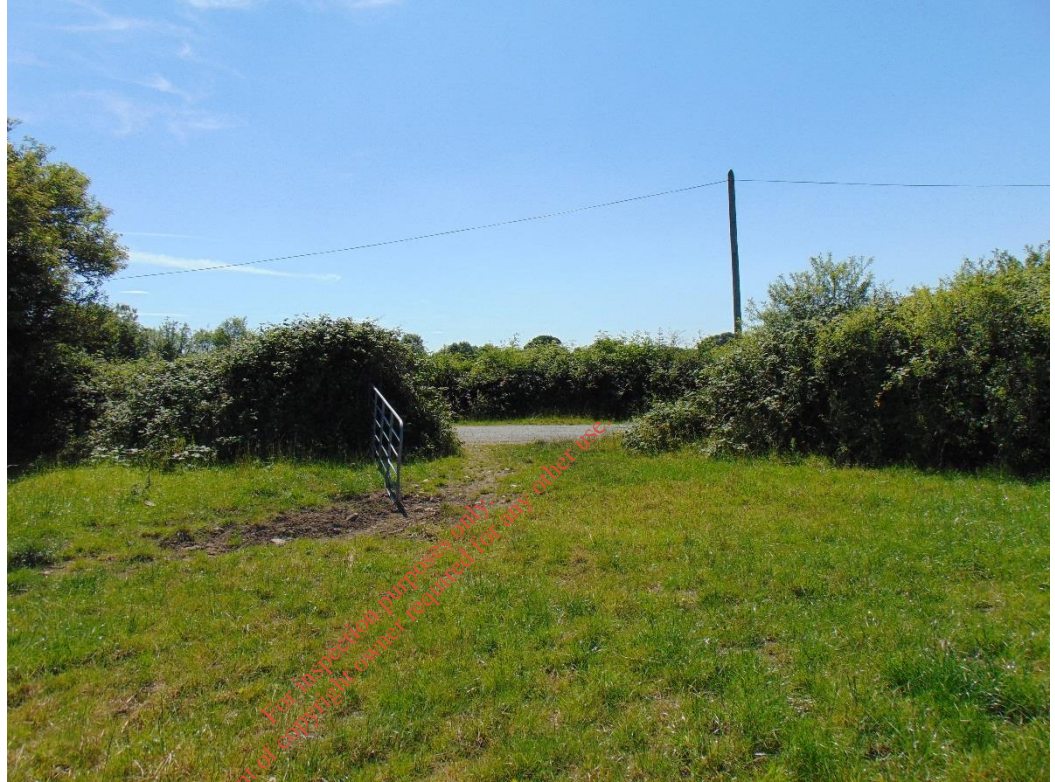
1

Main site entrance gates  
from L3538 road.

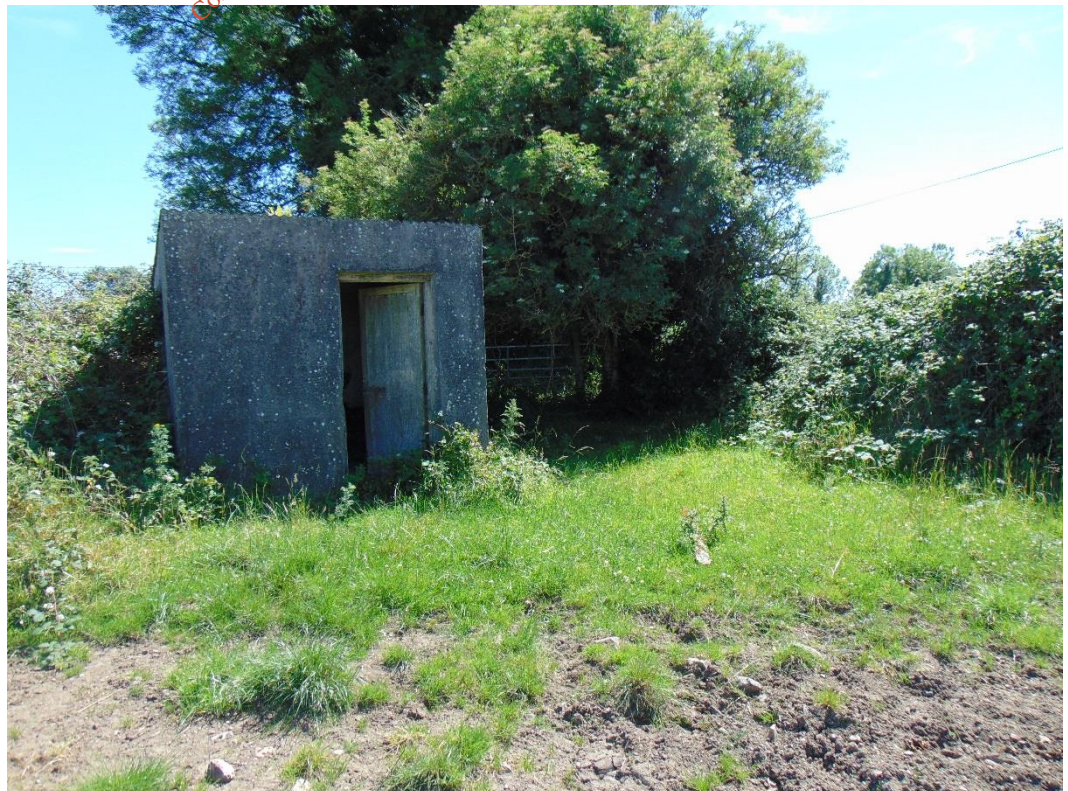
2

Derelict security hut near  
main entrance gates.

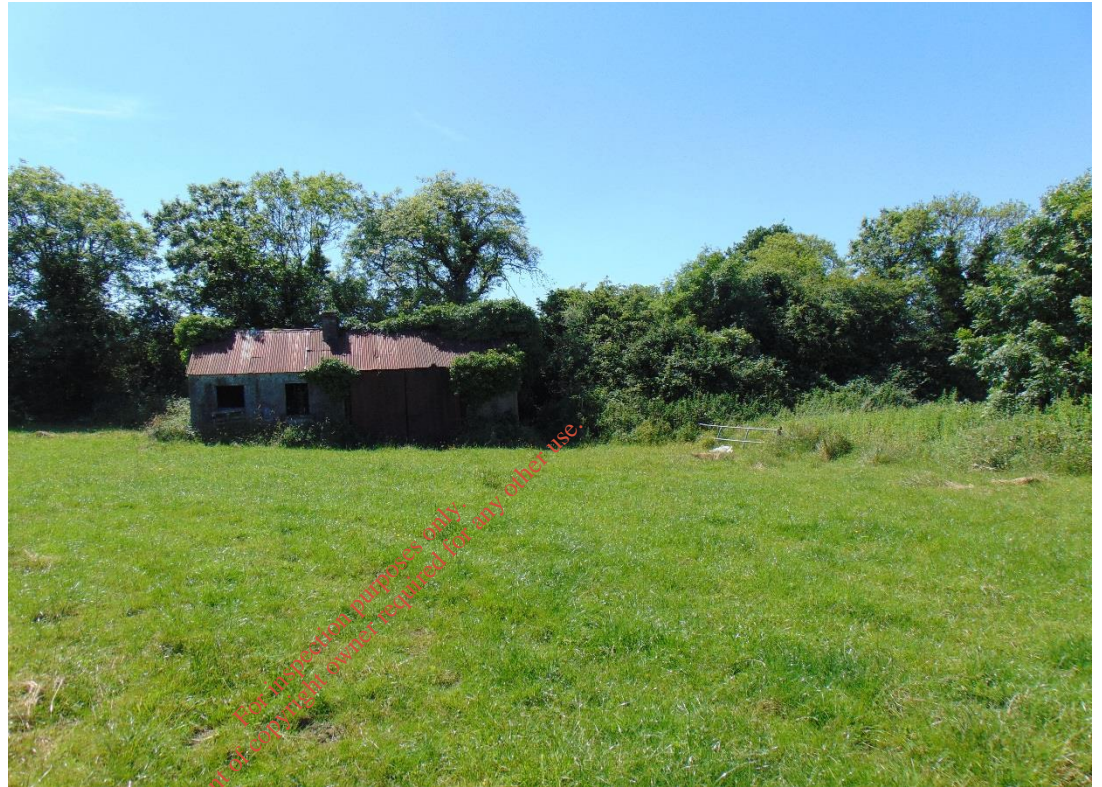
**Photo No.**  
3

Derelict building  
along western  
boundary and near  
to concrete  
hardstand area.

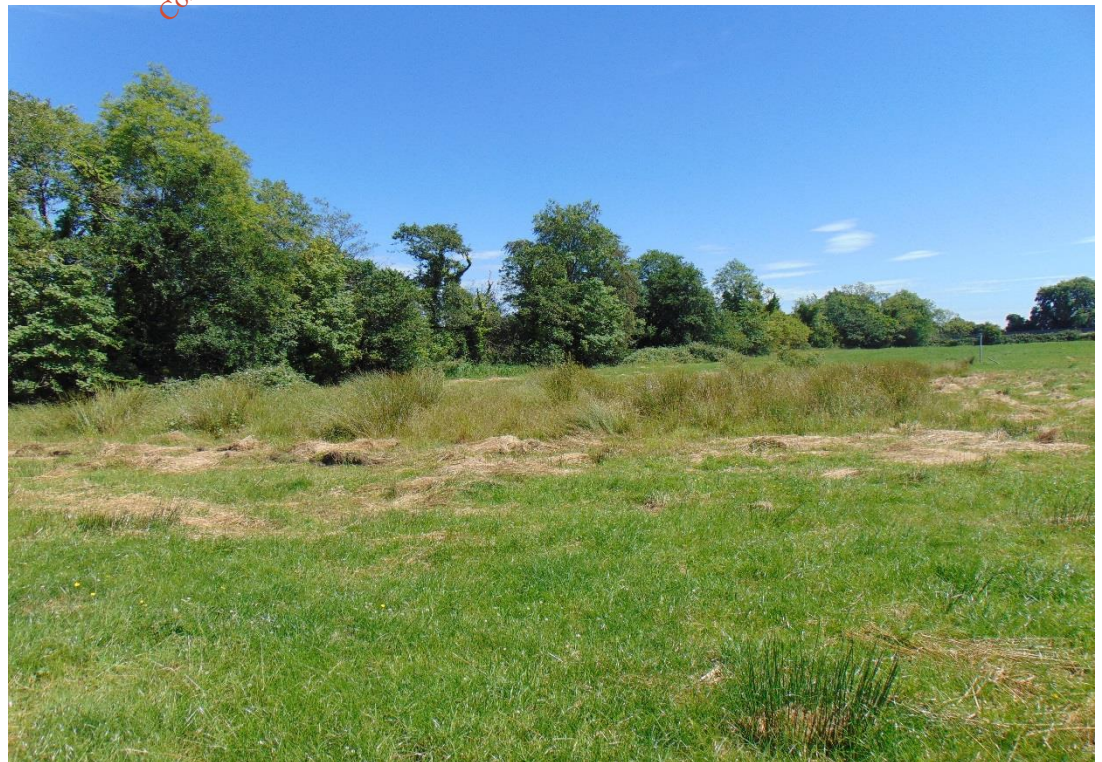
**Photo No.**  
4

View showing poorly  
draining grassland  
conditions prone to  
waterlogging along  
the eastern side of  
the site.

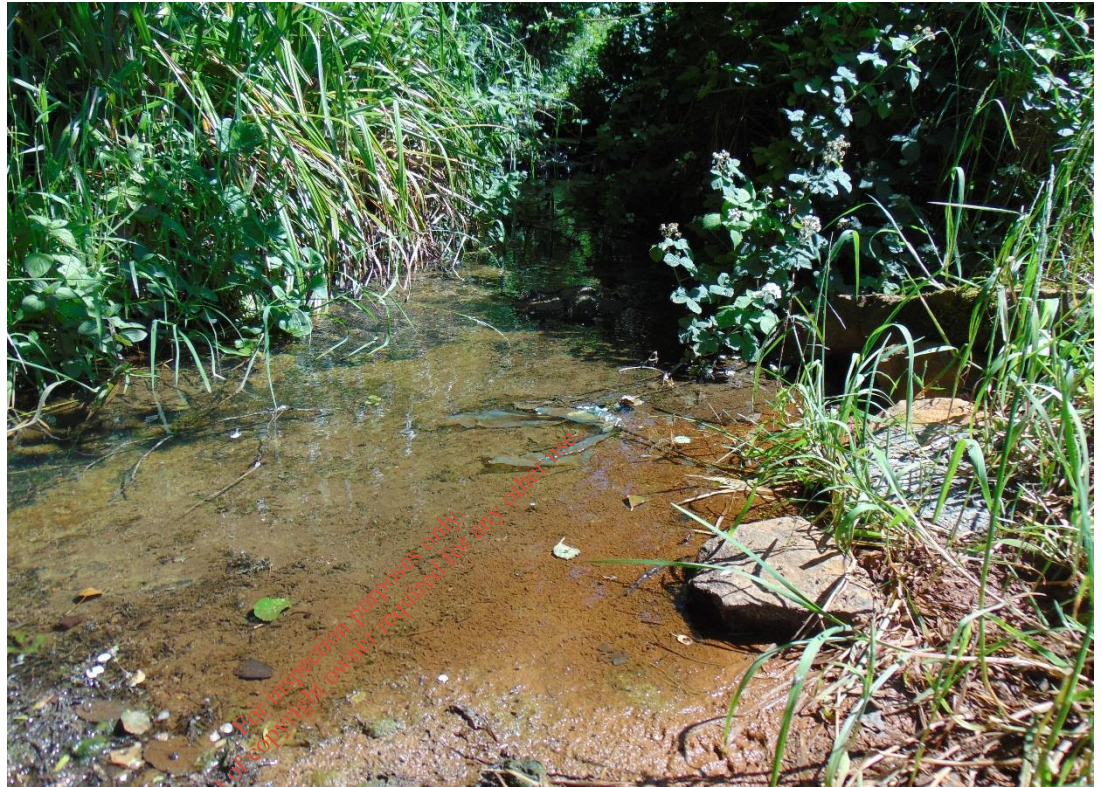
**Photo No.**  
5

View showing discoloration to the Clooncoose Stream near the eastern portion of the landfill (possible evidence of leachate seepage from the landfill)

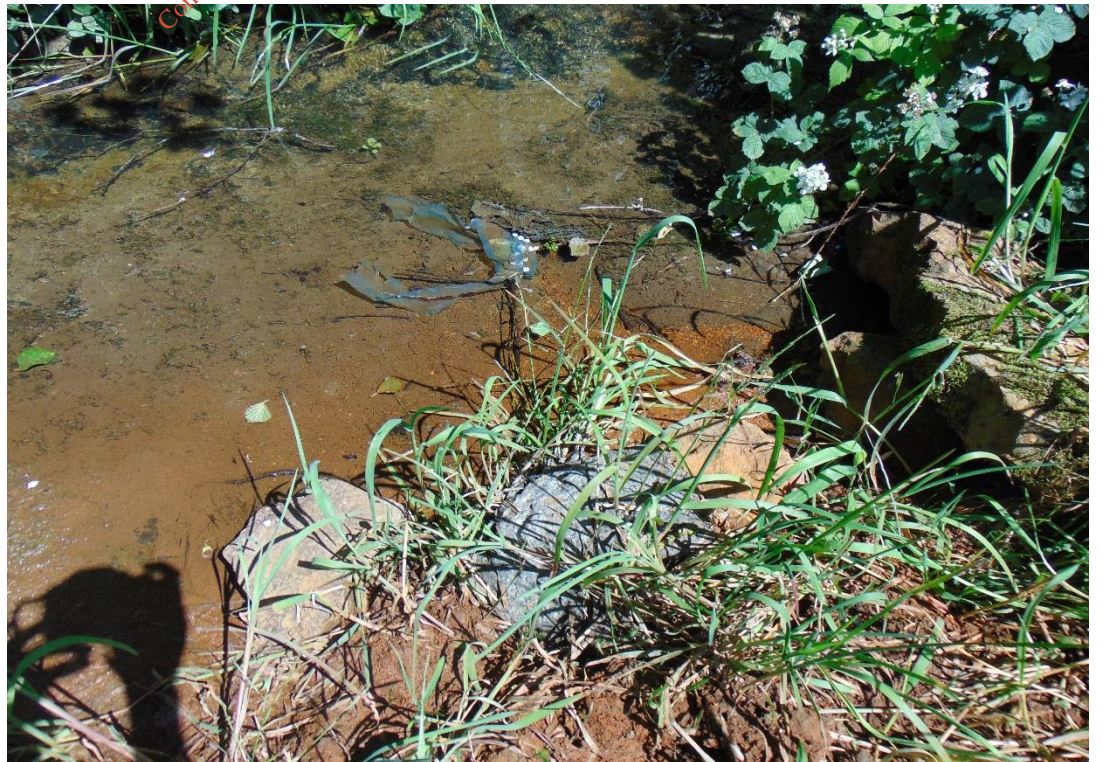
**Photo No.**  
6

Another view discoloration (red staining) to the Clooncoose Stream near the eastern portion of the landfill (possible evidence of leachate seepage from the landfill)

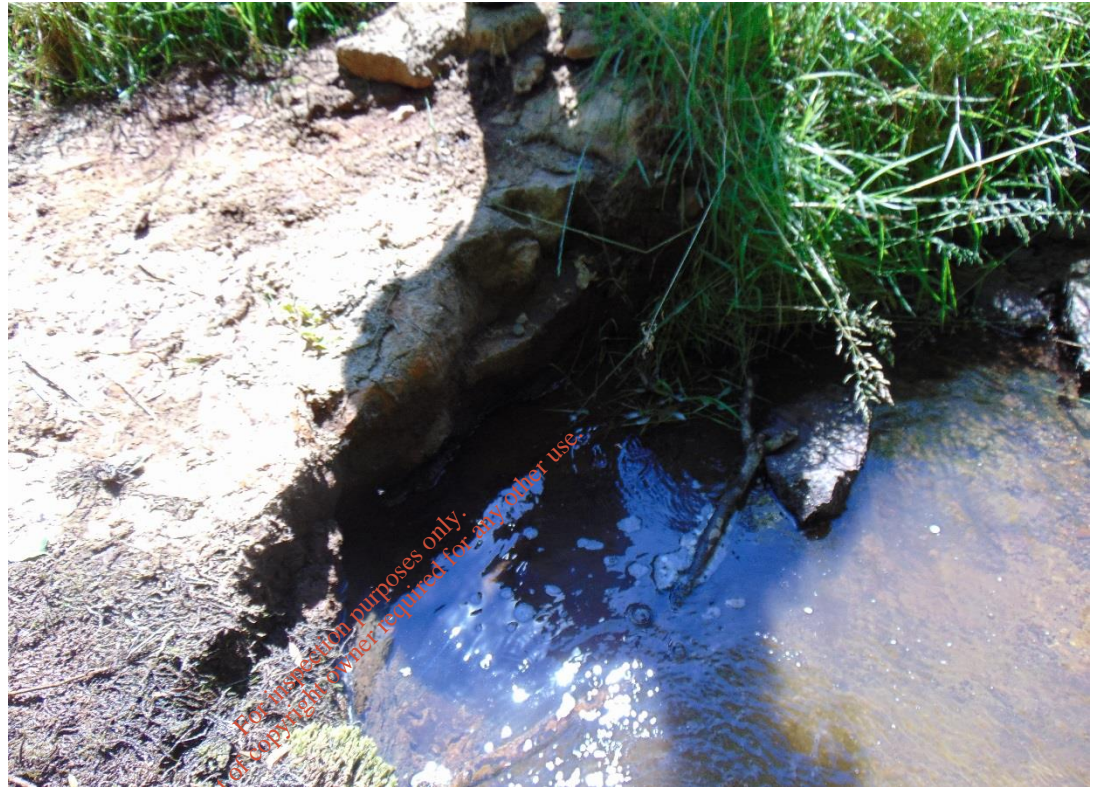
7

View showing area of Clooncoose Stream in north-eastern corner of landfill.

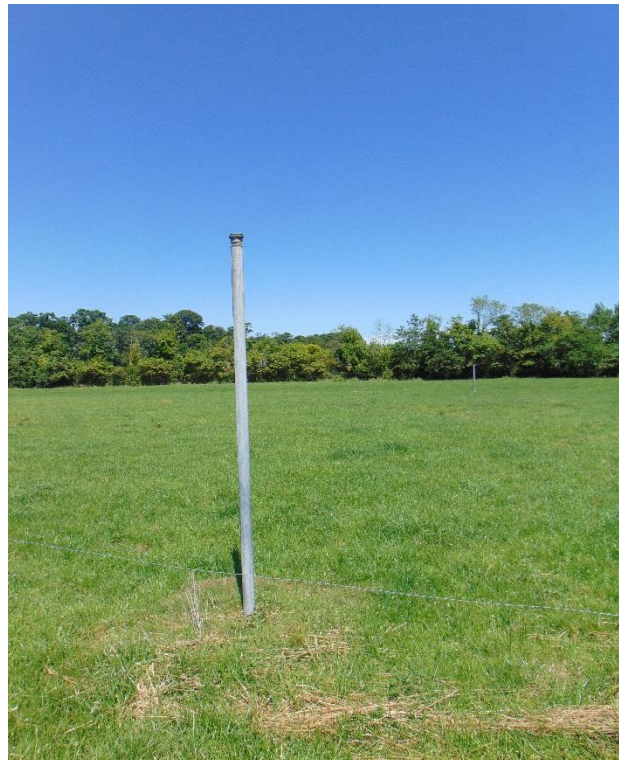
8

Existing gas venting system installed within landfill cap.

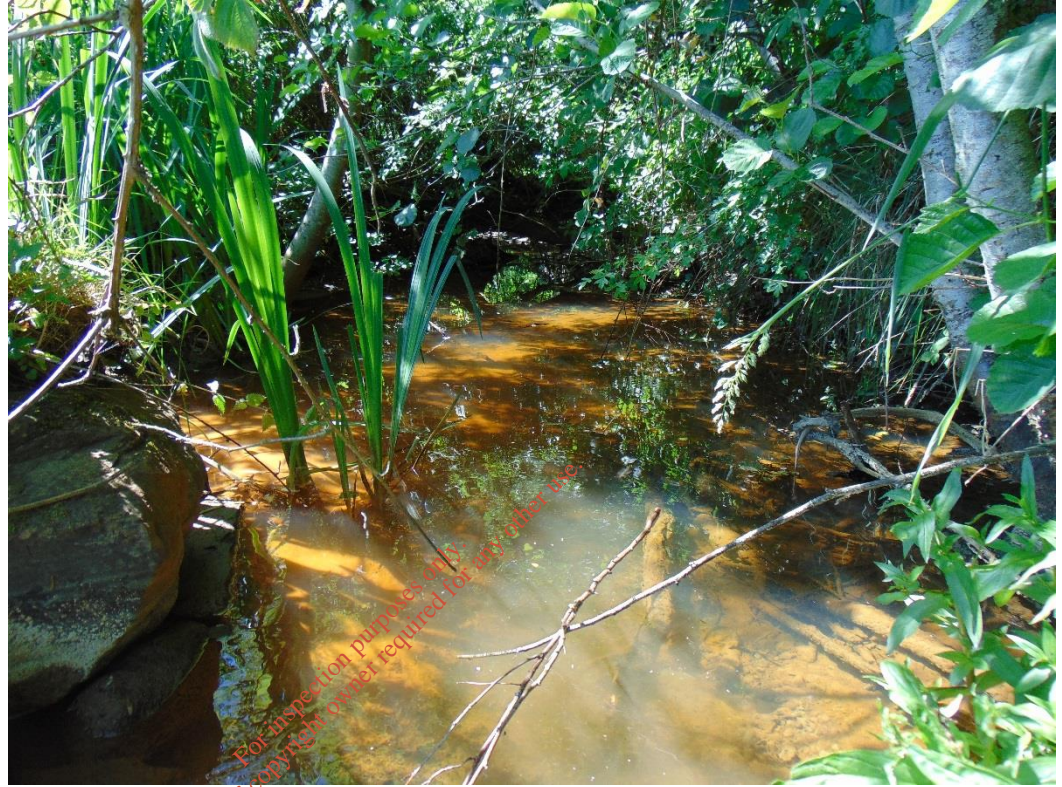
**Photo No.**  
9

View showing the discharge location of iron precipitate entering the Clooncoose Stream from the field north of the landfill. Possibly a preferential pathway to North-North East.

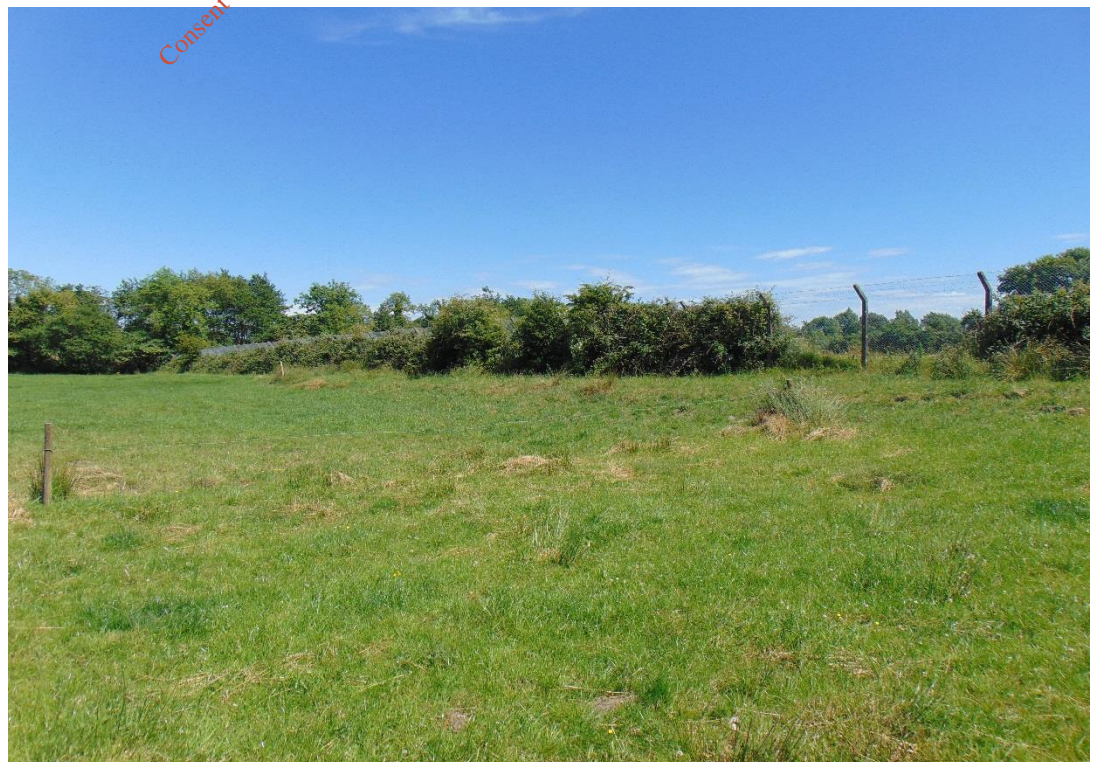
**Photo No.**  
10

Evidence of land subsidence towards the southern site boundary
