## Cartron Big Walkover Survey Checklist – 26<sup>th</sup> June 2018

# PHOTOGRAPHIC LOG

**Site Location:** Cartron Big Landfill

**Project Number:** P1444

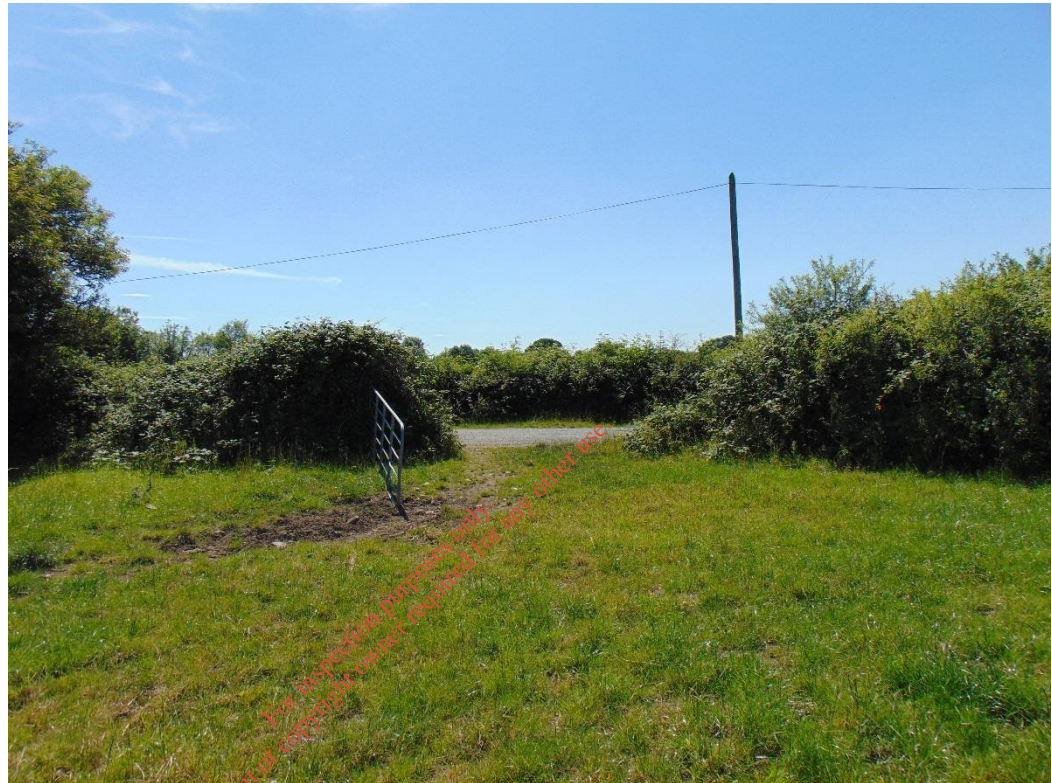
1

Main site entrance gates  
from L3538 road.

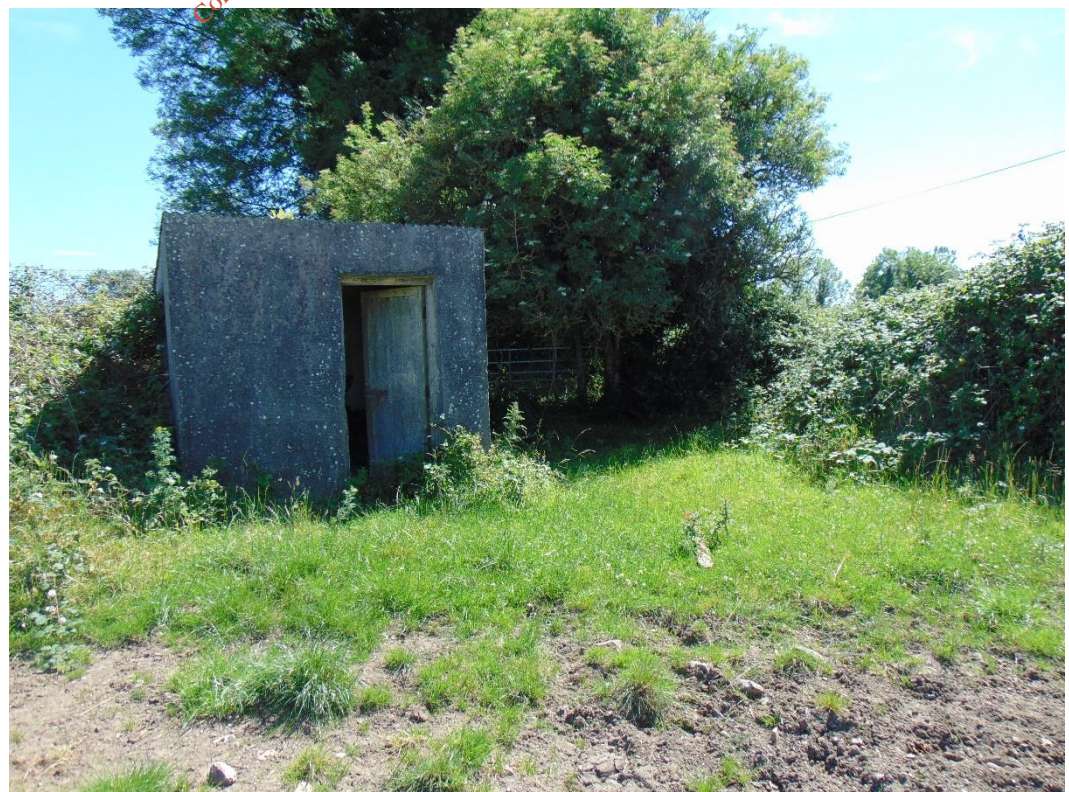
2

Derelict security hut near  
main entrance gates.

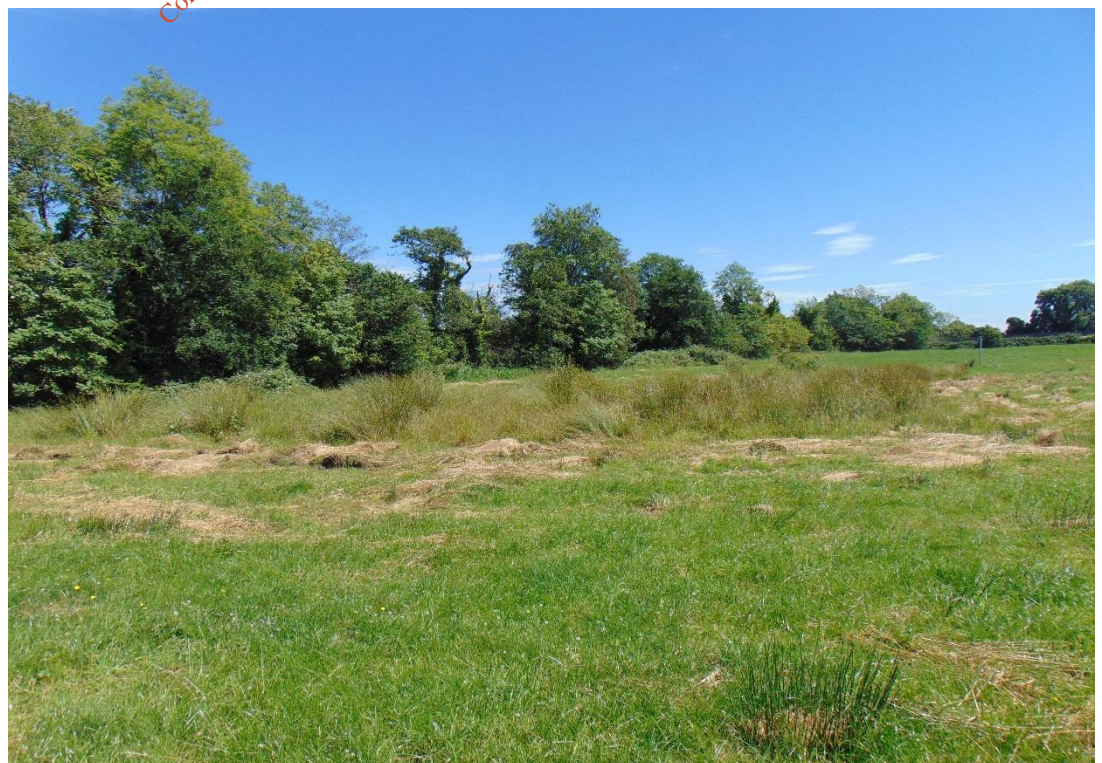
**Photo No.** 4  
**Date:** 26-06-18

**Description:**  
View showing poorly  
draining grassland  
conditions prone to  
waterlogging along  
the eastern side of  
the site.

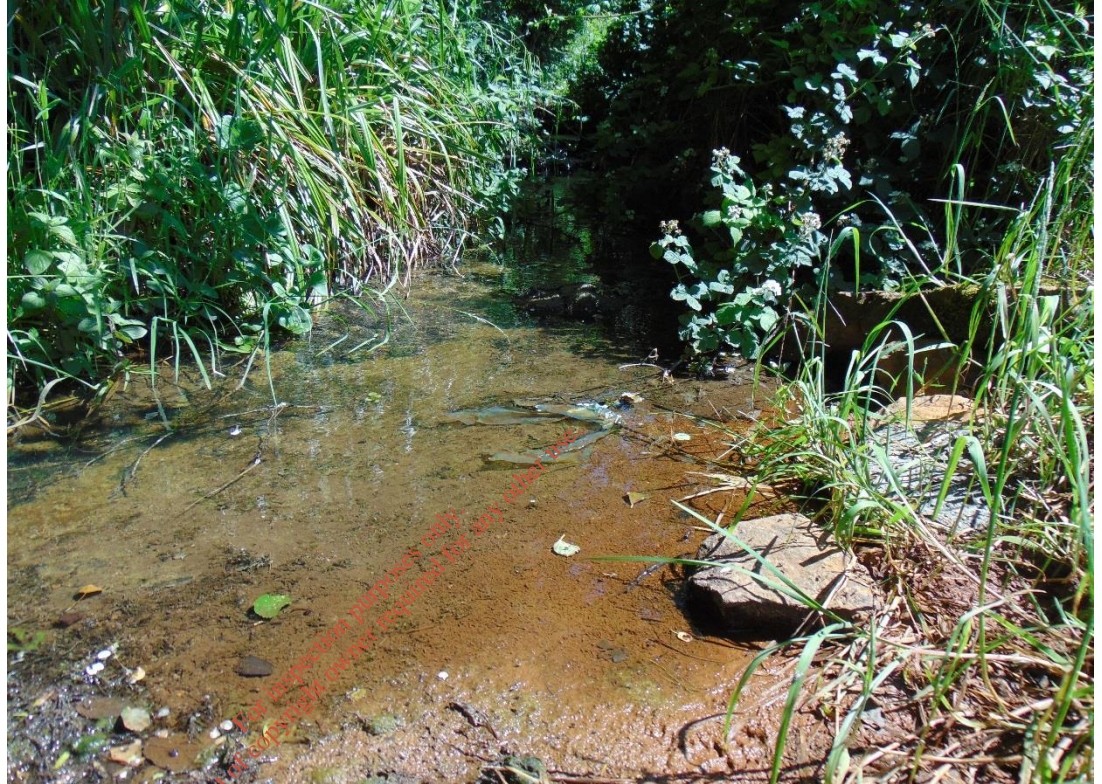
**Photo No.**  
5

7. Are there any outfalls to surface water? (If yes, are there discharges and what is the nature of discharge?)	√	Possible leachate seepage into the Clooncoose stream was observed i.e. red oxide staining to stream bed at two locations

View showing discoloration to the Clooncoose Stream near the eastern portion of the landfill (possible evidence of leachate seepage from the landfill)

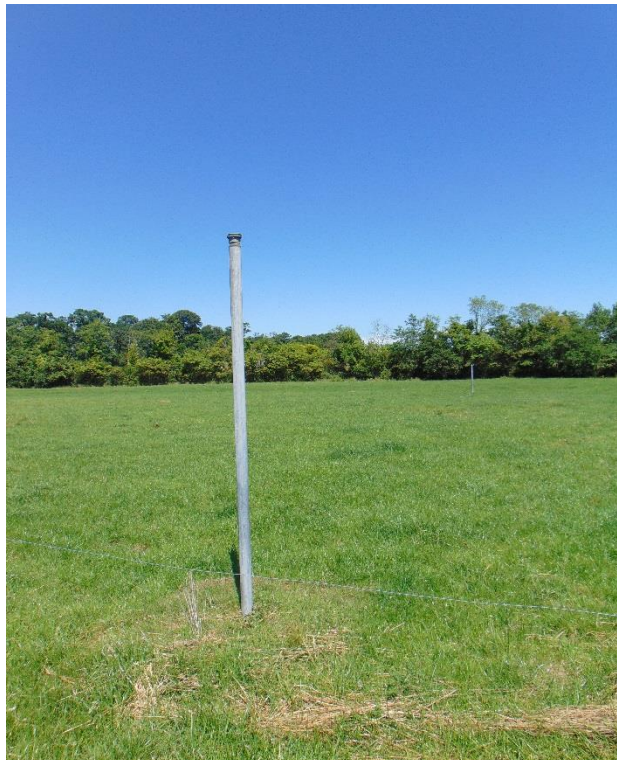
**Photo No.**  
8

Information	Checked	Comment (include distances from site boundary)
Landfill gas collection	√	Yes, there are a series of landfill gas vents across the site which appear to be passive. There does not appear to be a landfill gas collection system in place.
Leachate collection	√	No.

**Description:**  
Existing gas venting system installed within landfill cap.
