Cartron Big Landfill

Datagap Analysis & Tier 1 Assessment

Longford County Council

22 November 2017

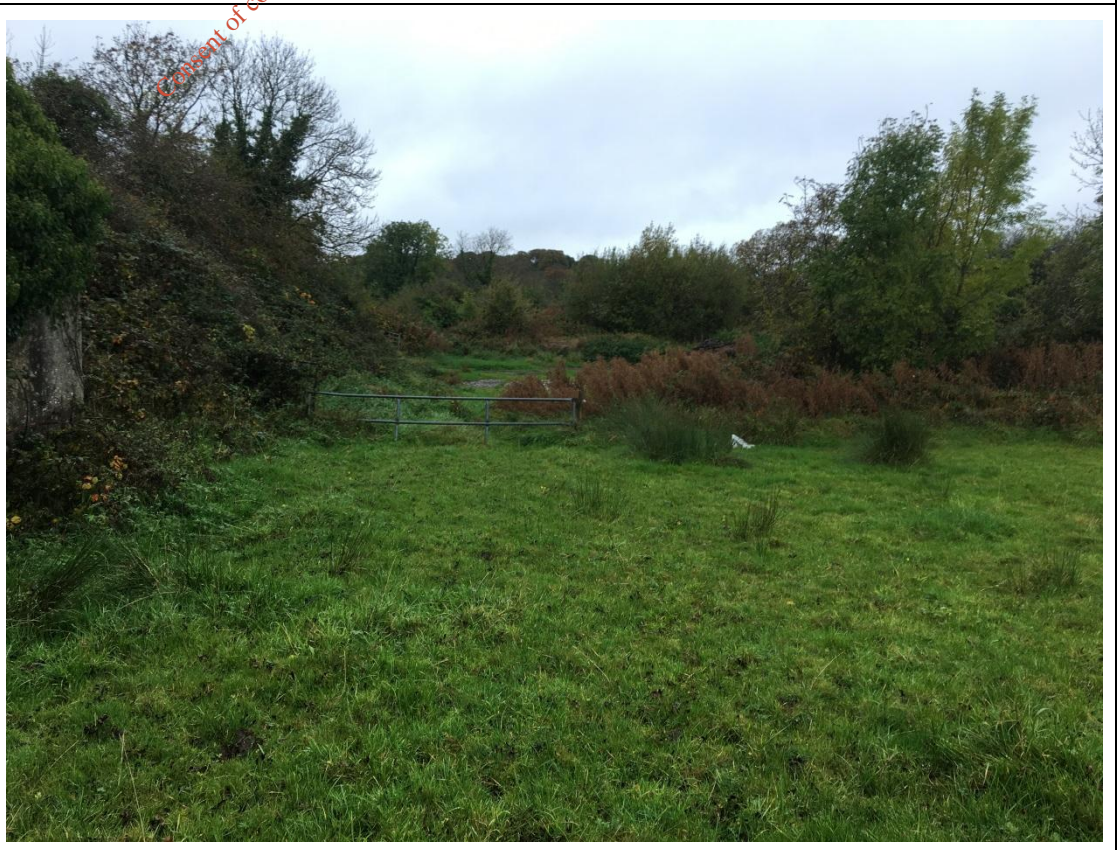
Photo No. 6	Date: 13/10/2017
-----------------------	----------------------------

Description:
Internal access gate from concrete hardstand to the field.

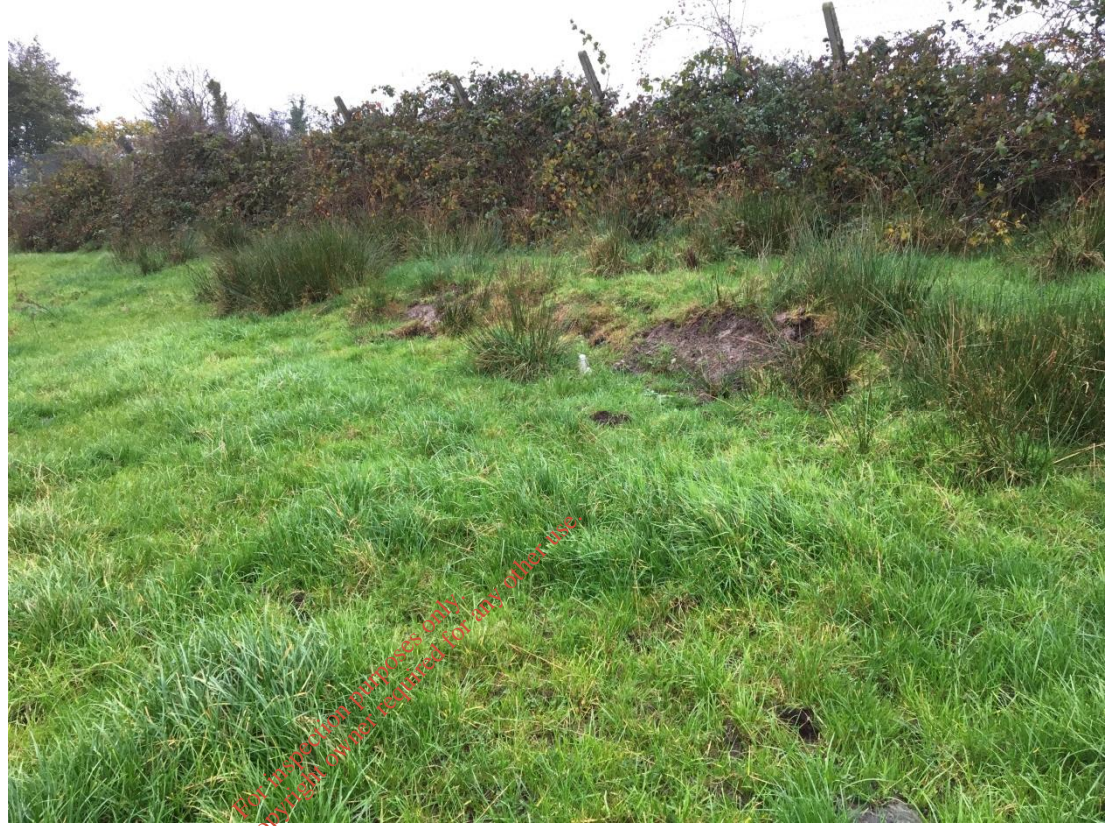
Evidence of subsidence along southern site boundary.
