# Appendix V

## Site Walkover Checklist & Photographs

## Ballymulvey Walkover Survey Checklist – 26<sup>th</sup> June 2018

**Site Location:** Ballymulvey Landfill

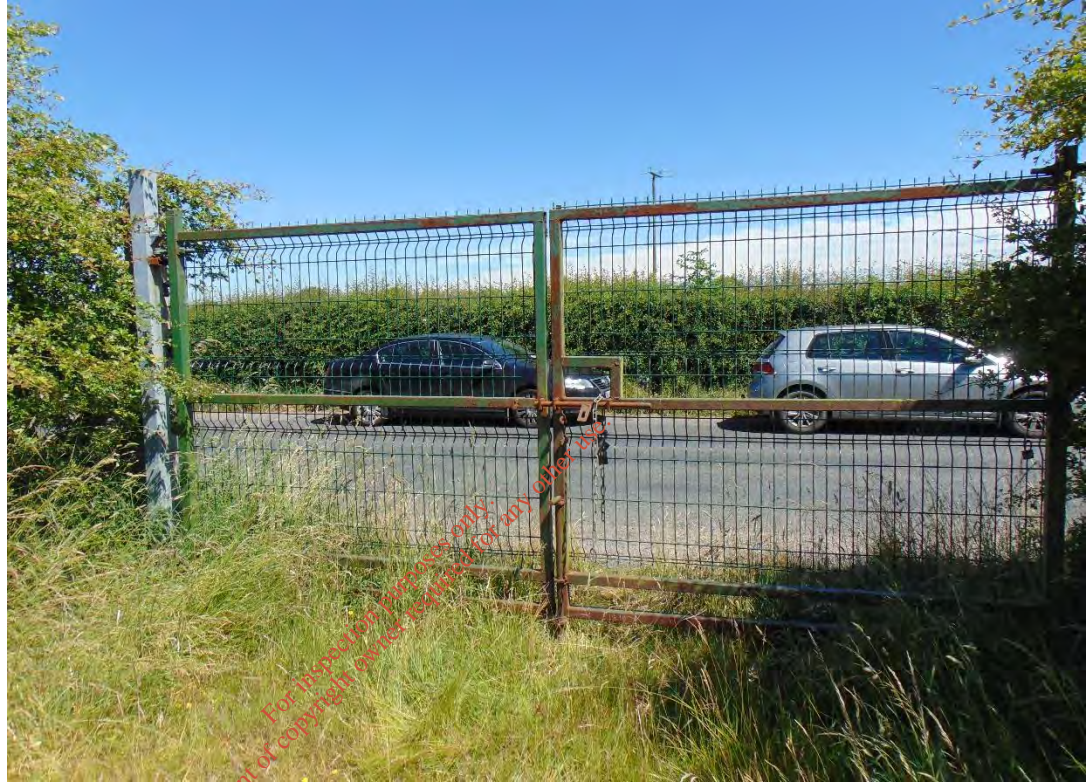
1

Main site entrance gates  
from L1121 road.

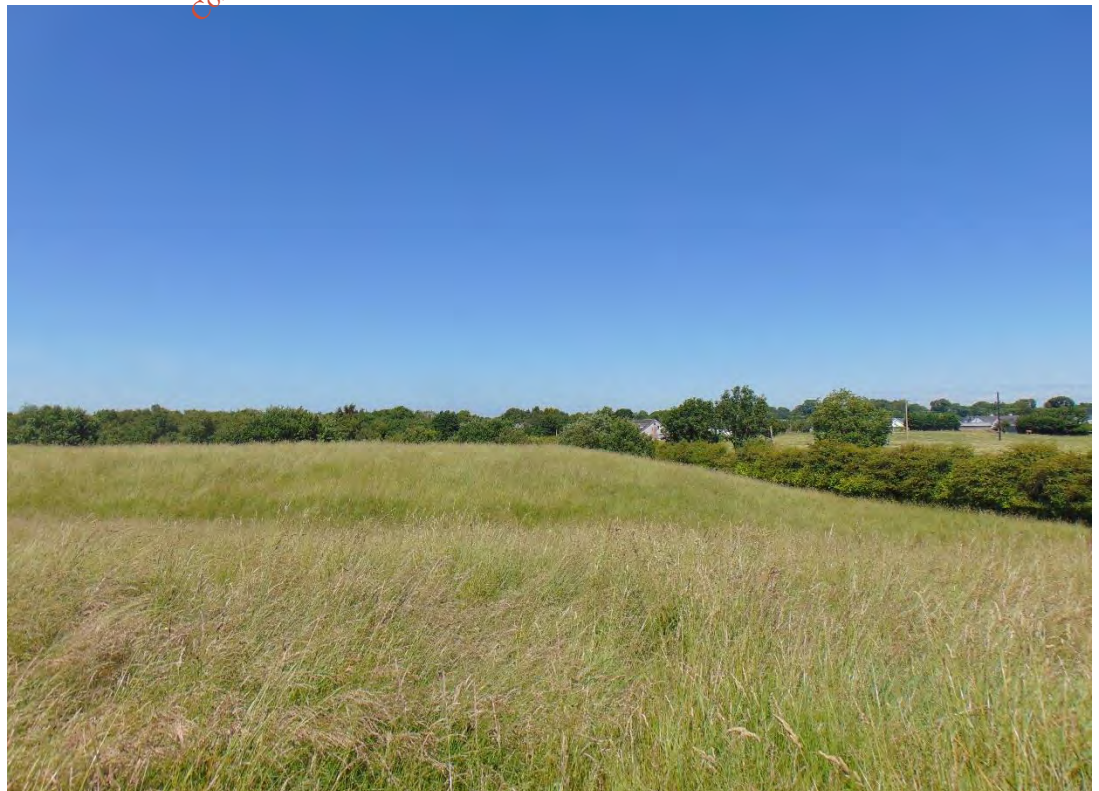
2

View from the top of Bund  
No.1 over to Bund No. 2.

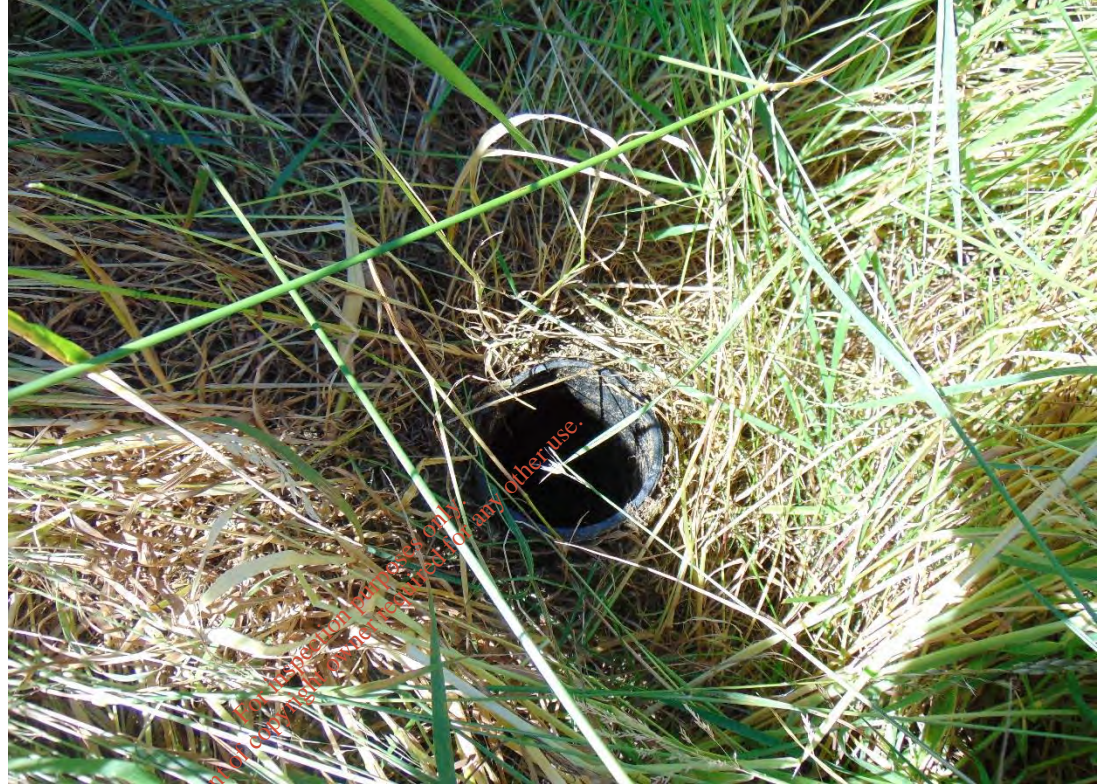
**Photo No.**  
3

Old groundwater monitoring borehole BH2 flush with ground and no well head or concrete plinth.

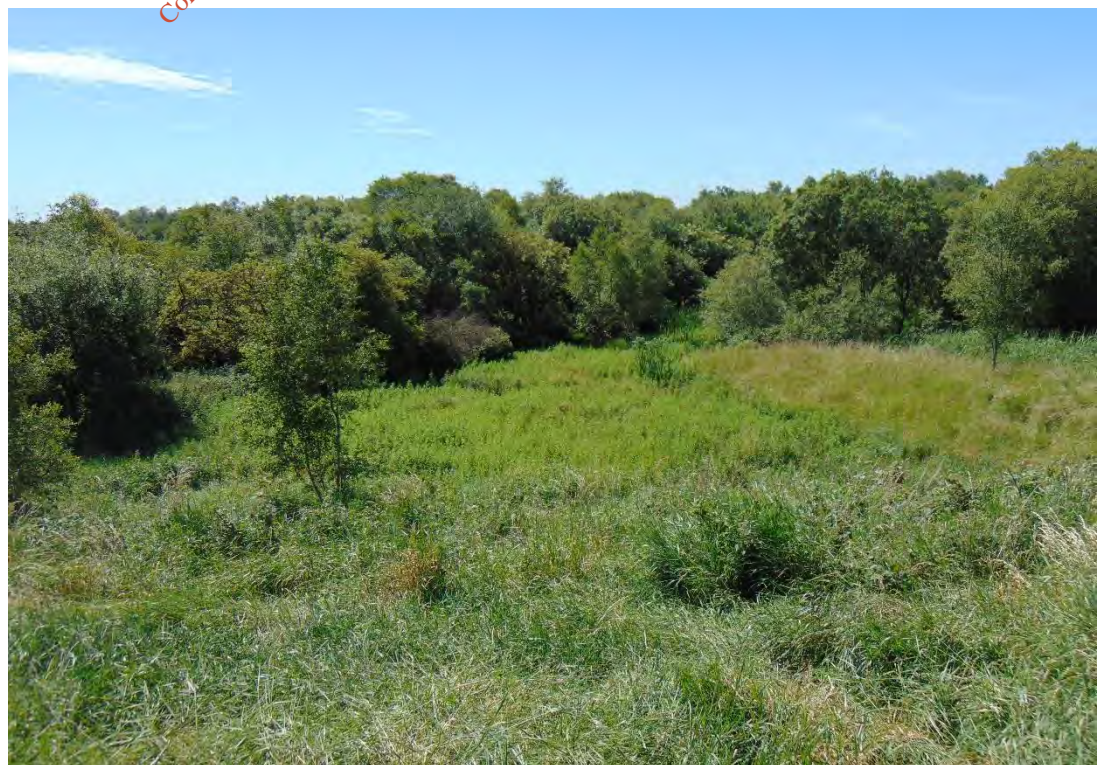
**Photo No.**  
4

5. Are there potential receptors (if yes, give details)?	√	<p>Lagoon in the southern portion of the site; abundant reed growth within the lagoon.</p> <p>Further south, maps indicate that there are land-drains across agricultural land/bog to the north-west and south-east. It appears that these land-drains feed into a tributary of the River Inny, 700 m west of the site.</p> <p>There are houses within 400m of the site.</p> <p>Bedrock Aquifer is classified as a locally important aquifer which is moderately vulnerable to contamination.</p>
Houses	√	There are houses within 200m of the site boundary.
Surface water features (if yes, distance and direction of flow)	√	At its closest point the River Inny is 900 m south of the site. The River Inny flows from north-east to south-west along the south-eastern boundary of Cloonkeen Woods. Approximately 1.5 km south-east of the site the flow direction of the River Inny changes course to a more westerly direction.

View showing lagoon to the south of the landfill with overgrown vegetation.

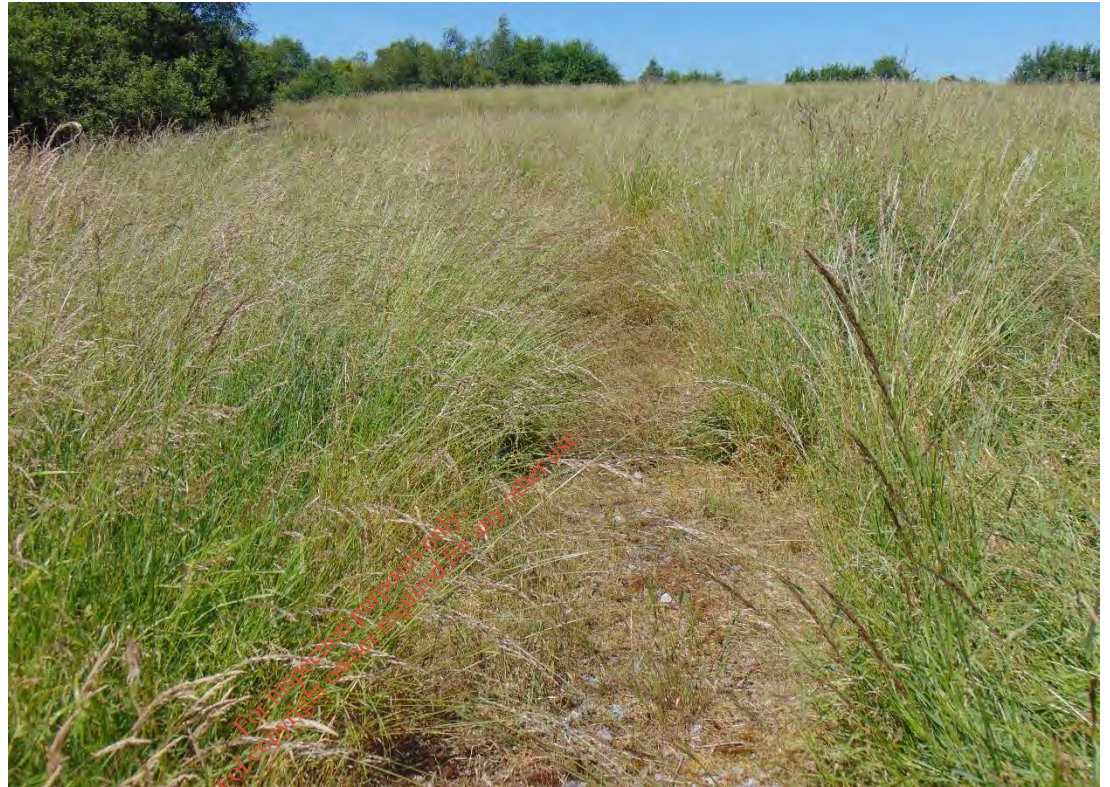
**Photo No.**  
5

Information	Checked	Comment (include distances from site boundary)
9. Are there any indications of remedial measures? (Provide details)	√	Capping Landfill Gas Collection Leachate Collection
Capping	√	Yes, the waste body is reported to have been capped with a soil cap.
Landfill gas collection	√	Yes, several gas monitoring points were observed during the site walkover, no vents observed.
Leachate collection	√	Yes, a series of gravel filled land-drains within the waste mounds draining to a toe-drain around the perimeter of the landfill. Unclear to where leachate in the toe-drain discharges.

**Description:**  
View showing evidence  
of perimeter drainage  
installed along the cap

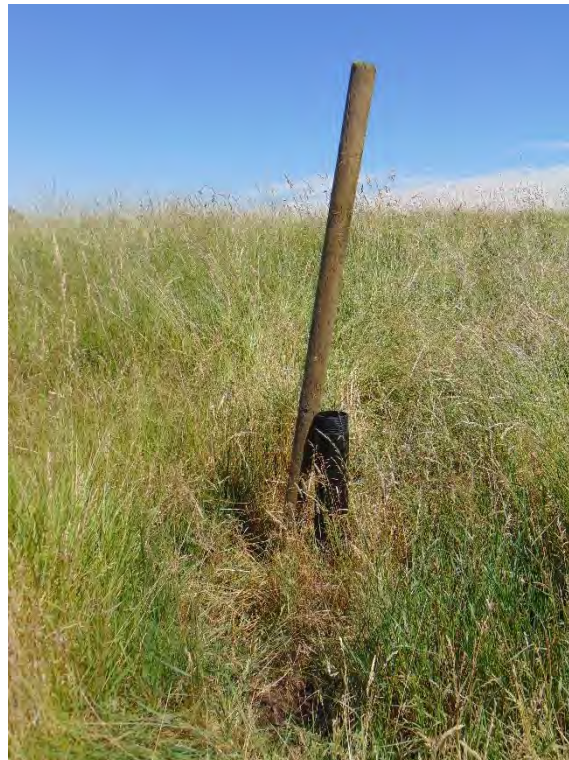
**Date:**  
26-06-18

**Description:**  
View showing leachate  
monitoring well BH6  
installed within Bund  
No. 1.

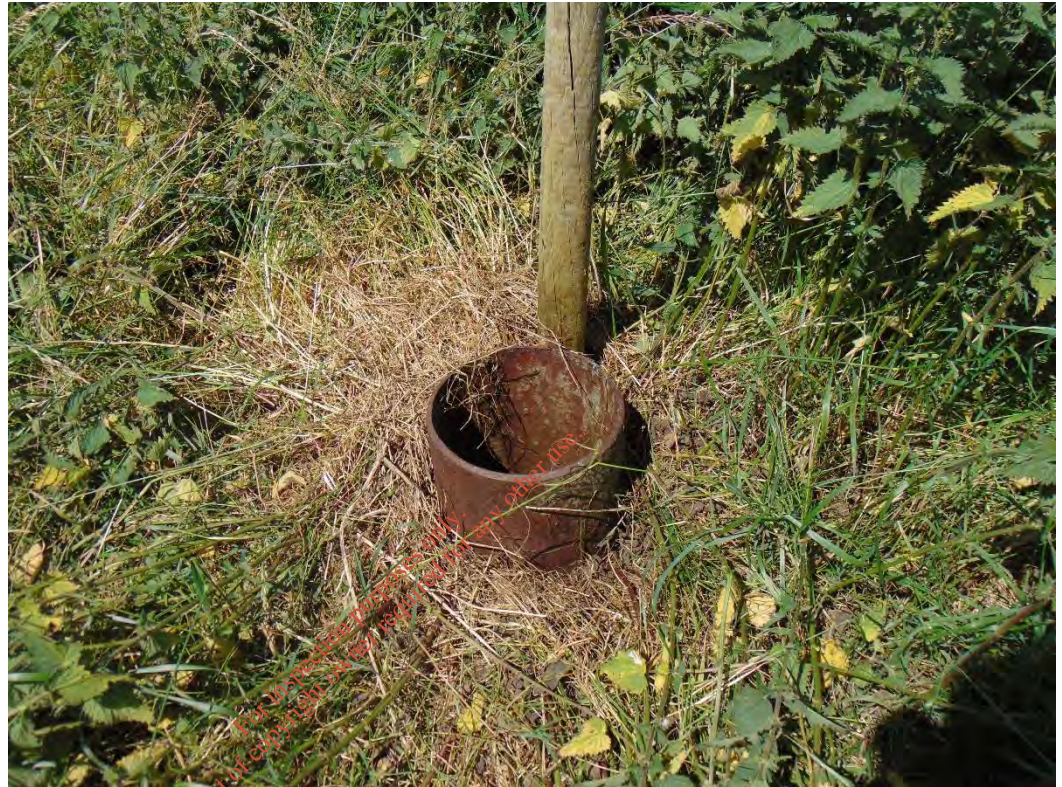
**Photo No.**  
7

8. Are there any signs of impact on the environment? (If yes, take photographic evidence)	√	See Photographic Log
Vegetation die off, bare ground	√	No
Leachate seepages	√	None observed.
Odours	√	From gas vents and groundwater monitoring wells GW01 and GW03.
Litter	√	No
Gas bubbling through water	√	No
Signs of settlement	√	No
Subsidence, water logged areas	√	No
Drainage or hydraulic issues	√	Evidence of localised areas of waterlogging and poor drainage.
Downstream water quality appears poorer than upstream water quality	√	N/A

**Description:**  
View showing one of  
the gas vents.

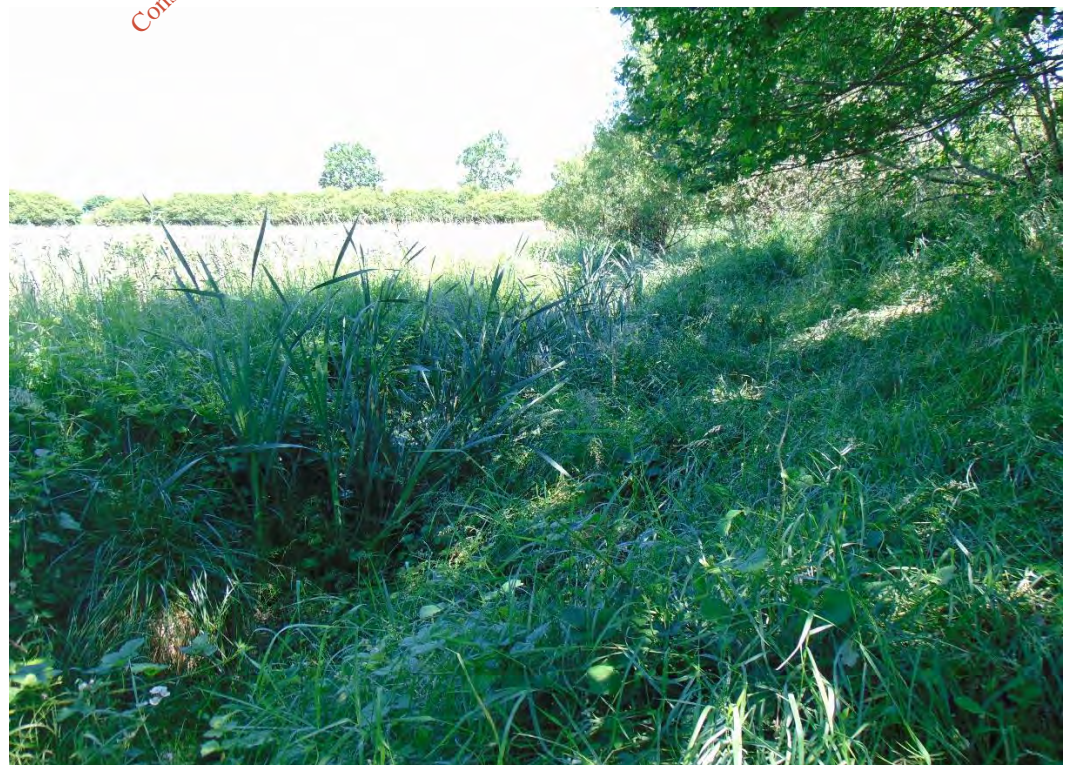
**Photo No.**  
8

7. Are there any outfalls to surface water? (If yes, are there discharges and what is the nature of discharge?)	√	Standing water level in the perimeter cut-off drain and lagoon was observed to be very high (at ground level); potential for overflow/seepage from lagoon to cut-off drain. Seepage southwards/south-westwards from cut-off drain to boggy woodland south of the site was observed.

**Description:**  
View showing perimeter  
cut-off drain along  
western side of Bund No.  
2.

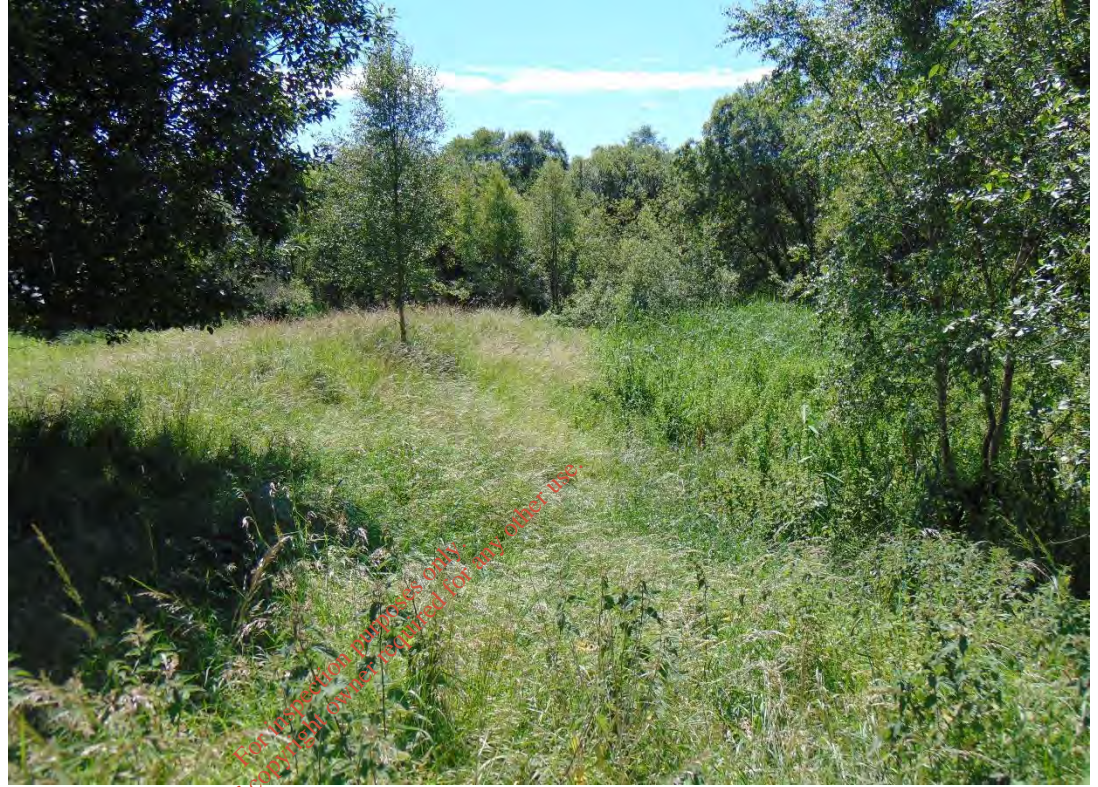
**Photo No.**  
9

**Description:**  
View showing slope  
down from Bund No. 2  
towards lagoon.

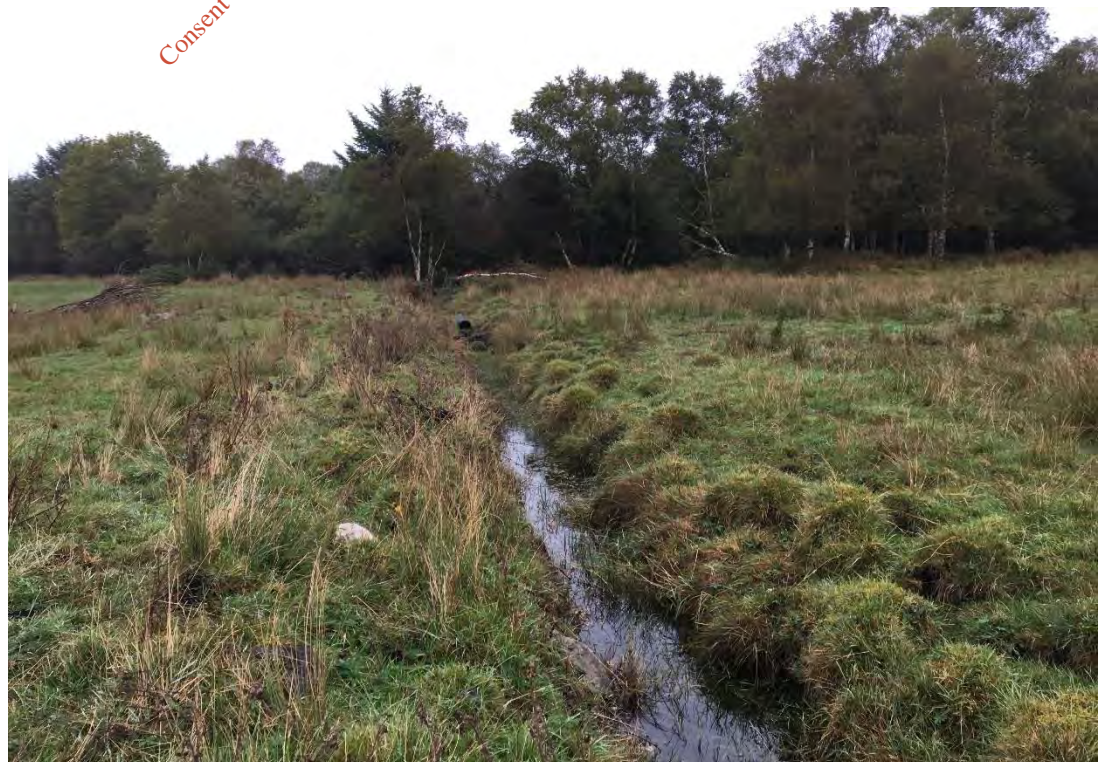
**Photo No.**  
10

**Description:**  
View showing location of  
surface water monitoring  
point SW-C to the south-  
west of the site.  
Woodland in background  
divides landfill from  
agricultural fields.

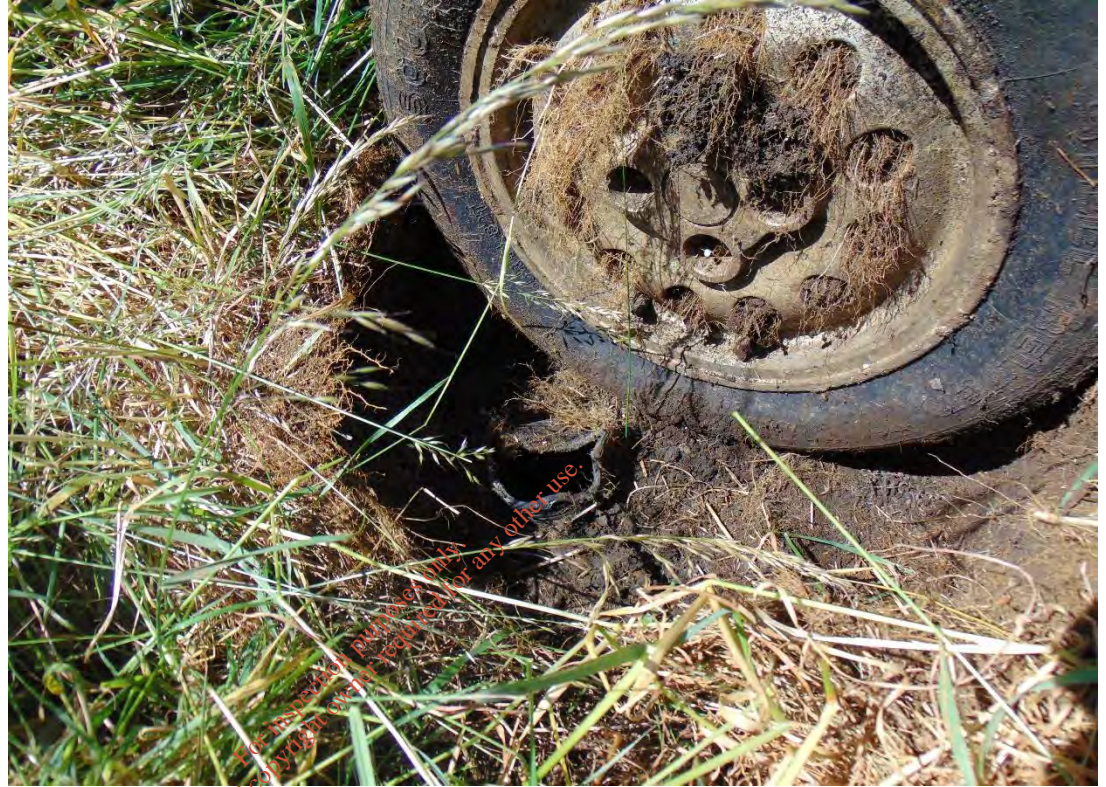
**Photo No.**  
11

**Description:**  
View showing old  
groundwater monitoring  
borehole BH1 near the  
L1121 roadway.

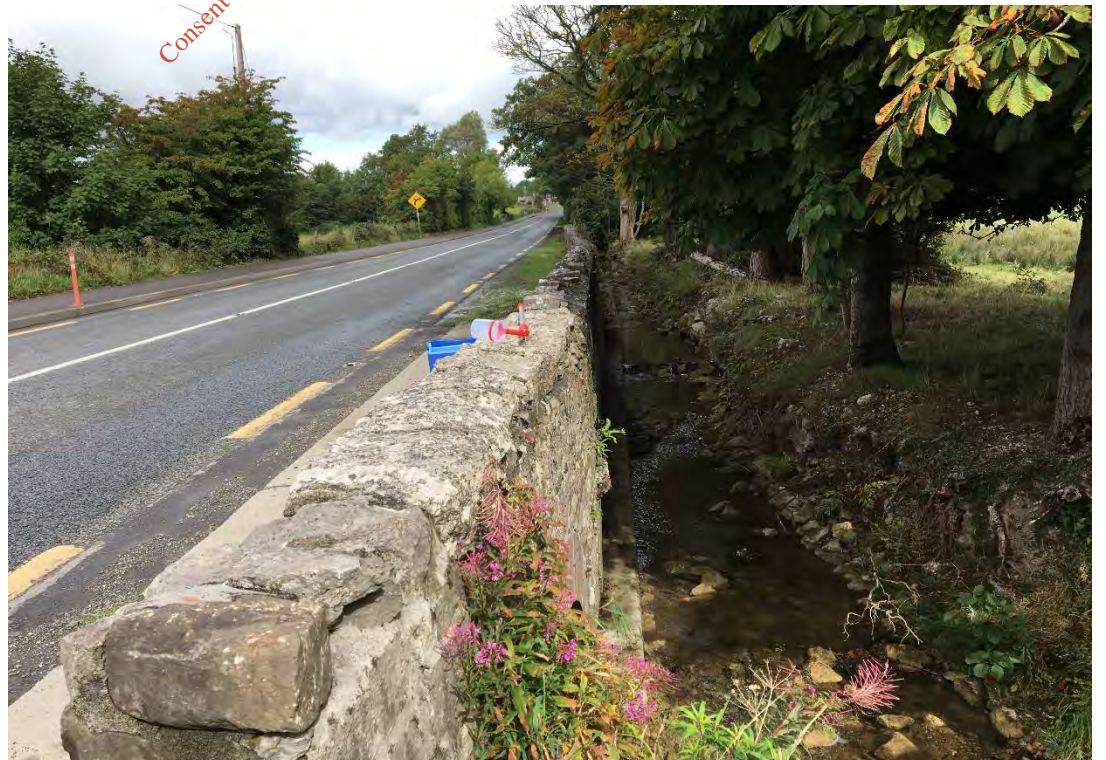
**Photo No.**  
12

**Description:**  
View showing location of  
surface water monitoring  
point SW-G, the tributary  
stream of the River Inny.
