Appendix 2

Photographs of the Site

PHOTOGRAPHIC LOG

Site Location: Ballymulvey Landfill

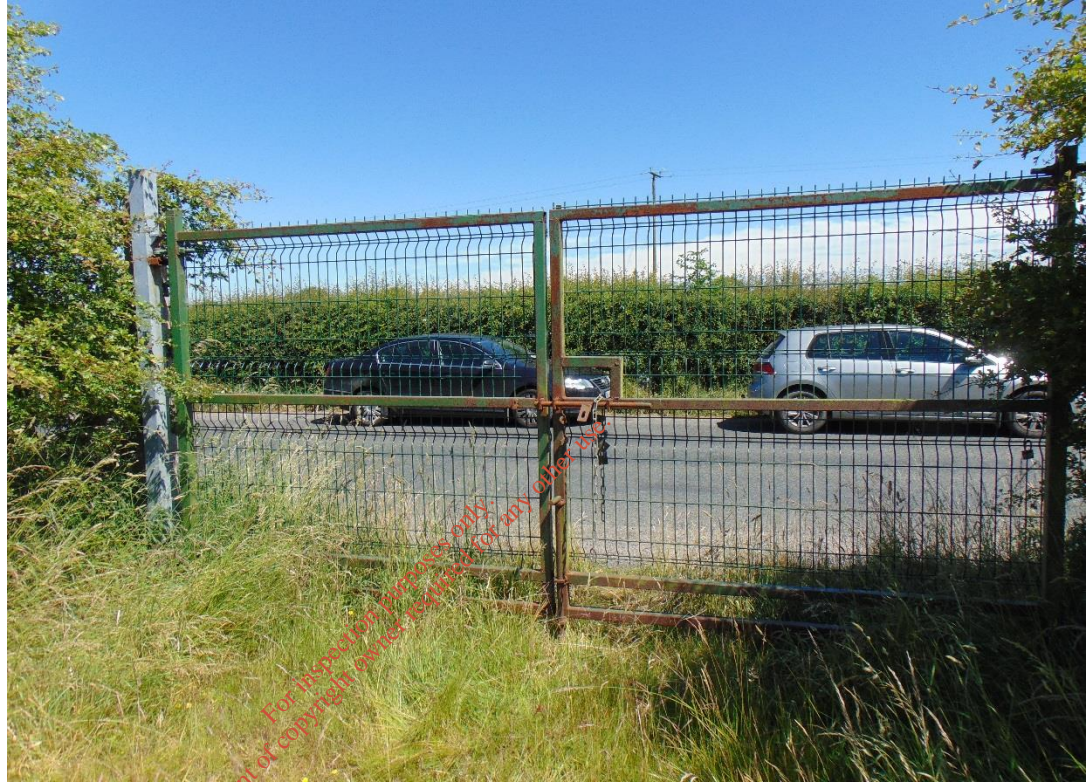
Photo No. 1
Date: 26-06-18

Description:
Main site entrance gates
from L1121 road.

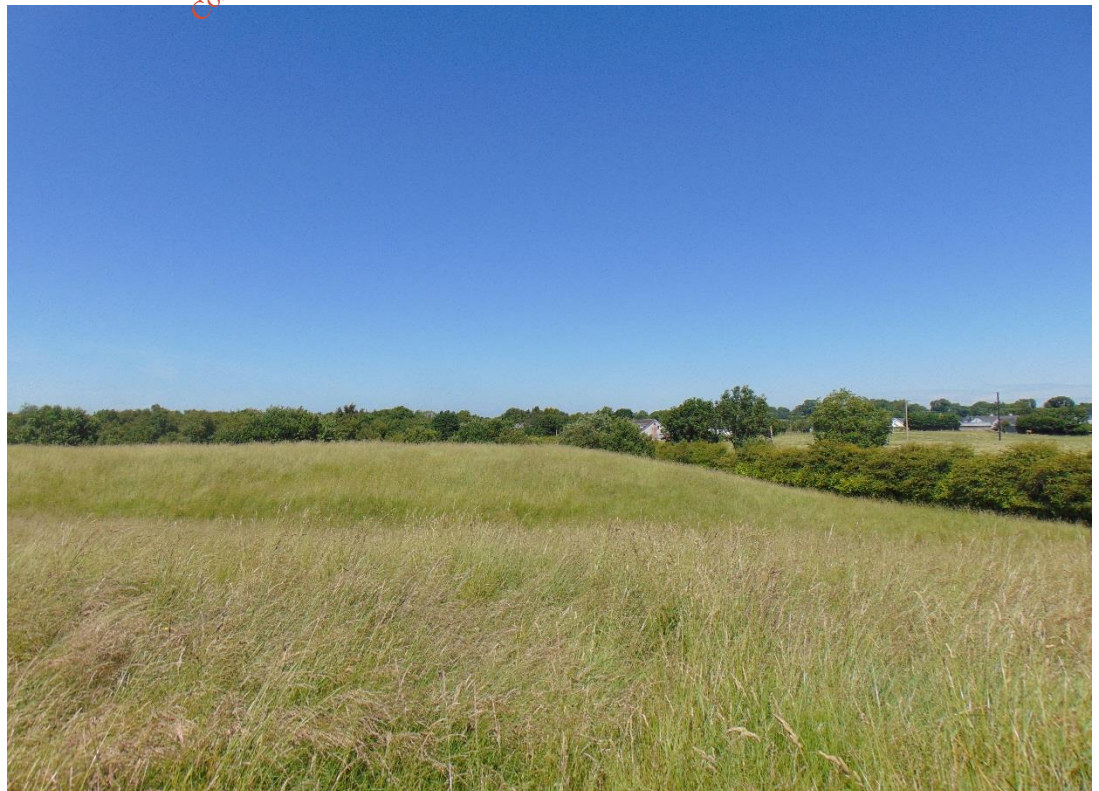
Photo No. 2
Date: 26-06-18

Description:
View from the top of Bund
No.1 over to Bund No. 2.

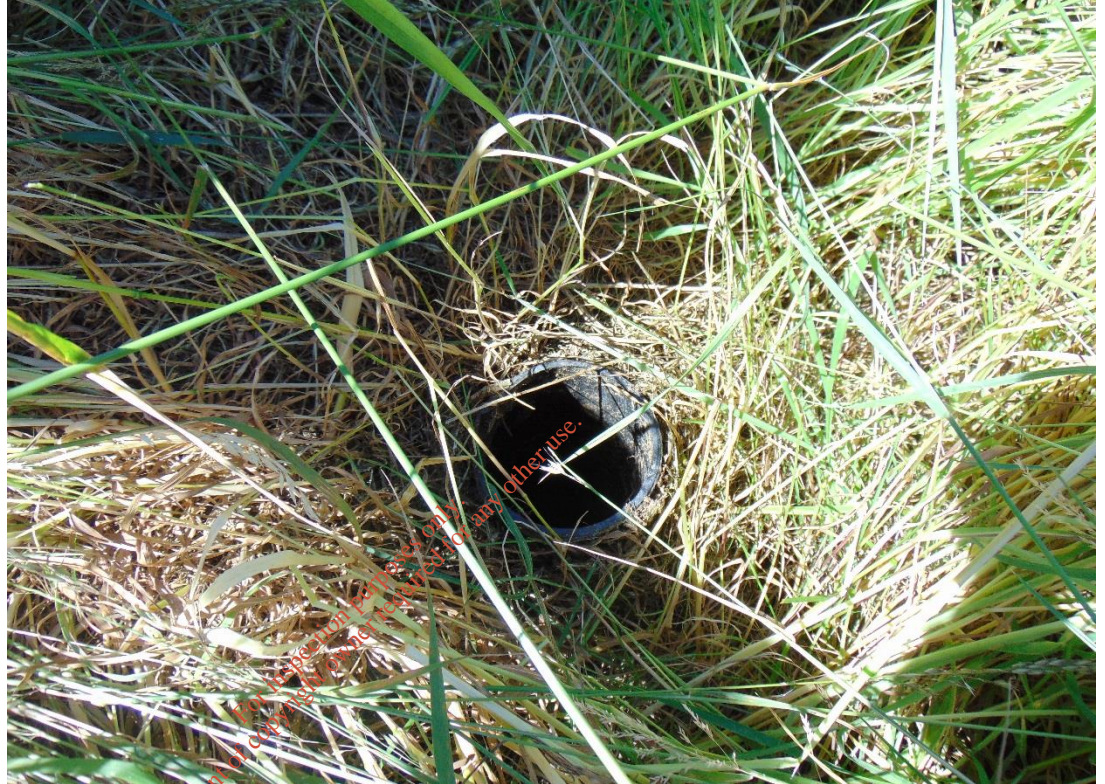
Photo No.
3

Old groundwater monitoring borehole BH2 flush with ground and no well head or concrete plinth.

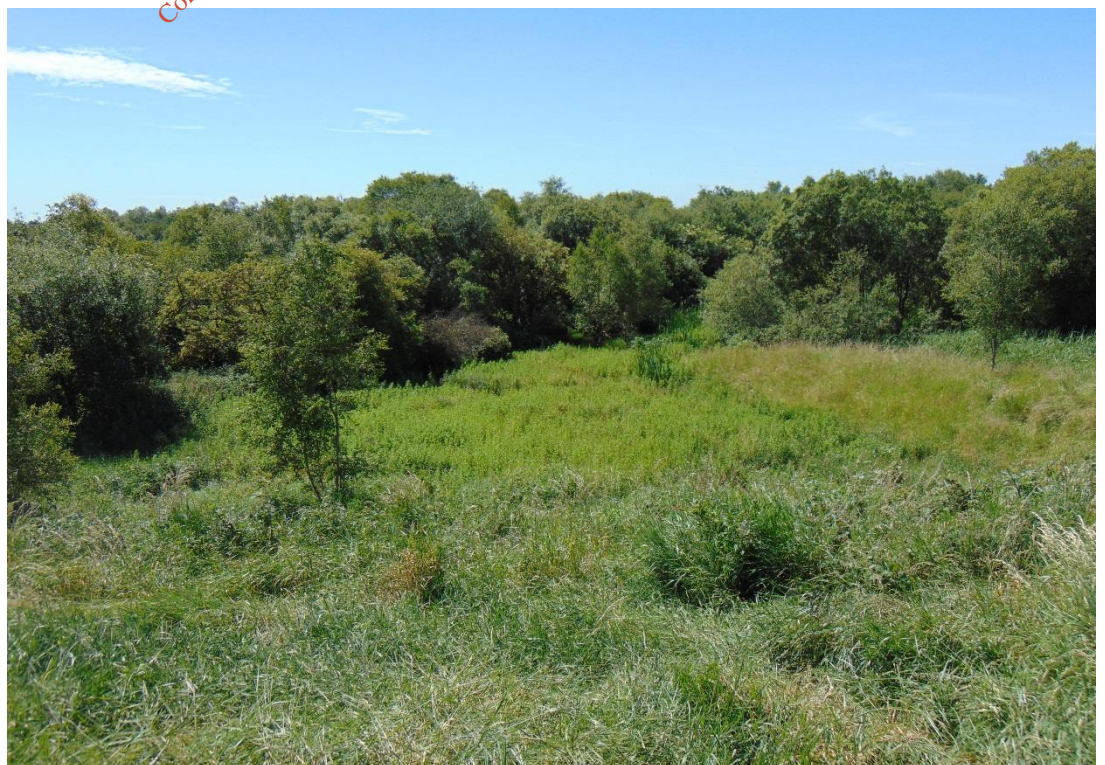
Photo No.
4

View showing lagoon to the south of the landfill with overgrown vegetation.

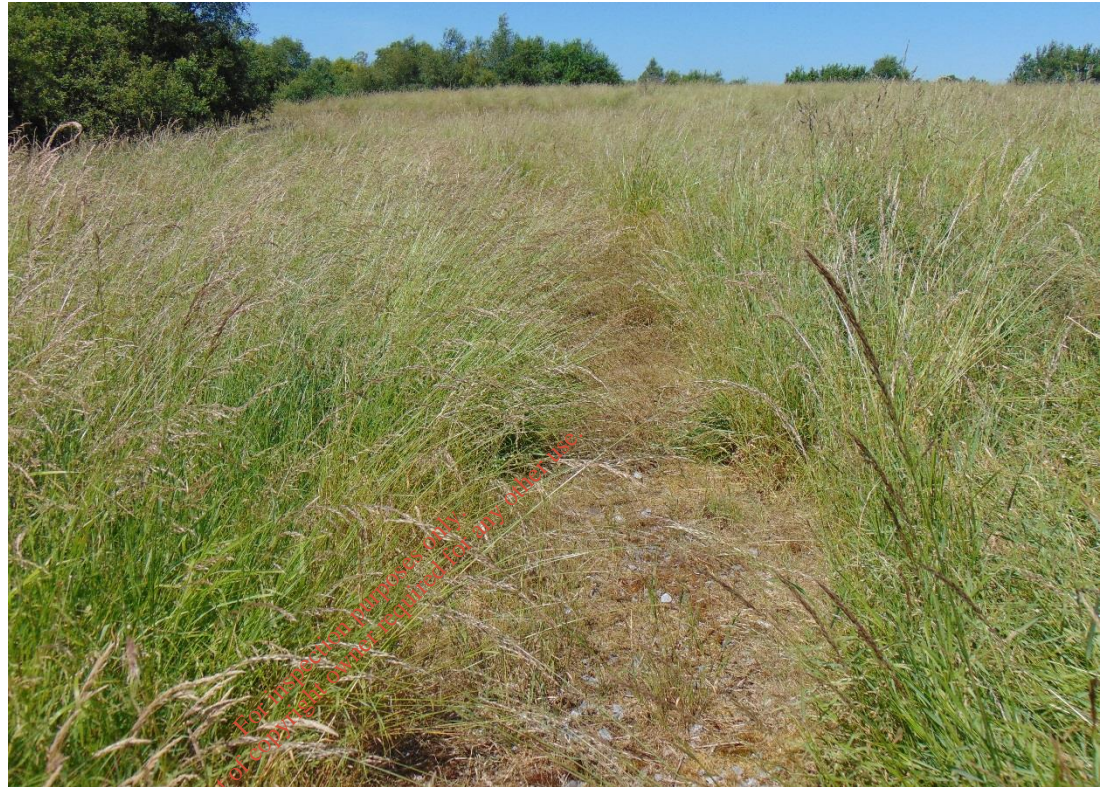
5

View showing evidence of perimeter drainage installed along the cap

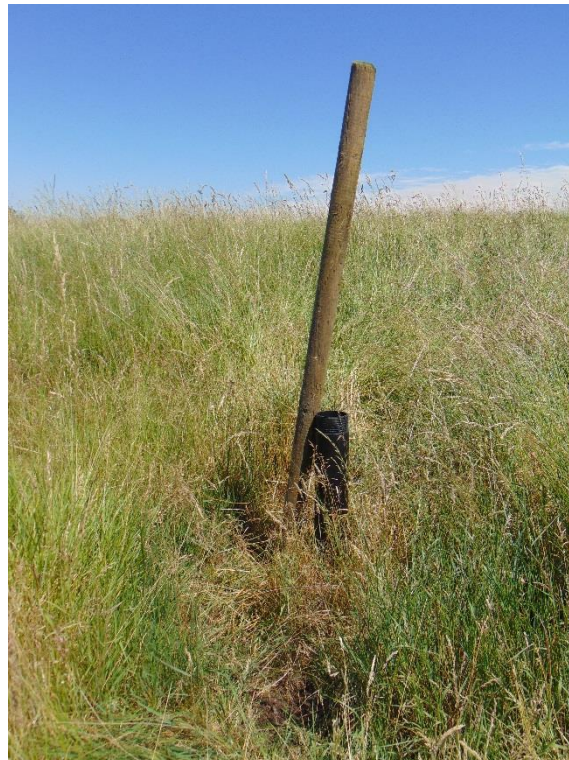
6

View showing leachate monitoring well BH6 installed within Bund No. 1.

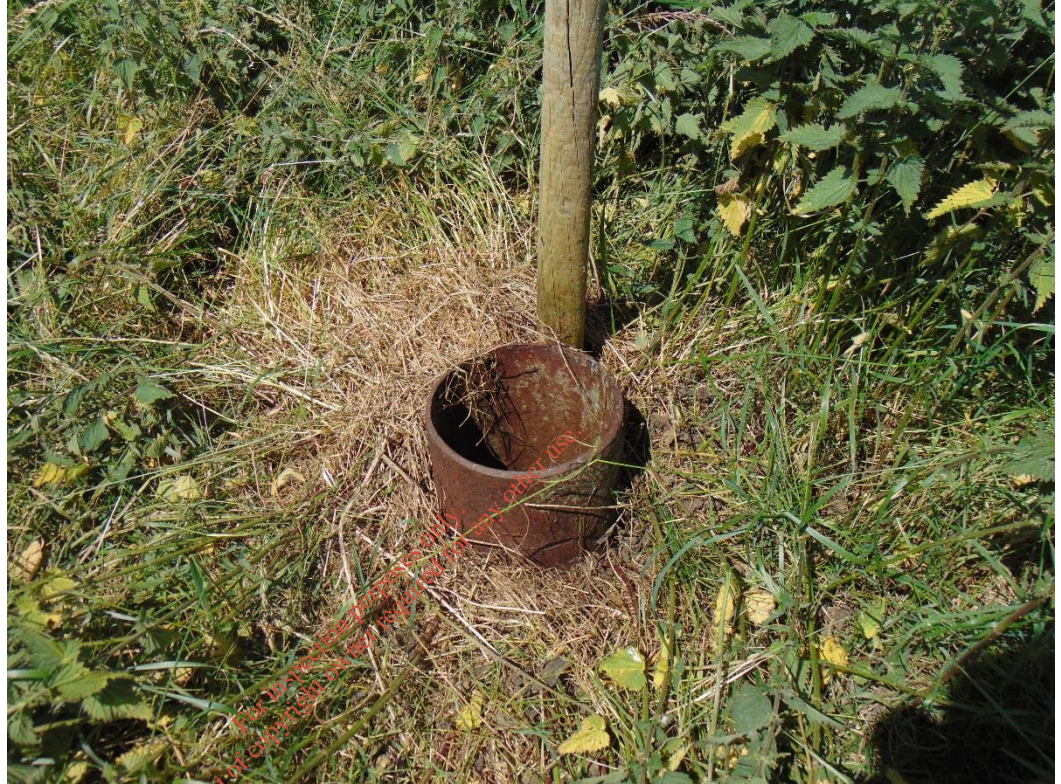
7

View showing one of
the gas vents.

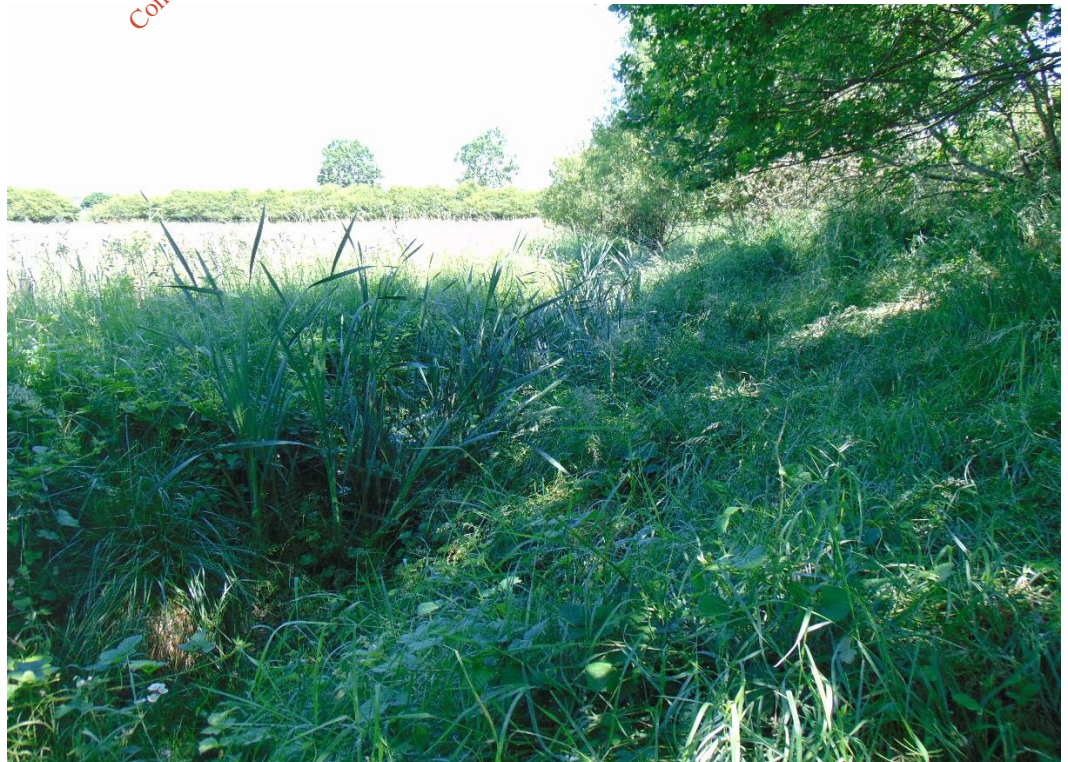
8

View showing perimeter
cut-off drain along
western side of Bund No.
2.

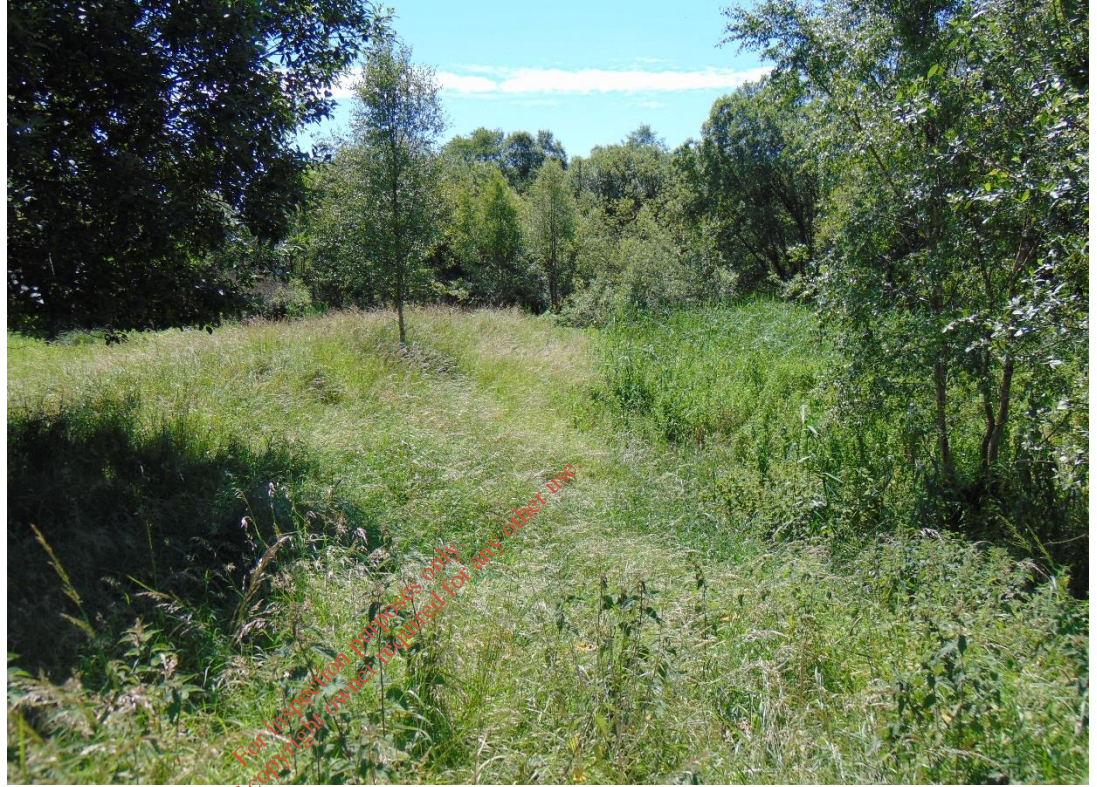
9

View showing slope down from Bund No. 2 towards lagoon.

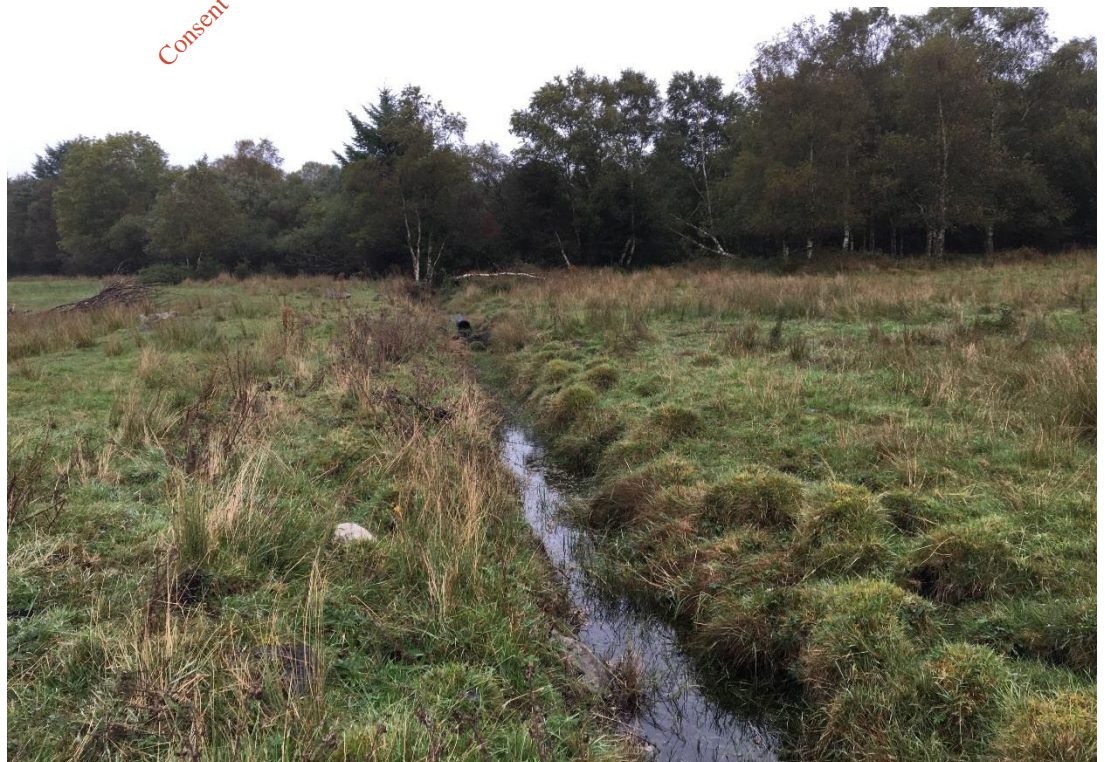
10

View showing location of surface water monitoring point SW-C to the south-west of the site. Woodland in background divides landfill from agricultural fields.

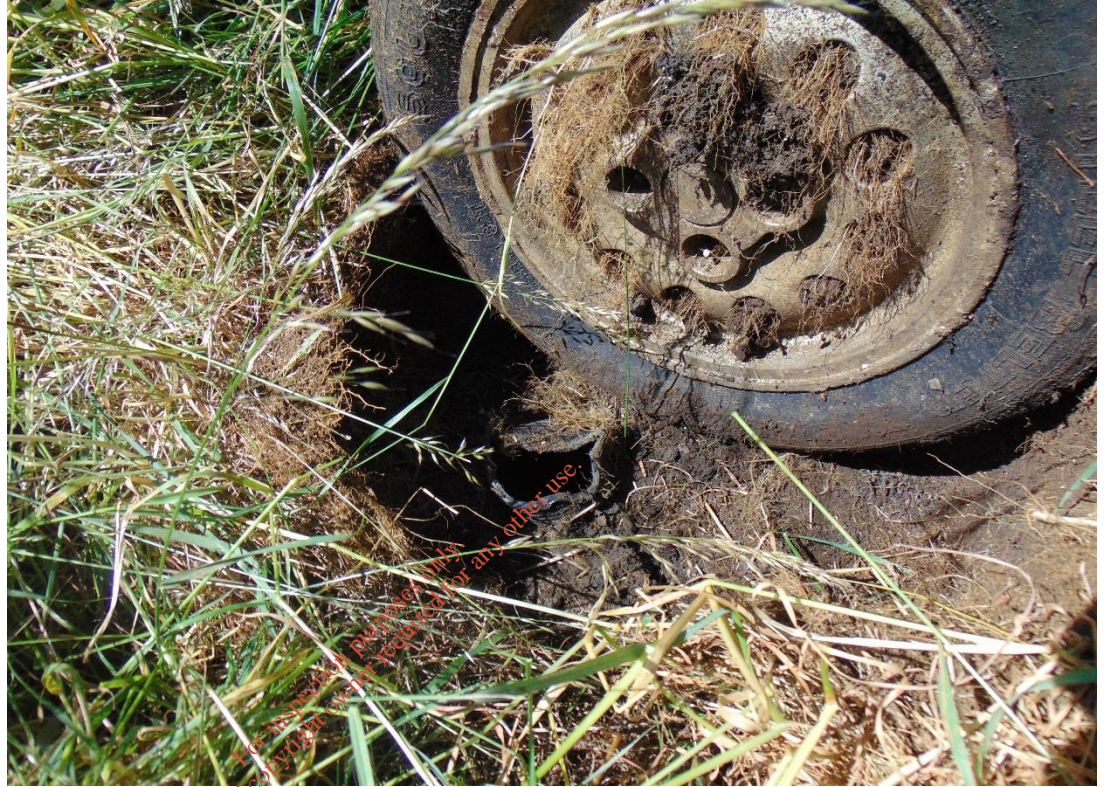
Photo No.
11

Description:
View showing old
groundwater monitoring
borehole BH1 near the
L1121 roadway.

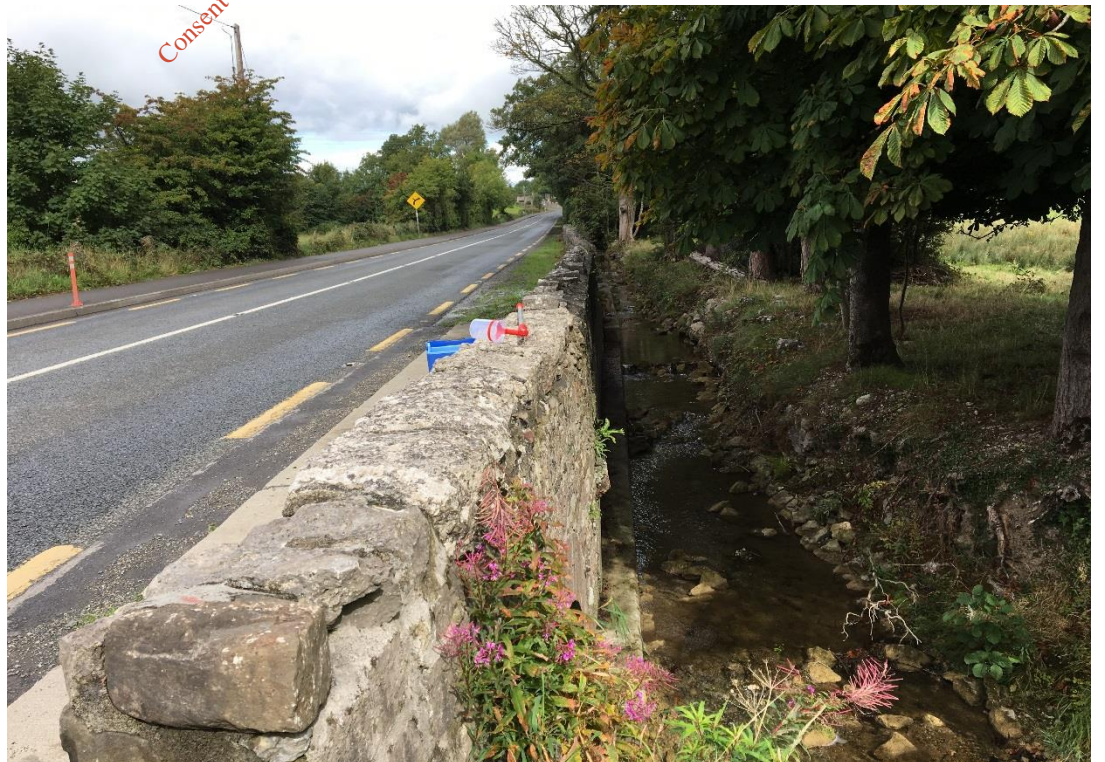
Photo No.
12

Description:
View showing location of
surface water monitoring
point SW-G, the tributary
stream of the River Inny.
