Appendix V

Site Walkover Checklist & Photographs

Ballymulvey Walkover Survey Checklist – 26th June 2018

Site Location: Ballymulvey Landfill

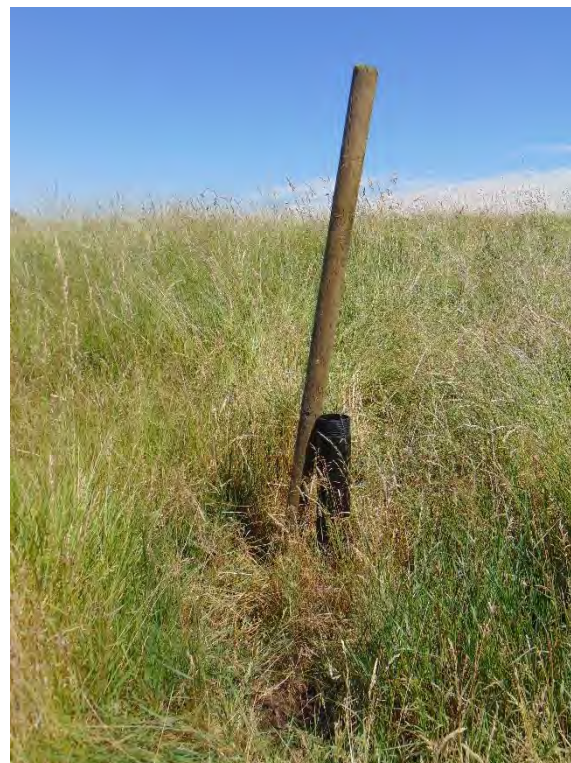
Photo No.
6

Description:
View showing leachate
monitoring well BH6
installed within Bund
No. 1.

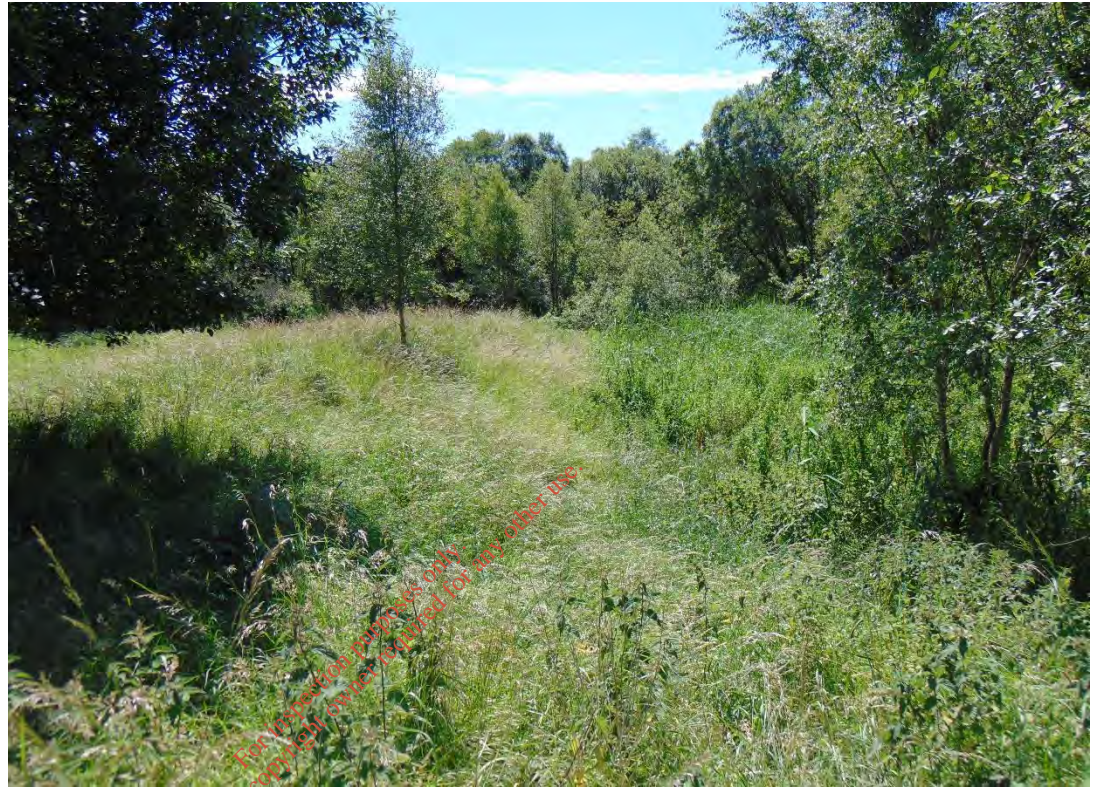
Photo No.
9

Description:
View showing slope
down from Bund No. 2
towards lagoon.

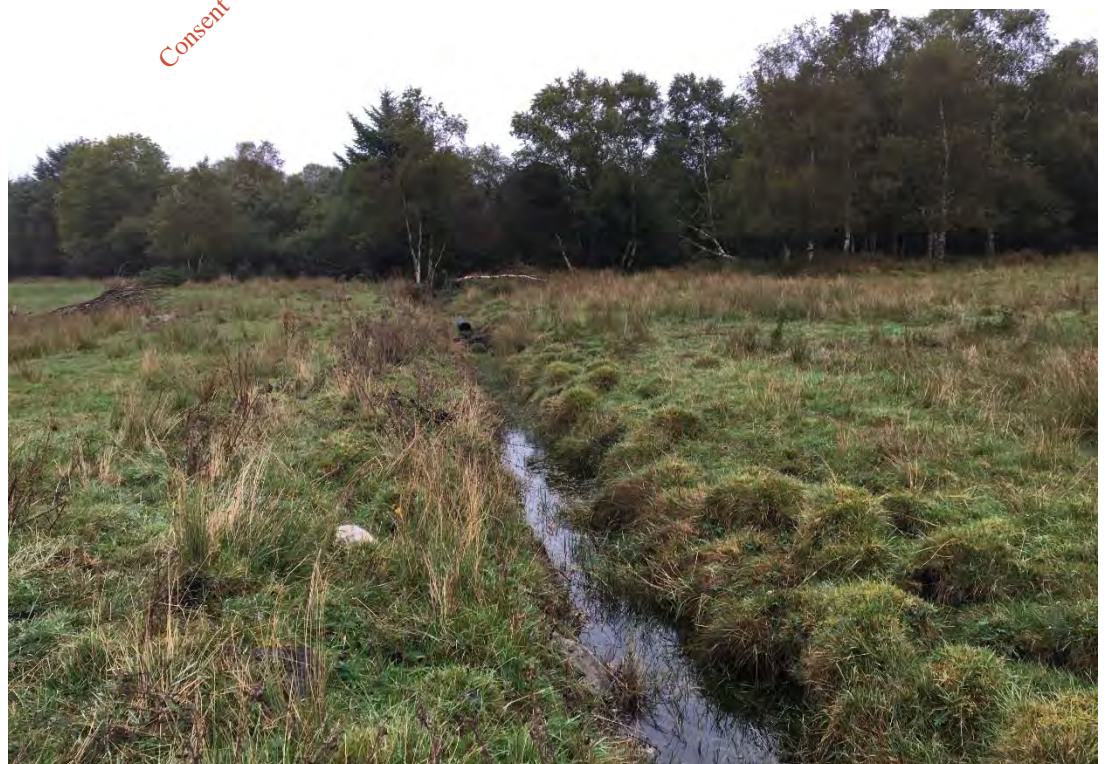
Photo No.
10

Description:
View showing location of
surface water monitoring
point SW-C to the south-
west of the site.
Woodland in background
divides landfill from
agricultural fields.

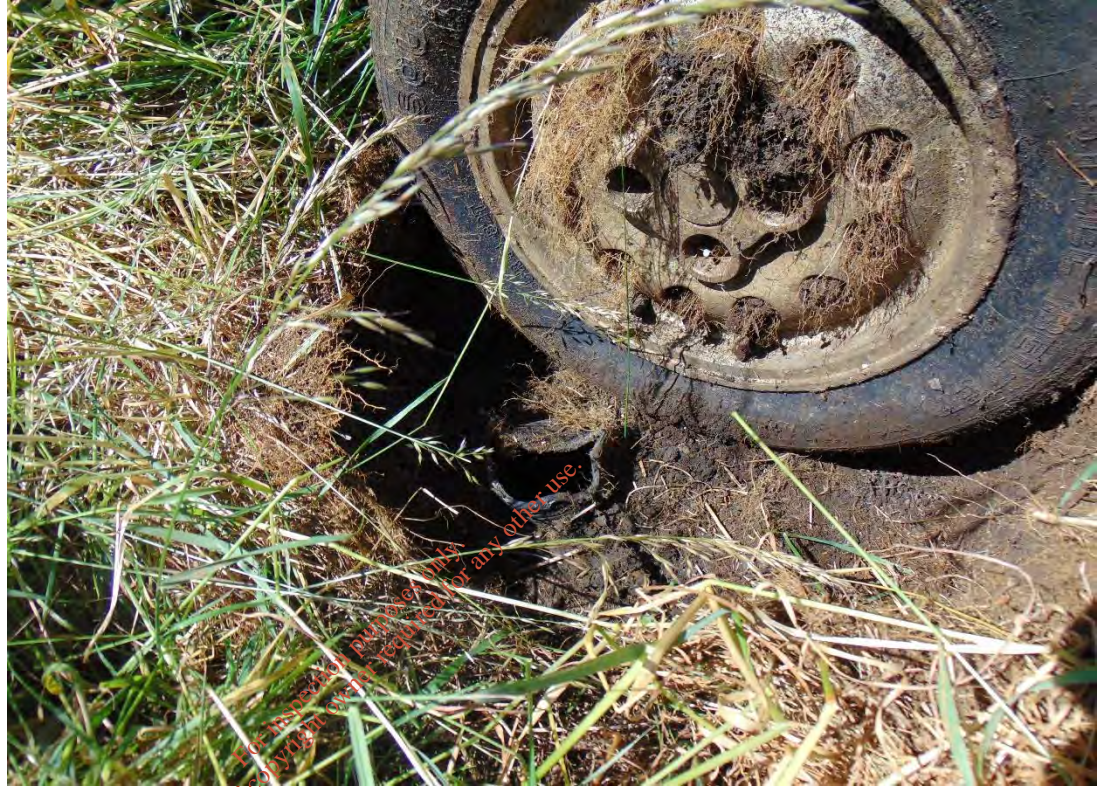
Photo No.
11

View showing old groundwater monitoring borehole BH1 near the L1121 roadway.

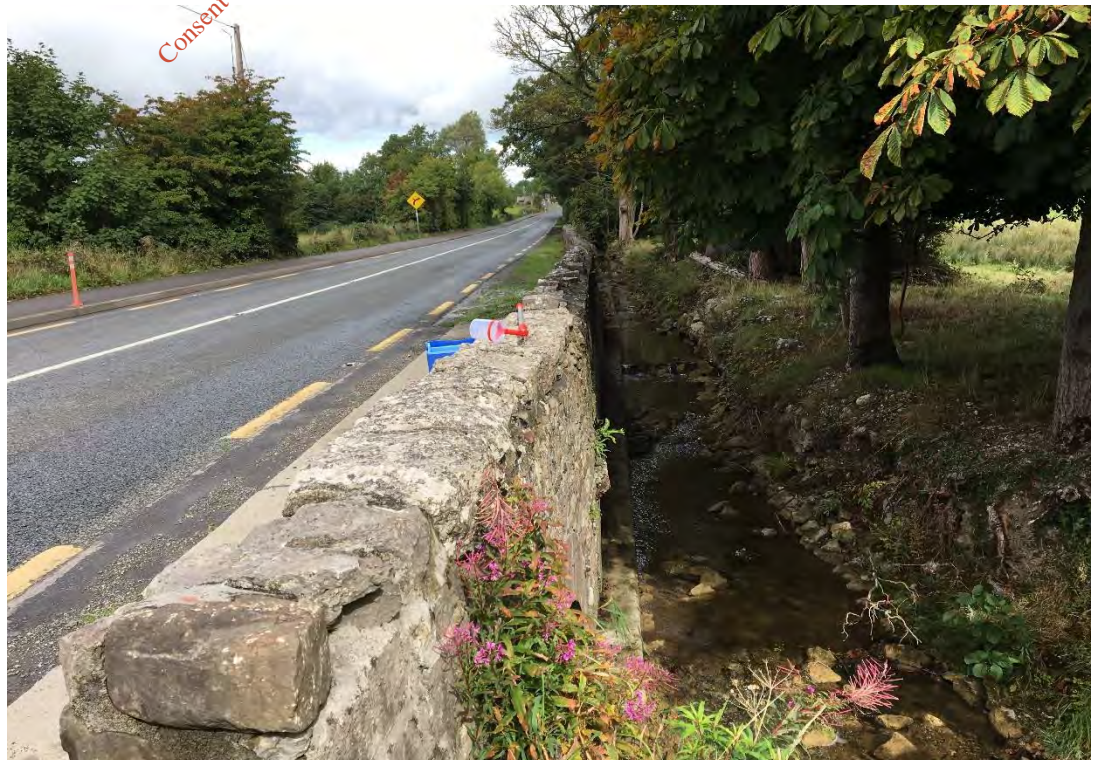
Photo No.
12

View showing location of surface water monitoring point SW-G, the tributary stream of the River Inny.
