Site Walkover Checklist and
Photographic Log

Historic Kerry Landfills - Ahascra

Client Name: Kerry County Council

Project Number: P1766

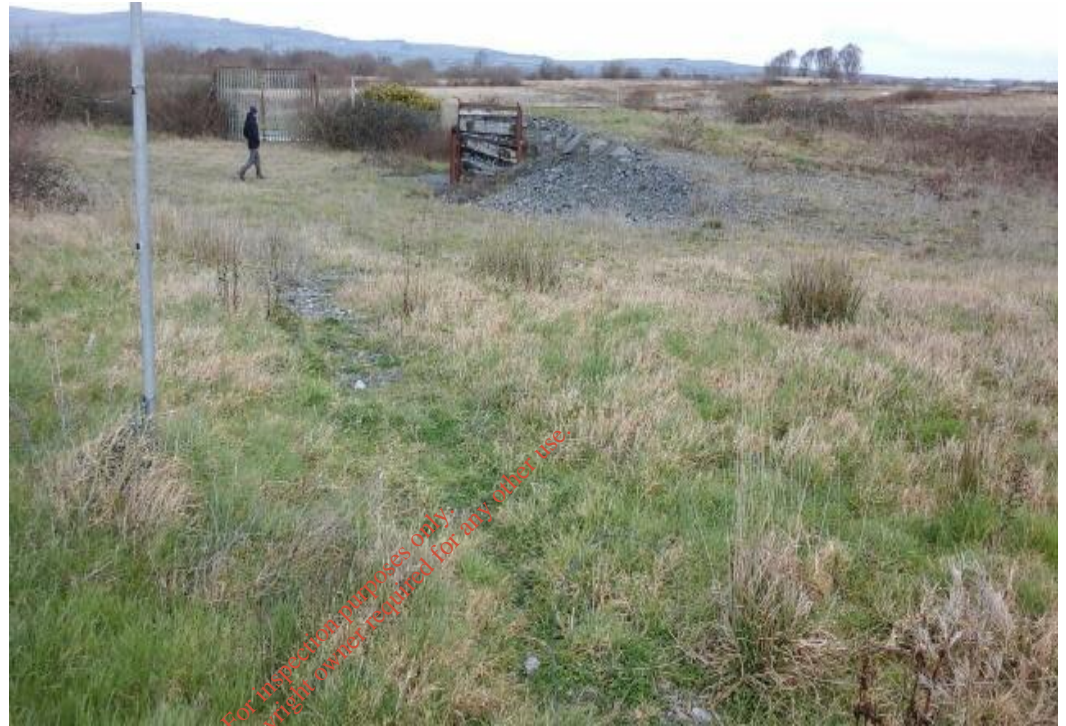
1

Main site entrance along south-eastern side of landfill.

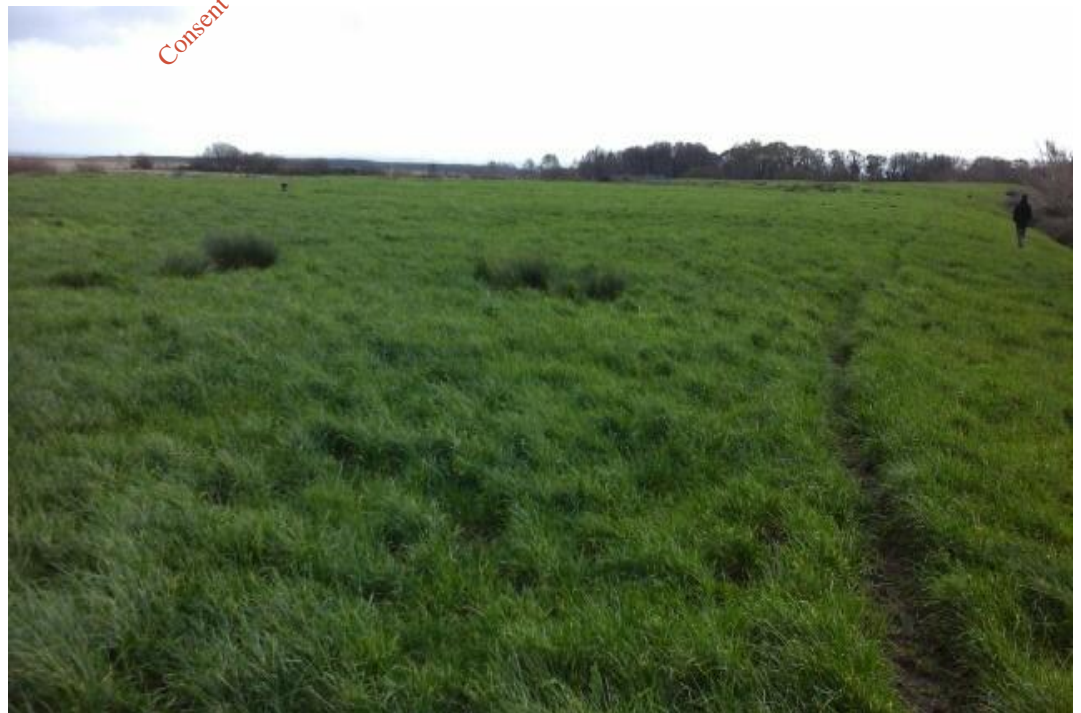
2

View showing raised mounded profile of the landfill.

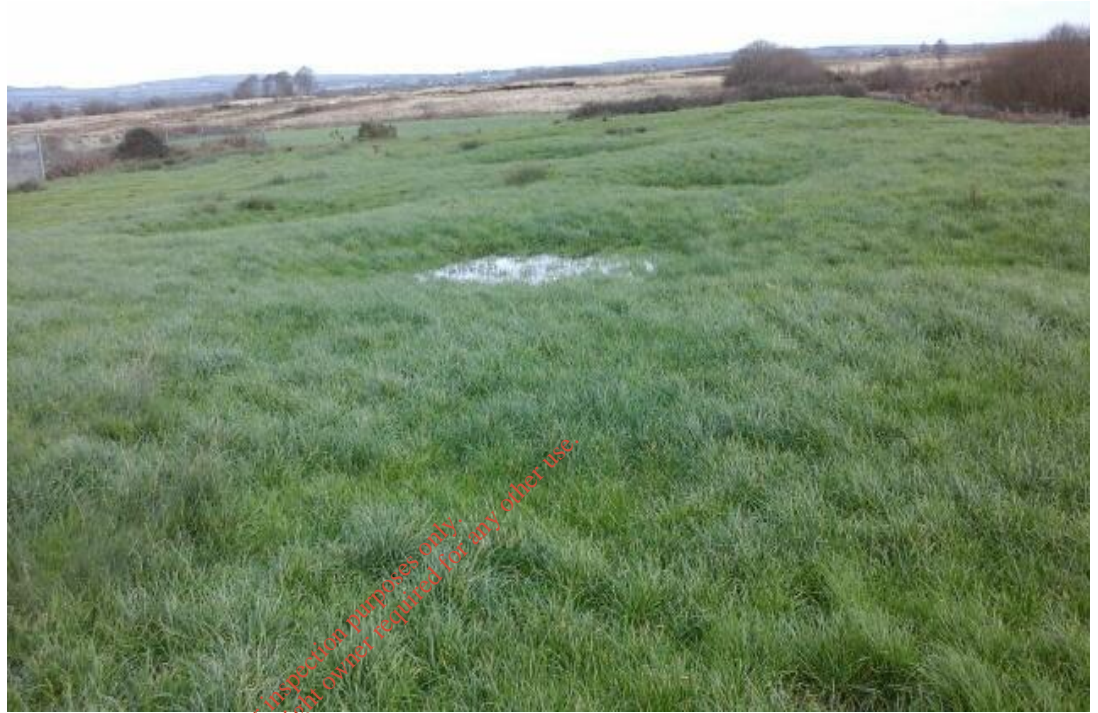
3

Several deep depressions with surface water pools were identified across the landfill cap.

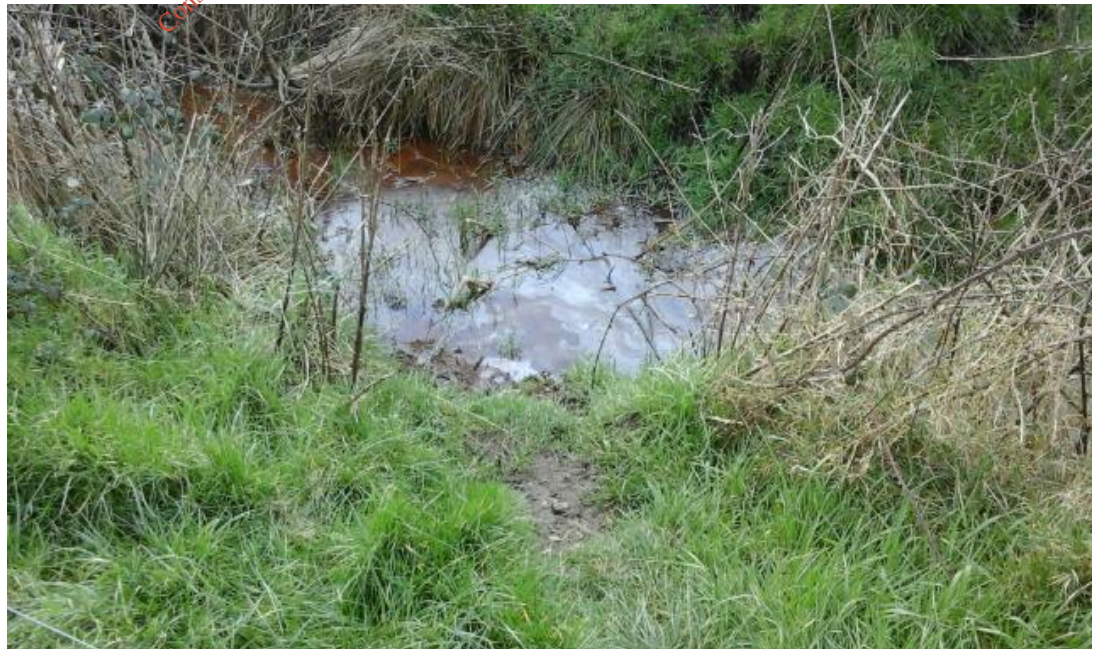
4

Possible leachate seepage identified within perimeter drain along western side of landfill.

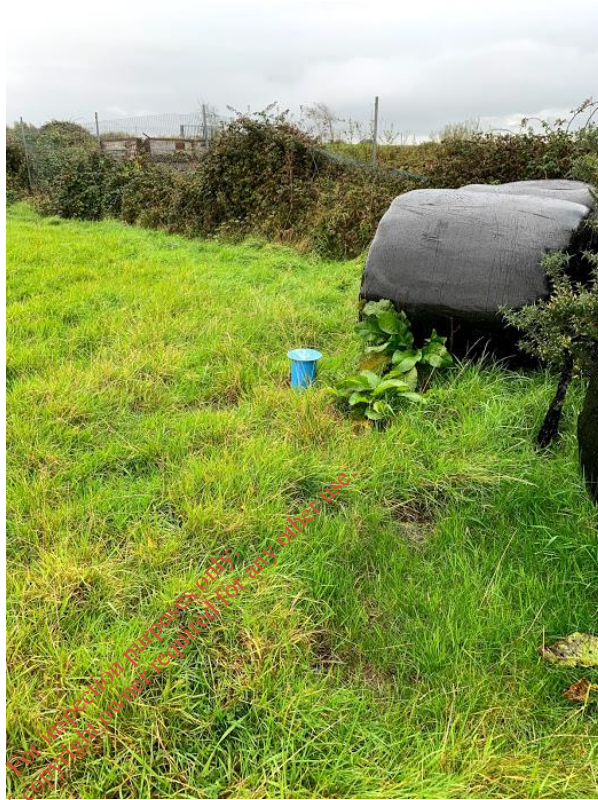
5

Surface water (SW01) located north-east of old landfill. Ponded water.

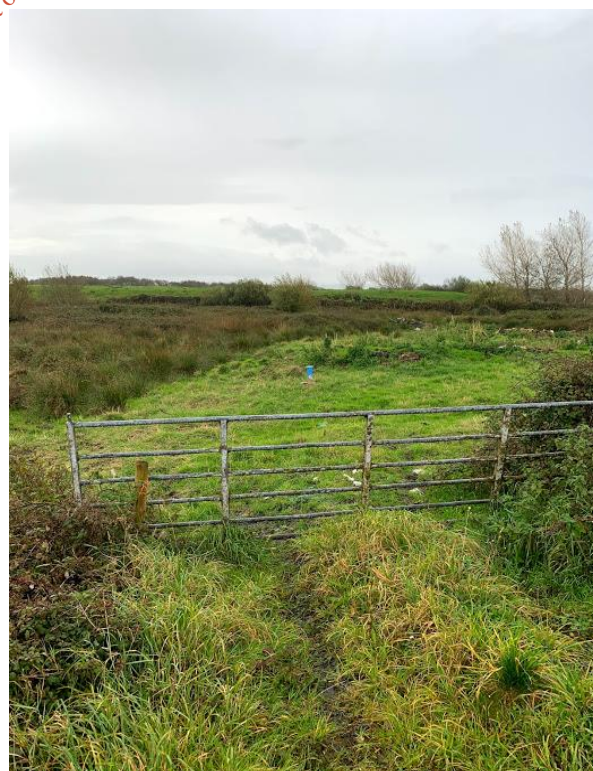
6

Surface water (SW02) located south-east of old landfill. Ponded water.

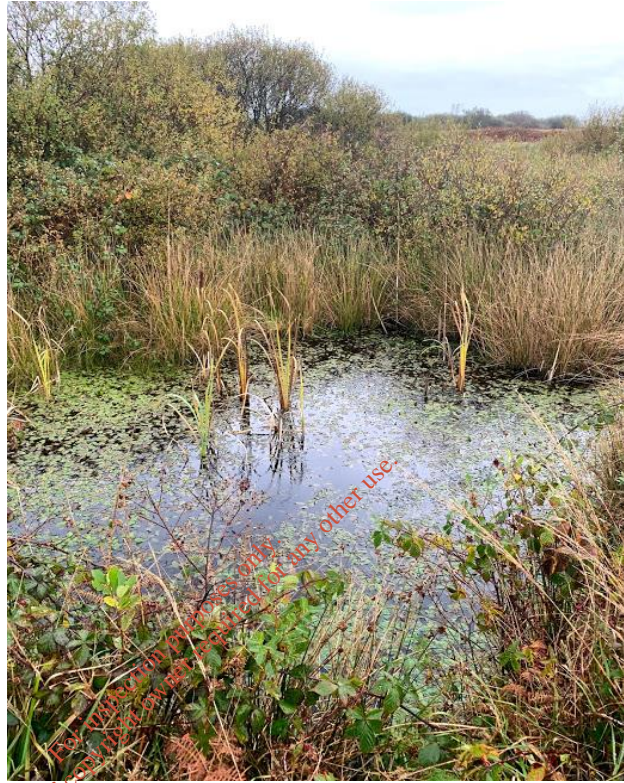
7

Surface water (SW01) located north-east of old landfill. Ponded water.

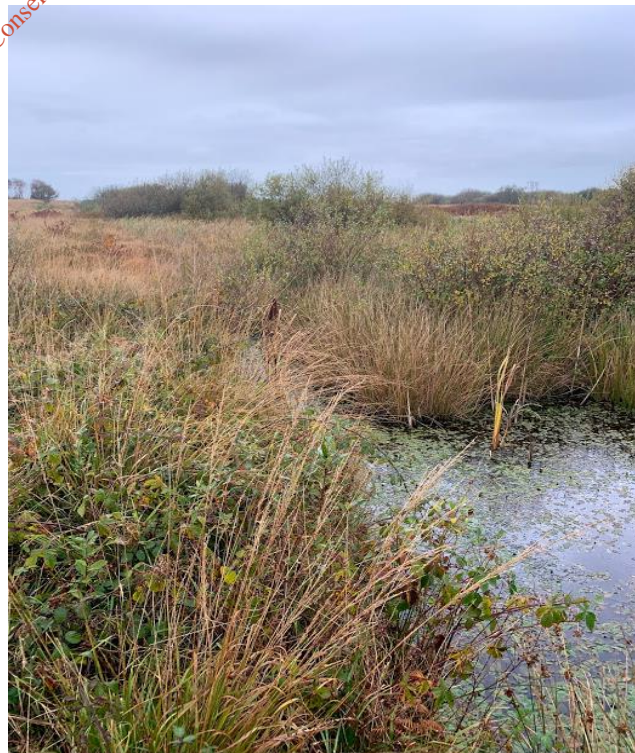
8

Surface water (SW02) located south-east of old landfill. Ponded water.
