# **APPENDIX 5**

**Site Walkover Checklist and  
Photographic Log**

**Historic Kerry Landfills - Ahascra**

**Project Number:** P1766

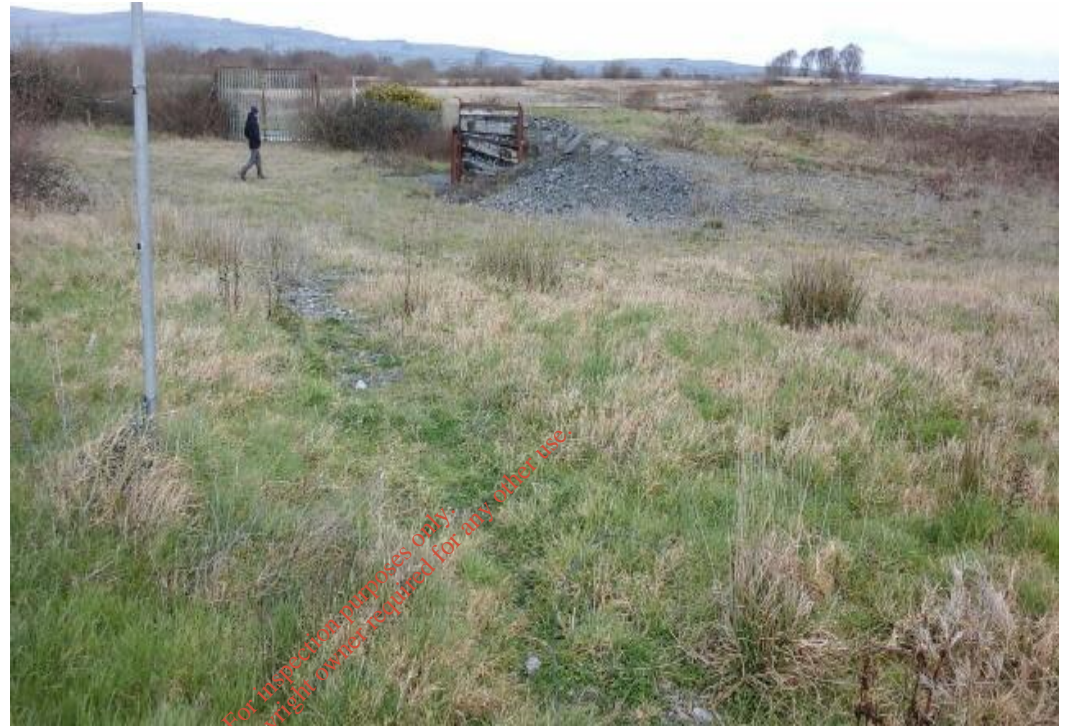
1

Main site entrance along south-eastern side of landfill.

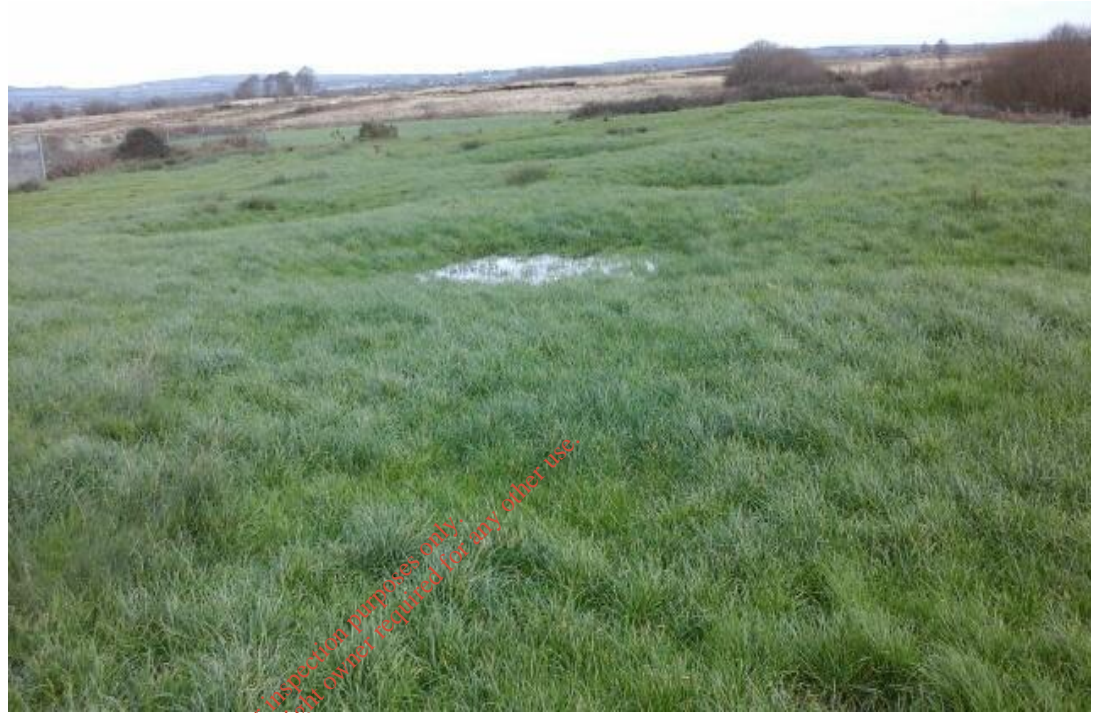
3

Several deep depressions with surface water pools were identified across the landfill cap.

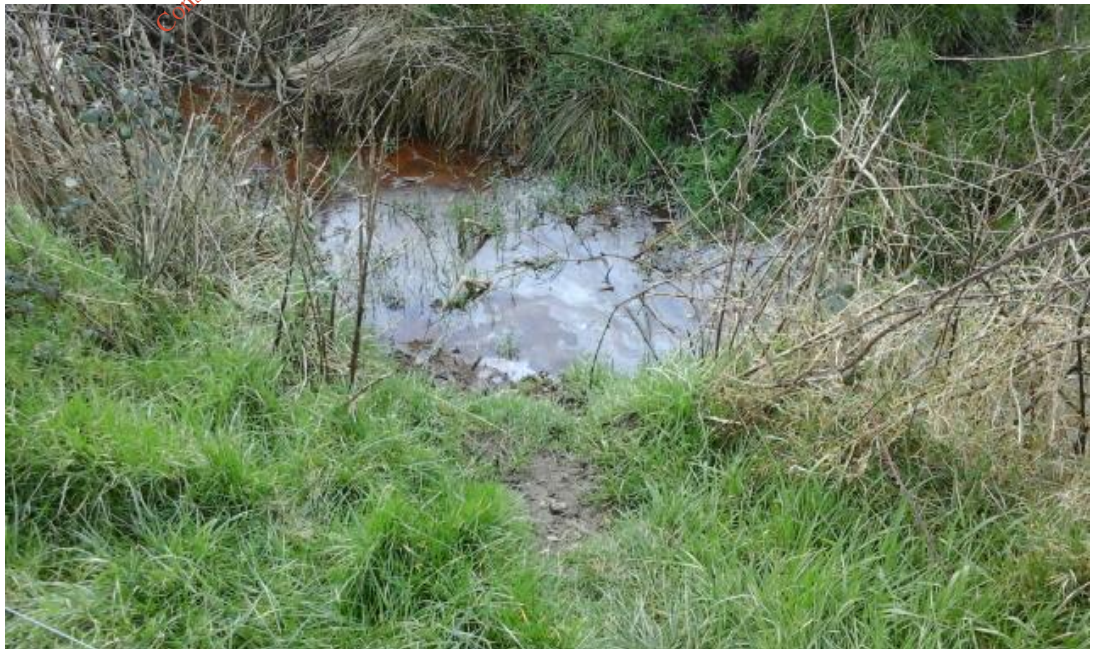
4

Possible leachate seepage identified within perimeter drain along western side of landfill.

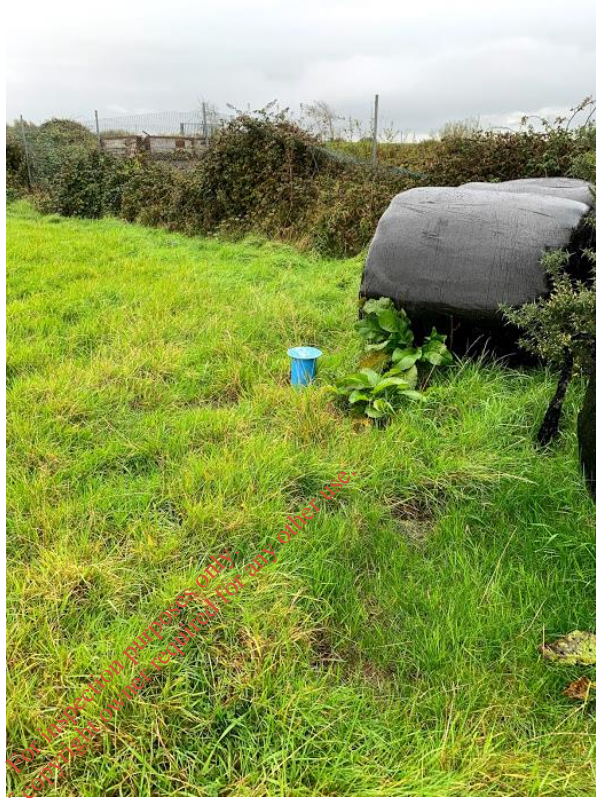
5

Surface water (SW01) located north-east of old landfill. Ponded water.

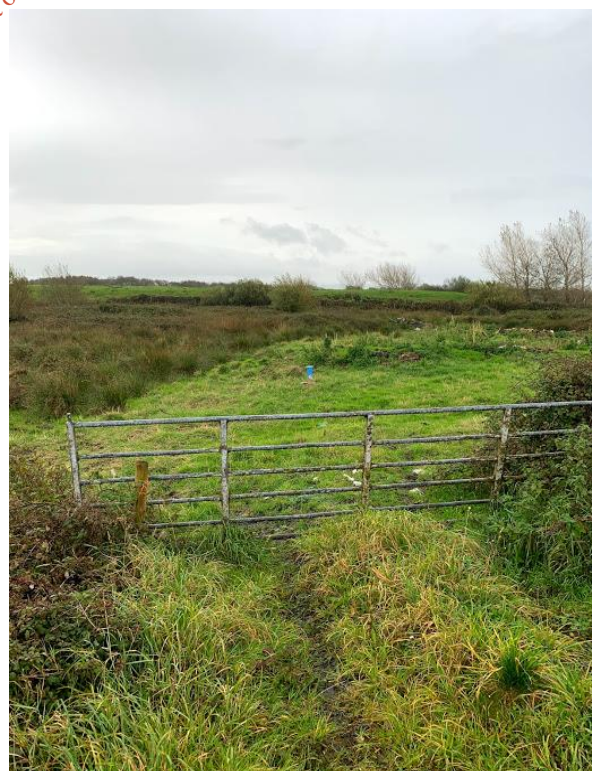
6

Surface water (SW02) located south-east of old landfill. Ponded water.
