# **APPENDIX 5**

**Site Walkover Checklist and  
Photographic Log**

#### Historic Kerry Landfills - Ardferf

**Client Name:** Kerry County Council

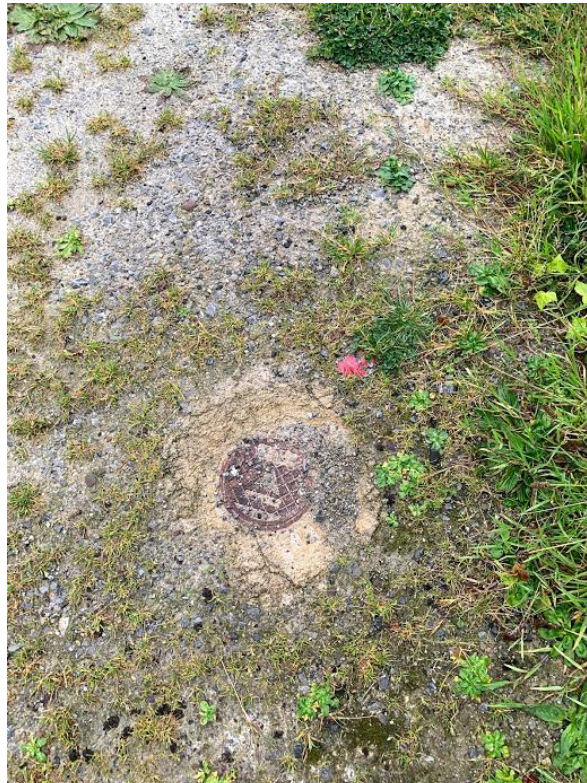
BH01

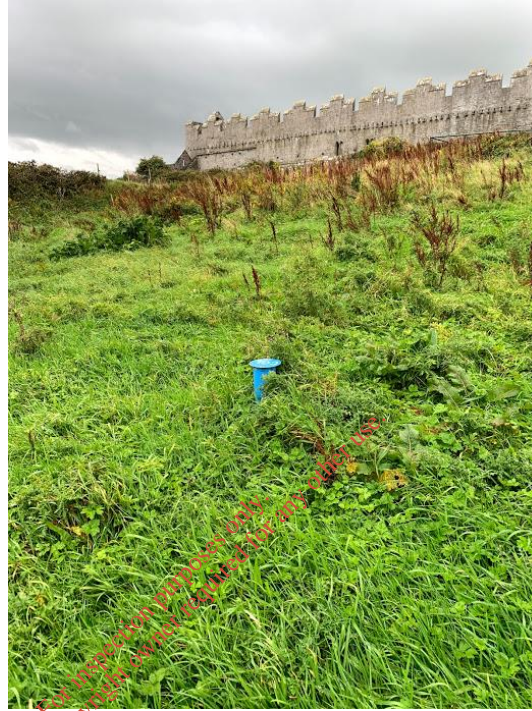
BH02 within field just north of old cathedral

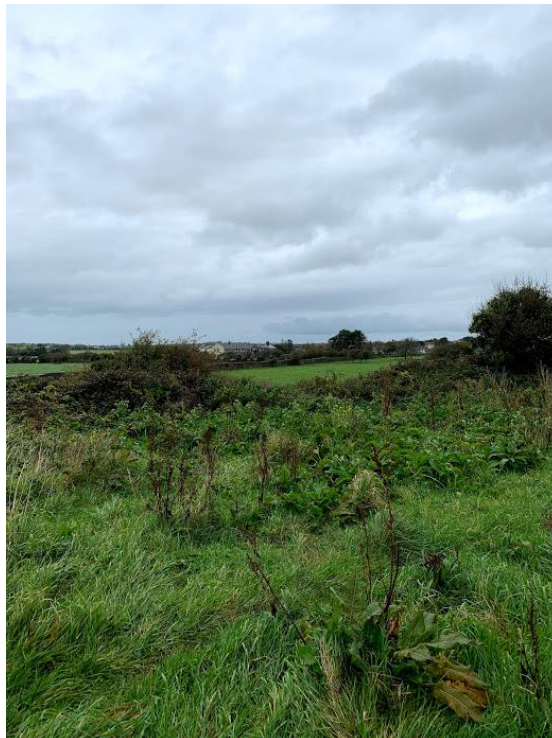
Looking north from BH02 to river flowing in an east to west direction where surface water samples were collected.
