APPENDIX 3

Site Walkover Checklist and Photolog

Historic Kerry Landfills - Castleisland

Project Number: P1767

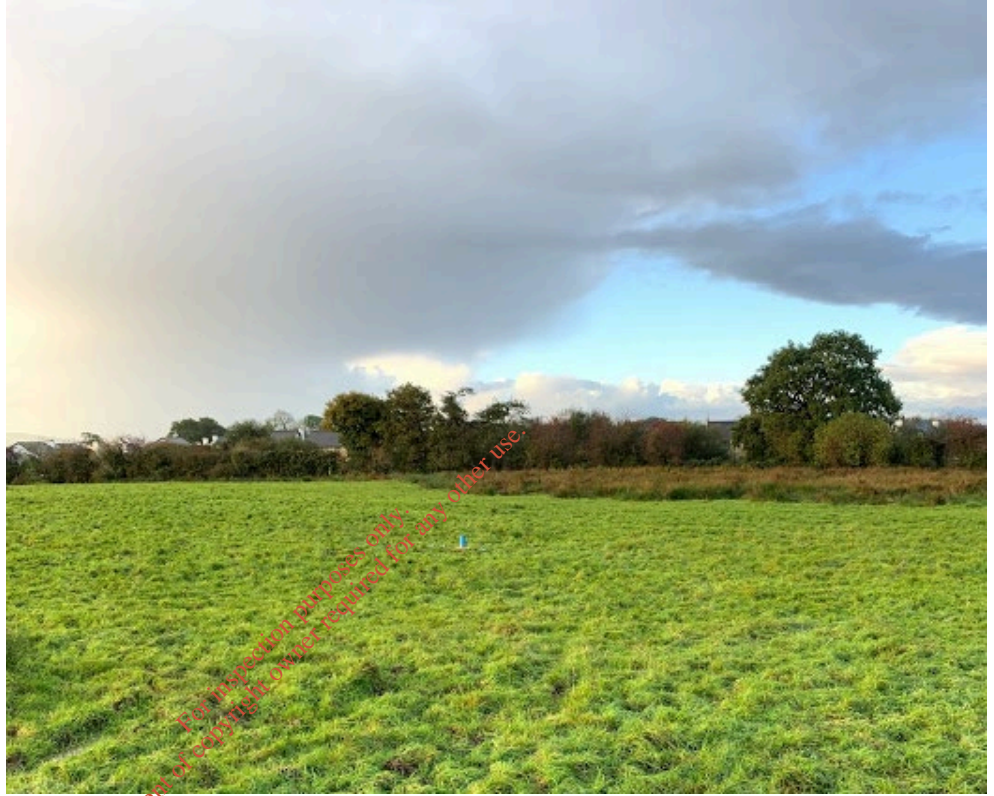
3

BH02 in the centre of an agricultural field

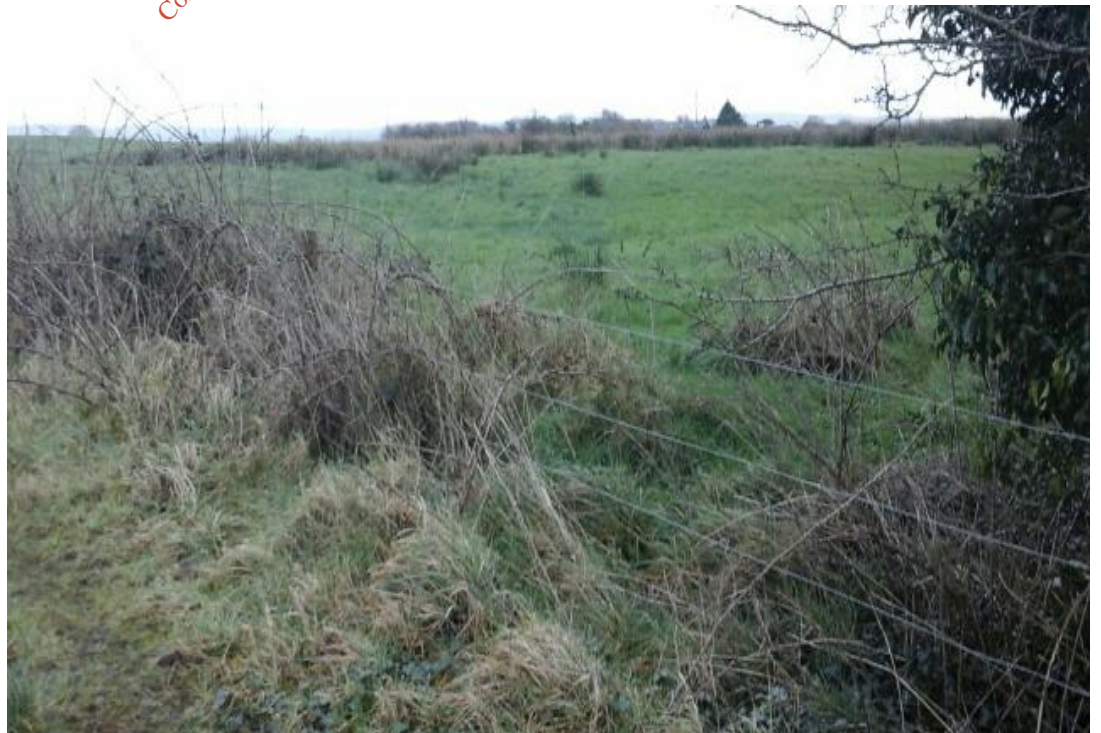
4

View showing evidence of reeds along western site footprint indicating poor drainage. Could be signs of surface runoff problem.

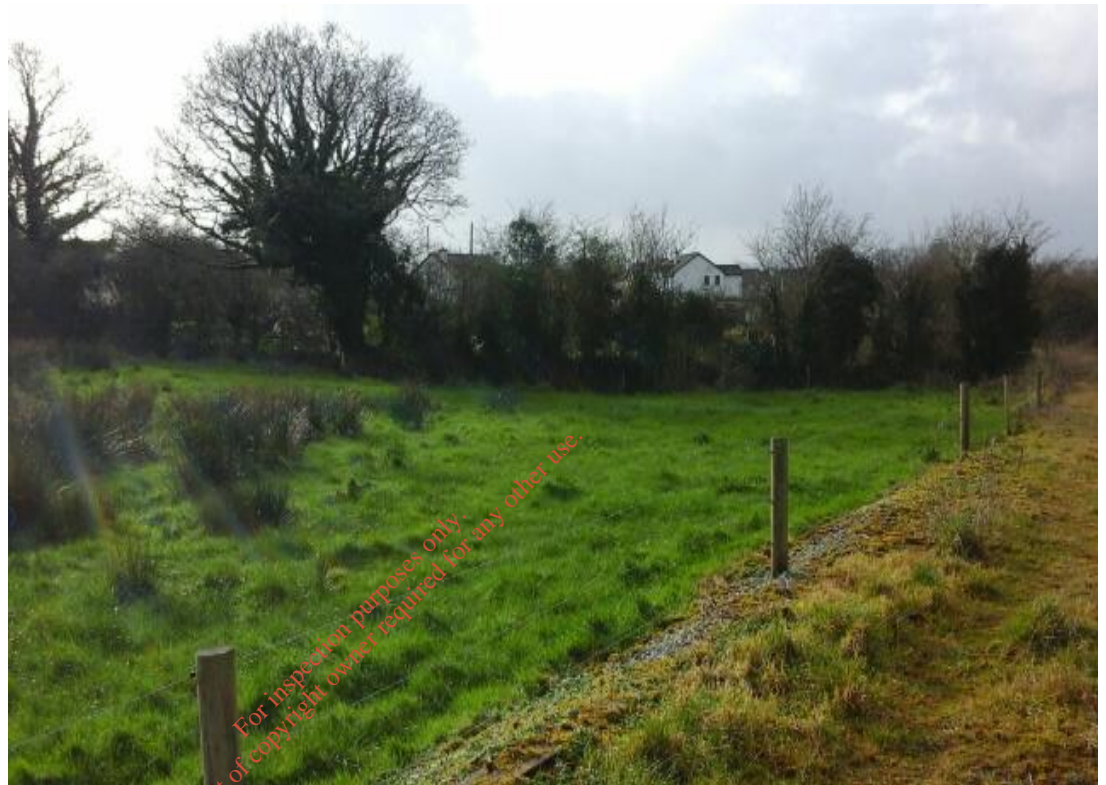
5

View showing nearest potential receptor is a housing estate located within 100m of the site.

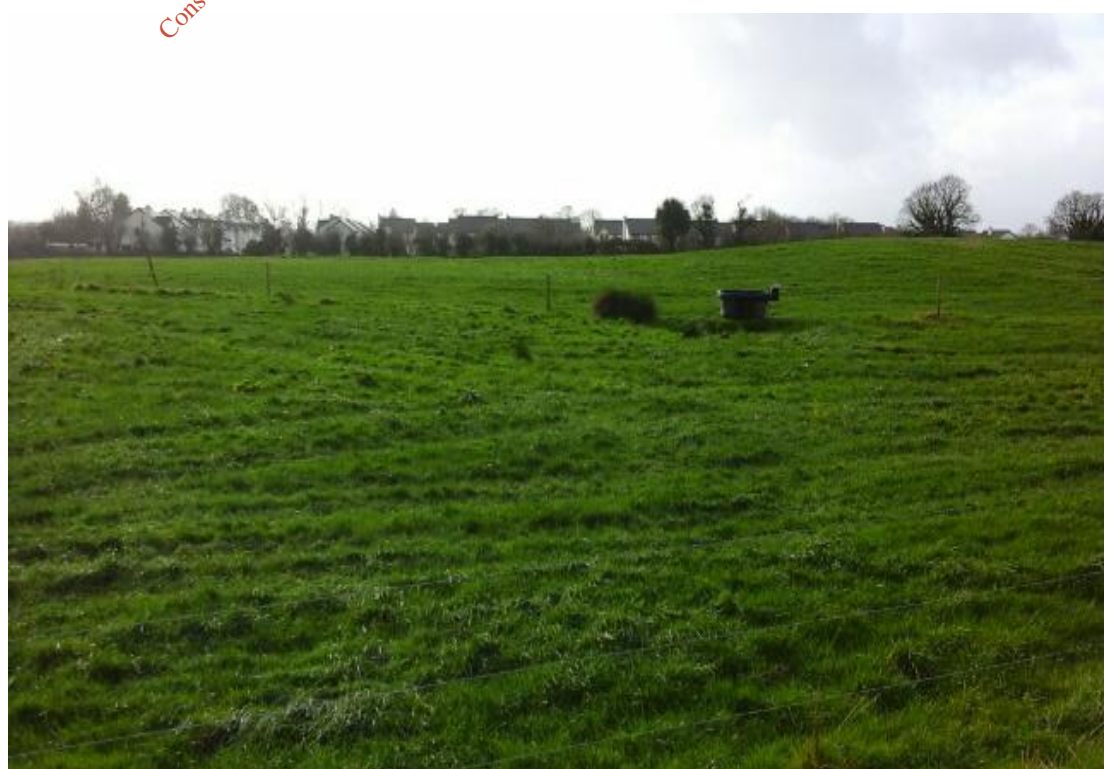
6

View showing landfill capping indicating good grass growth quality and well managed. No obvious drainage outlets, evidence of poor surface drainage where reeds present below west foot site print.
