# **APPENDIX 3**

## **Site Walkover Checklist and Photolog**

**Historic Kerry Landfills - Castleisland**

# PHOTOGRAPHIC LOG

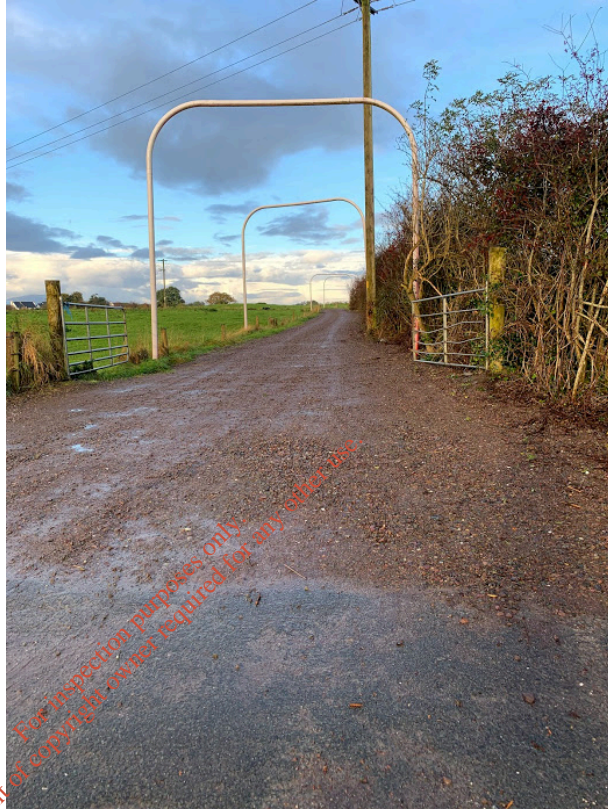
1

Entrance into site.

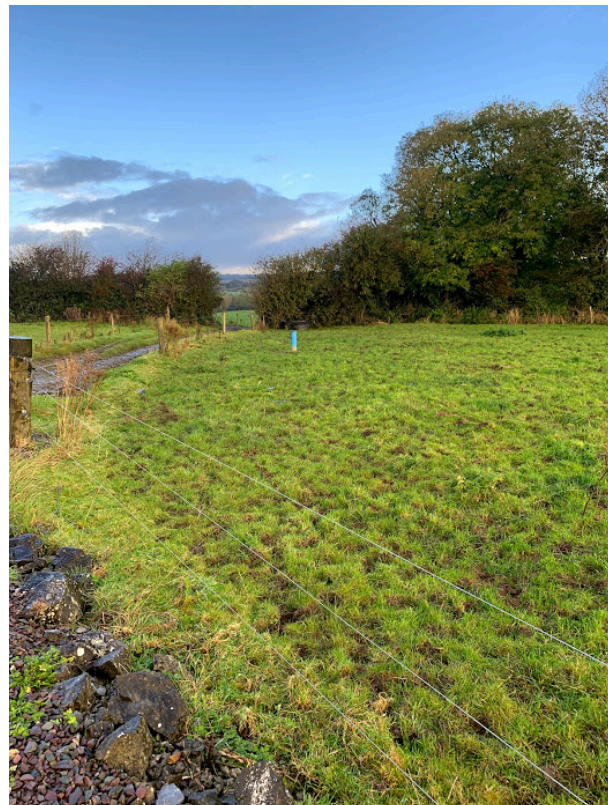
2

BH01 in agricultural land

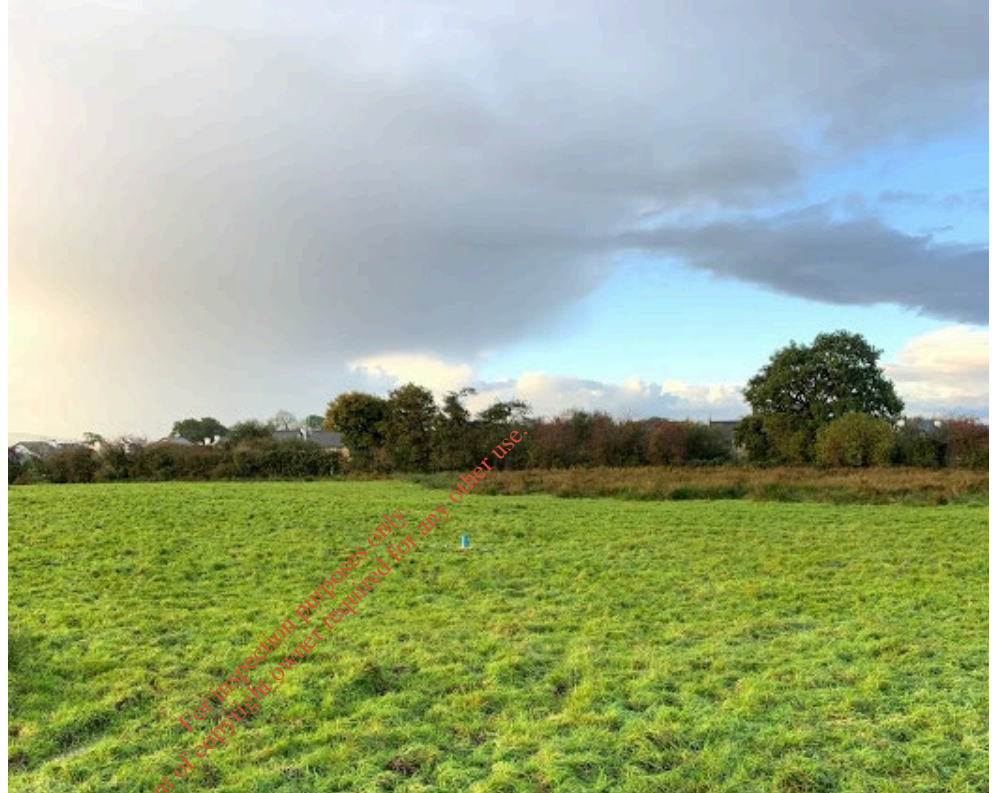
3

BH02 in the centre of an agricultural field

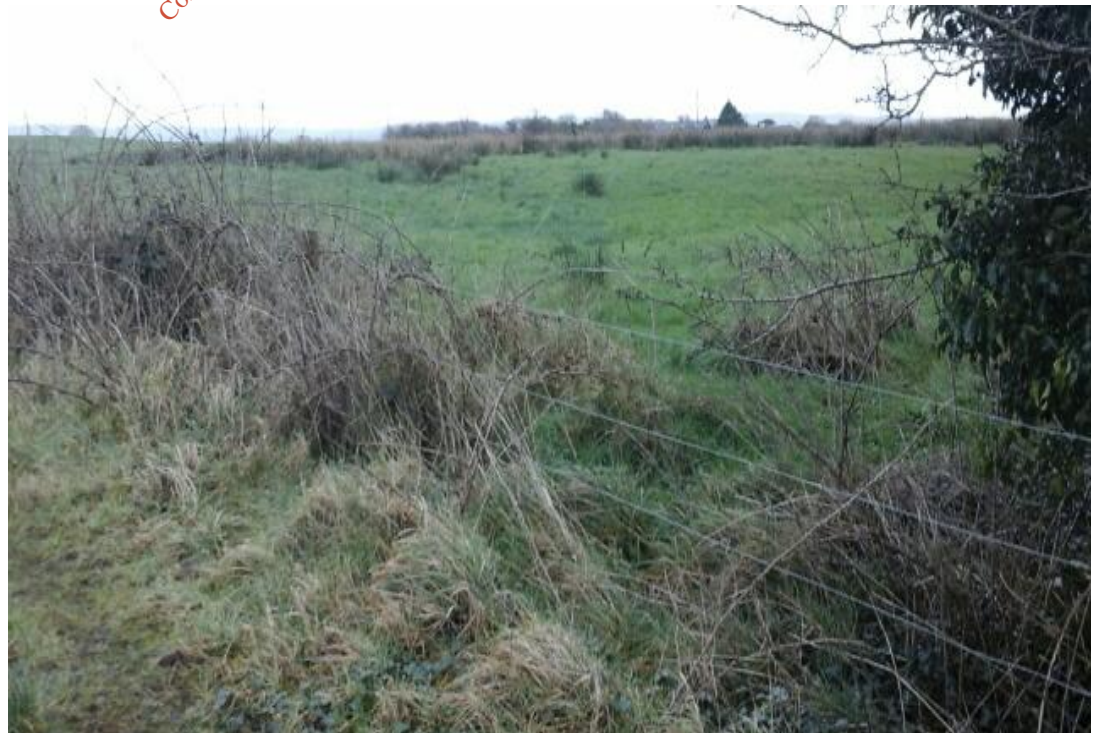
4

View showing evidence of reeds along western site footprint indicating poor drainage. Could be signs of surface runoff problem.

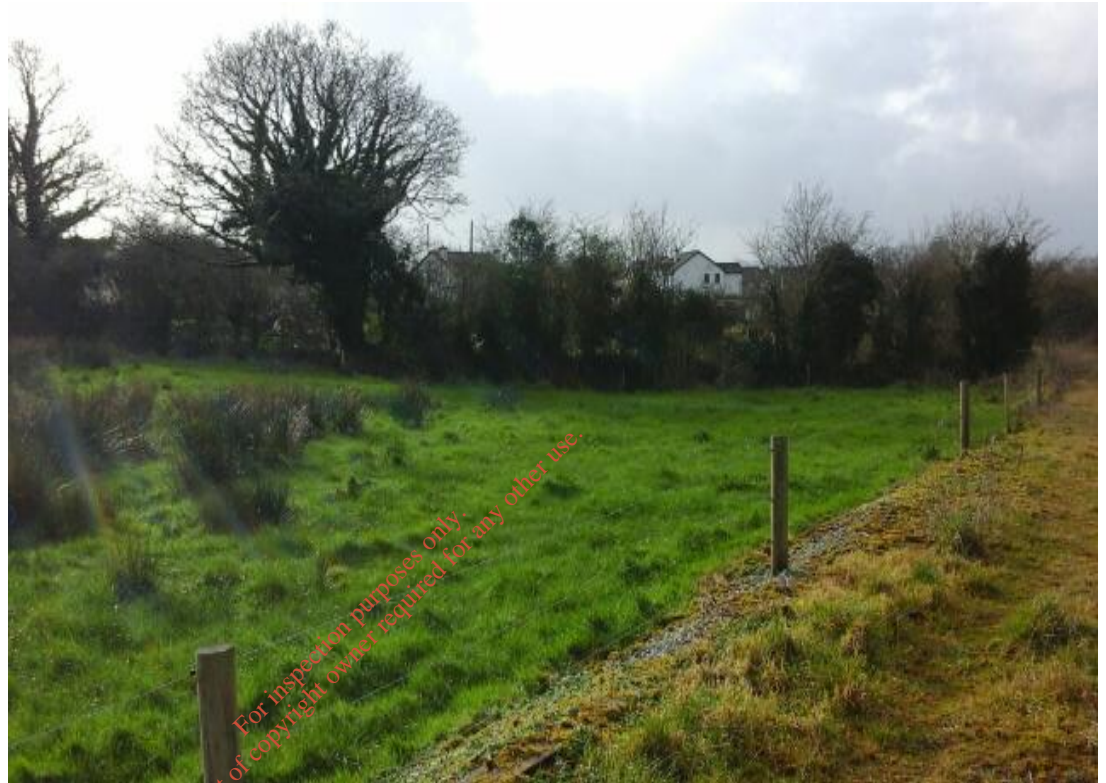
5

View showing nearest potential receptor is a housing estate located within 100m of the site.

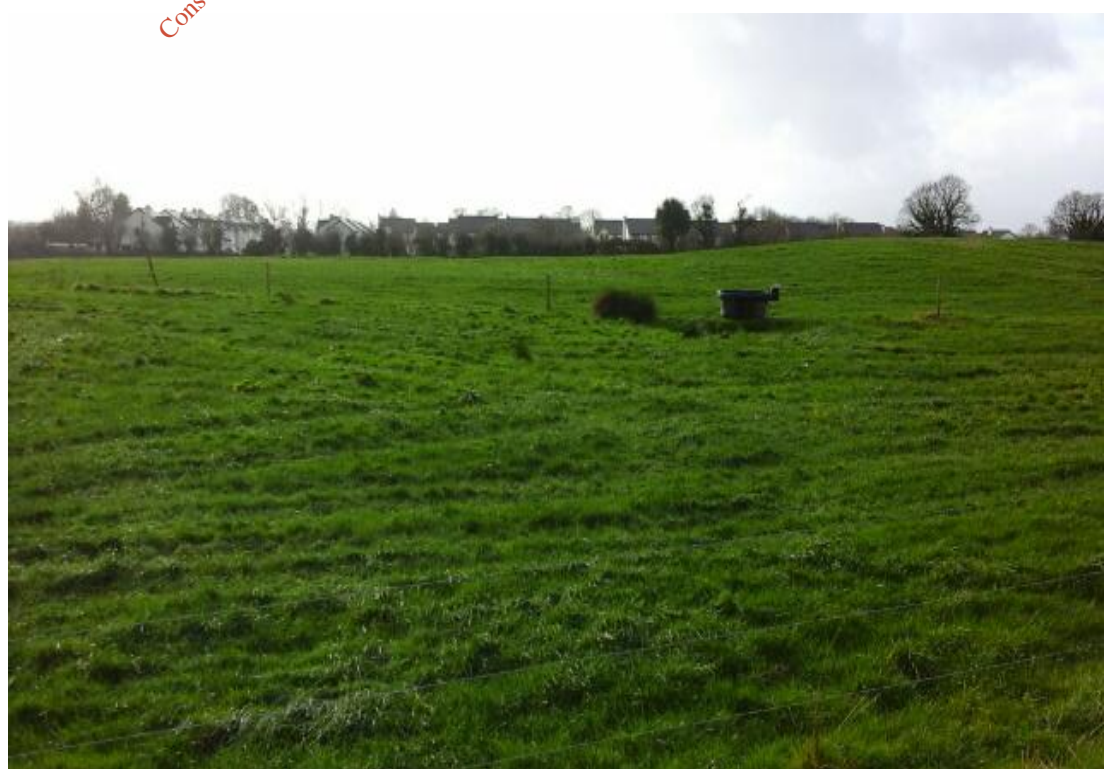
6

View showing landfill capping indicating good grass growth quality and well managed. No obvious drainage outlets, evidence of poor surface drainage where reeds present below west foot site print.
