Site Walkover Assessment and Photo Logs

Client Name: Kerry
County Council

Site Location: Dingle

Historic Kerry Landfills - Dingle

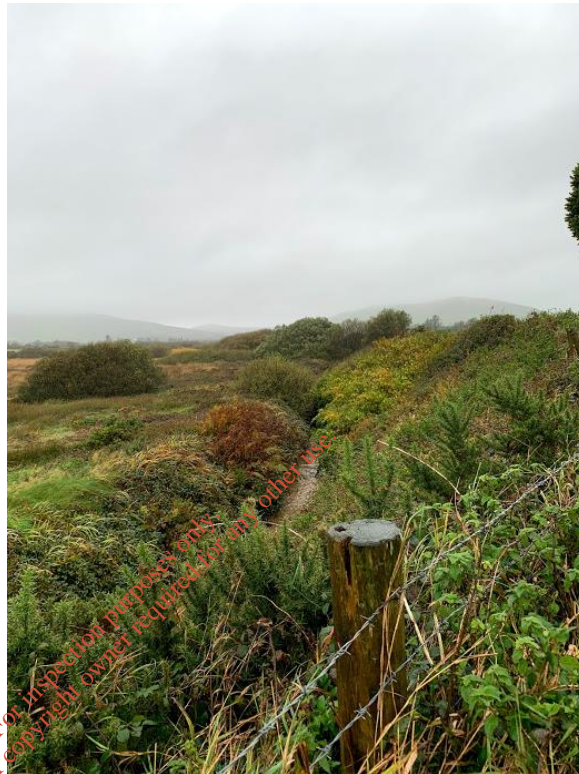
1

River flowing along
the south-western
boundary of site,
where surface water
samples were
collected

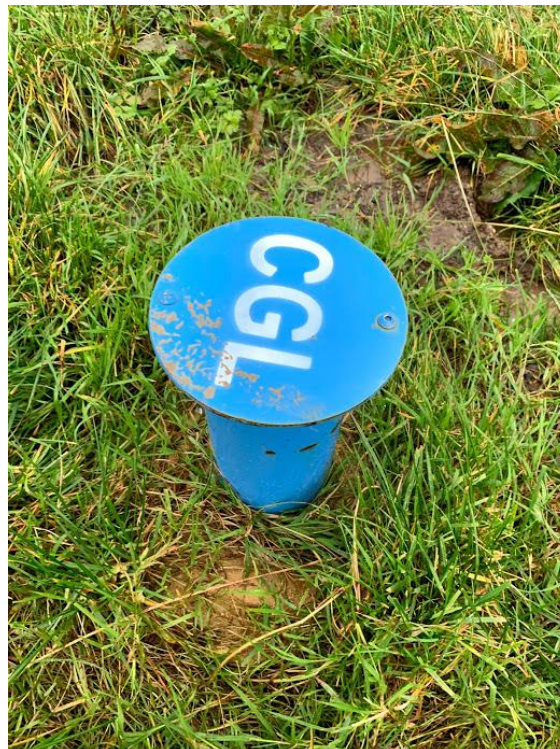
2

BH02 within agricultural
field

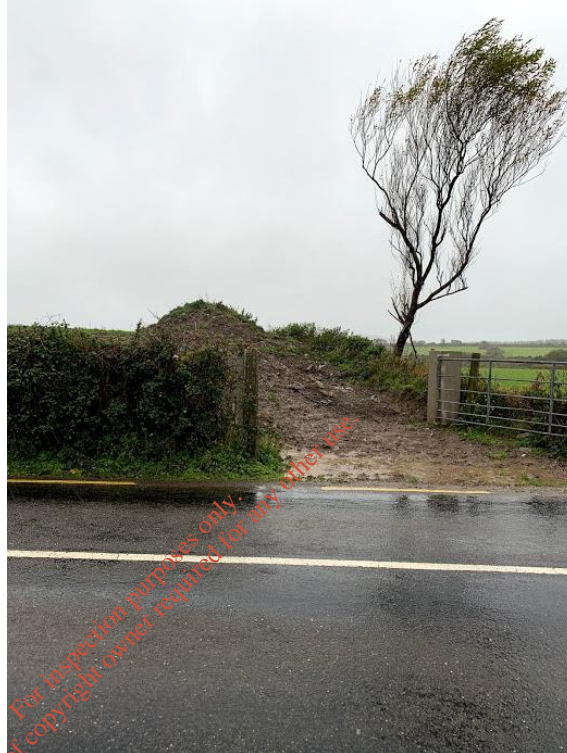
3

Looking at old landfill
from BH01 (facing
south-west)

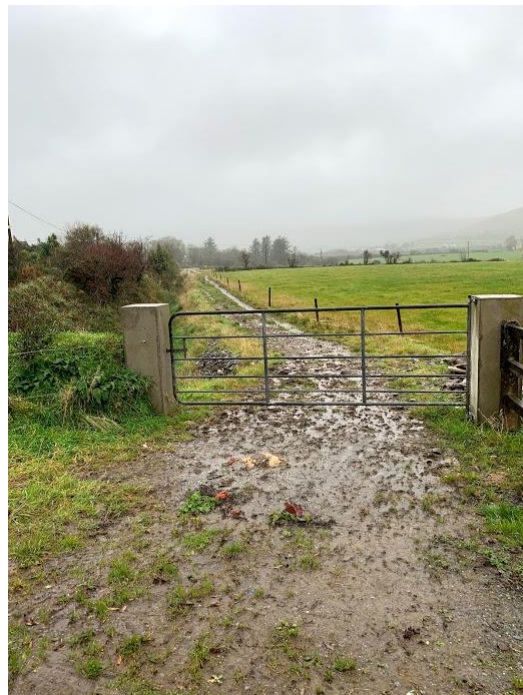
4

BH01 location, just in
front of a farm lane
(facing north-east)
