**► Tier 1 Review Report – Leanmore ◀**

**S22 - 02666**

November 2013

*Environmental Services,  
Kerry County Council.*

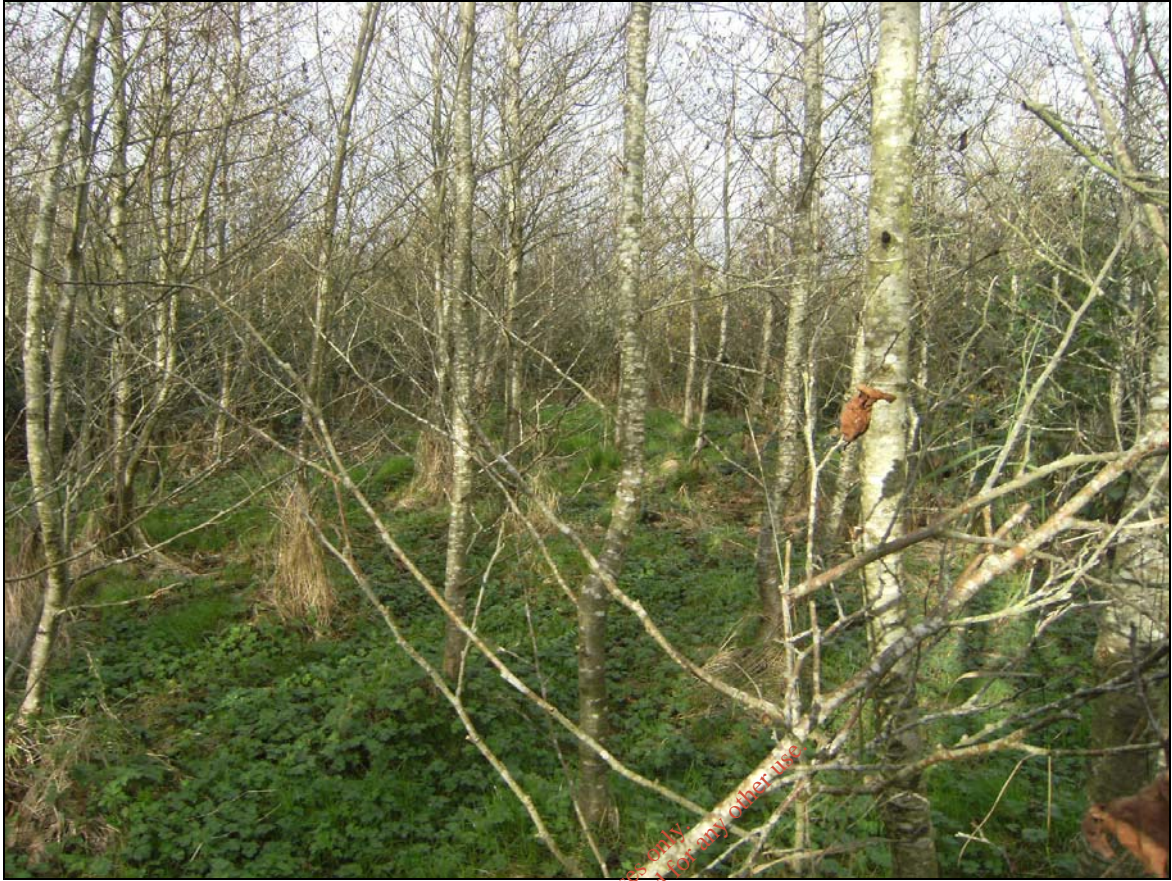
Photot No 1; Typical view in centre

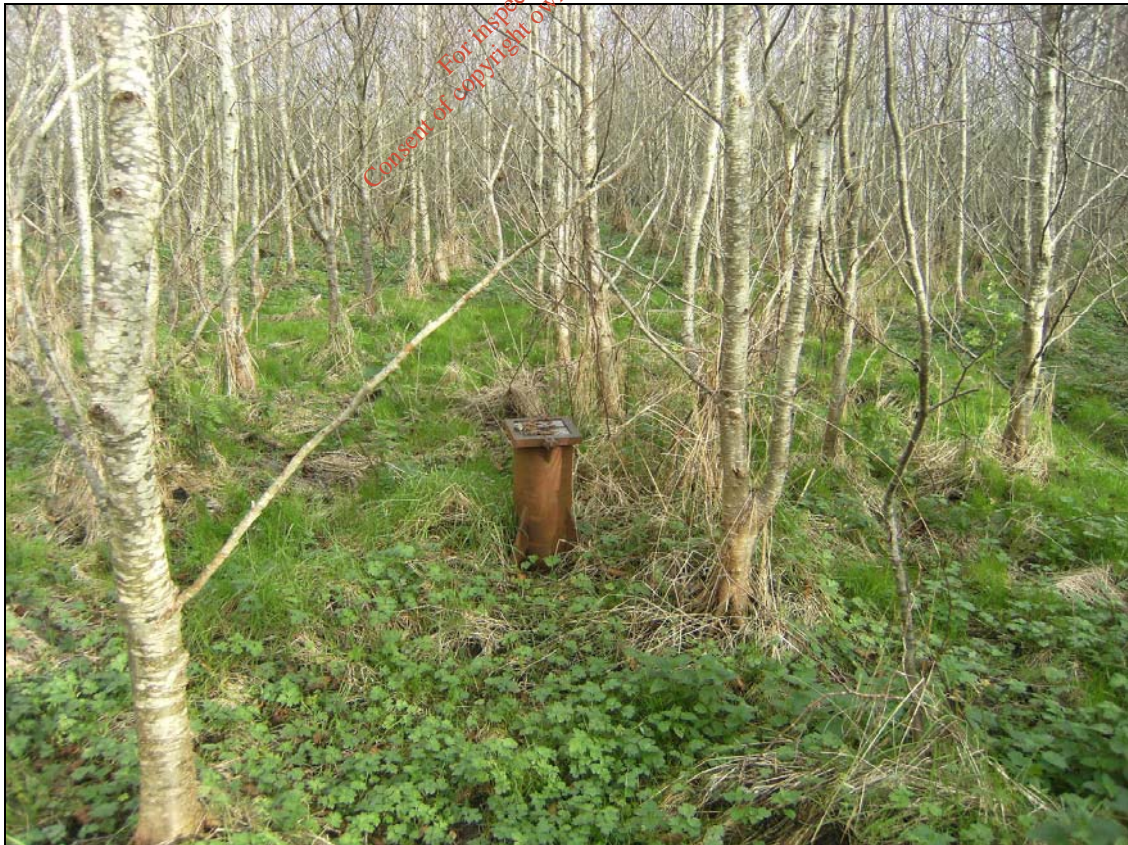
Passive vents are in evidence on the ground with no noticeable odour.

Photo No 2; Passive vent

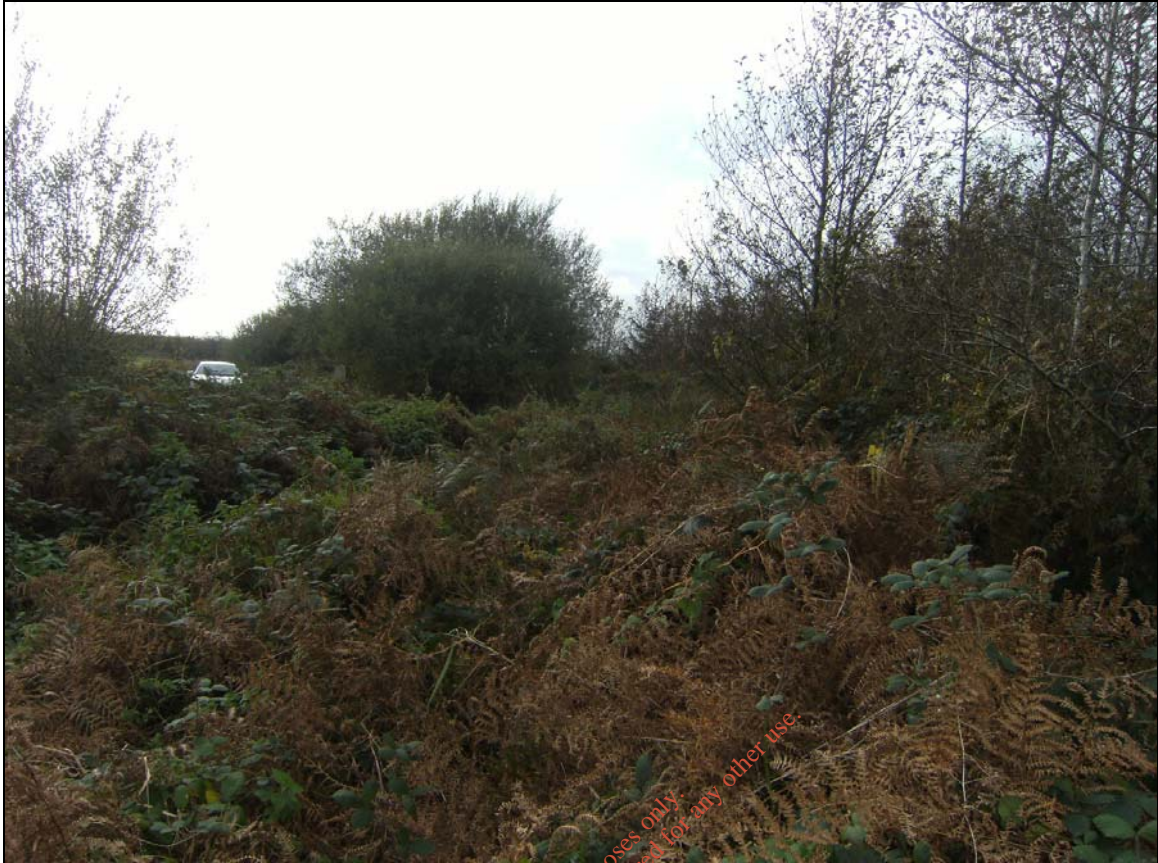
Photo No 3; View looking SW from front

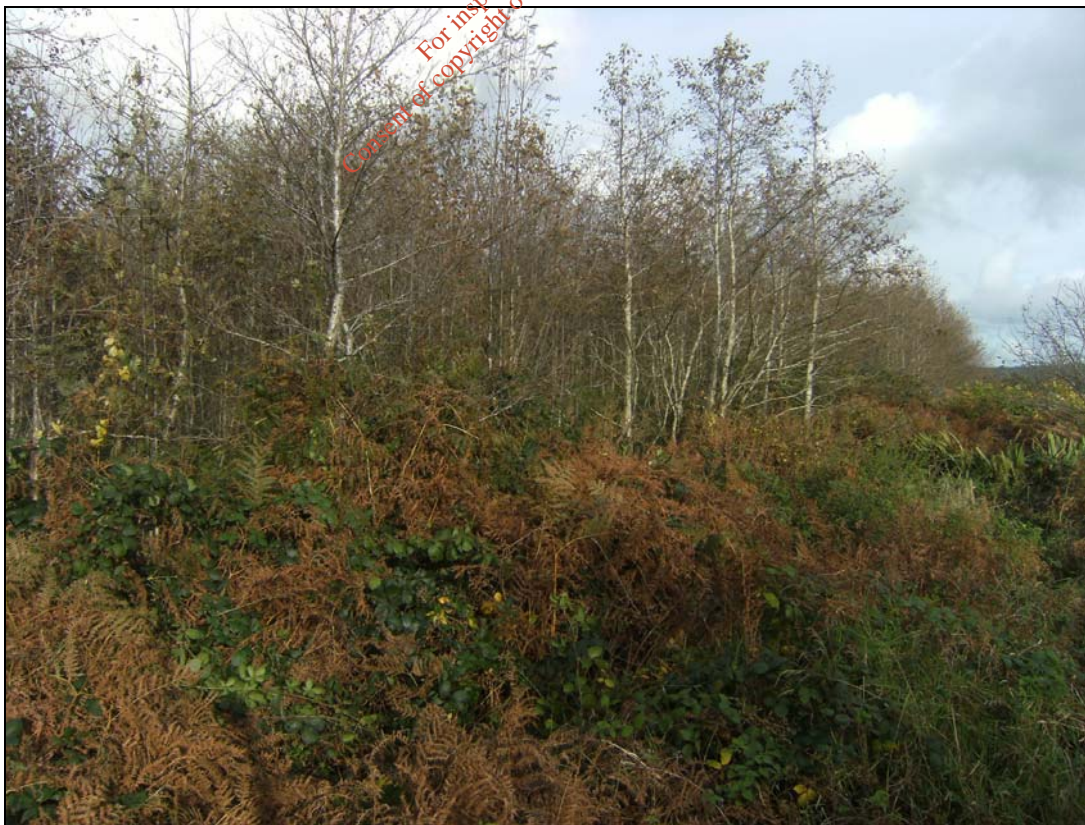
Photo No 4; View looking NE from front

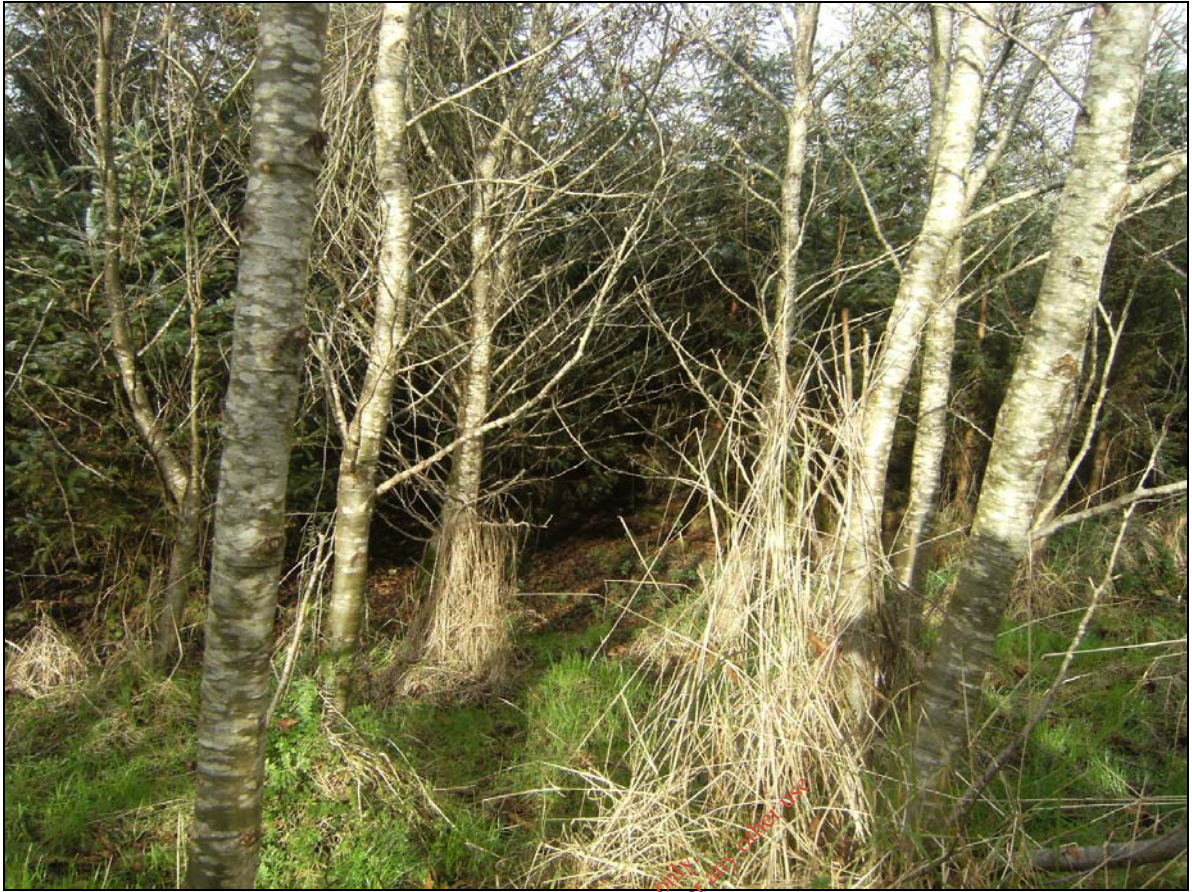
Photo No 5; Where planted area meets spruce grove

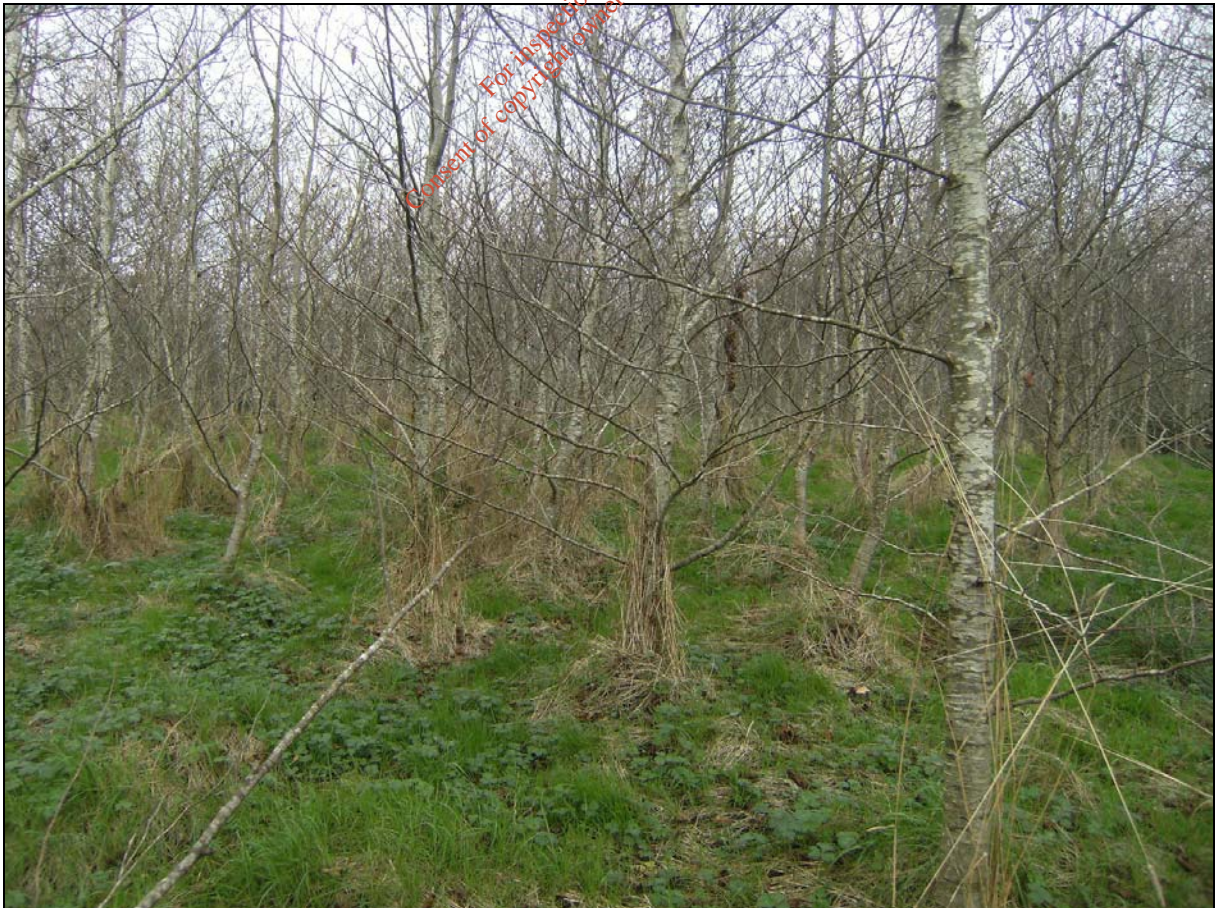
Photo No 6; View from rear of site looking front

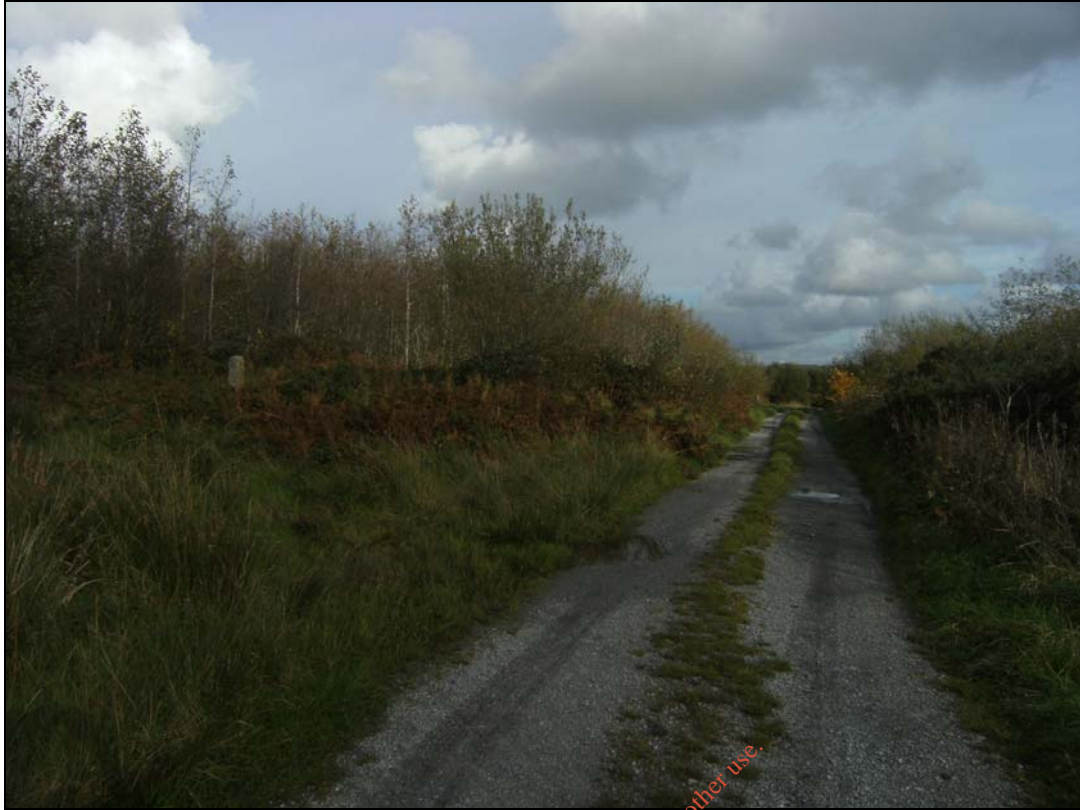
Photo No 7; Adjacent to access point looking NE
