APPENDIX 2

Site Walkover Checklist and Photographic Log

Client Name: Kerry
County Council

Site Location: Lenamore

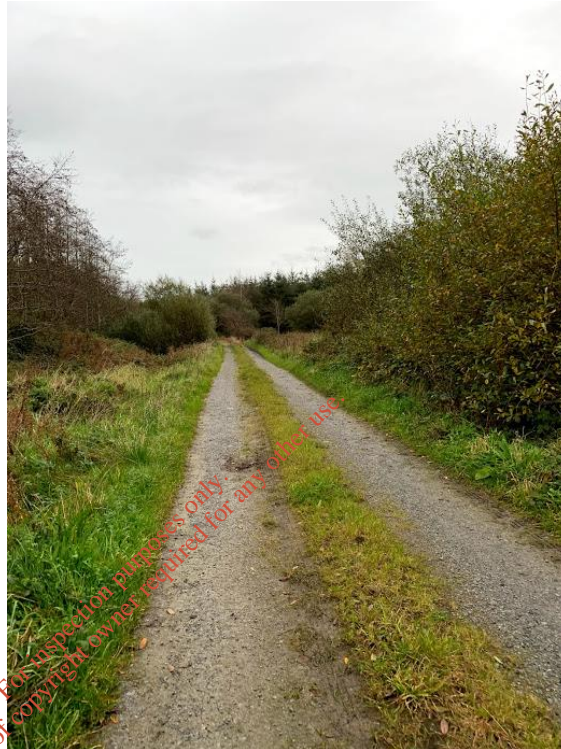
1

Access track to BH
location

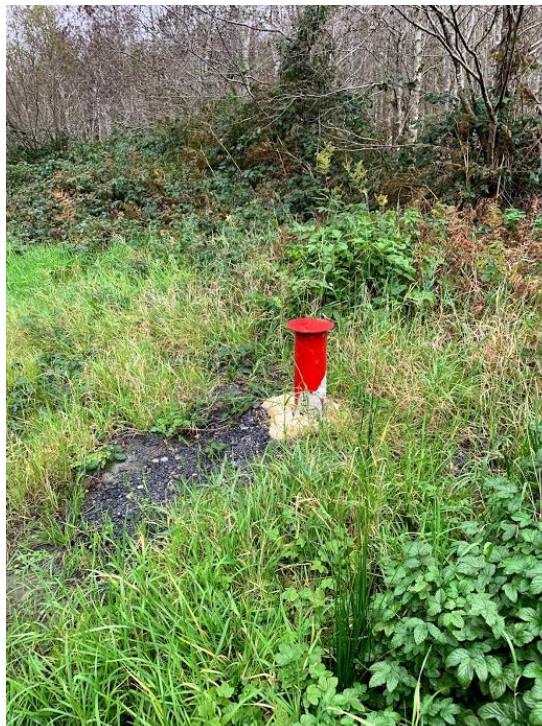
2

BH01 located at the edge
of forestry

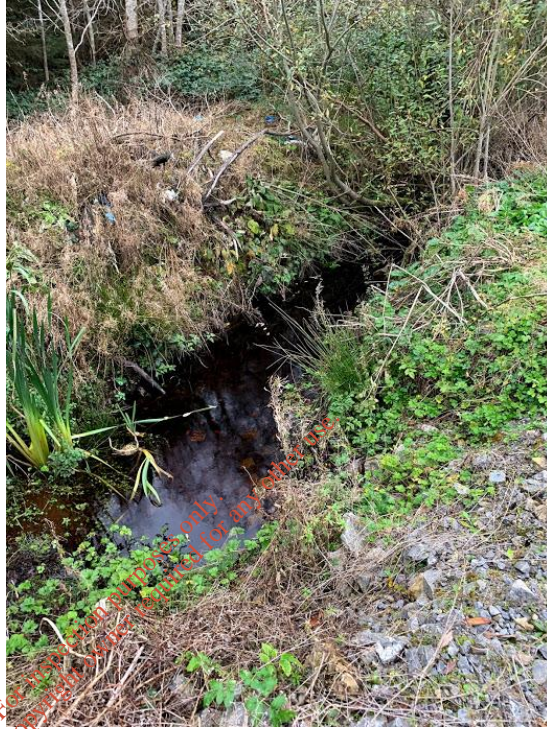
3

SW01 (upstream)

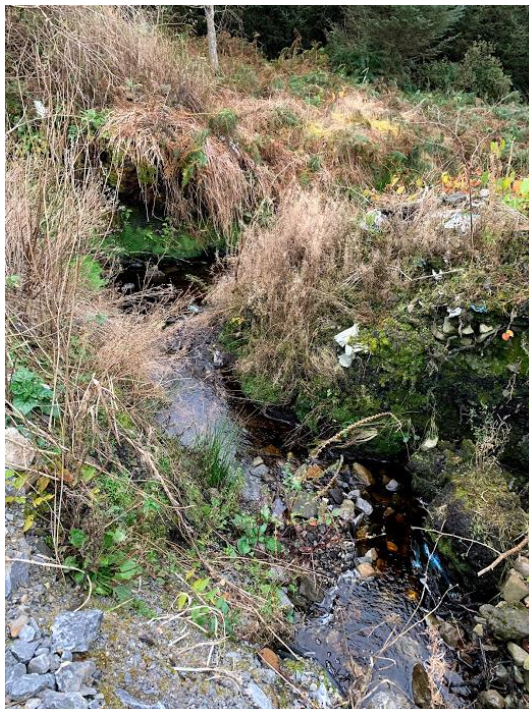
4

SW01 (downstream)

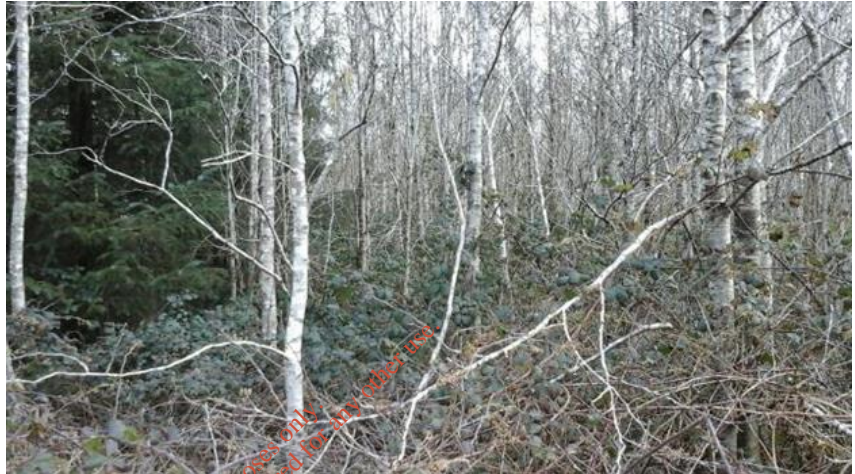
5

Forestry site
