APPENDIX 4

**Site Walkover Checklist and
Photographic Log**

Client Name: Kerry County Council

Historic Kerry Landfills - Listowel

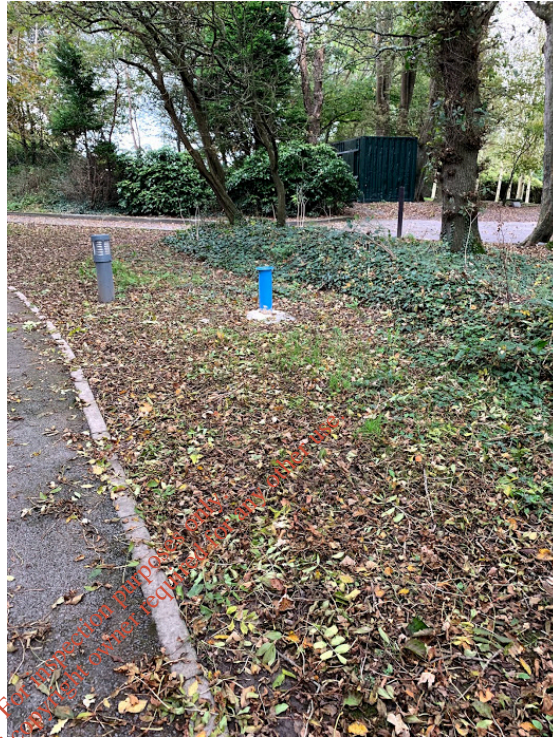
1

BH02 within Garden of Europe

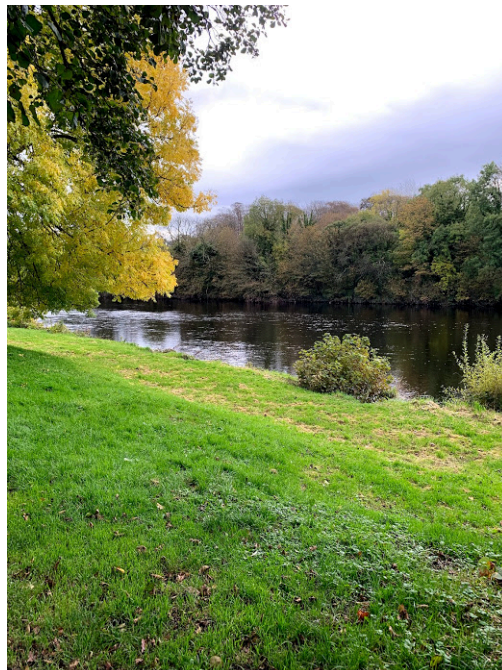
2

SW01 (upstream)

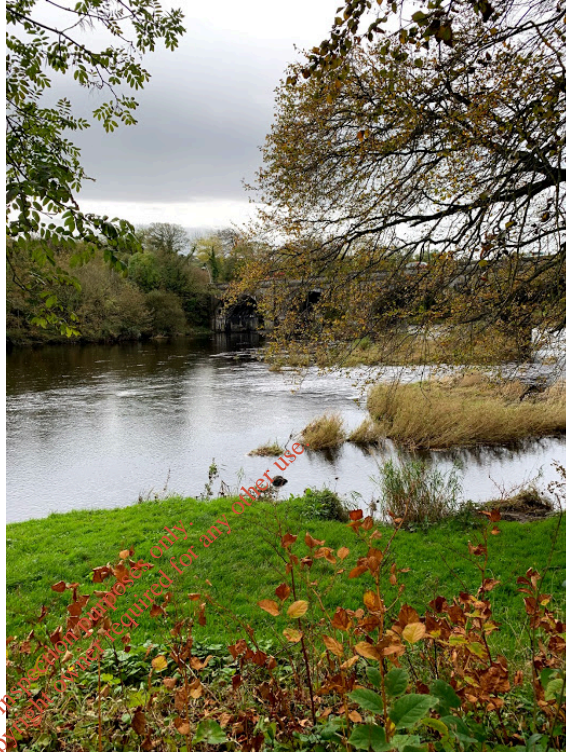
3

SW02 (downstream), close to bridge

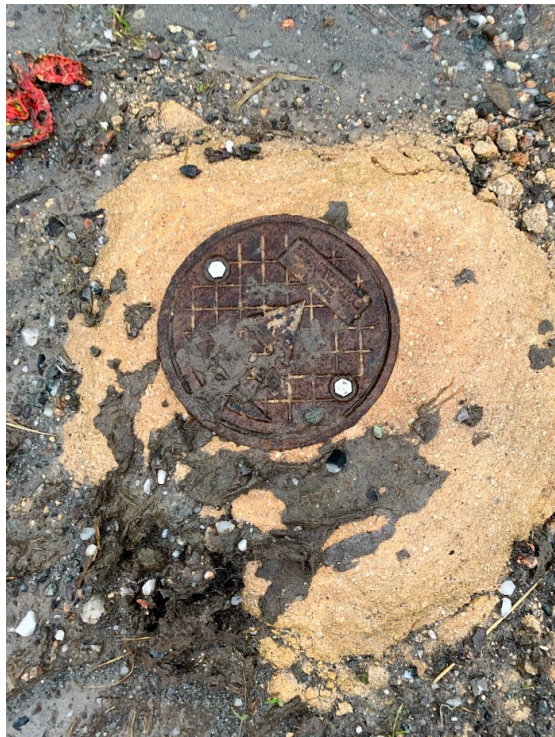
4

BH01 within council work yard, south of site boundary

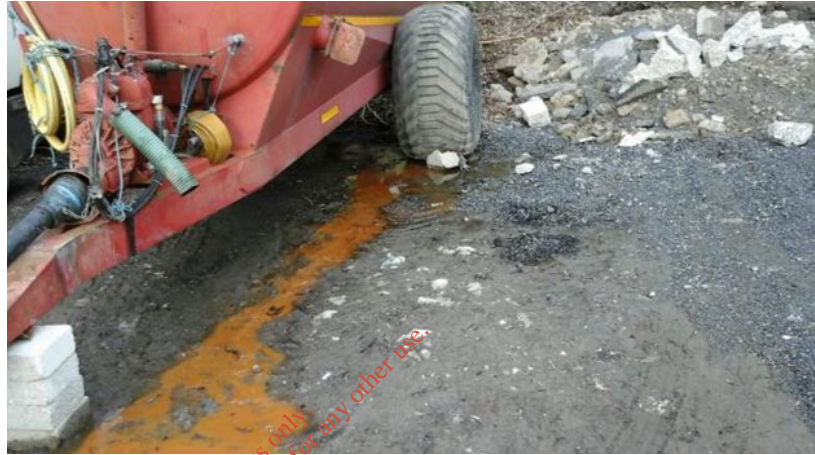
5

Leachate see page on council work yard

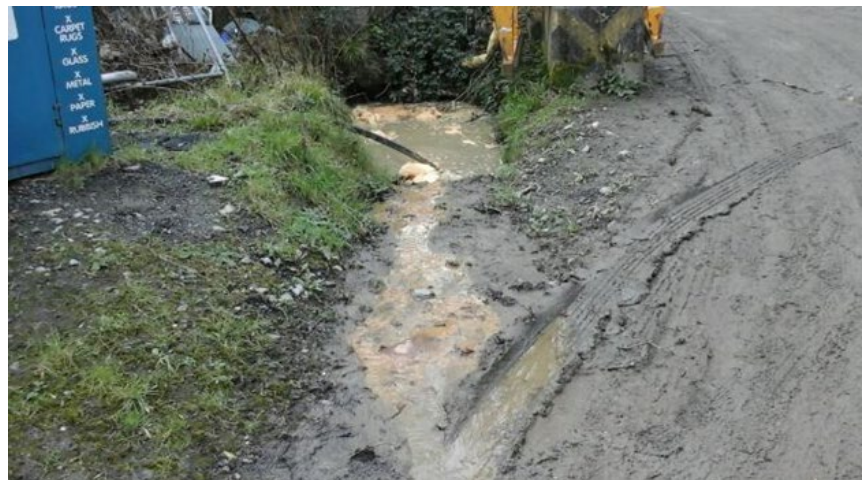
6

Leachate seepage

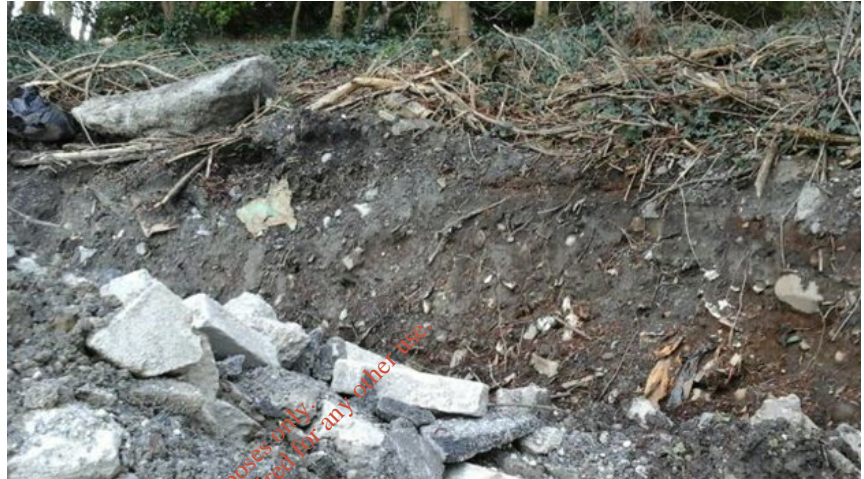
7

Surface waste

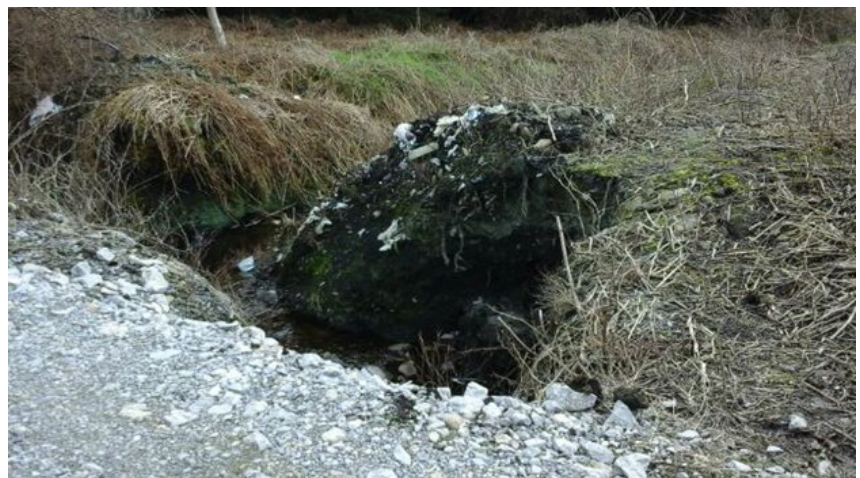
8

Surface waste
