**TIER 2 RISK ASSESSMENT  
HISTORIC LANDFILL AT LISTOWEL, CO. KERRY**

Prepared for: **Kerry County Council**

**Date:** August 2021

**Abstract:** This report represents the findings of a Tier 2 site investigation carried out at Listowel Historic Landfill, Co. Kerry and conducted in accordance with the EPA Code of Practice for unregulated landfill sites. The site investigation was undertaken to determine the extent of the historic landfilling at the site.

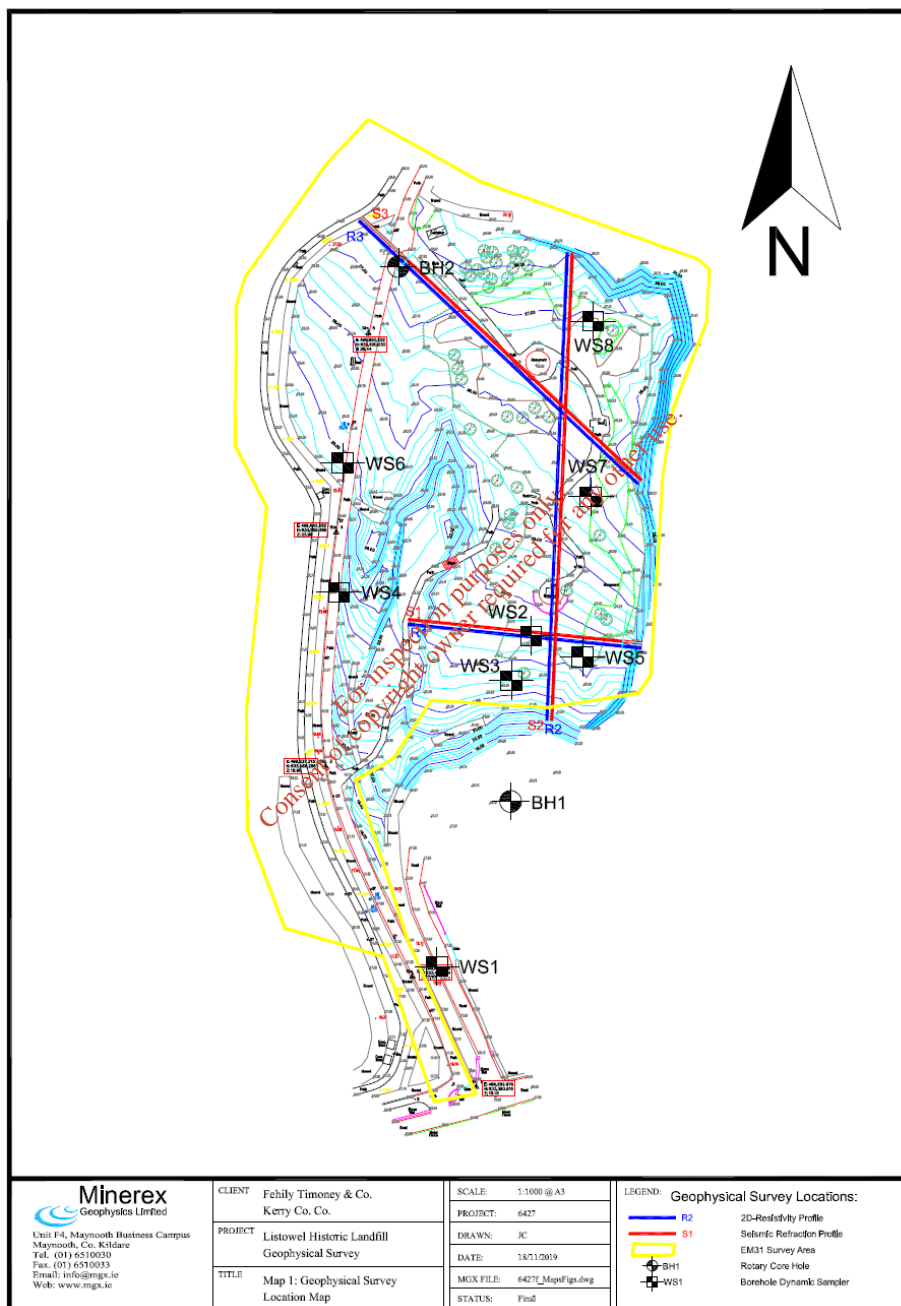
Figure 3.2: Geophysical Survey Location Map

MGX recorded RT profiles data along 3 designated profiles due to the elongated nature of the site. RT profiles named R1, R2 and R3, and three seismic refraction profiles (S1- S3) were recorded across the site. See Figure 3.2.

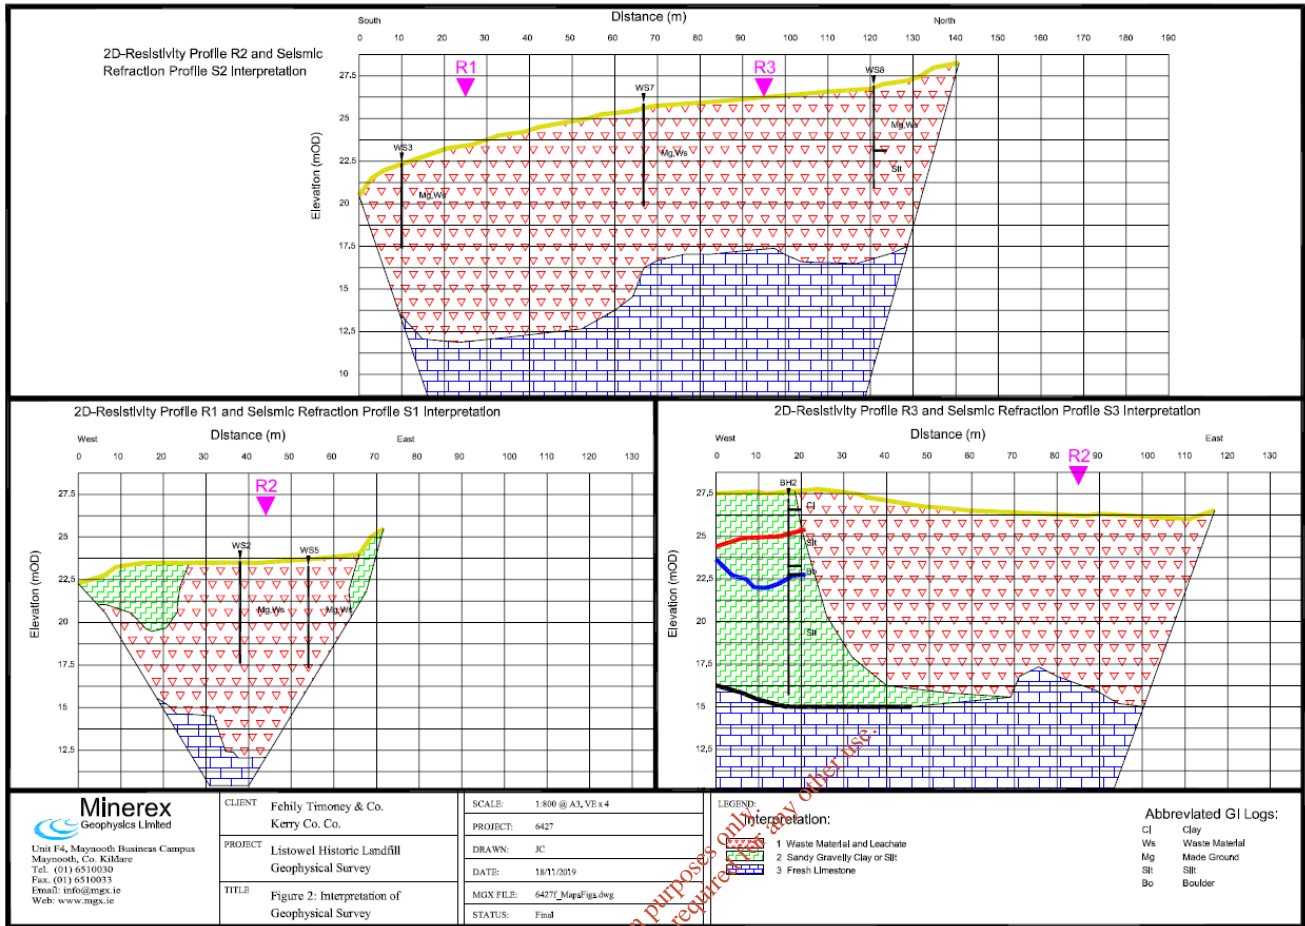
Figure 3.3: Integration of Geophysical Survey

*Layer 1 has a seismic velocity range of 200 m/s and 250 m/s and is found in most of the survey area. This velocity would represent landfill material which has a lower velocity than the surrounding natural ground.*

*Layer 2 has a seismic velocity range of 400 and 2200 m/s. This layer is interpreted as natural overburden material, in this case sandy gravelly Clay or Silt and it is found only in some areas, such as start and end of profile R1 and start of profile R3.*

*Layer 3 is interpreted as fresh Limestone and is found in most of the survey area, under layers 1 and 2. This layer has N/A seismic velocity.*

MGX note that possible leachate movement was identified at the start of profile R1 where low resistivities below higher resistivities were found.

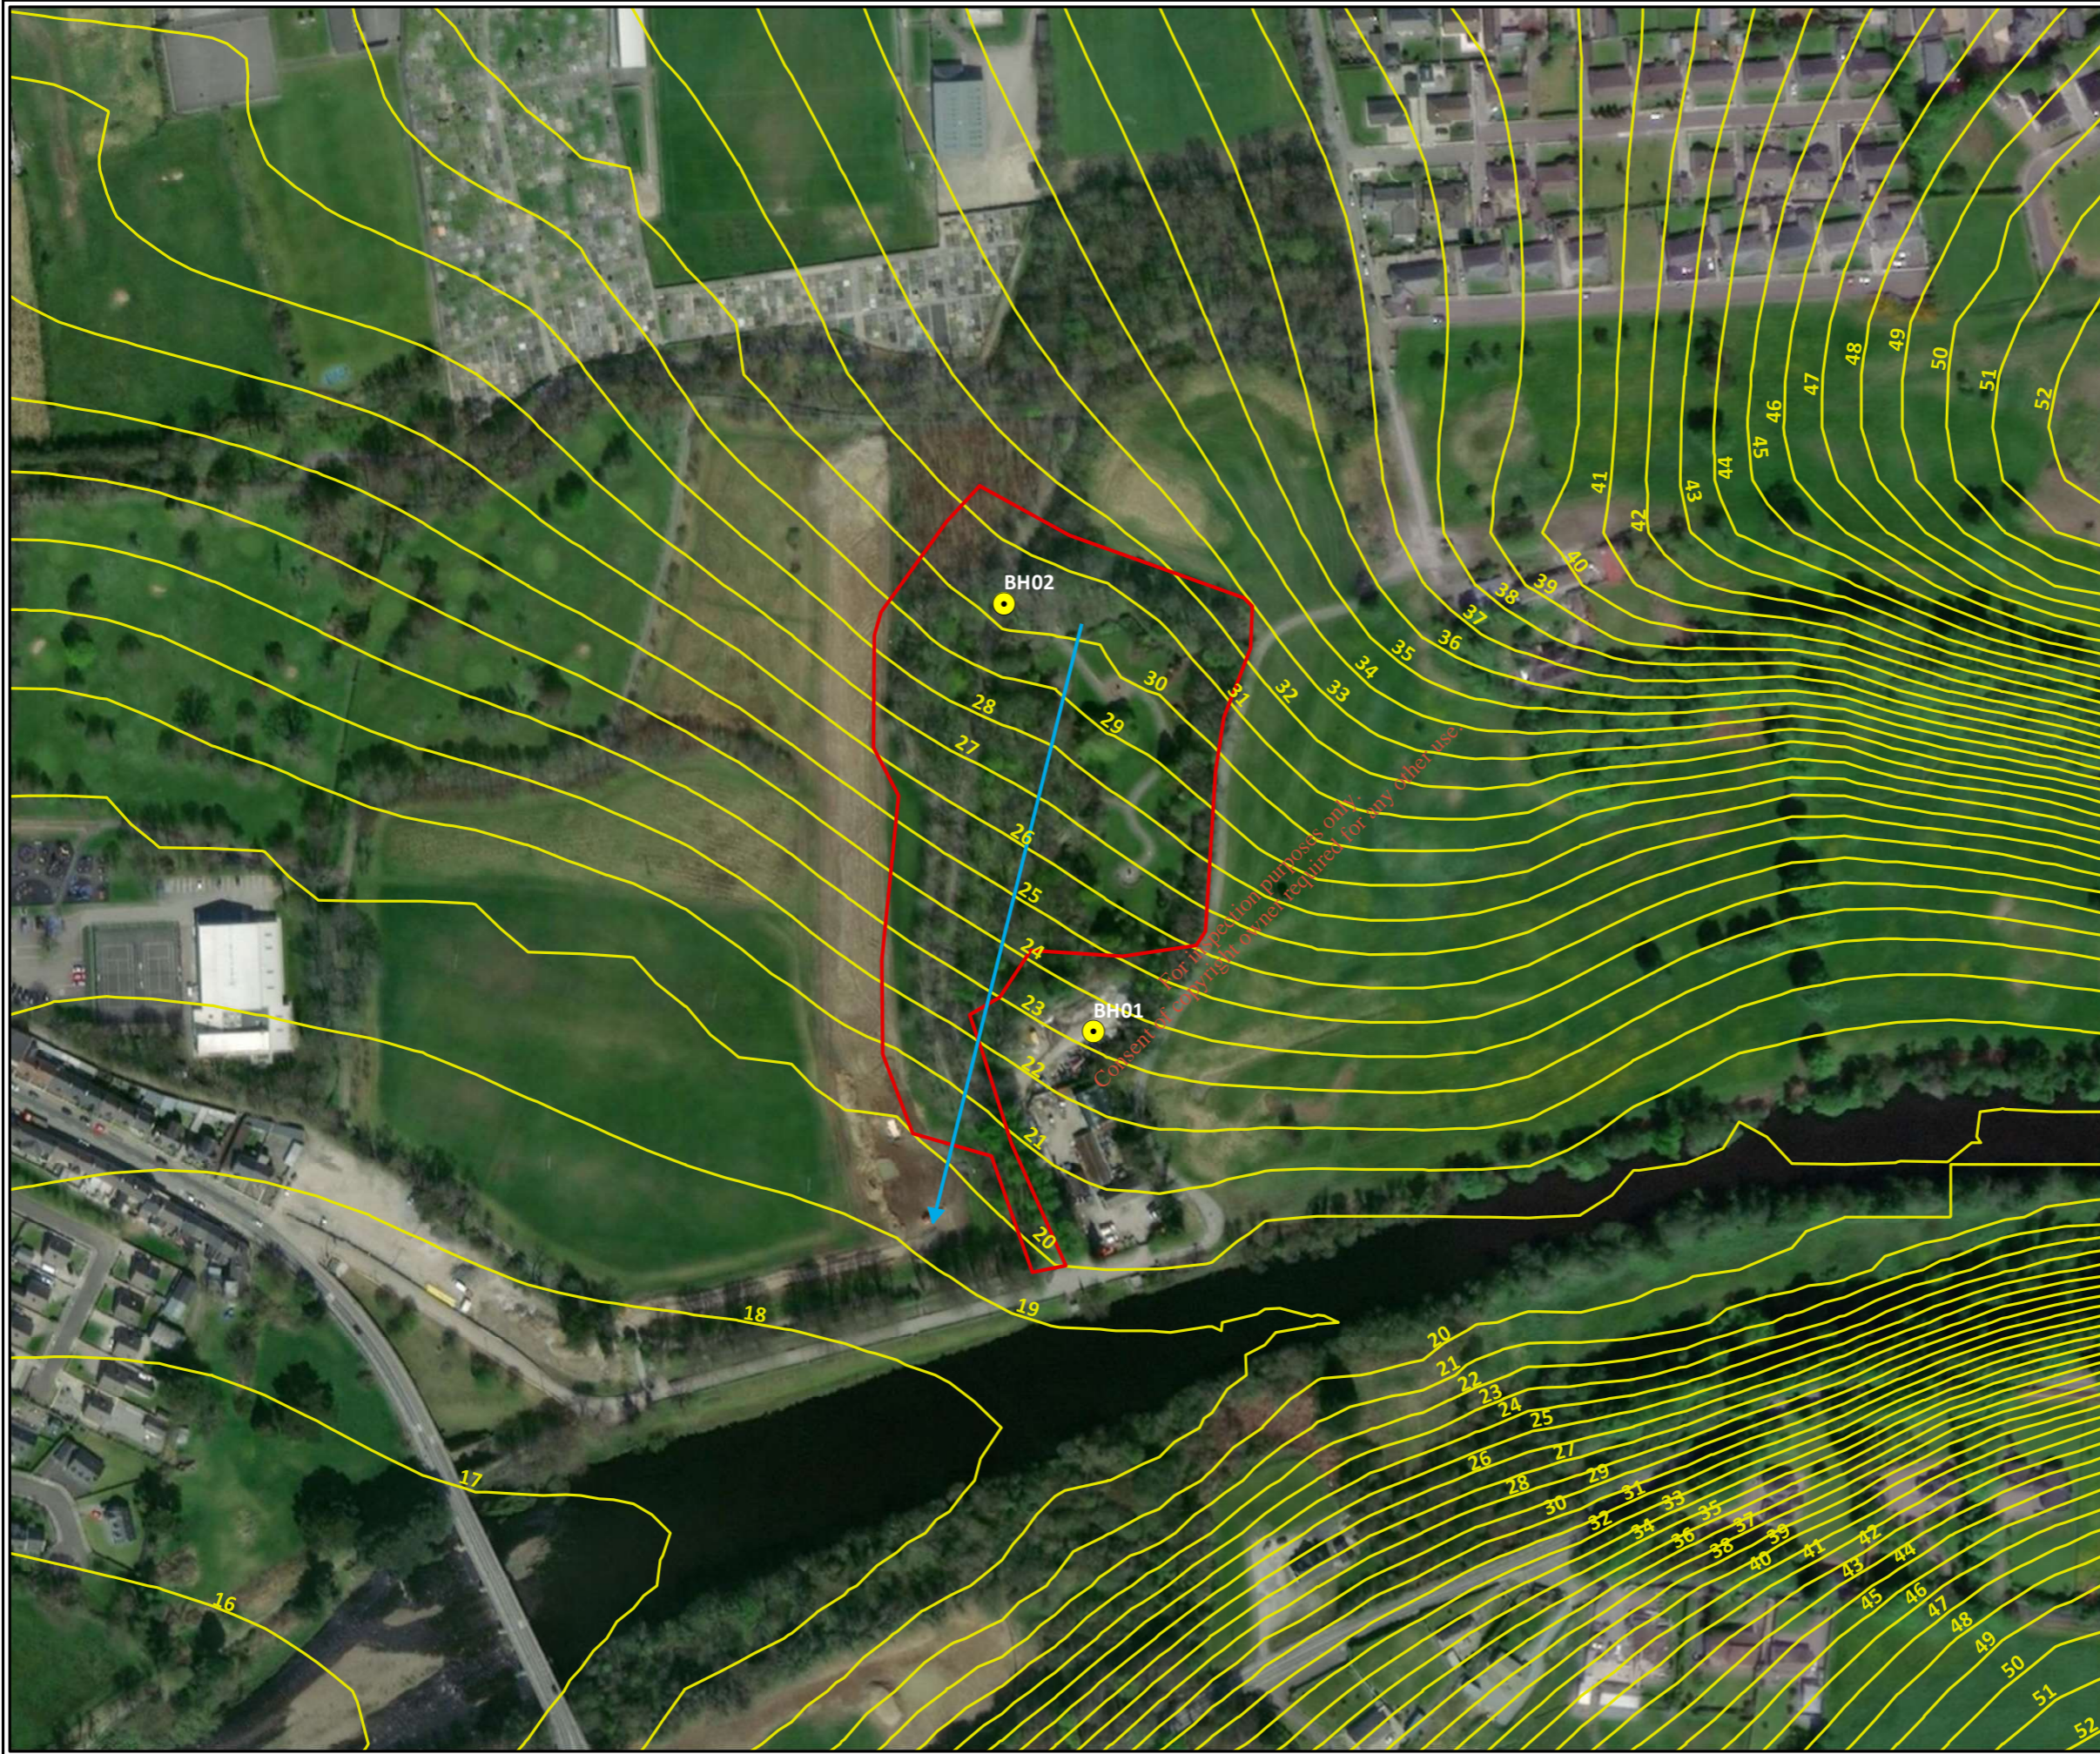
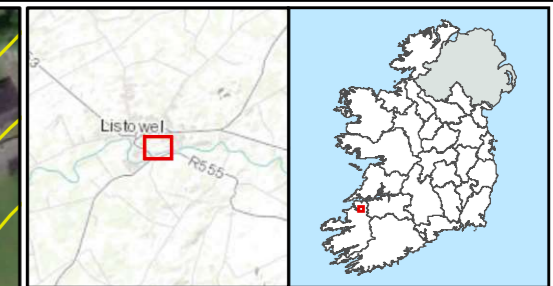
<b>TITLE:</b>	Groundwater Flow Direction		
<b>PROJECT:</b>	Environmental Risk Assessment for Listowel Landfill, Co. Kerry		
<b>FIGURE NO.:</b>	4.1		
<b>CLIENT:</b>	Kerry County Council		
<b>SCALE:</b>	1:2500	<b>REVISION:</b>	0
<b>DATE:</b>	31/10/2019	<b>PAGE SIZE:</b>	A3

The location of the groundwater boreholes installed at the site where based on the anticipated groundwater flow direction. A desktop analysis of the site in tandem with a site walkover estimated that the likely groundwater flow direction was North to South based on the location of the Feale River.

The results of groundwater monitoring indicate a north to south groundwater flow direction.

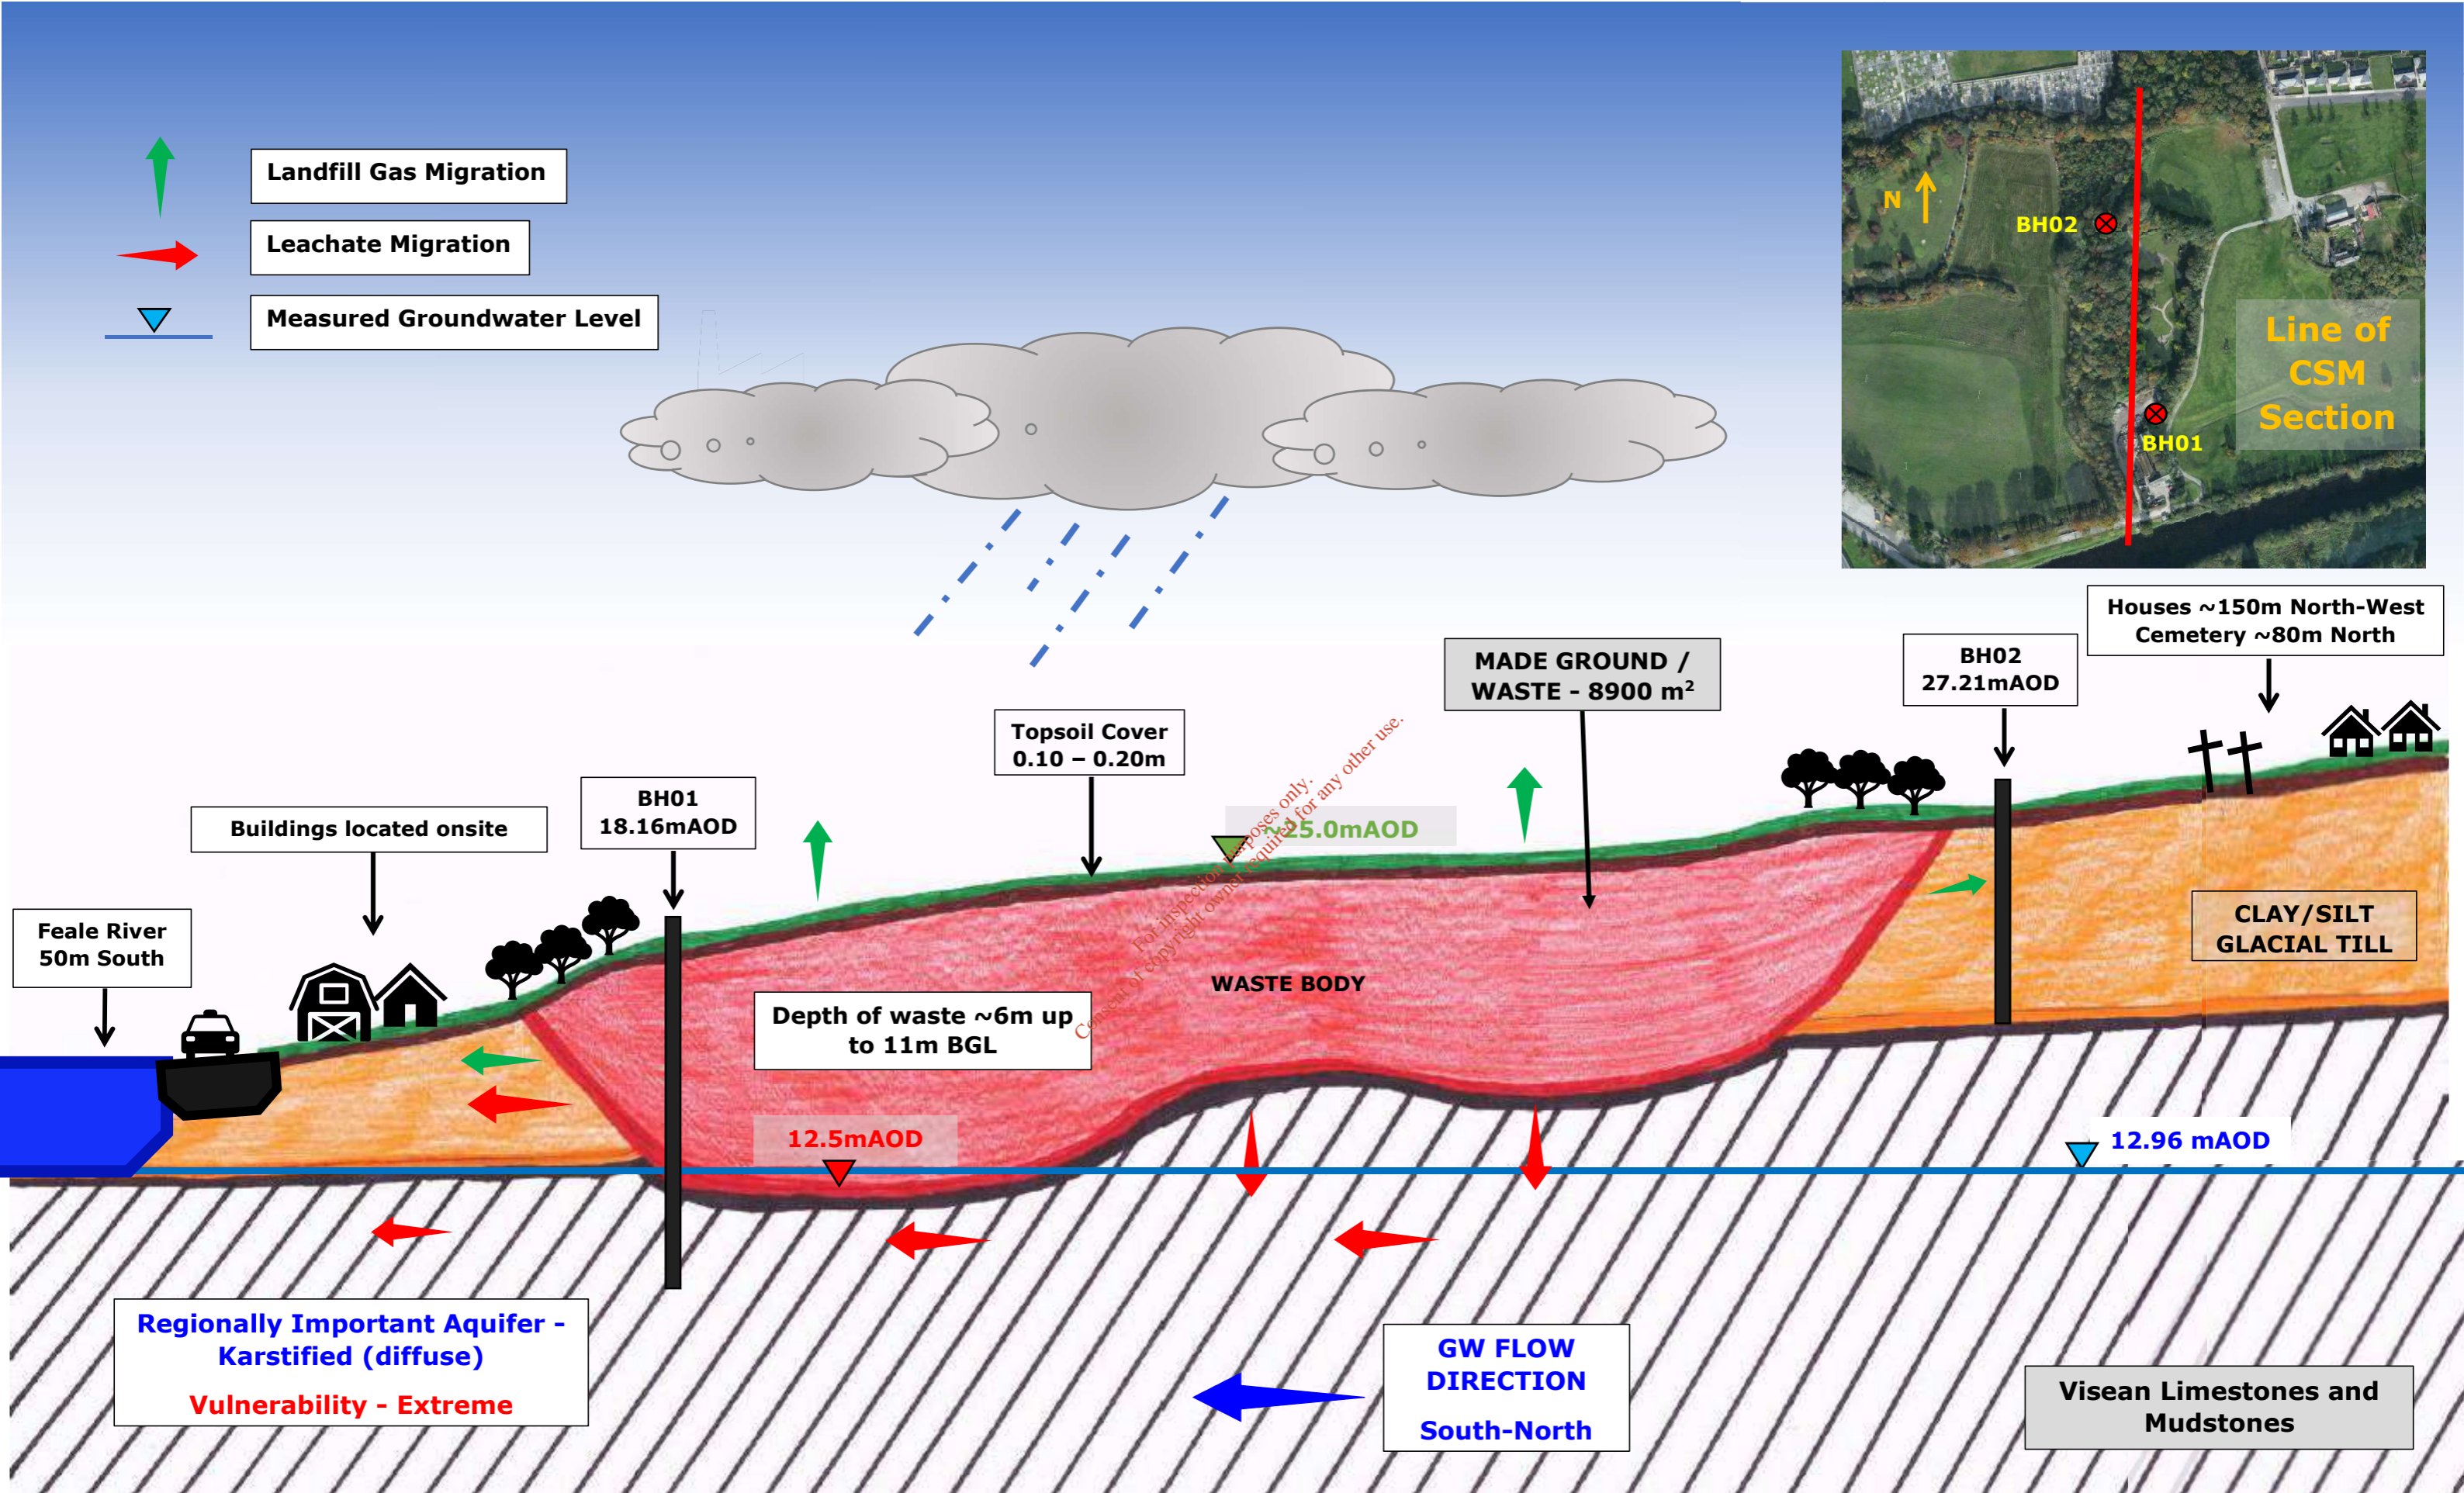
**FIGURE 5.1 Listowel HISTORIC LANDFILL  
CONCEPTUAL SITE MODEL**

Based on the review of the Tier 1 assessment and site investigation works undertaken for Listowel Historic Landfill, an assessment of the risk is made to confirm the source – pathway – receptor (S-P-R) linkages identified in the preliminary investigation. The results and analysis of the investigation has enabled a revised conceptual model to be produced for the site, which is presented in Figure 5.1, overleaf.

It is therefore recommended by FT that a Tier 3 DQRA be undertaken for the site in conjunction with an application for a Certificate of Registration for this site.
