APPENDIX 5

**Site Walkover Checklist and
Photographic Log**

Historic Kerry Landfills - Ardferf

Project Number: P1766

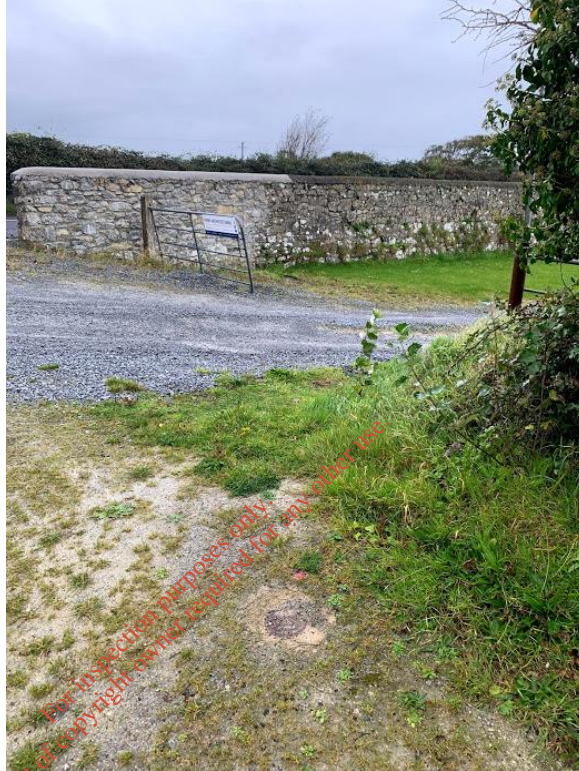
Residential entrance west of site, BH01 located just outside

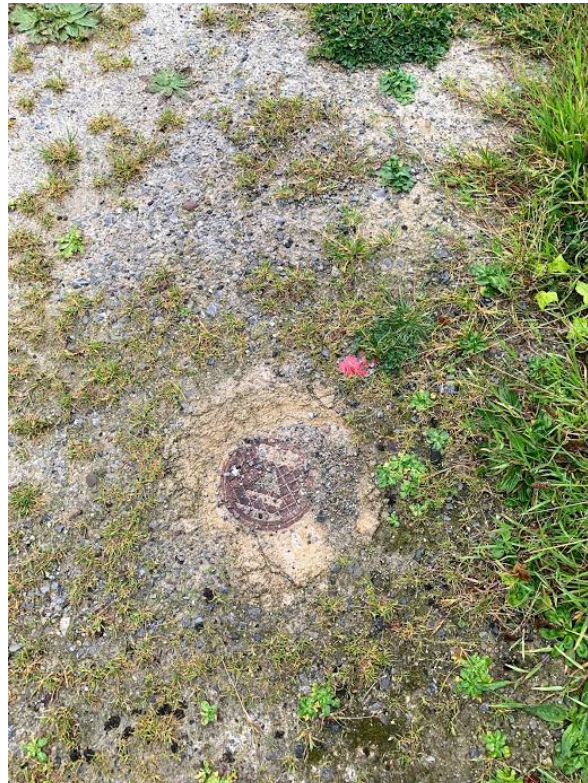
BH01

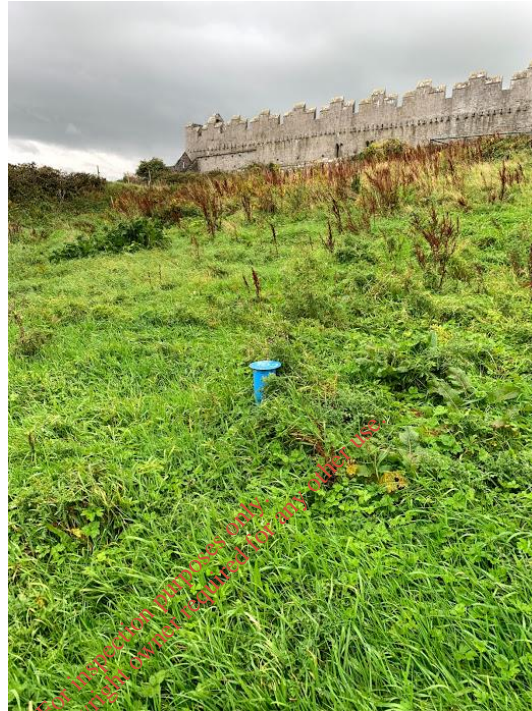
BH02 within field just north of old cathedral

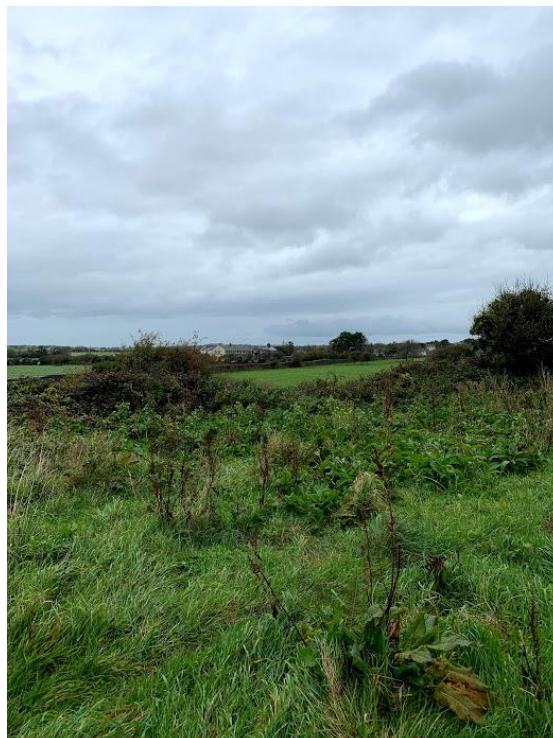
Looking north from BH02 to river flowing in an east to west direction where surface water samples were collected.
