# Site Visit Report

Licensee	
<b>Name of Installation</b>	John Ronan & Sons
<b>Licensee</b>	John Ronan & Sons
<b>Licence Register No.</b>	P0225-01
<b>CRO Number</b>	17270
<b>Site Address</b>	Dudley's Mills, Clonmel, Tipperary
<b>Site Visit Reference No.</b>	SV21793

Report Detail	
<b>Issue Date</b>	17/08/2021
<b>Prepared By</b>	Irene Doyle

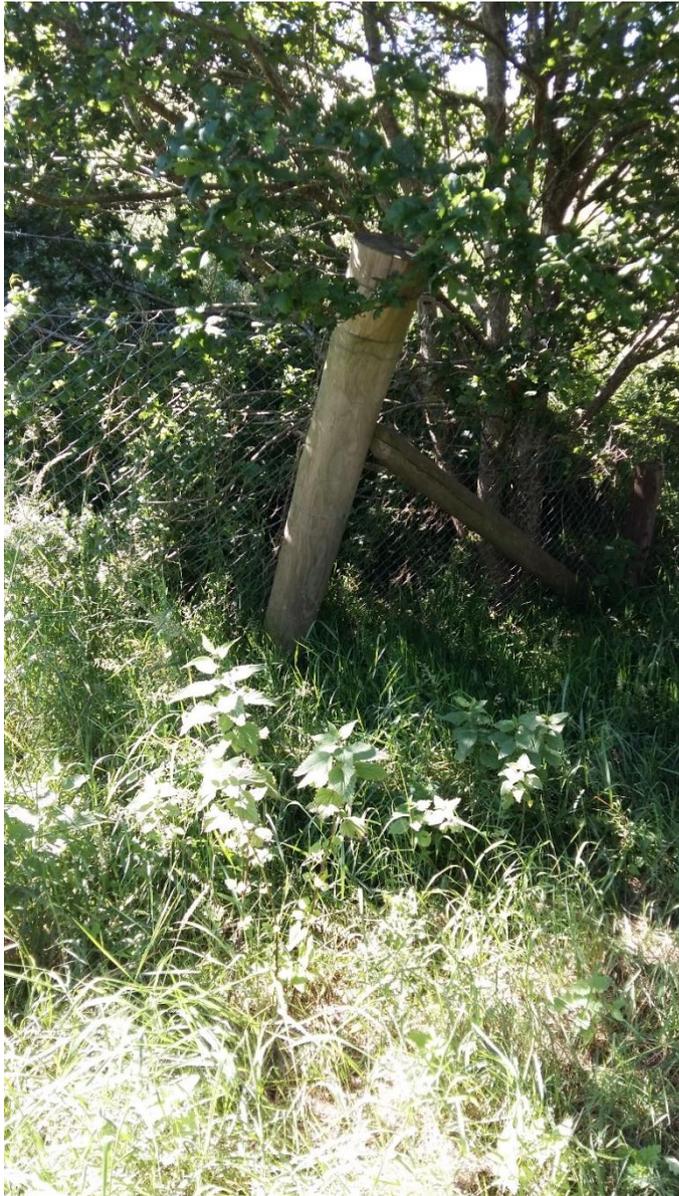
*Figure 2 Damaged fencing*

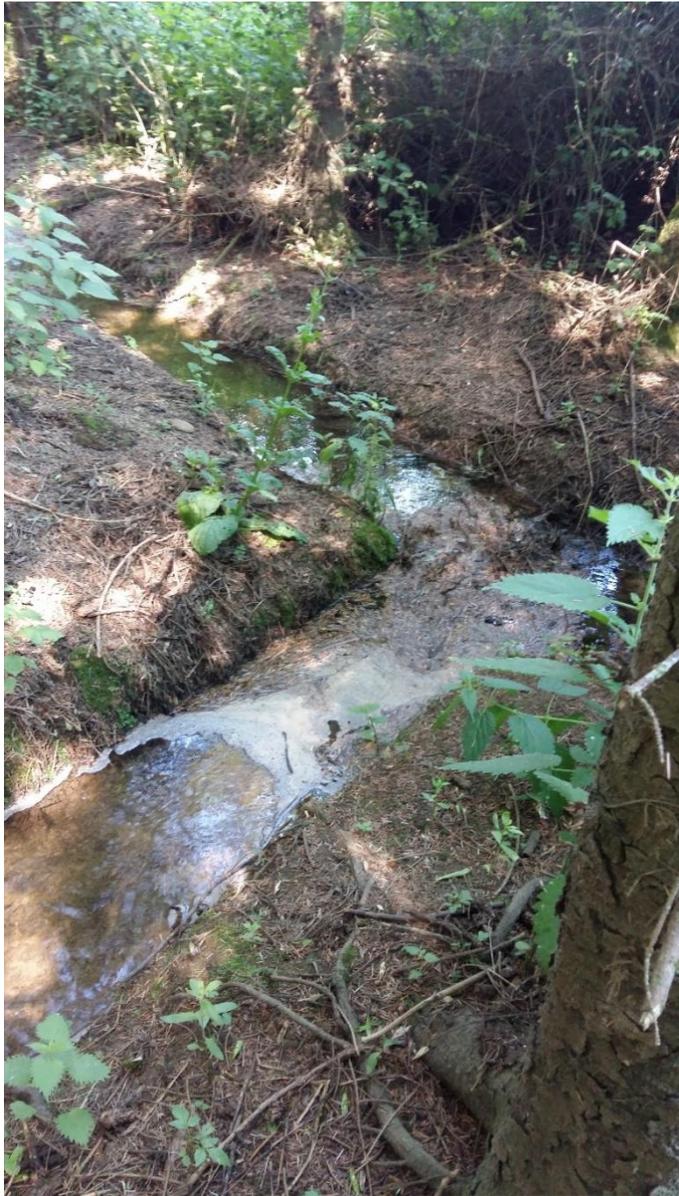
*Figure 3 Cleared drainage channel*

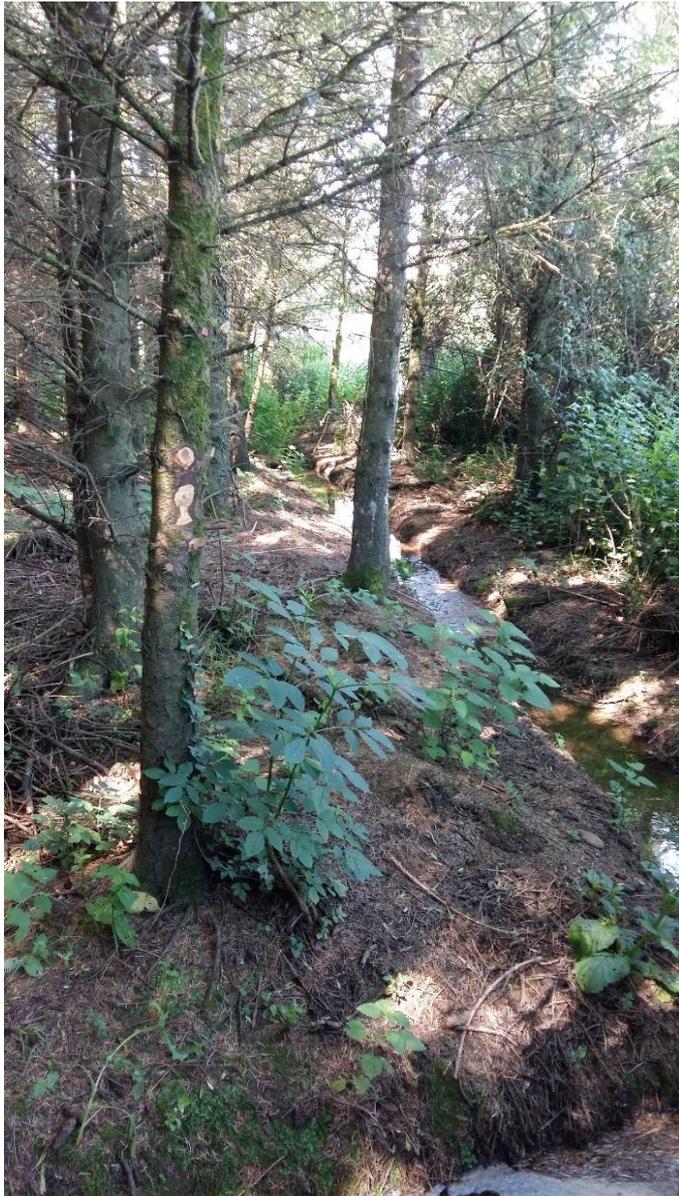
*Figure 4 Extent of drainage channel - past this view the channel is blocked*

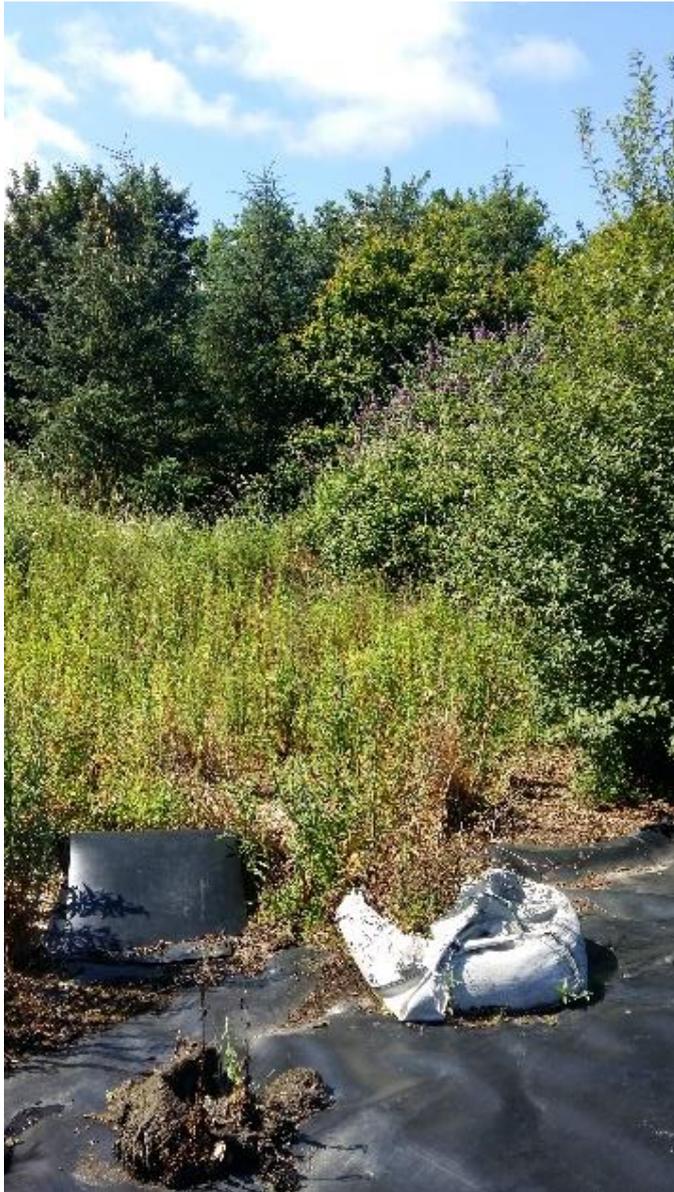
*Figure 5 Overgrown vegetation hiding rubble and site debris making the site unsafe to walk around*
