Golder Associates (UK) Limited

**INVESTIGATION INTO THE CAUSES OF THE
SURFACE SUBSIDENCE
AT GALMOY MINE, CW ORE-BODY,
MARCH 2002**

March, 2002

021-9302 (02511369)

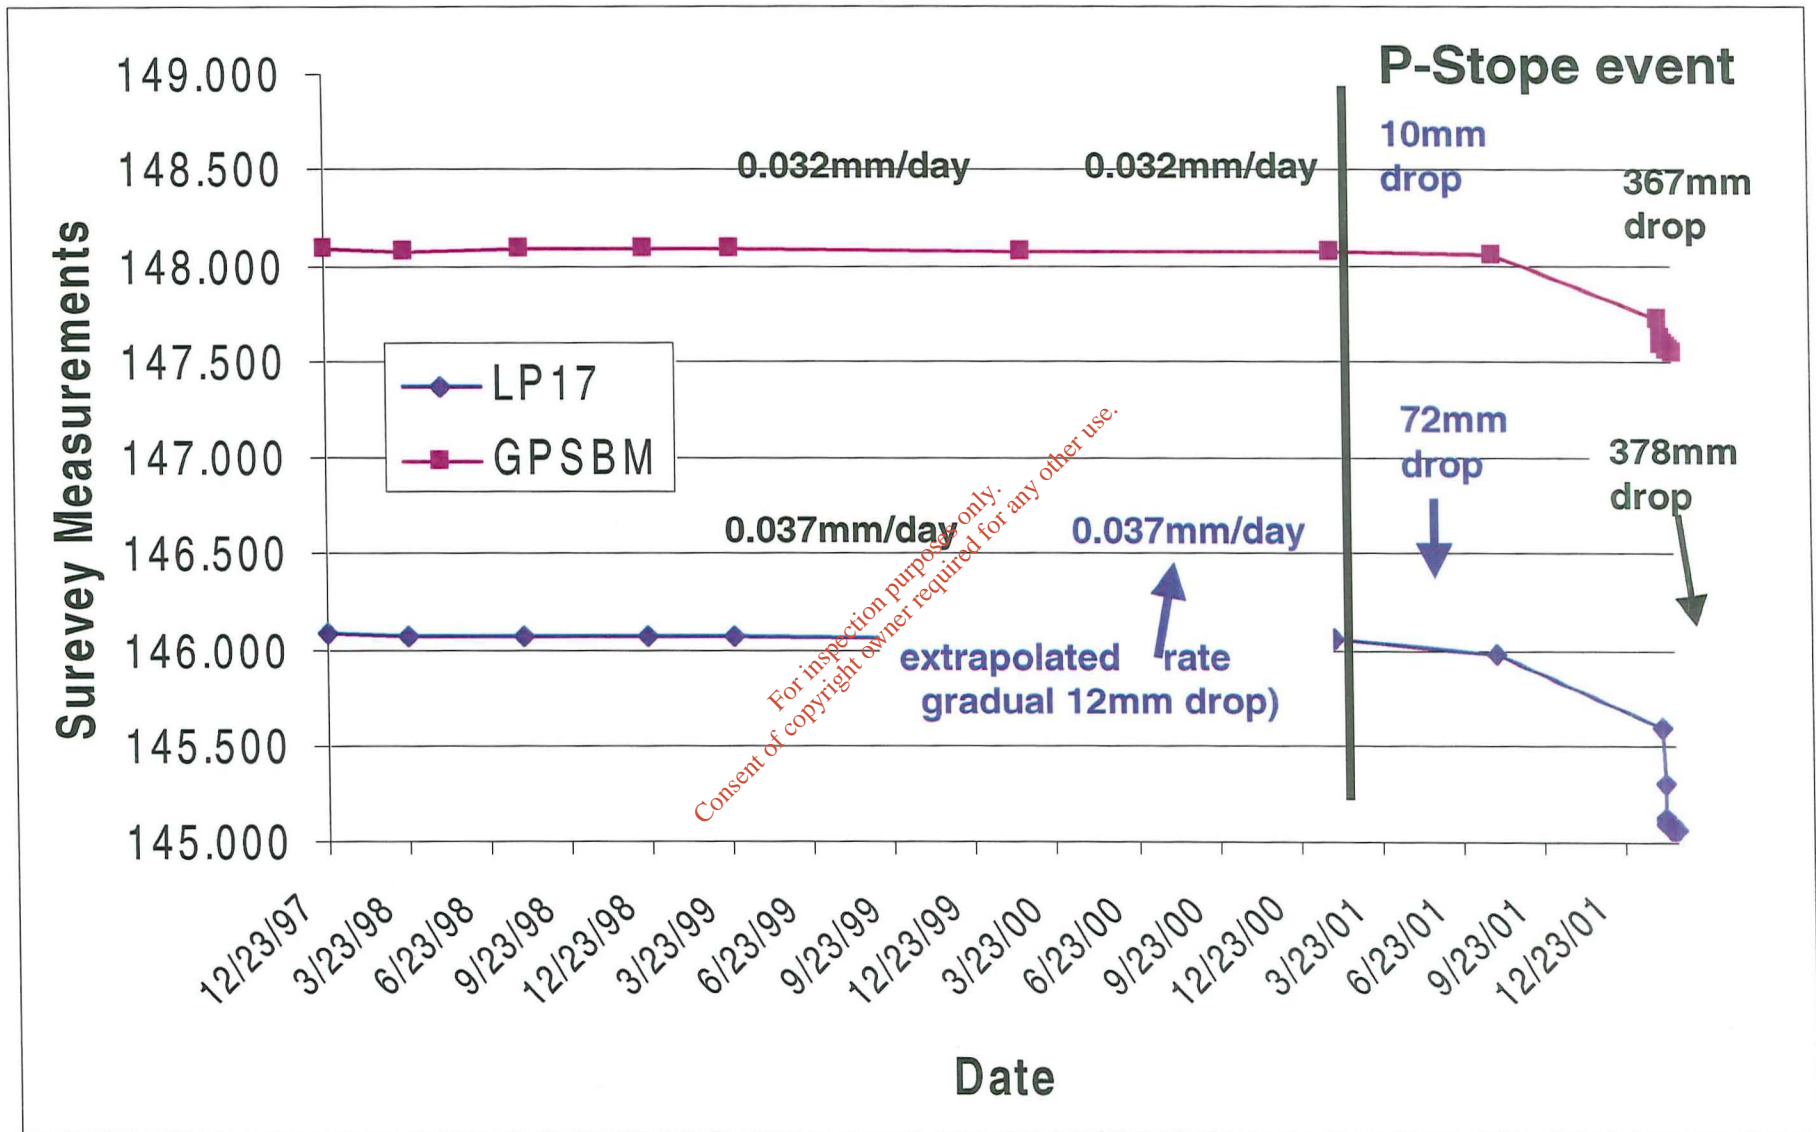
Figure 6. Graph of Subsidence Readings

Prior to August 2001, the average displacement rate at the LP17 was 0.157mm/day (Figure 6) which is in the quasi-unstable range and should have initiated more frequent readings (see Appendix). During this period the displacement rate at GPBSM was 0.026mm/day, indicating completely stable conditions.

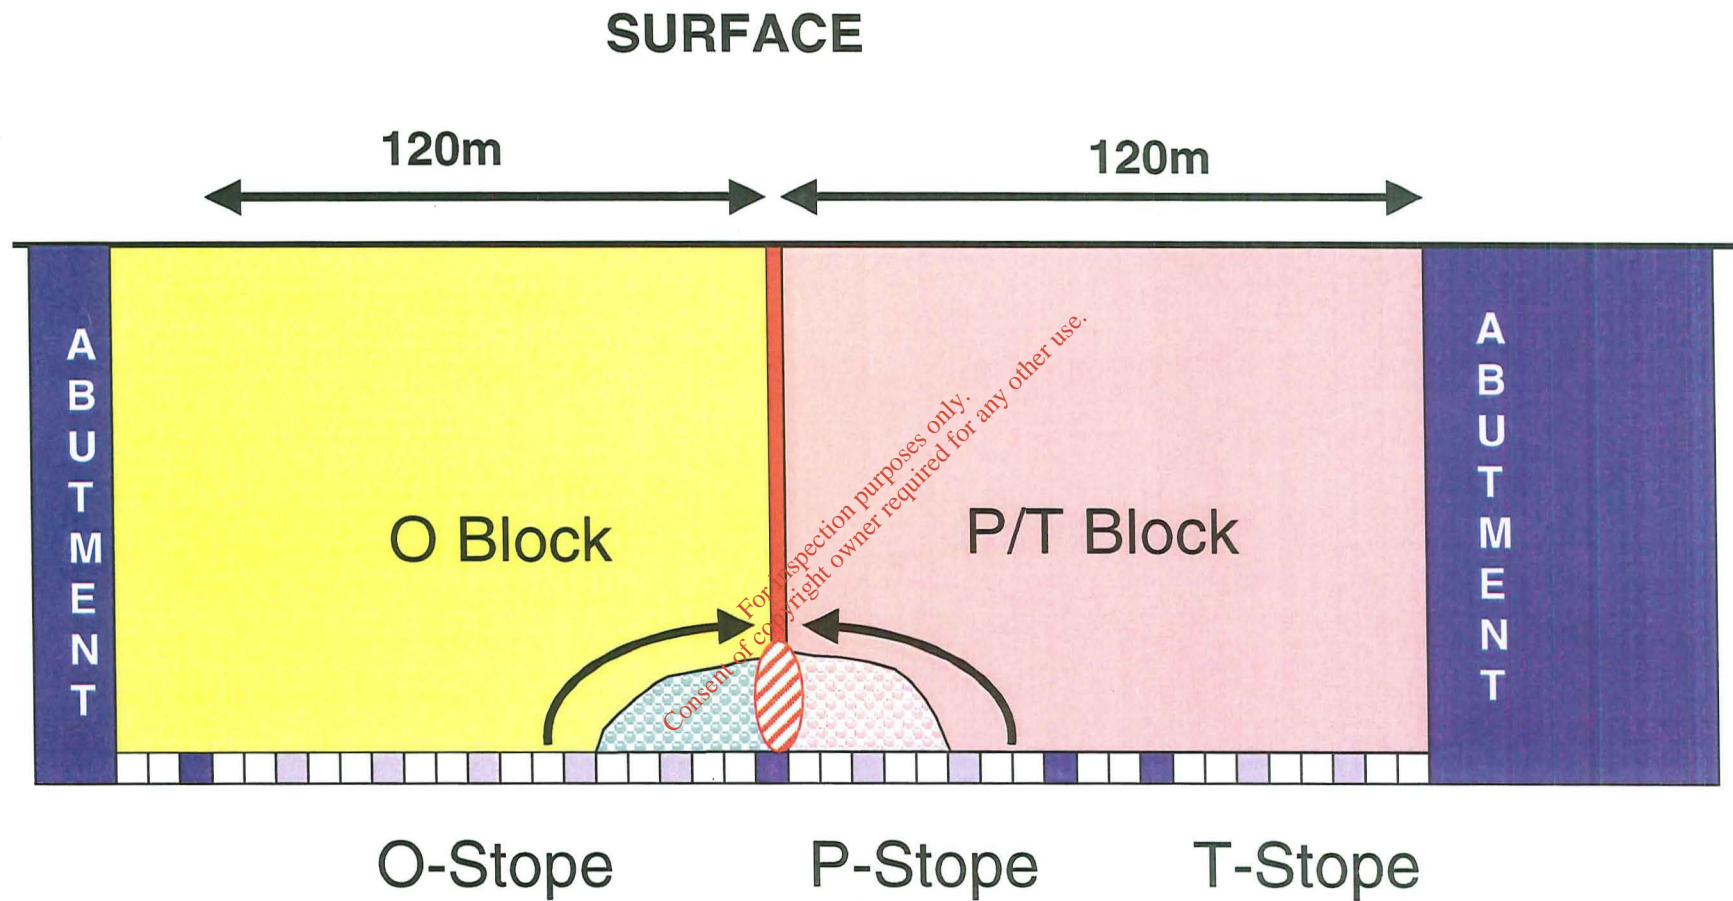
Figure 9. i) Schematic showing section through O/P/T Stopping Area, with Main Fissure extending to surface.

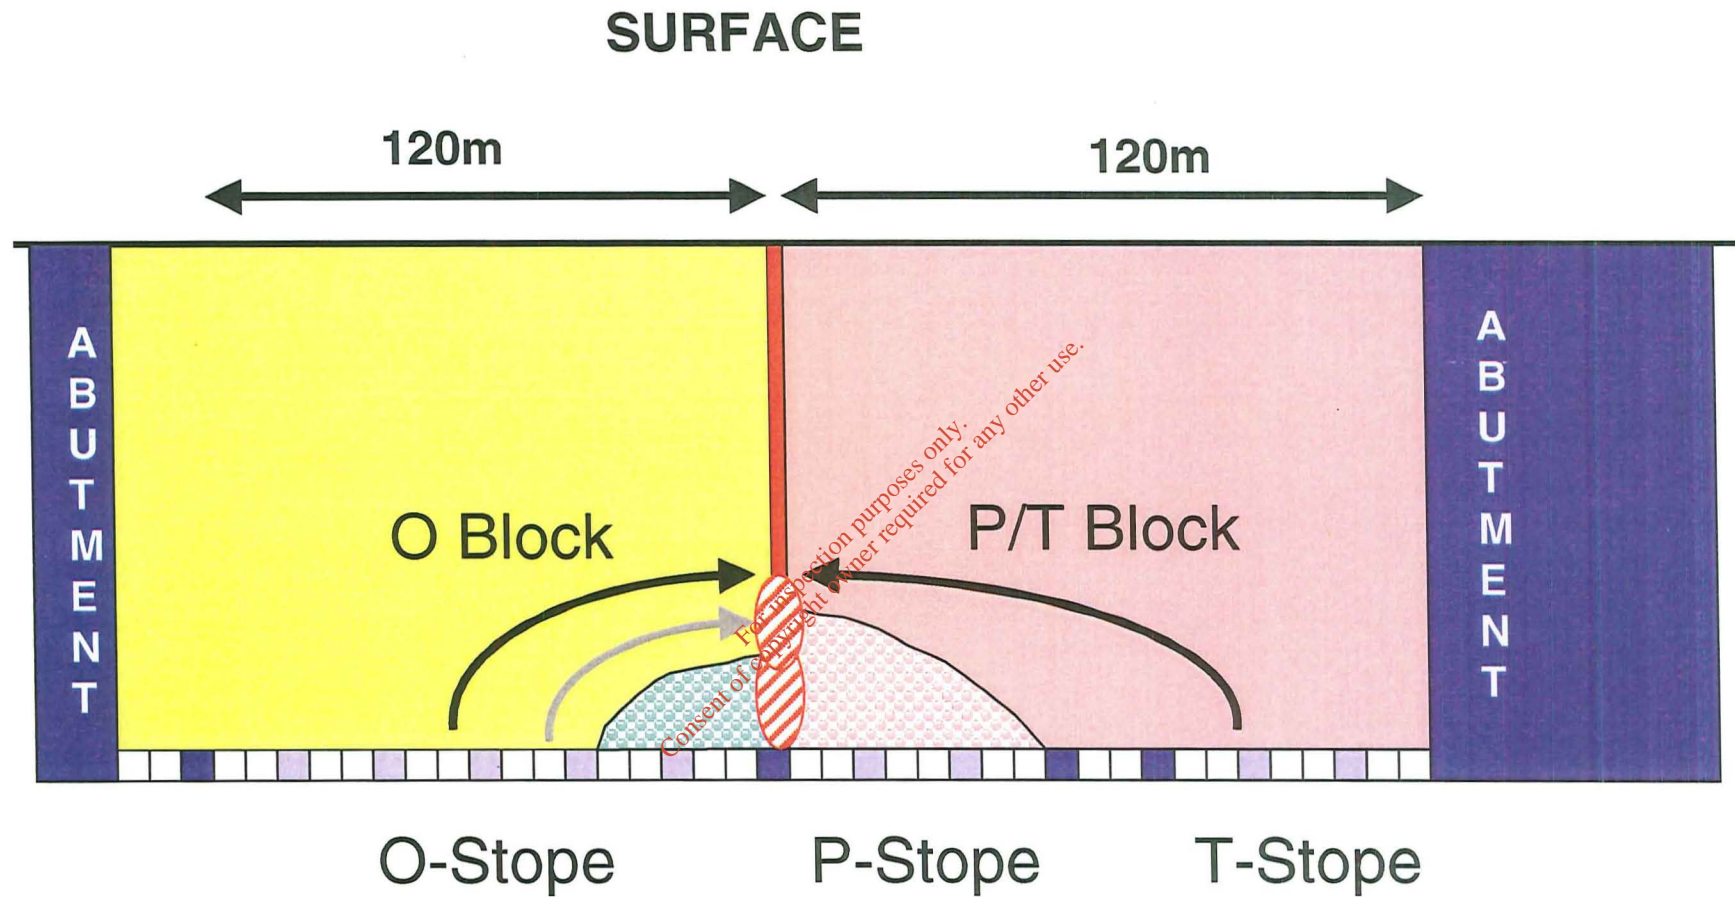
Figure 9. ii) Showing collapse along the Main Fissure in O-Stope and in P-Stope, with redistribution of stresses to adjacent pillars.

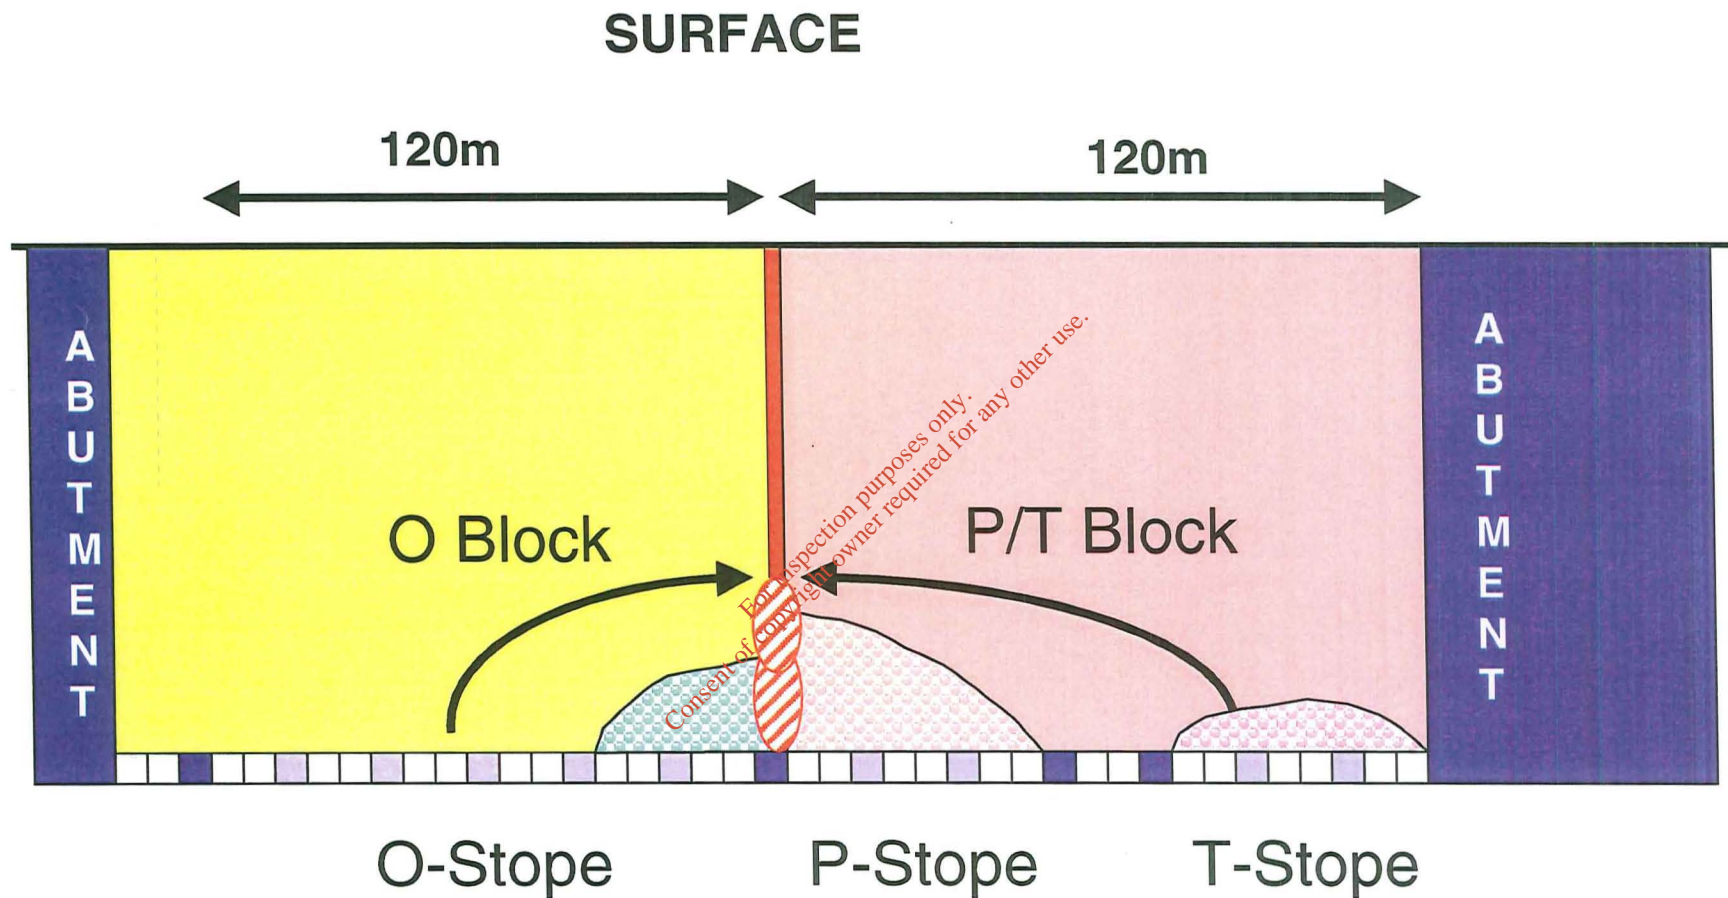
Figure 9. iii) Lateral and vertical extension of initial collapse across whole of P-Stoppe, with stress redistribution to T-Stoppe.

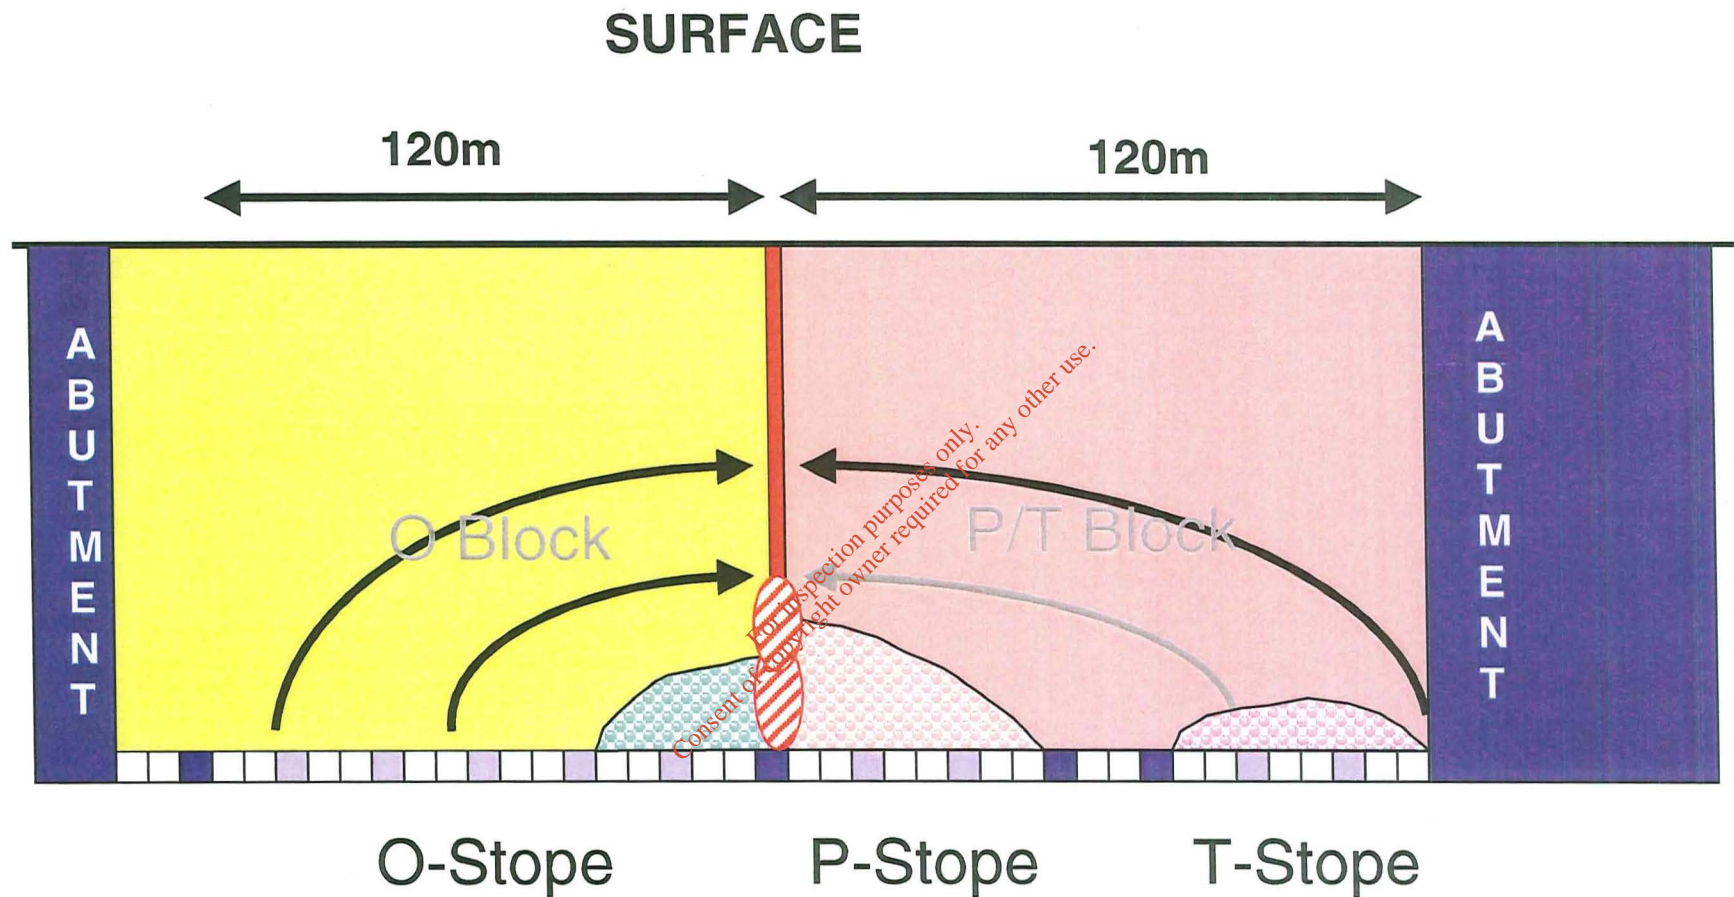
Figure 9. iv) Collapse in T-Stoppe caused by redistributed stresses applied to extremely poor roof conditions.

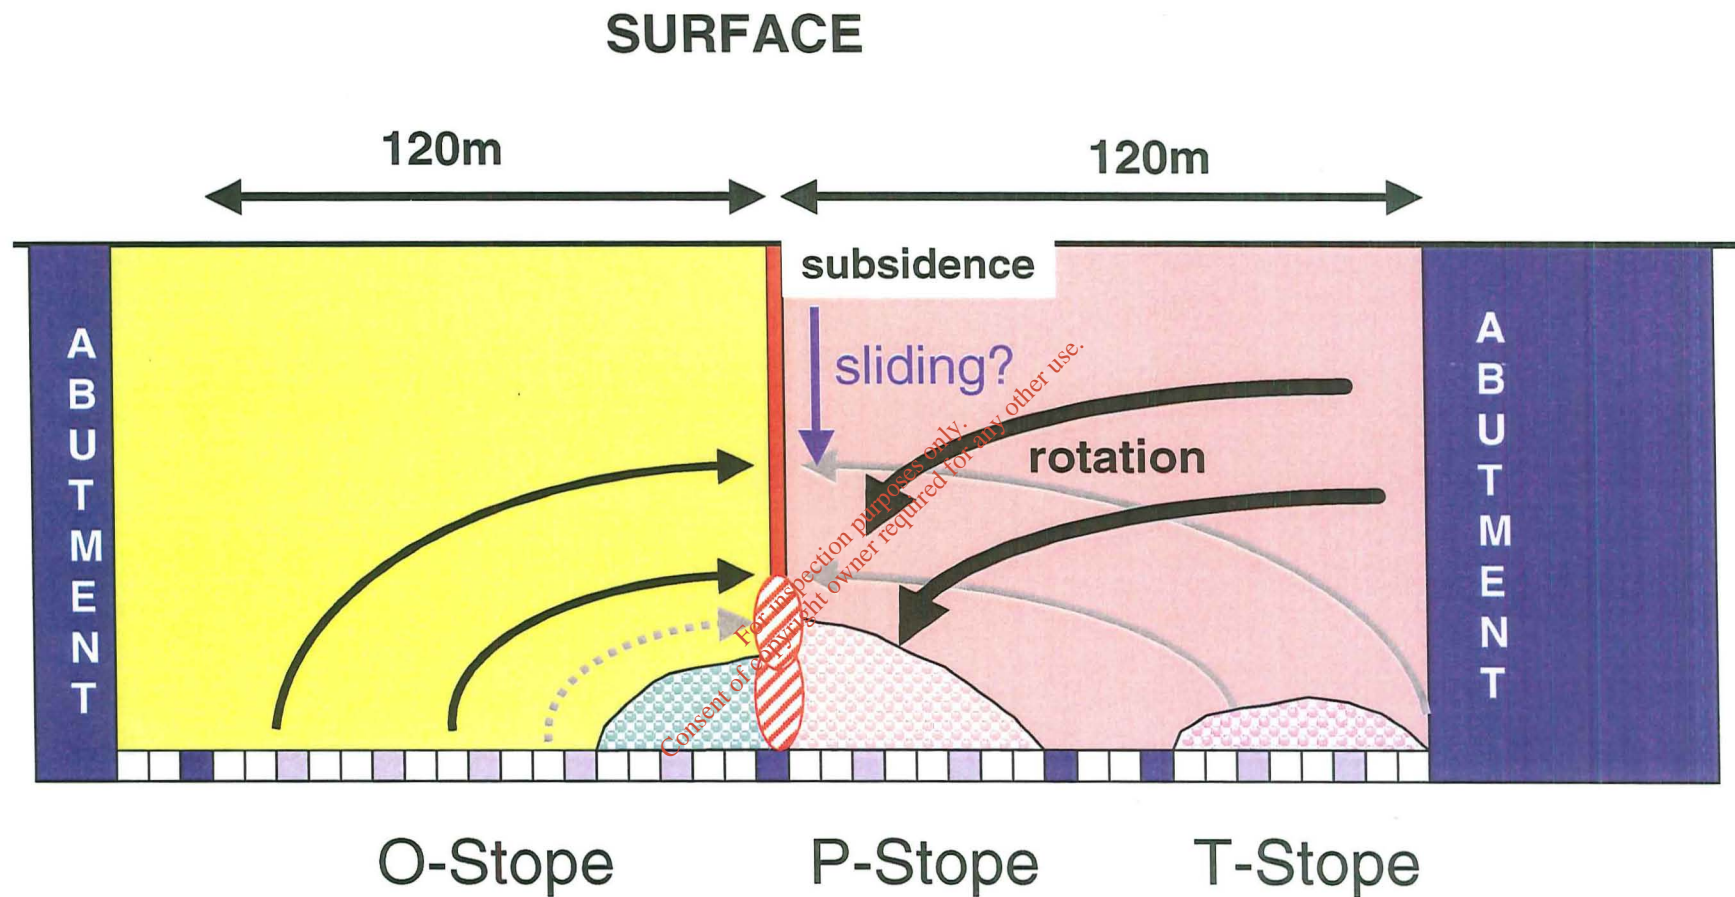
Figure 9. v) Redistribution of stresses to abutment after collapse of T-Stope and arching across to south part of O-Stope.

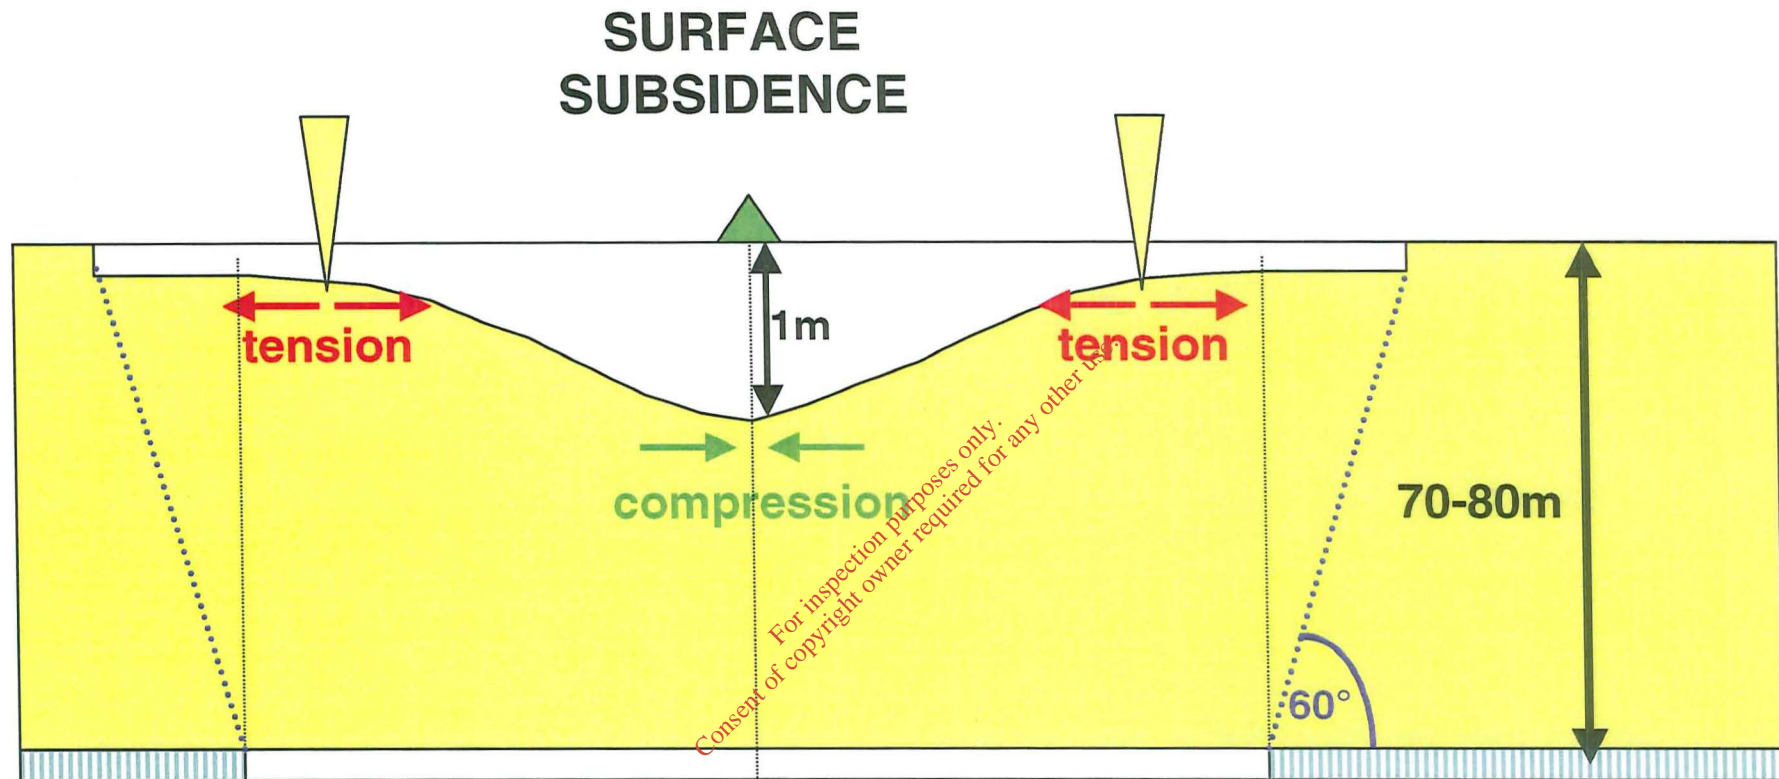
Figure 9. vii) Rotation of P Block causes subsidence on surface at LP127 of 84mm (August 2001) and possibly sliding down the Main Fissure.

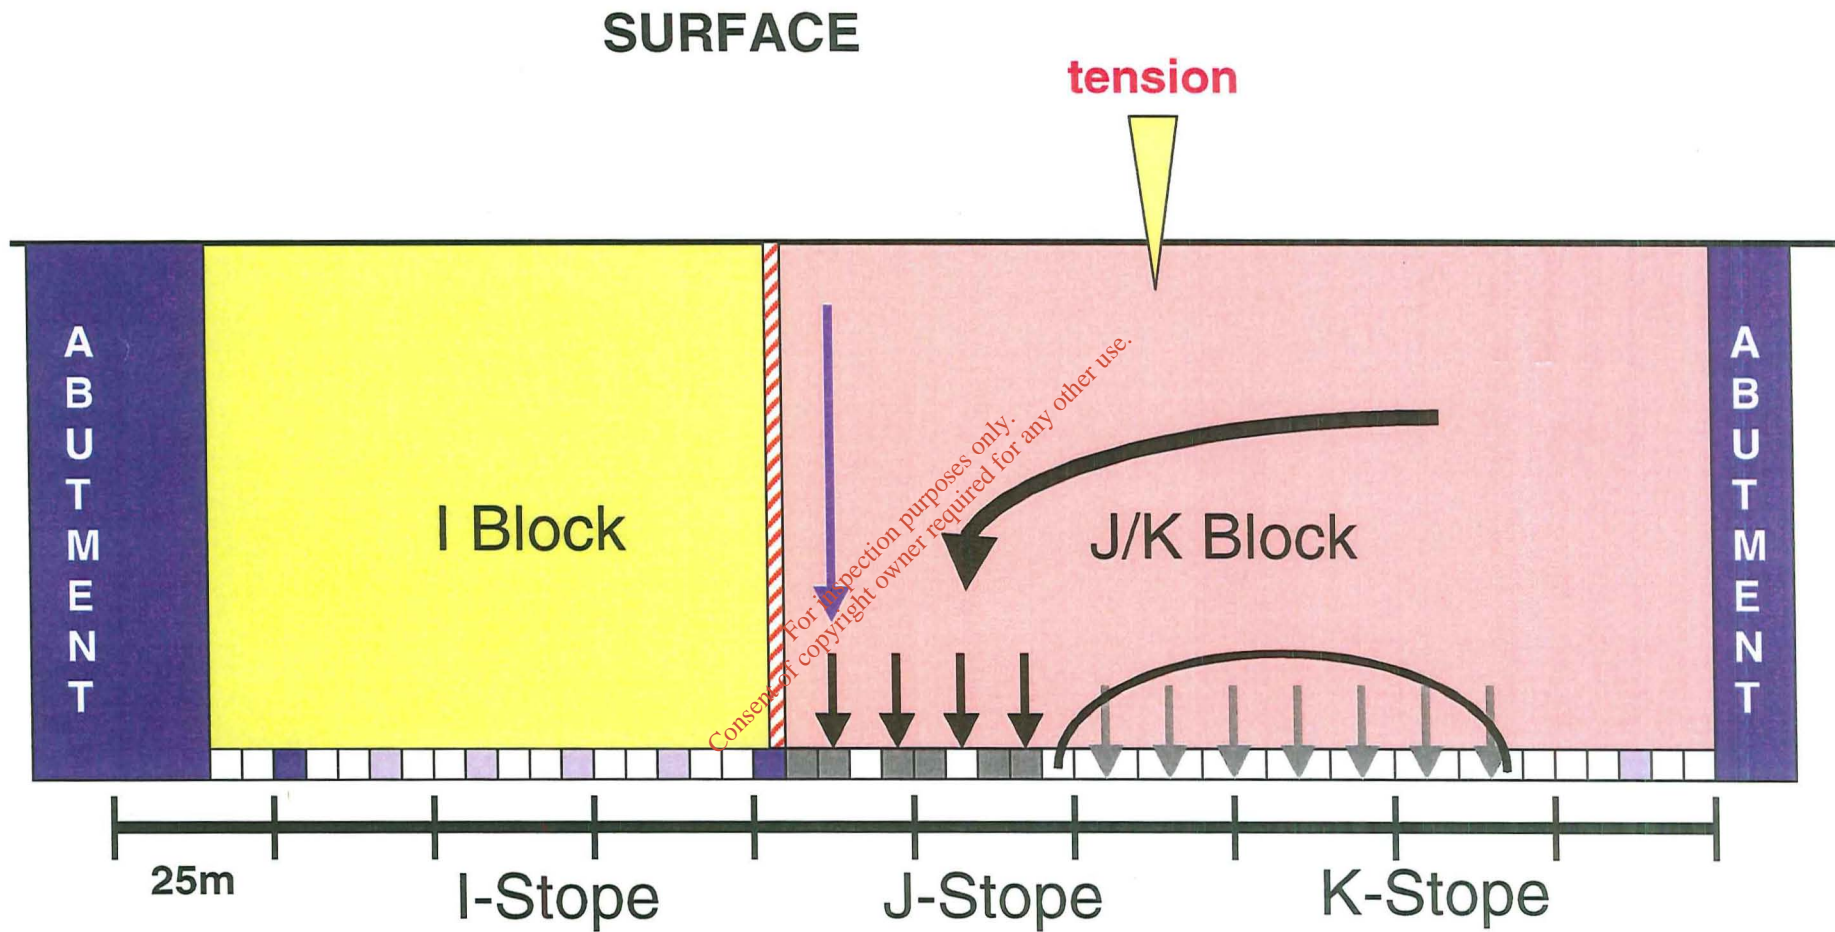
Figure 10. iv) Schematic of I/J/K Stopping area, showing collapse in K-Stoppe and further collapse of J-Stoppe pillars.

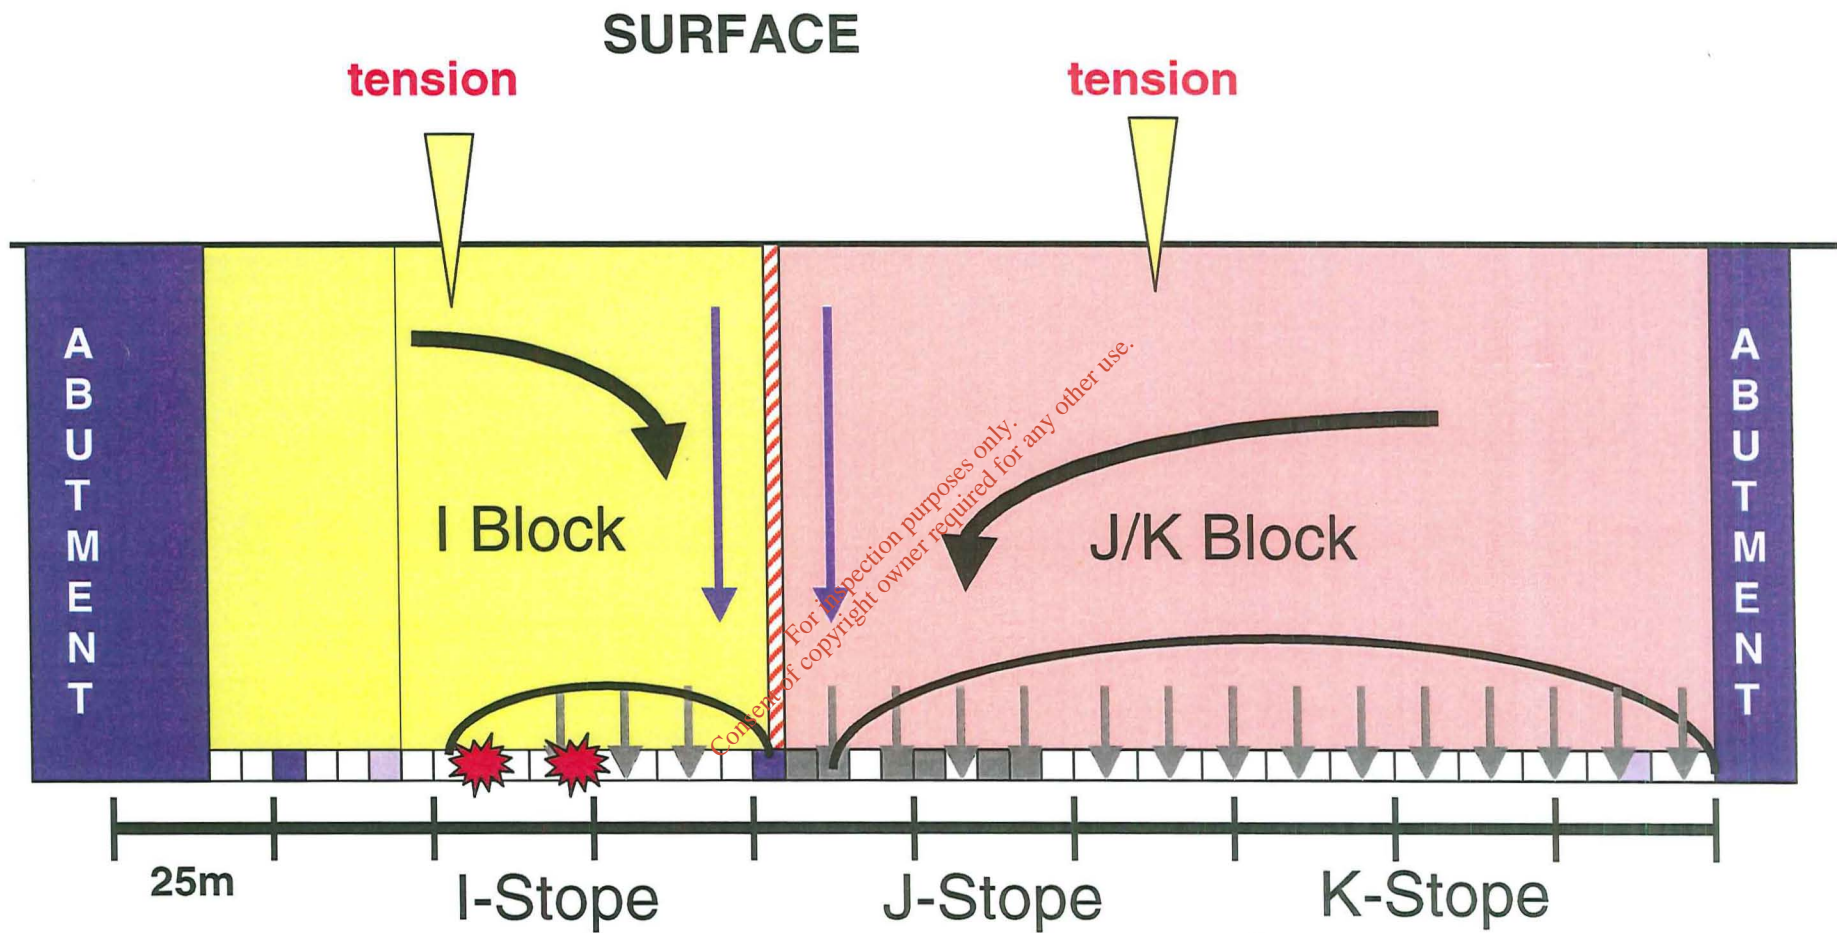
Figure 10. v) Rotation of J/K Block and mobilization of the Main Fissure and tension cracks on surface.

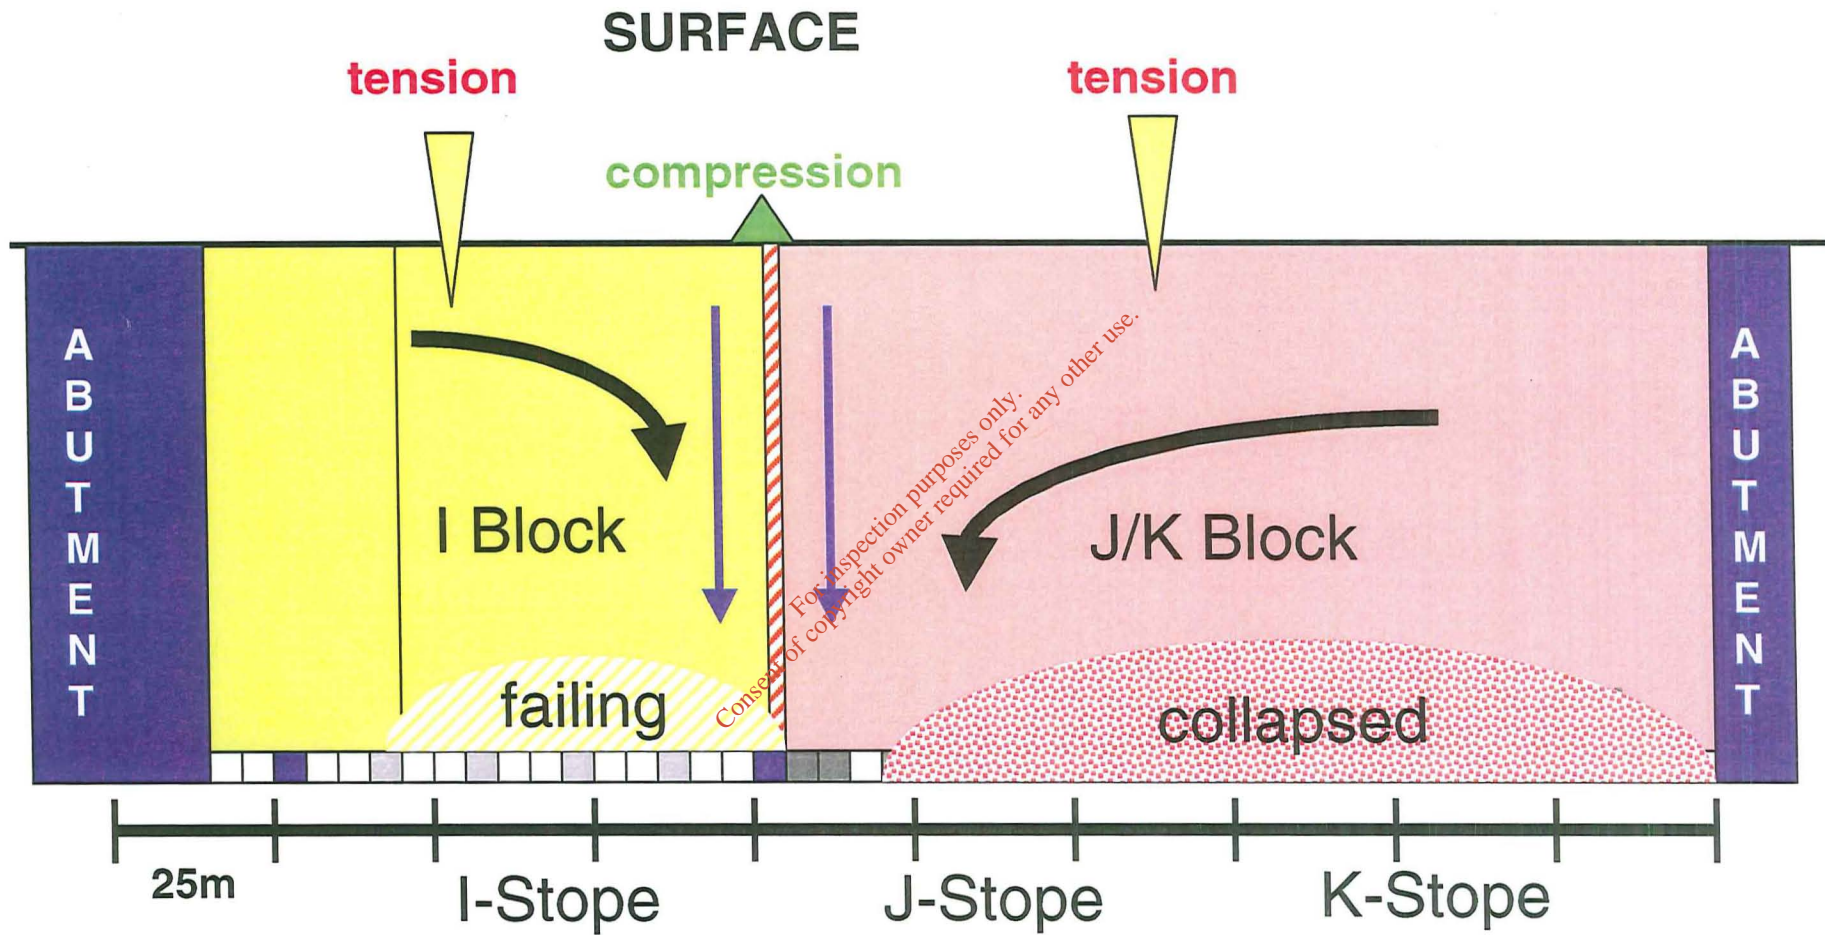
Figure 10. vii) Rotation of I Block results in pillar failure in I-Stoppe and roof falls along G4 Fault.

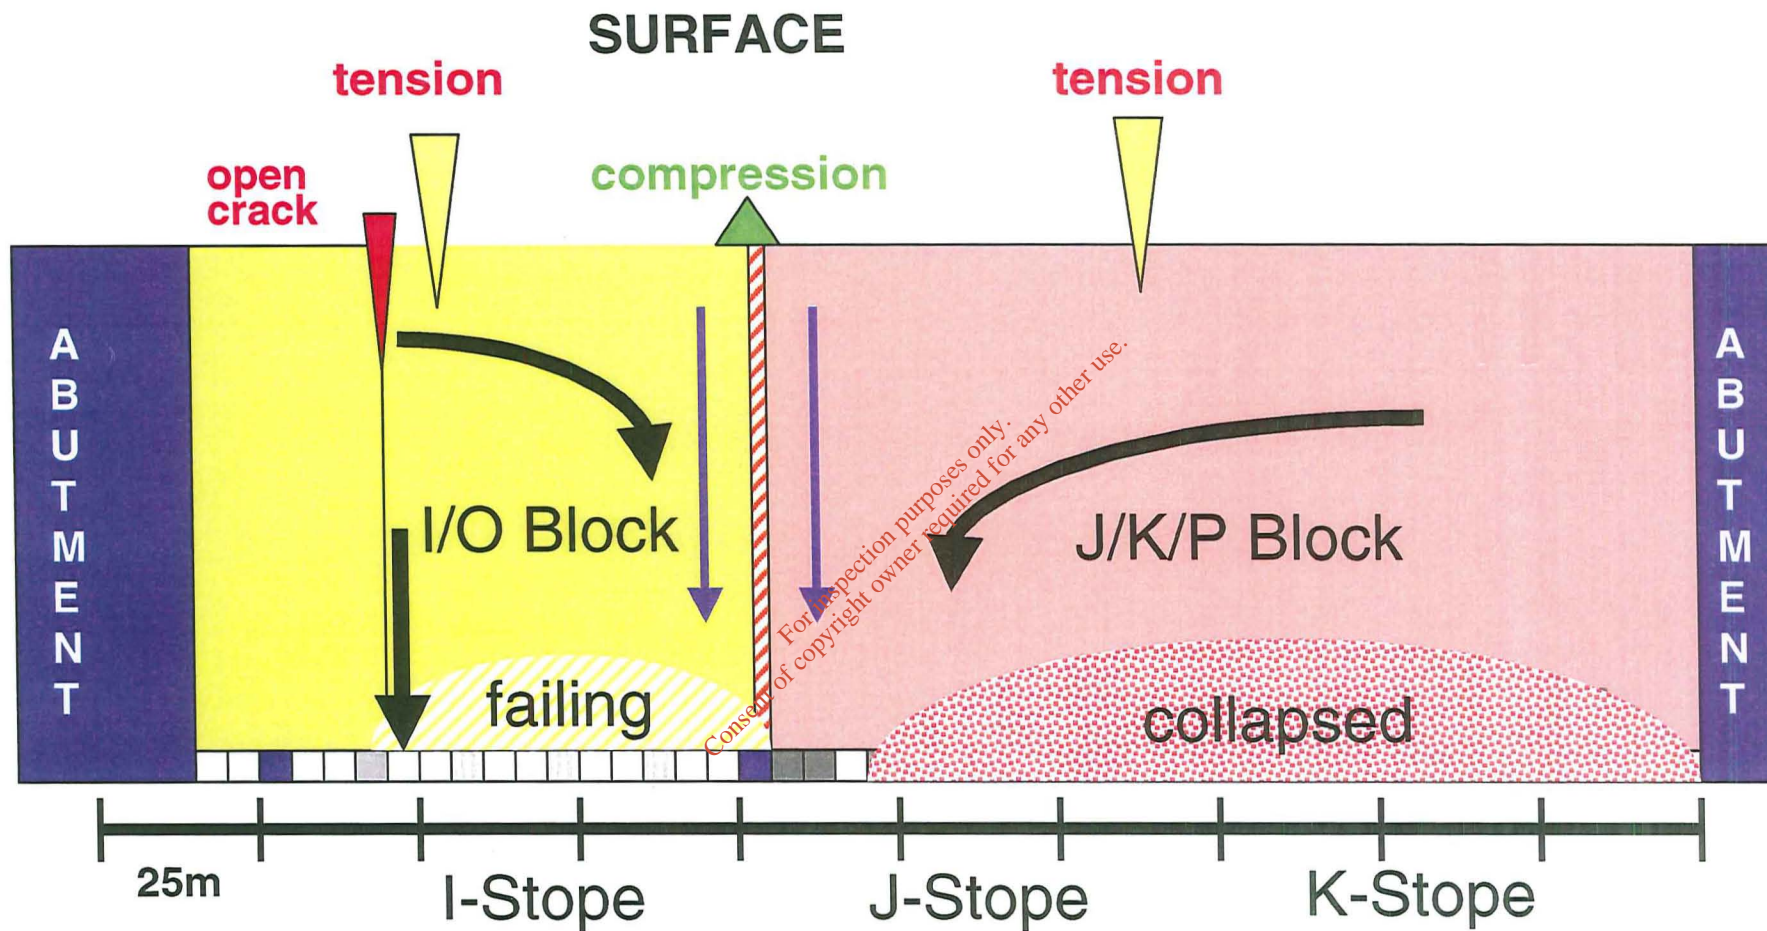
Figure 10.viii) Rotation of I Block and J/K Block causes pressure ridge on surface above Main Fissure.

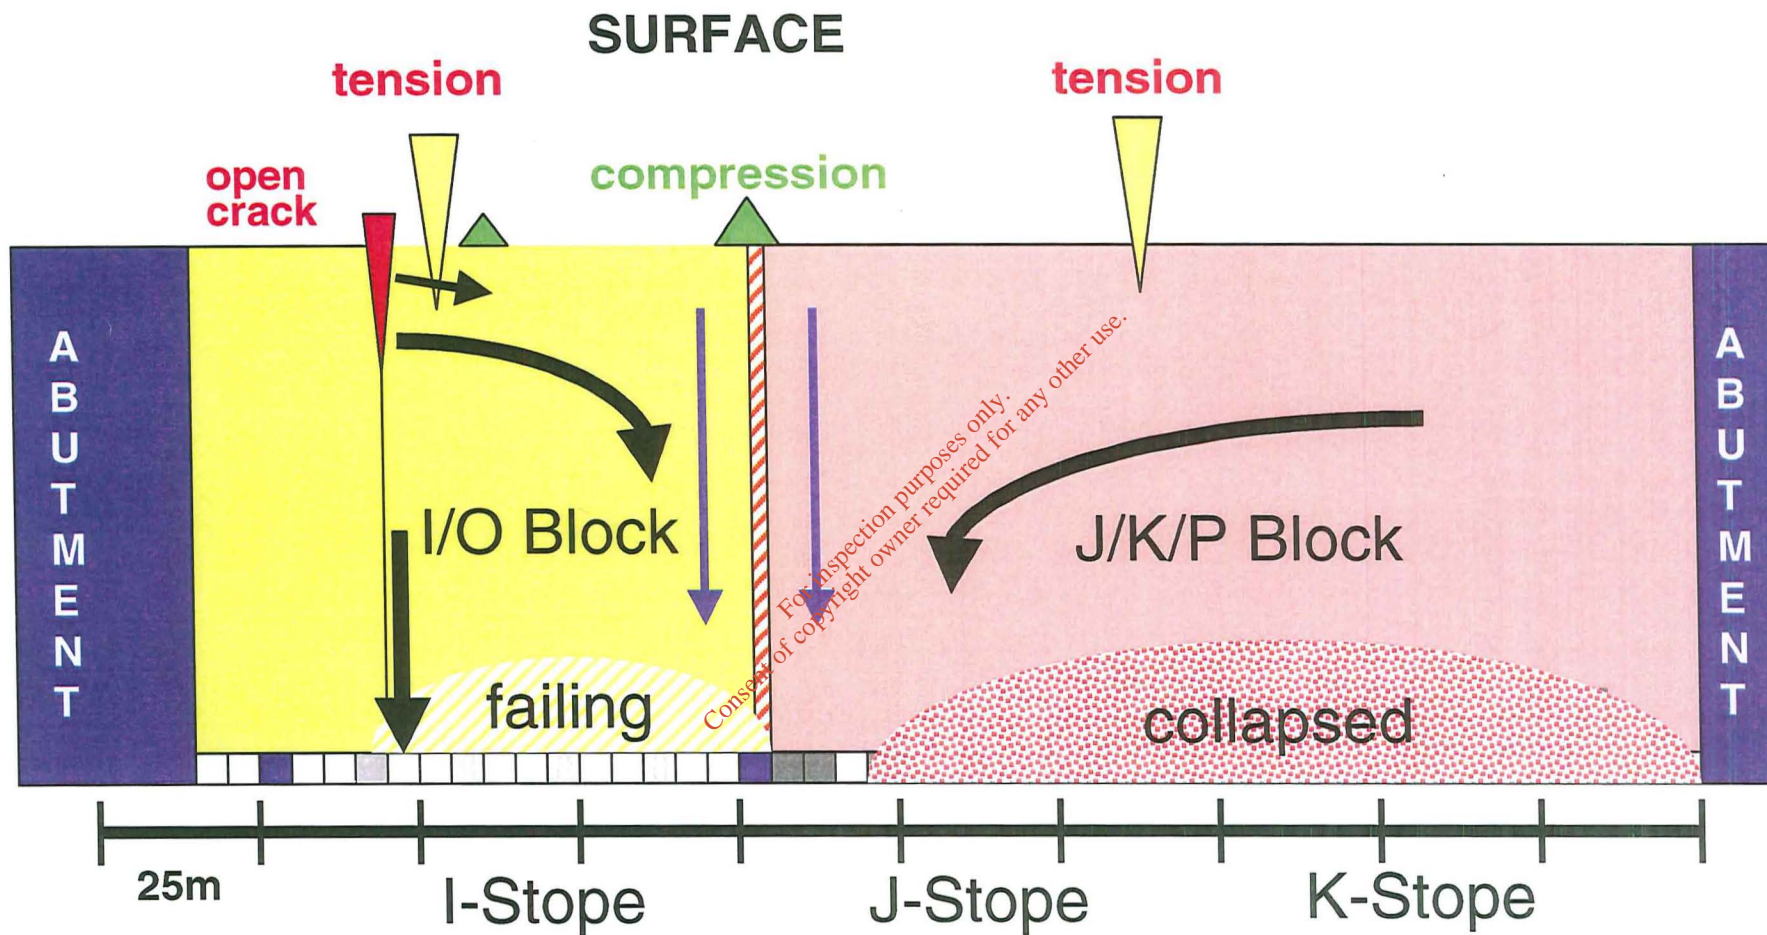
Figure 10. ix) Development of open crack. The J/K/P Block subsides gradually to abutment, but the shorter, stiffer I/O Block cannot and opens a crack along the G4 Fault.

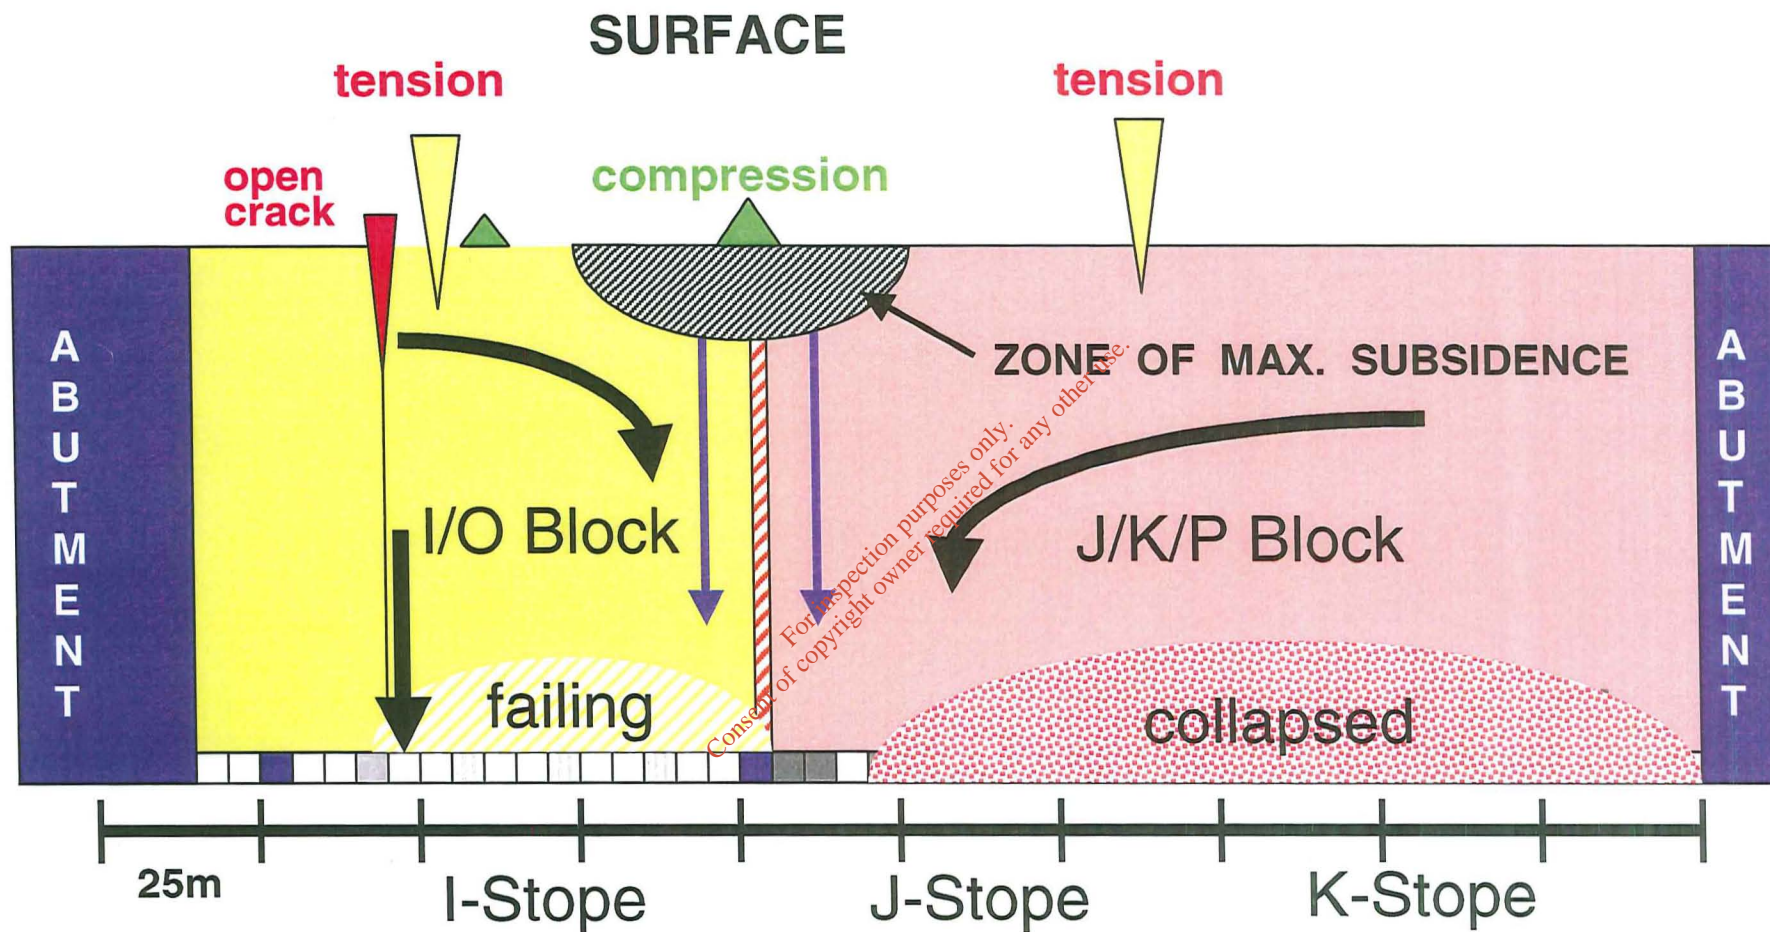
Figure 10. x) As the open crack allows the I/O Block to drop, it re-converges with the other part of the block and causes a small convergence ridge at the top of the hill.

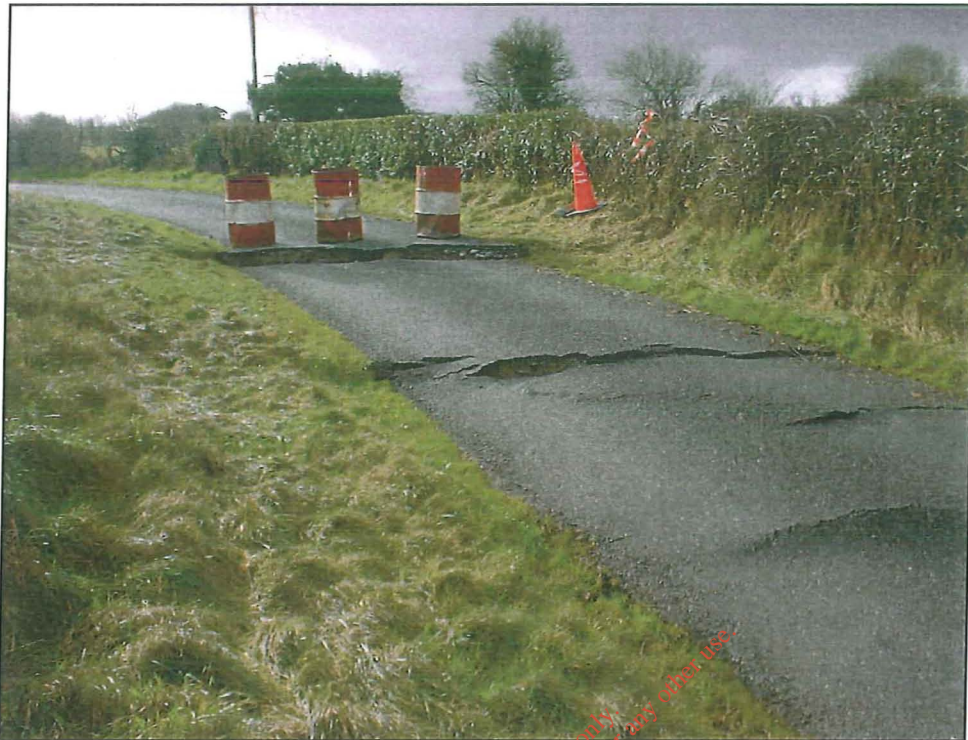
On surface, the subsidence of the J/K-Block and the I-Block resulted in damage to the Whiteswall Road at the top of the hill, including an open crack, tension (en echelon) cracks typical of surface subsidence and a pressure ridge (Photo 1). Unlike the tension cracks, the open crack had significant vertical downward displacement (150-200mm) (Photo 2). At roughly the same time, other tension cracks appeared some 40m north (Photo 3).

By Monday, February 4th, 2002, two pressure ridges also appeared in the road, one close to the top of the hill (Photo 1) and one at the bottom of the hill 23 m to 24 m north of the open crack (Photo 9). The pressure ridges were caused by the tarmac on the road being raised up as the ground underneath it is compressed. The height of each pressure ridge was controlled by the amount of compression taking place. Since it first appeared, the larger pressure ridge at the bottom of the hill continued to develop noticeably, perhaps 150-180 mm. The smaller one appeared to stabilise soon after it first appeared, and remained only 80-100 mm high.

Photo 1. Damage to Whiteswall Road showing the open crack (top), the tension cracks (middle) and the pressure ridge (foreground).
