Golder Associates (UK) Limited

**INVESTIGATION INTO THE CAUSES OF THE
SURFACE SUBSIDENCE
AT GALMOY MINE, CW ORE-BODY,
MARCH 2002**

March, 2002

021-9302 (02511369)

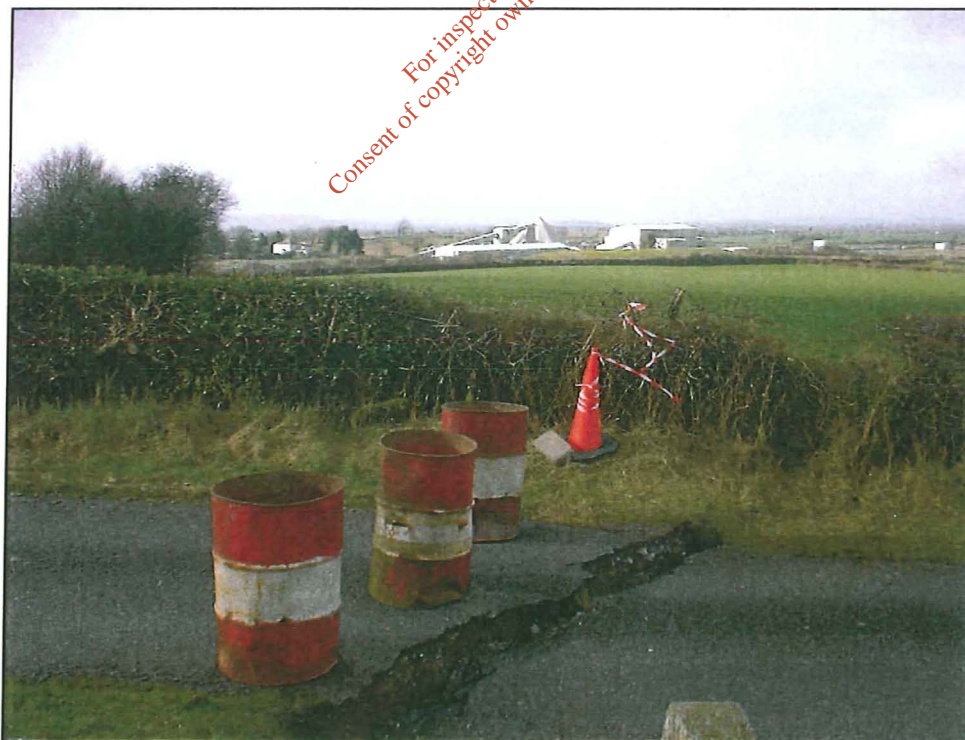
Photo 2. Vertical displacement on the open crack at the top of the hill, with the Galmoy facility in the background.

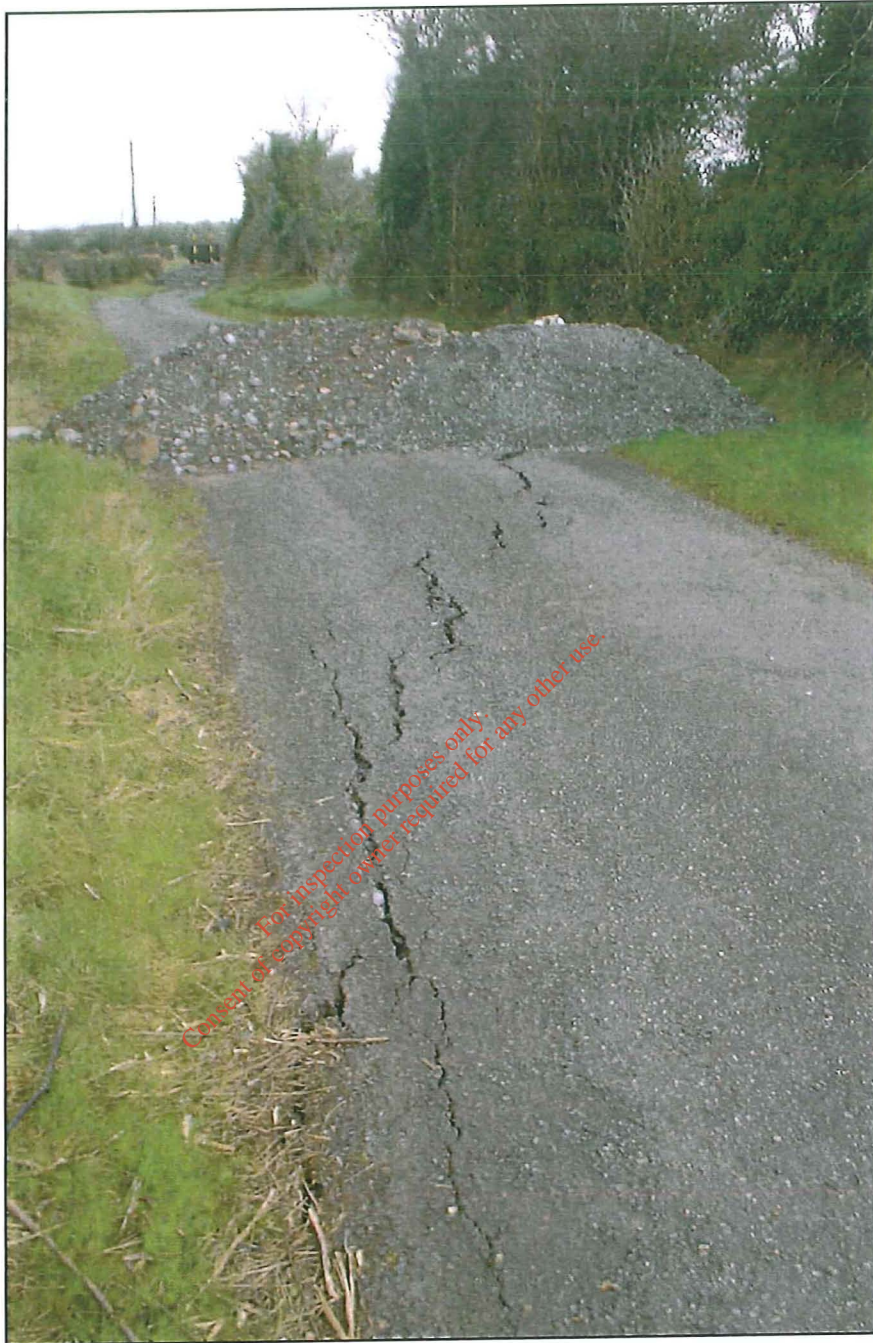
Photo 3. Tension cracks at the north end of the closed section of the road.

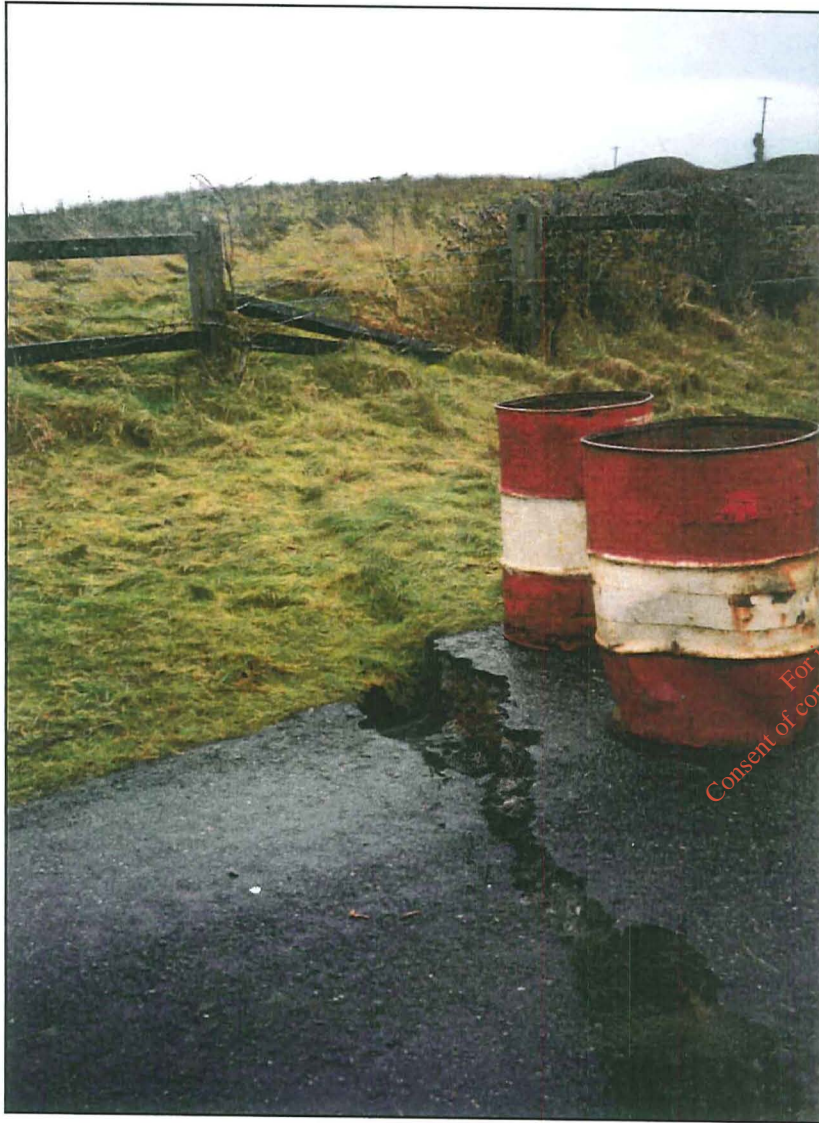
The development of the cracks was first recognised on Wednesday afternoon, January 30th, 2002 and these progressively extended into the fields on either side of the road. The most prominent crack (Photo 4) extended southward into the field to the south-east of the road (Photo 5) towards the access road to the farm building that now serves as a core shack. These cracks indicate that the rock above O-Stope and P-Stope also subsided, but by a smaller amount than the I and J/K Blocks. The open crack also extends northward into the neighbouring field (Photos 6, 7, 8).

Photo 4. The open crack looking southeast.

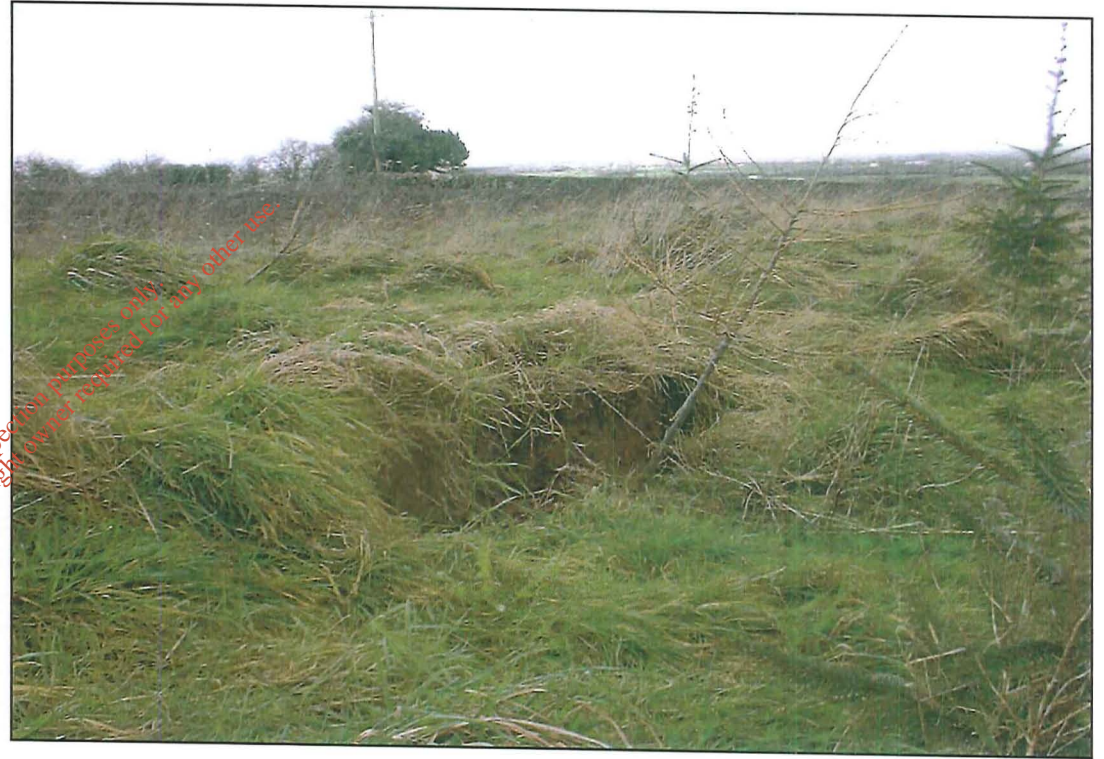
Photo 5. The open crack in the forested field, south-east of the road.

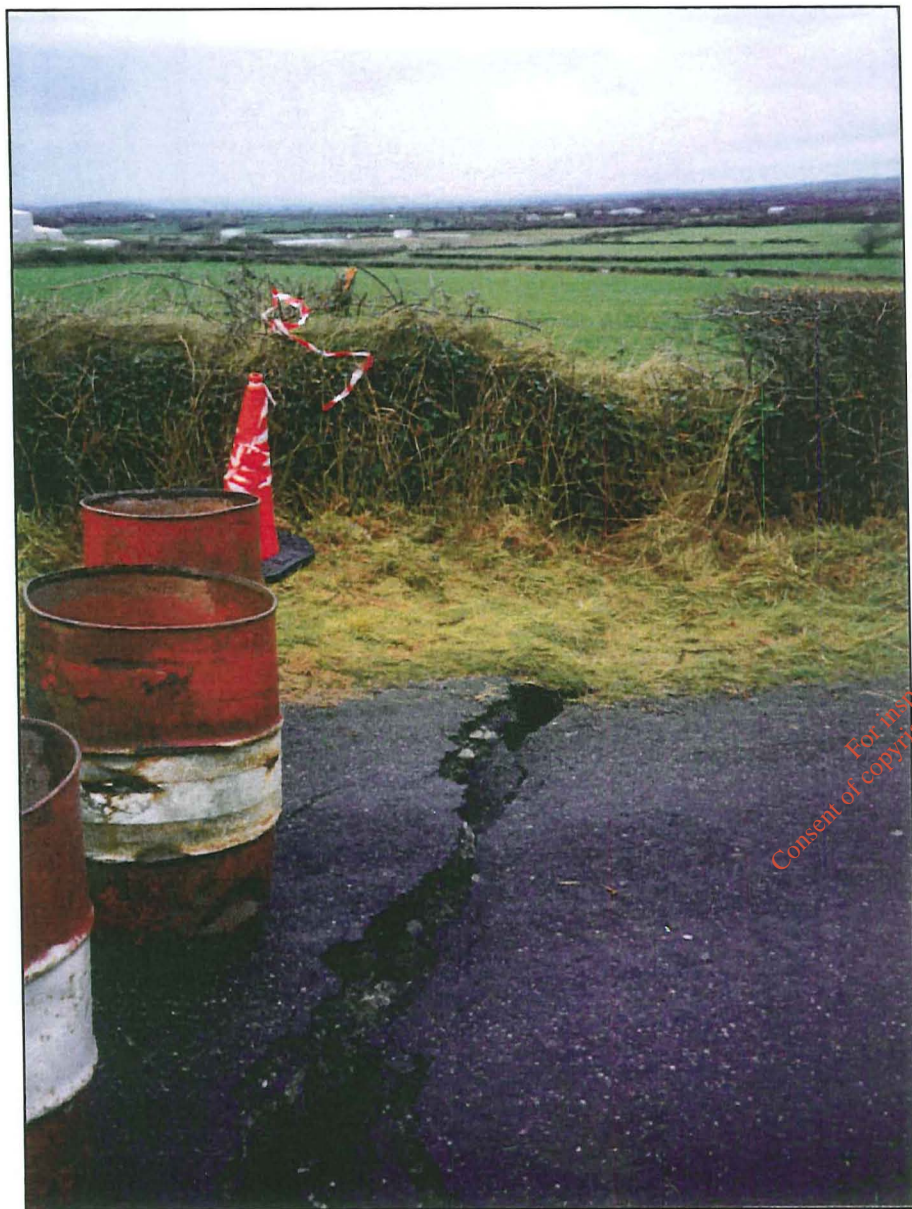
Photo 6. The open crack looking north-west.

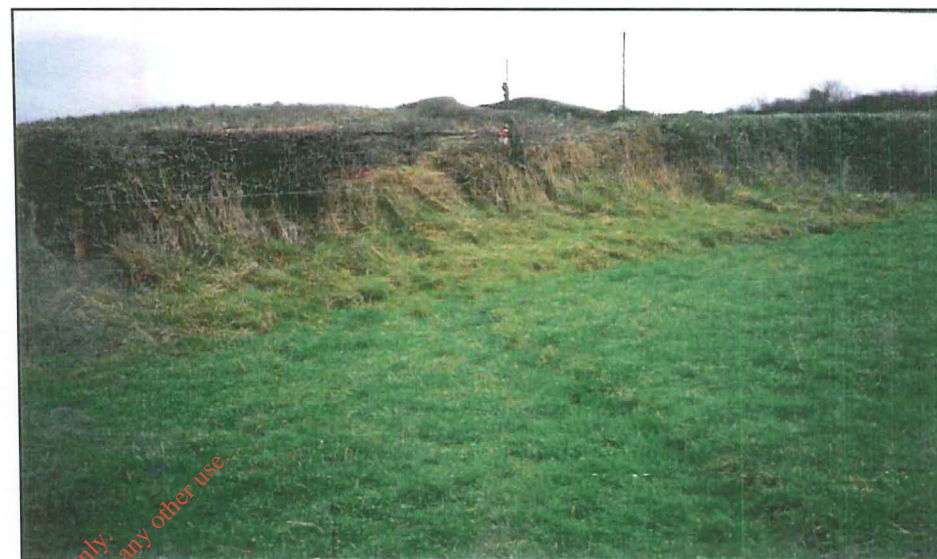
Photo 7. The north-westward extension of the open crack in the adjacent field.

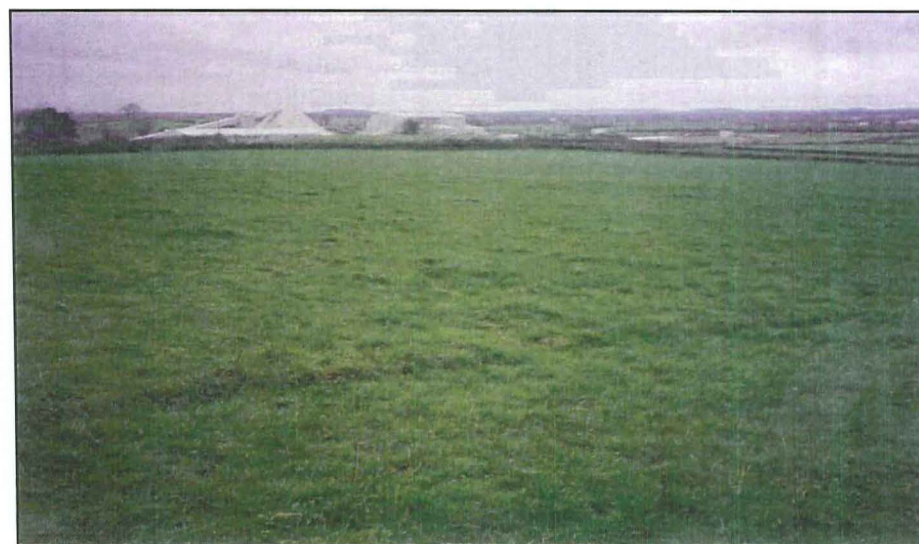
Photo 8. The northern extension of the open crack in the north-west field.

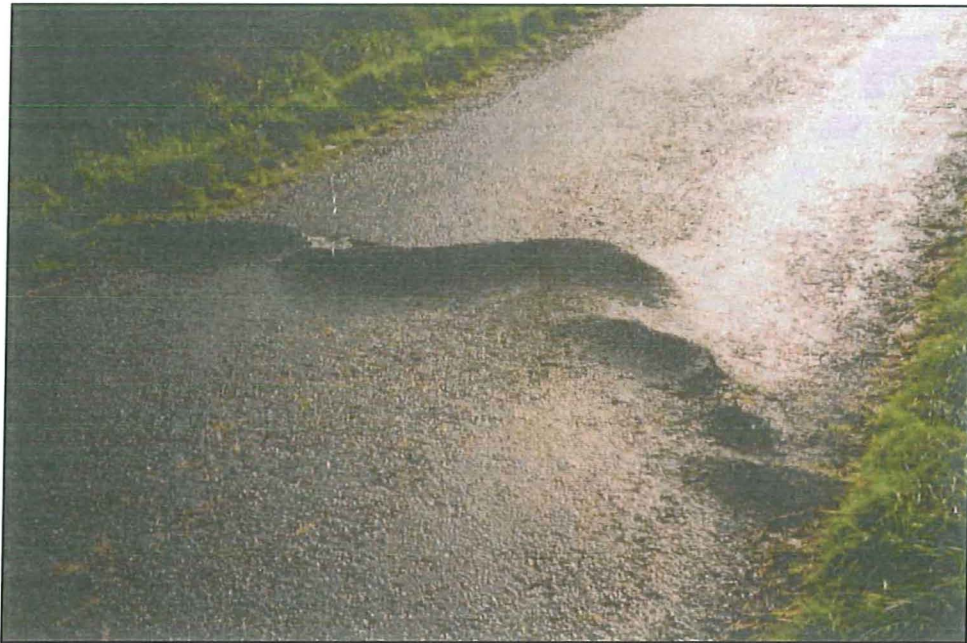
Photo 9. The central pressure ridge at the bottom of the hill, looking south, in early February.

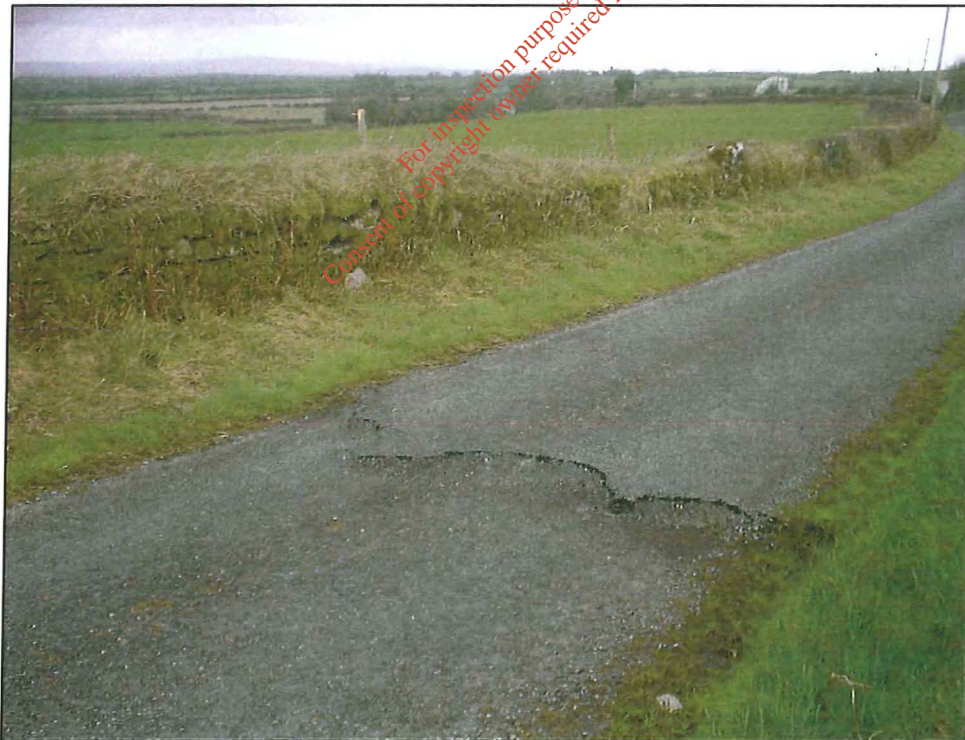
Photo 10. The cracked axis of the central pressure ridge, looking north, in early March.
