GALMOY MINE

Investigation of the Possible Causes of the Sinkhole in the vicinity of the Galmoy Mine Workings and Recommended Remediation

Report Number 14507150031.R01.A0

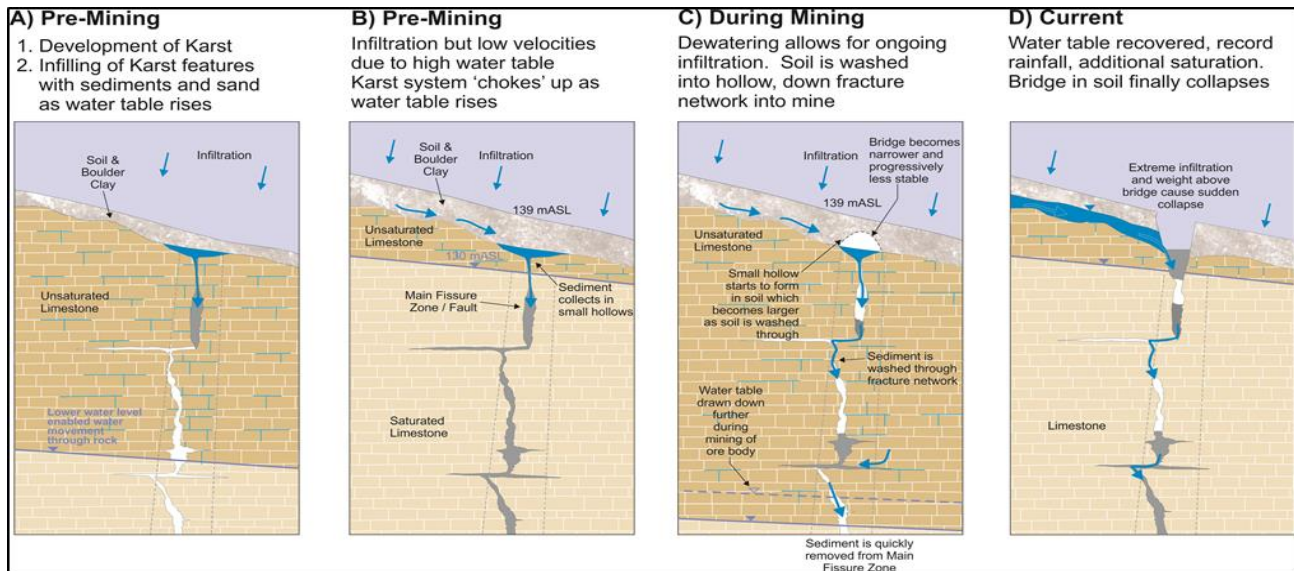
- **A) Development of palaeokarst (65.5 million to 12,000 years ago):** Evidence from mid-Tertiary organic clays in buried sinkholes indicates that there was an active karst at this time and it is considered likely that groundwater was circulating through the Main Fissure. There may have been subsequent periods of active karstification but by 12,000 years ago all the voids in the limestone that had formed in the Tertiary had become clogged with sediment and there was no longer any active groundwater circulation through them;

- **(B) Pre-mining (12,000 to 20 years ago):** During the Holocene there was slow groundwater flow at shallow depth through immature fissures some of which are likely to have been slightly enlarged by dissolution to form channels and conduits. The water-table would have been similar to that which it has recovered to following cessation of dewatering, with very low hydraulic gradients and consequent low groundwater velocities which would have been insufficient to entrain and transport sediment. Hence, no void could have formed in the overburden at this stage;

- **(C) During Mining:** During the mining stage dewatering had the effect of lowering of the water-table and increasing the water velocity giving rise to a greater washout potential. The higher velocity water flows in the Main Fissure accelerated the removal of sediment and water through this route and it is likely that voids formed in the Main Fissure allowing sediment to be moved down from the overburden and development of a void at the base of the overburden; and

Schematic summary of the Main Fissure sinkhole development

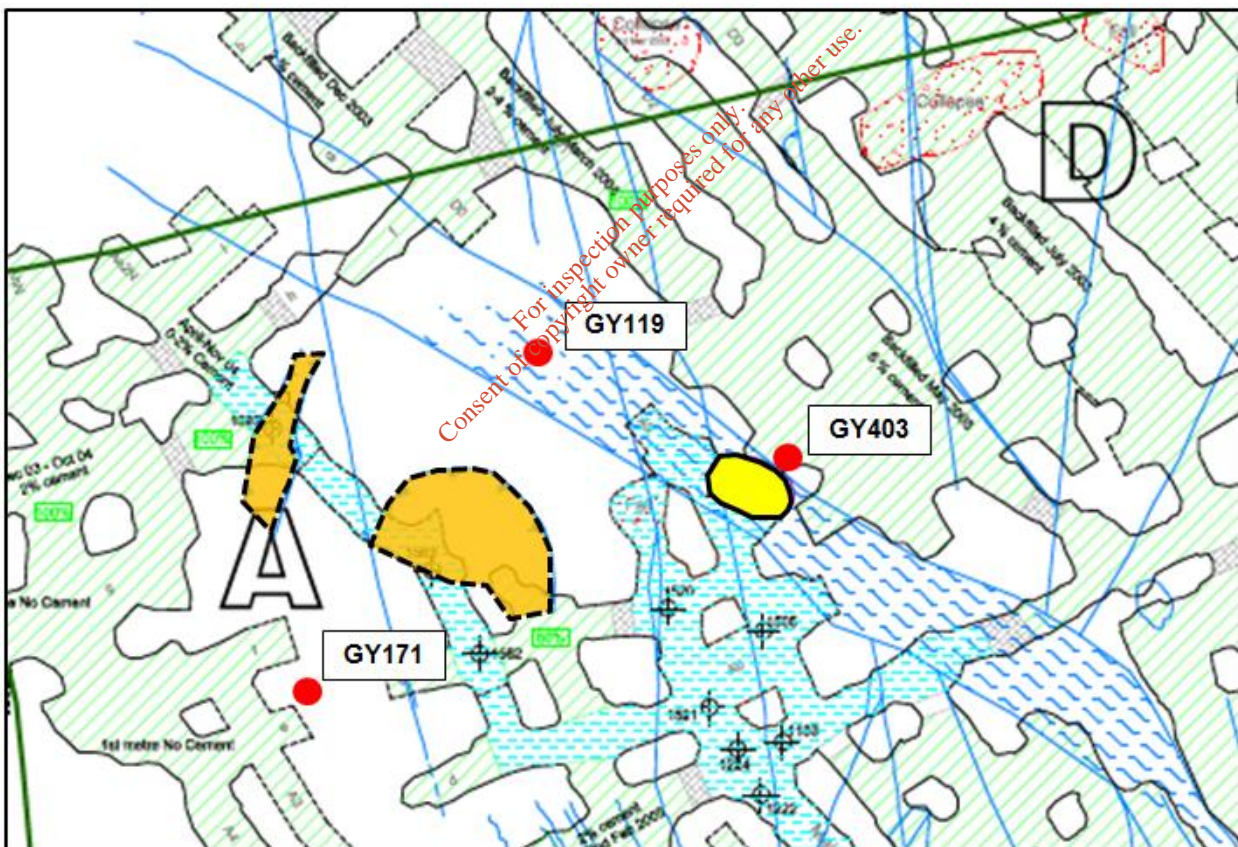
Underground mapping of the CW Orebody identified the development of localised karstification in the vicinity of the sinkhole at the orebody horizon where an area immediately to the west of the Main Fissure was found to be choked with clays and dolomite sands when it was mined into (Figure 9). As this material carried no grade it was not extracted.

Figure 9: Areas of underground karstification and extent of Main Fissure from underground mapping (orange). Also, note locations of GY119, GY171 and GY403 and sinkhole (yellow). Backfilled areas in green open excavation in light blue.

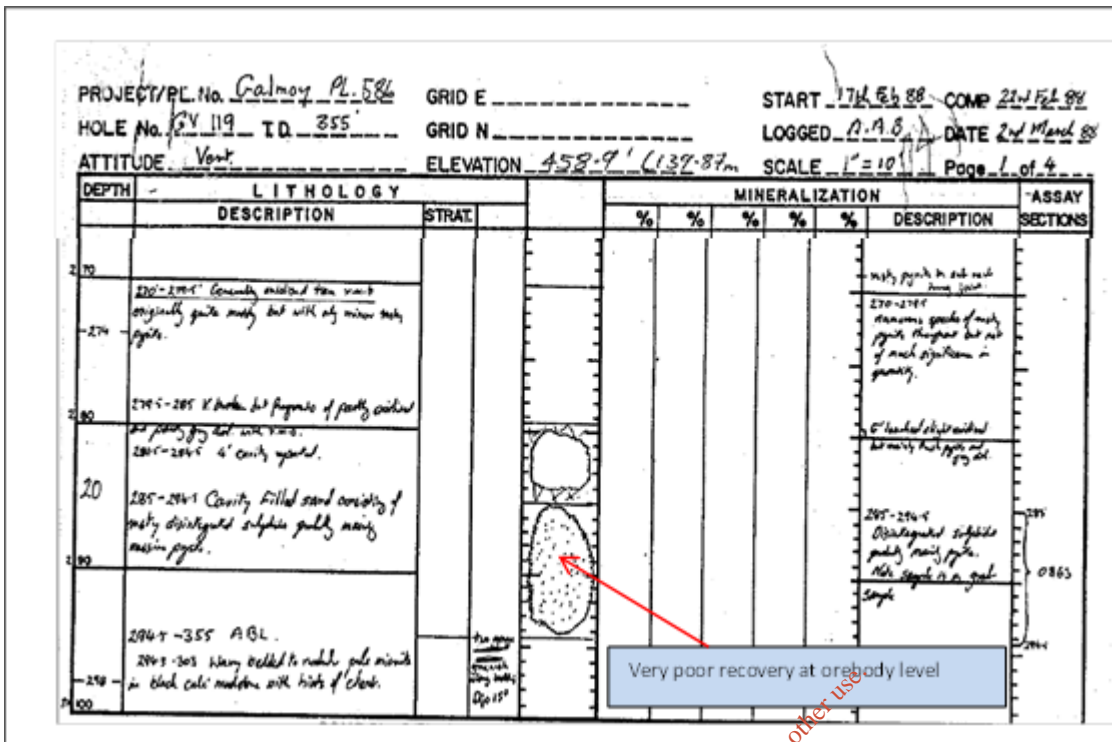
Figure 10: Borehole log for GY119 (drilled on the underground mapped extent of the Main Fissure) showing a zone of very poor recovery at orebody level (note scale on log is in feet)

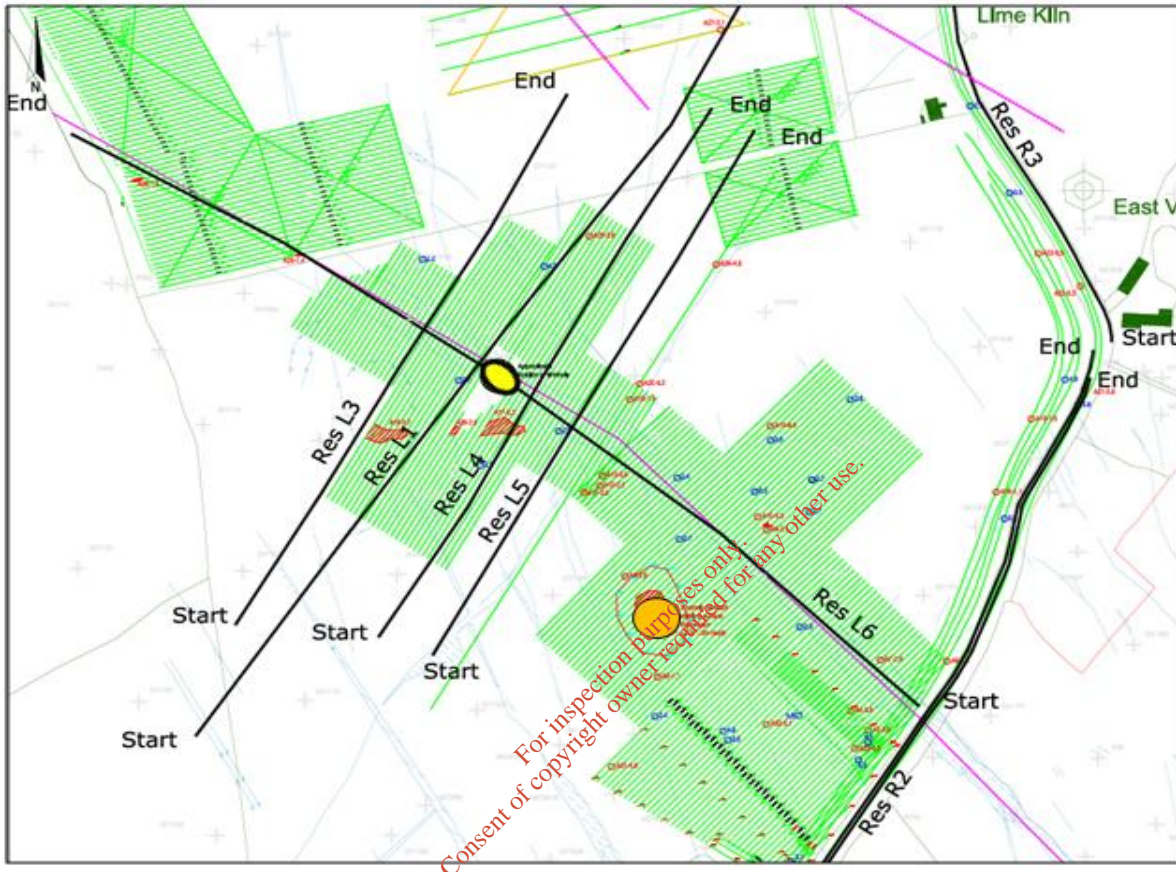
The features identified were divided into two groups; probable (blue) and possible (red) (Figure 17). A detailed explanation of the findings of the GPR survey is given in Appendix B.

Figure 17: Plan showing location of identified GPR features possible (red) and probable (blue), with sinkhole (yellow) and surface depression (orange) south-east of sinkhole

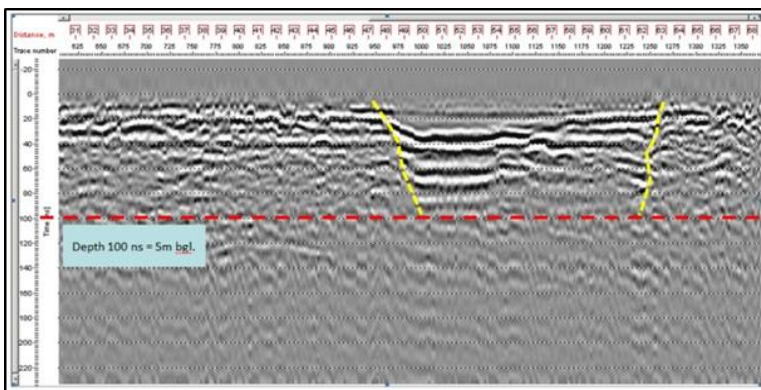
A surface depression to the south-east of the sinkhole was identified at the time of the GPR survey (it occurs on the original OSI 6" sheet from ca. 1850). This feature was surveyed with the GPR and shows reflections consistent with previous subsidence and infilling (interpreted as an old suffosion sinkhole adjacent to the Main Fissure) (Figure 18).

Figure 18: GPR profile across surface depression showing evidence of previous subsidence that has subsequently been naturally filled by material washing into it (see Figure 17 for location).

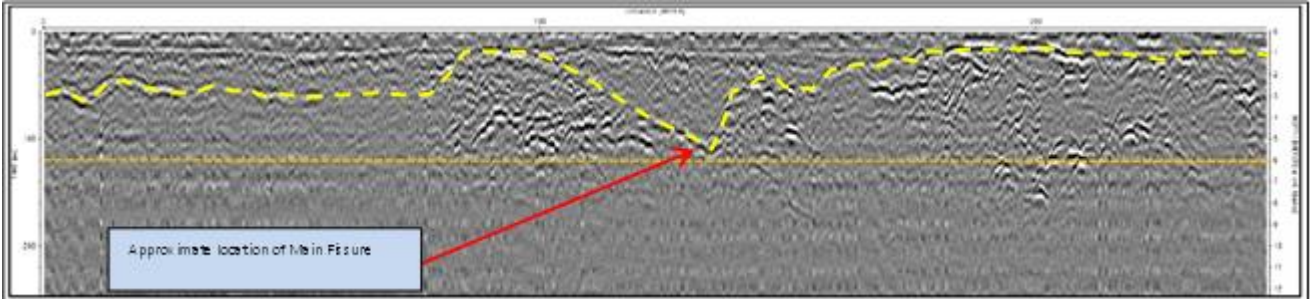
Profiles trending SW-NE at 90° to the Main Fissure (Figure 19) show thickening of the overburden in the vicinity of the Main Fissure. Deep point reflectors, indicative of cavities within the heavily weathered bedrock are especially evident along the north-eastern part of the profile in Figure 19). These may be reflecting karstification of the upper part of the bedrock.

Figure 19: GPR profile running SW-NE (looking north-west) at 90° to the Main Fissure (red arrow), showing increase in overburden thickness in the vicinity of the Main Fissure (dashed yellow line). Also evident are point reflections on either side of the Main Fissure

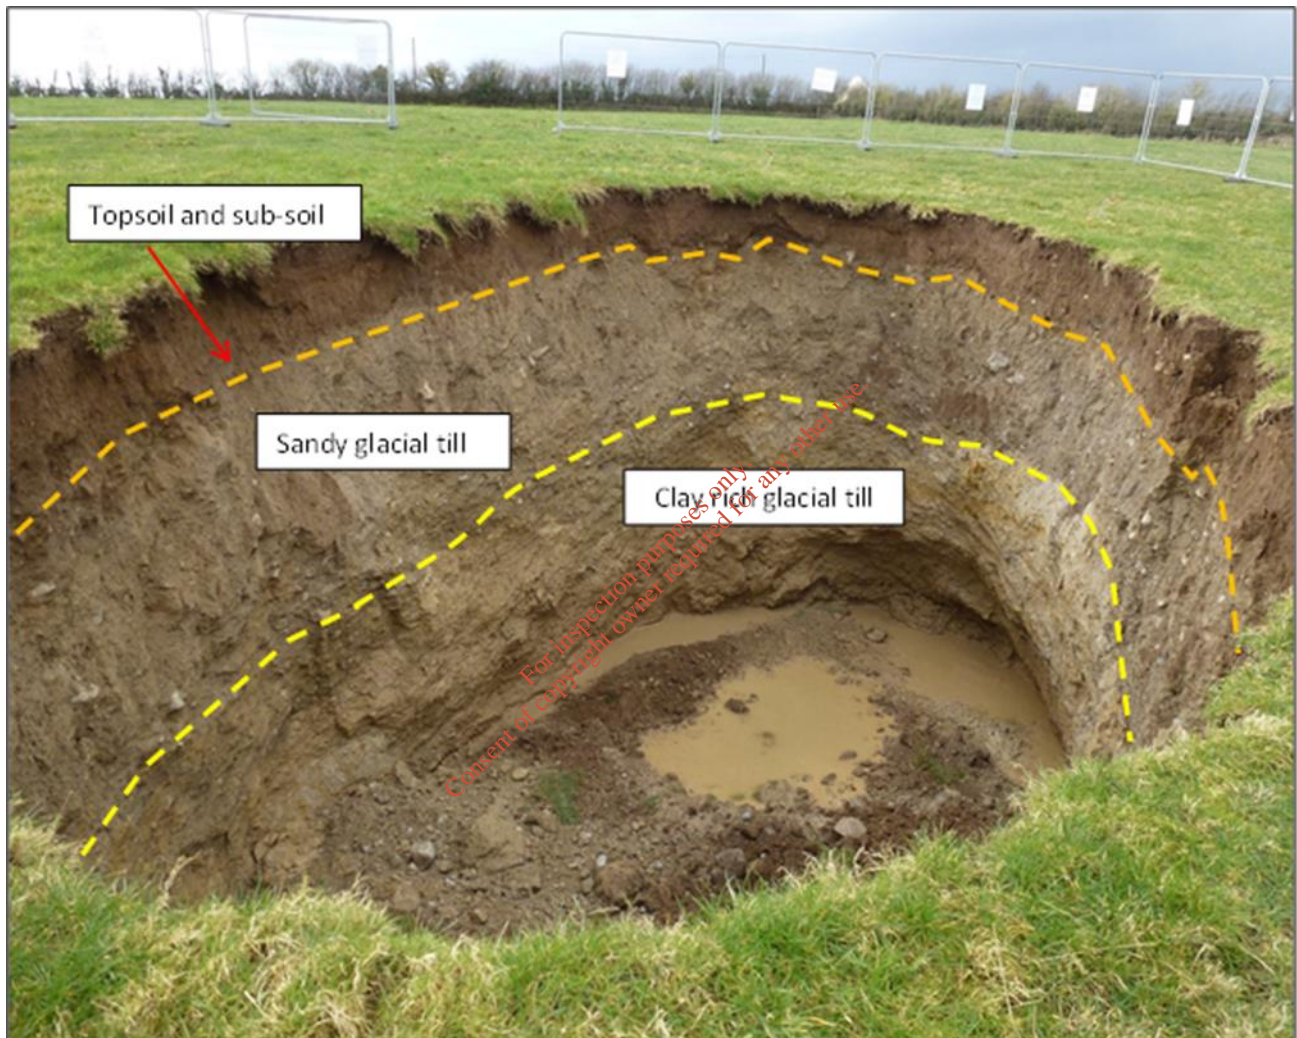
Overburden in the vicinity of the sinkhole is approximately 6 – 7 m in thickness and is typically comprised of topsoil (ca. 0.2 m), over sub-soil (ca. 0.6 m in thickness), over ca 2.5 – 3 m of sandy glacial till, over a more clay rich, cohesive glacial till (ca.2.5 – 3 m). Figure 28 shows overburden as exposed in the sinkhole.

Figure 28: Typical overburden sequence as exposed in the sinkhole

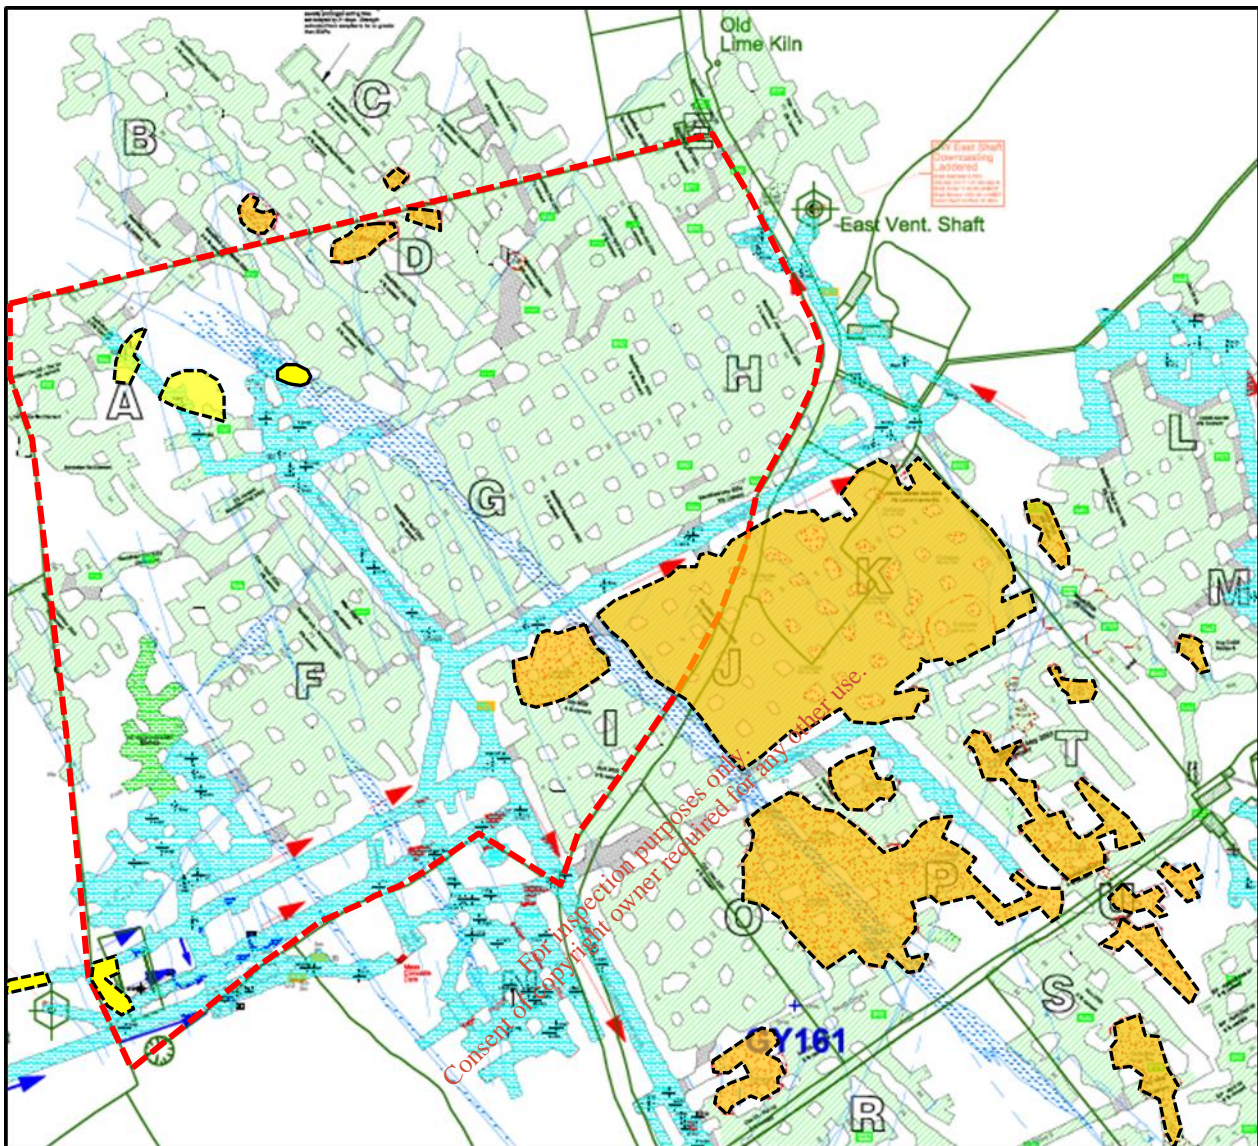
In 2002, a series of roof collapses and pillar failures occurred in the CW Orebody resulting in a complete collapse of J and K Stopes, followed by major instabilities in some adjoining stopes to the south. The collapse undermined the rockmass above the stopes and caused it to subside, resulting in surface damage with a crack opening up in the public roadway overhead and several smaller tension cracks developing. The bitumen road pavement was 'heaved' into a ridge in two places, forming a pressure ridge. It is notable that no sinkholes formed following the underground collapse.

Figure 30: Plan of CW Orebody showing main structural features mapped at orebody elevation with Main Fissure, areas of significant 'run-of-ground' associated with fissures/fractures and main palaeokarst features (in yellow) intersected by mining. Failed stope areas from 2002 collapse are shown in orange, with backfilled areas in green (areas in pale blue are not backfilled). Land holding in red dashed line.

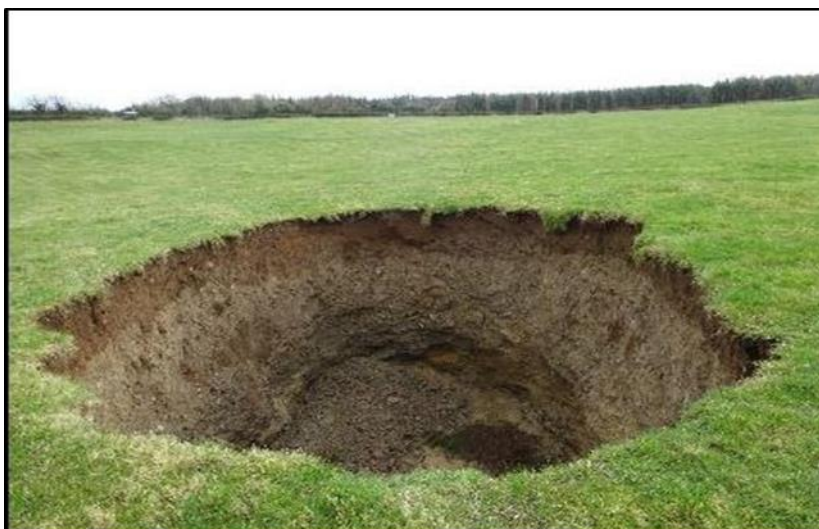
The size and morphology of the sinkhole above the Main Fissure (Figure 31) displays dropout sinkhole characteristics including steep sides in cohesive soils with collapsed soil in the base of the hole. The morphology is not suggestive of any bedrock collapse and it appears to be developed entirely within the glacial till.

Figure 31: Main Fissure sinkhole approximately 13 m (long) x 8 m (wide) x 7 m (deep)

A simple bridging mechanism, over the throats between the limestone pinnacles, is proposed for the remedy of the sinkhole; the lower section comprises a permeable rip rap and ballast plug encapsulated in a geotextile. The upper section of repair entails compacted layers of rock fill/glacial till and a final capping layer of appropriate subsoil and topsoil to rehabilitate the agricultural surface.

A permeable plug is recommended to conserve the drainage pathway and to help alleviate the formation of further sinkholes in the vicinity. The repair of the sinkhole is recommended to commence without excessive delay to alleviate the risk of collapse of the sides of the sinkhole.

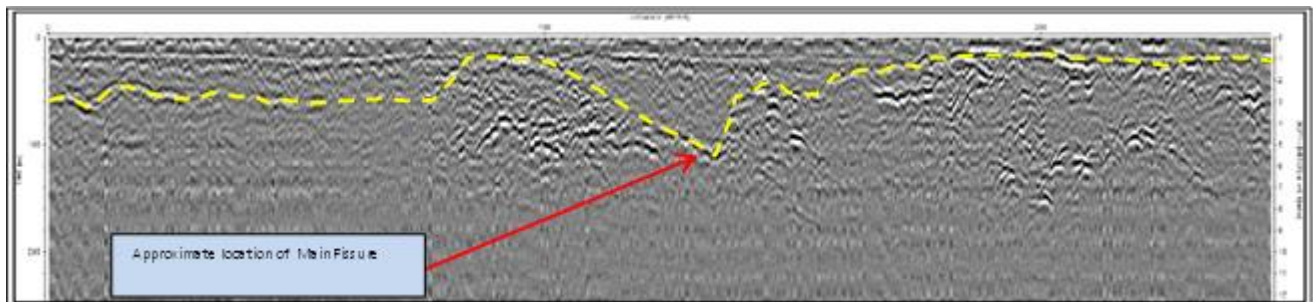
Figure 32: GPR section along the Main Fissure from SW to NE (looking northwest) in the vicinity of the sinkhole showing the presence of a bedrock valley feature associated with the location of the sinkhole.

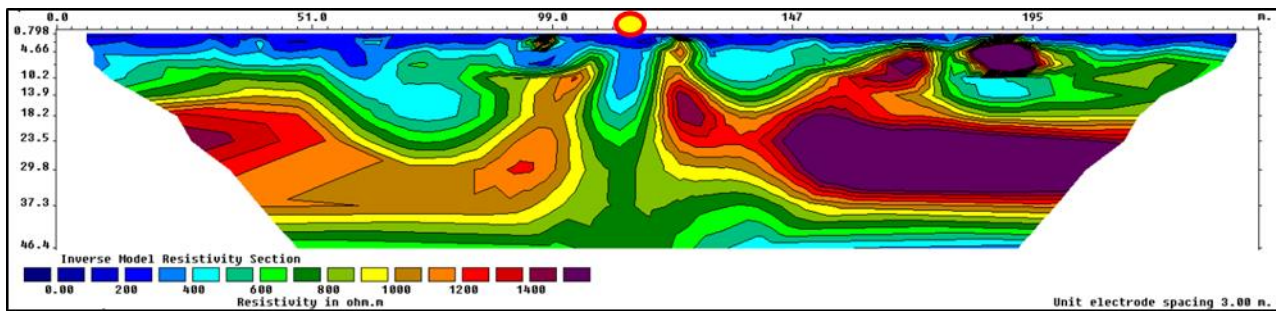
Figure 33: ERI imaging section across the Main Fissure (yellow dot) in the vicinity of the sinkhole, looking northwest

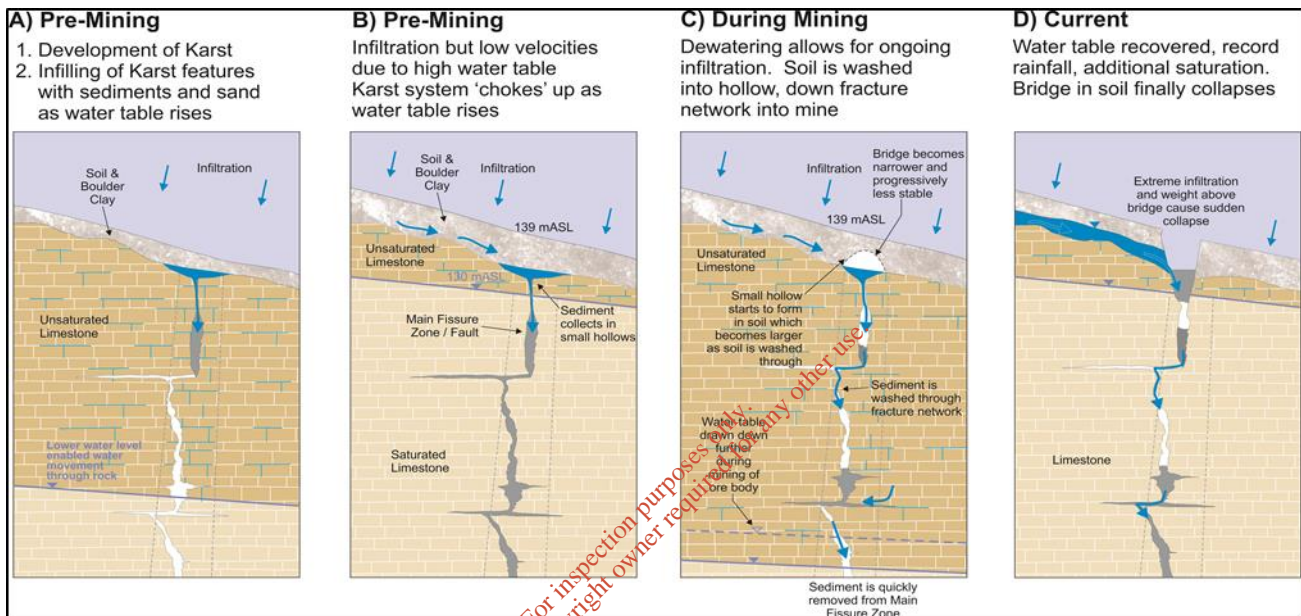
Figure 39: Schematic showing summary of proposed Main Fissure Sinkhole development

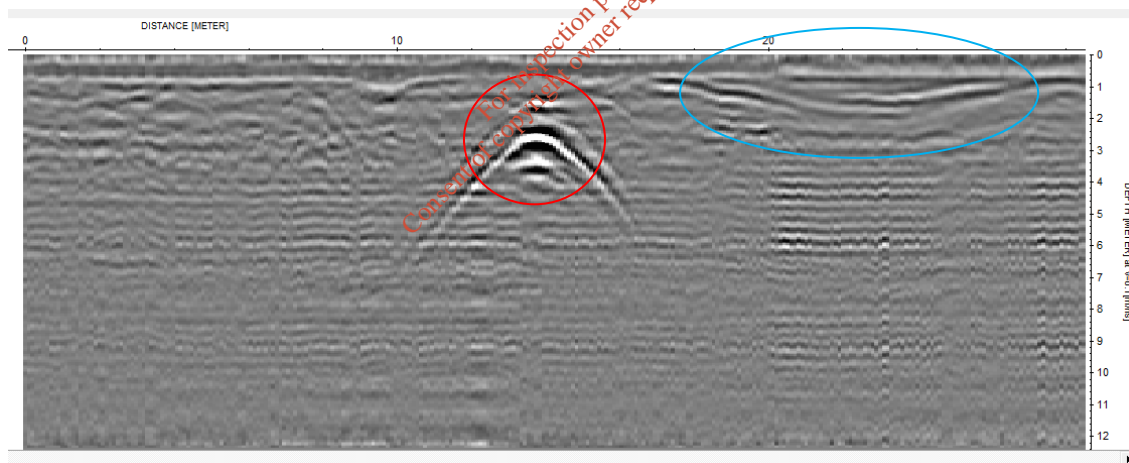
Fig. 3.3 Reflection from buried 400mm diameter pipe in northern field. Record 560 crossing pipe at 13.9m, 1.4m deep. Also noted infilled surface depression (blue) between 17.0-28.0m, possibly related to construction.

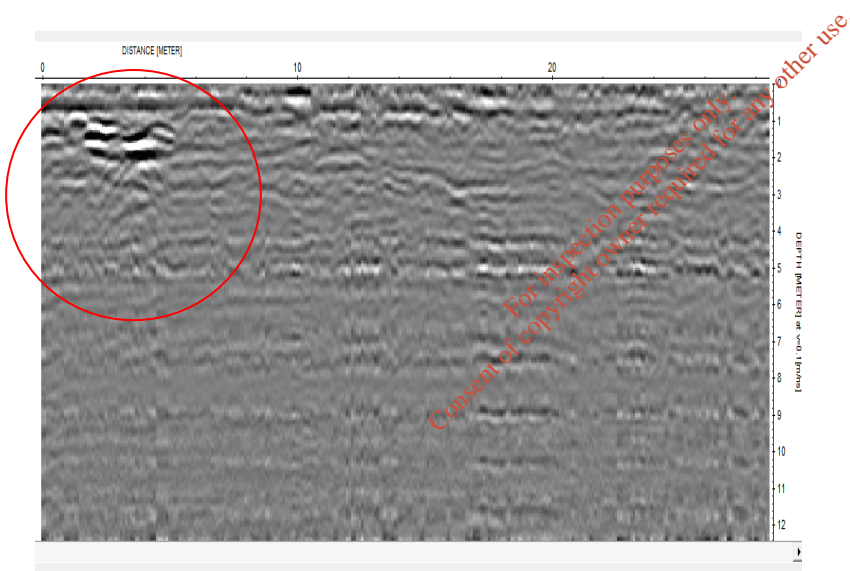
Anomaly A29. Record 441 showing flat reflector between 1.6-4.2m at depth of 1.4m. Located over Main Fissure.

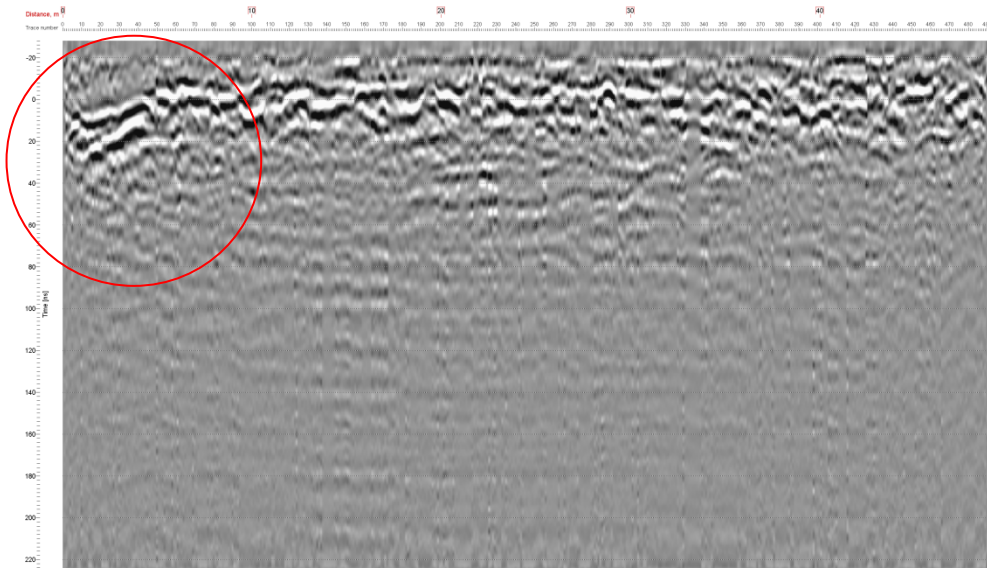
Anomaly A30. Record 437 showing weak reflector between 1.0-5.0m at depth of 1.3m.
