APPENDIX 2

Site Walkover Checklist and
Photographic Log

Client Name:
Galway Co. Co.

Site Location: New Inn Historic Landfill

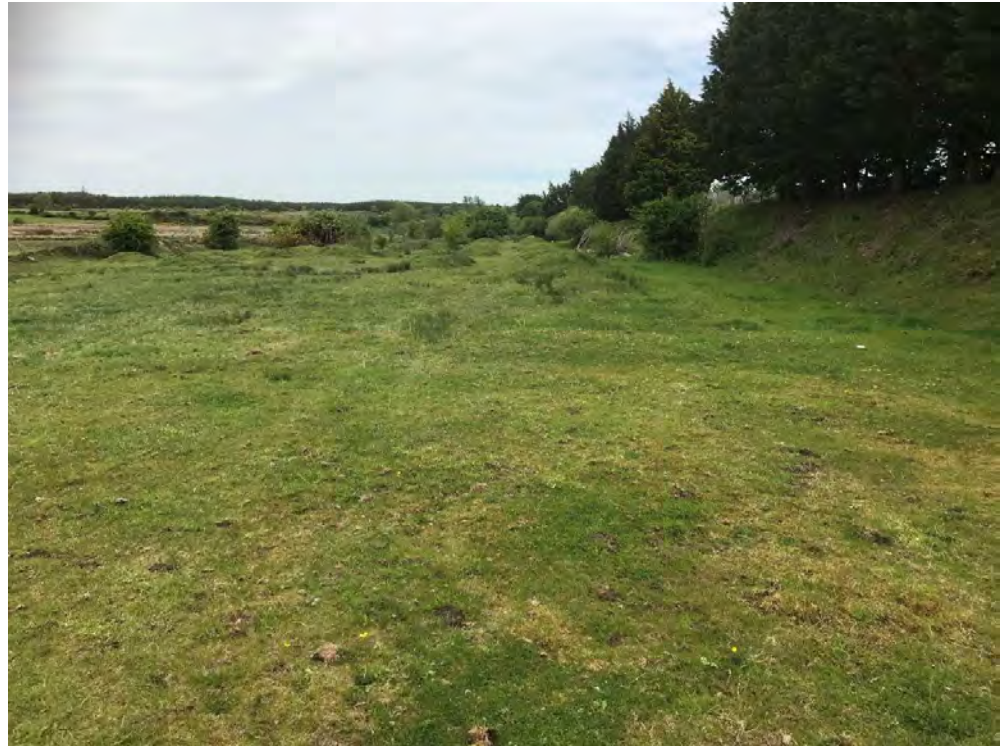
Photo No.
1

View from Entrance
looking east

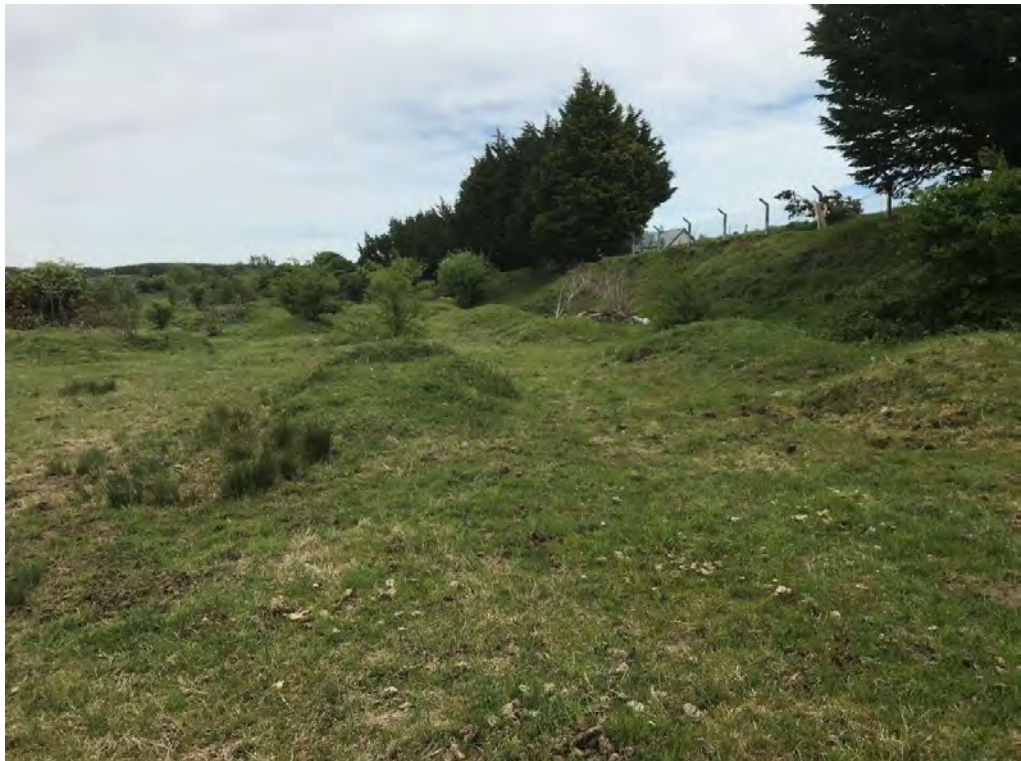
Photo No.
2

Evidence of deposition of
trailer full of materials

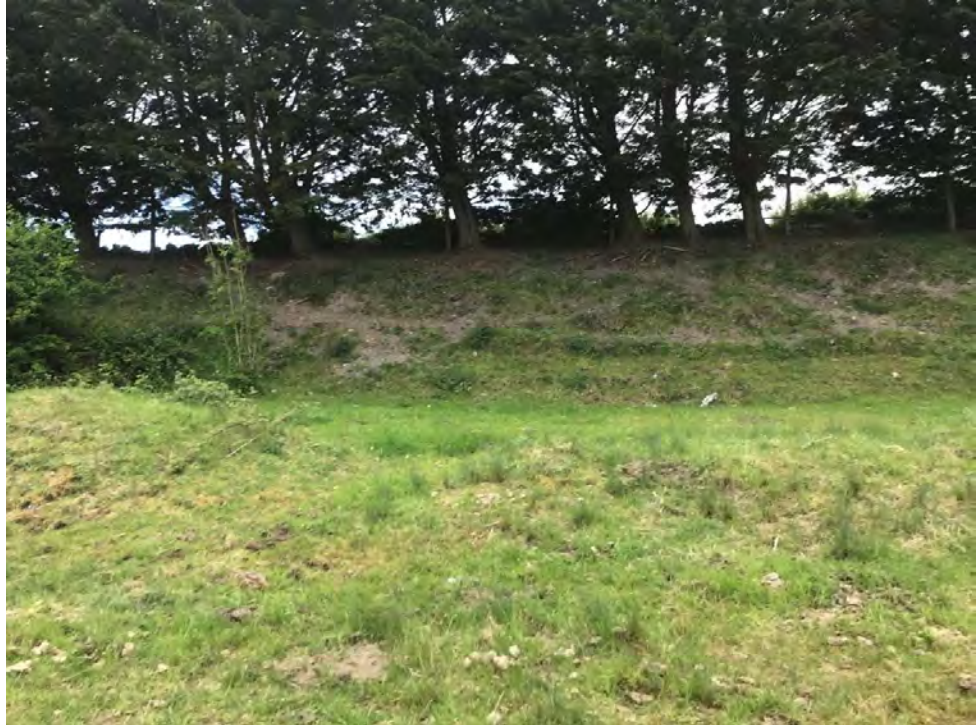
Photo No.
3

Evidence of previous cutting into hedgeline

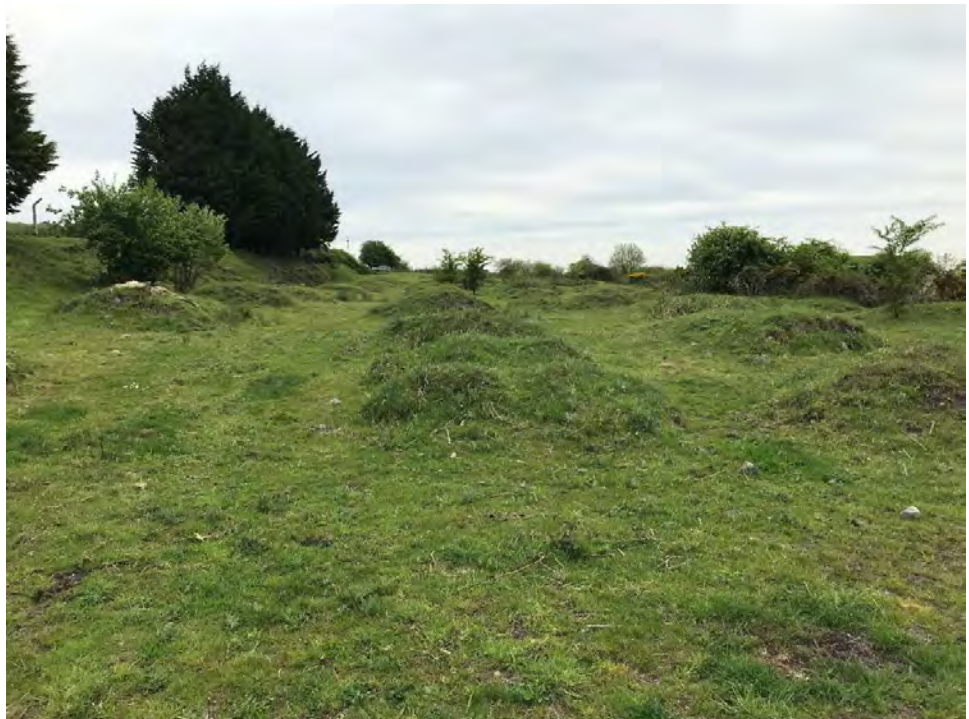
Photo No.
4

Random tipped loads to surface

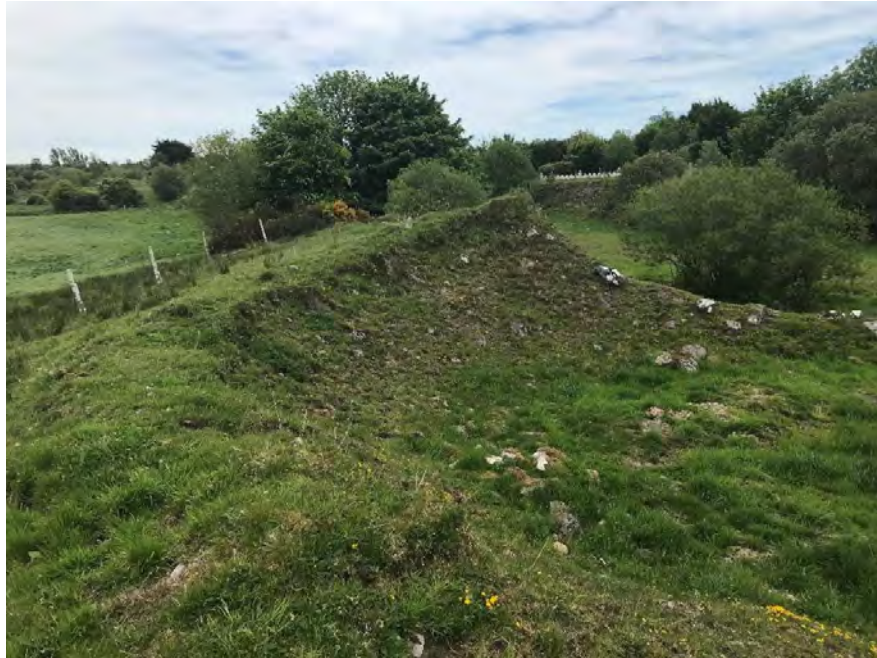
Photo No.
5

Description:
Natural ground cutting

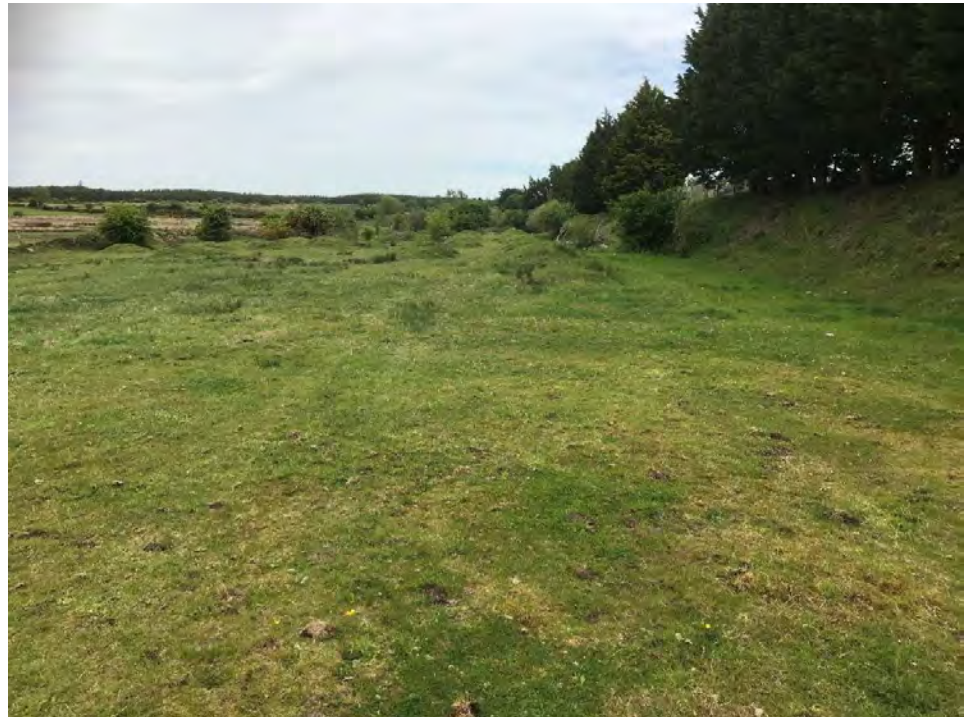
Photo No.
6

Description:
Landfill area looking East

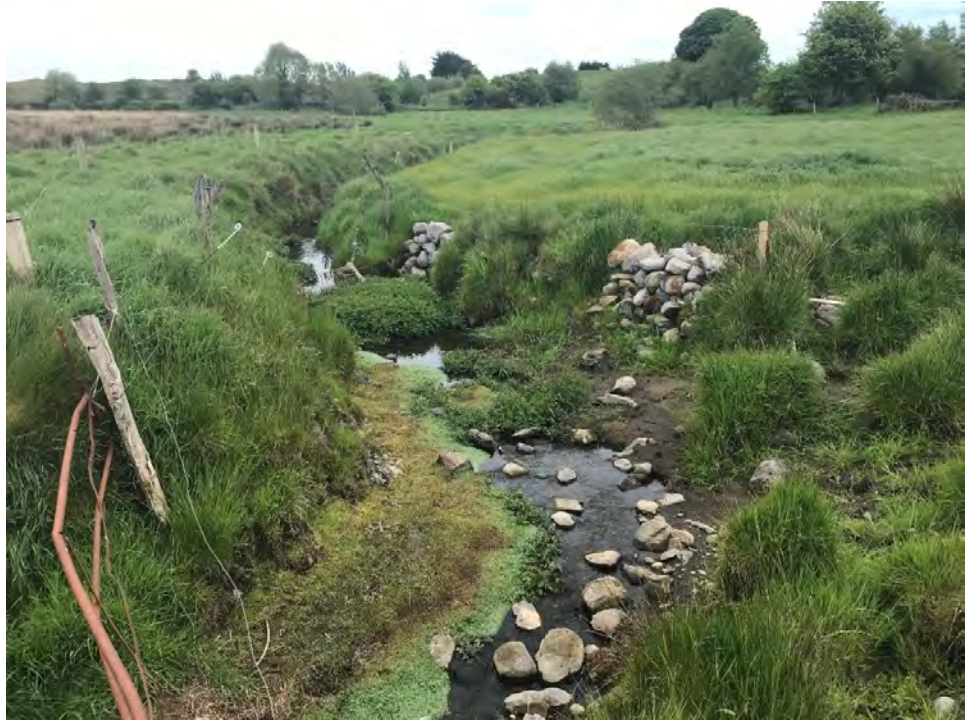
Photo No.
7

Nearby stream, no direct connection to assume landfill area

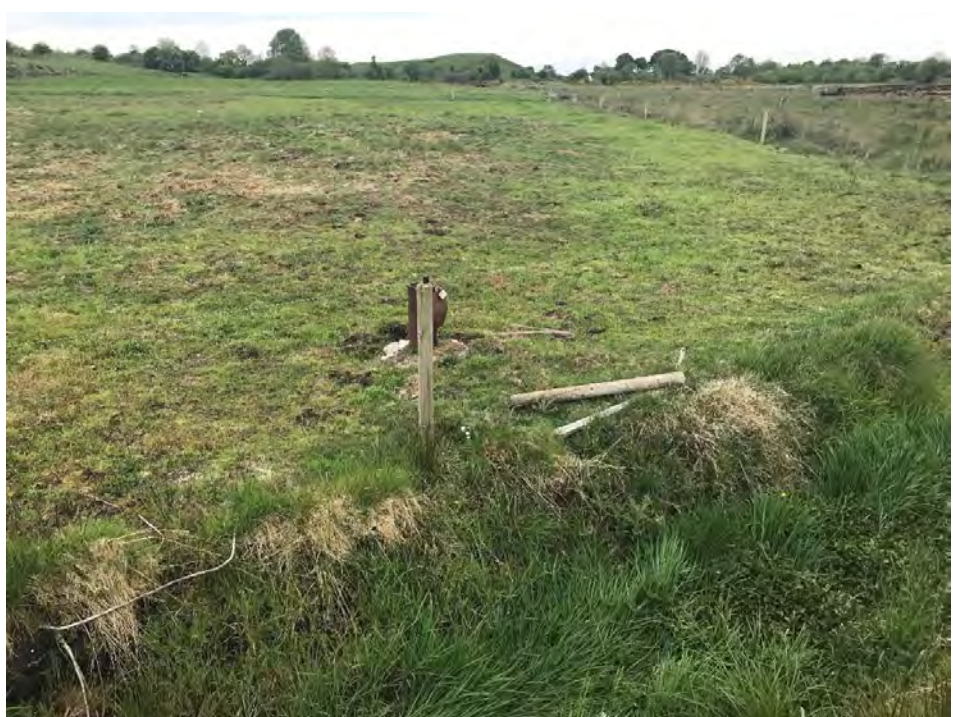
Photo No.
8

Monitoring infrastructure in adjoining field

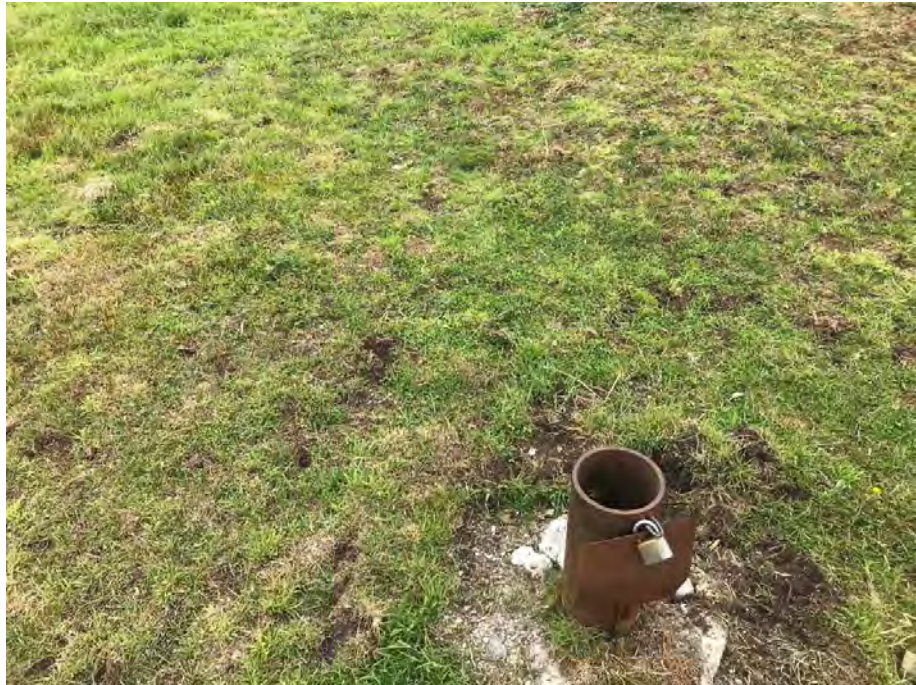
Photo No.
9

Groundwater monitoring infrastructure to North East of assumed area

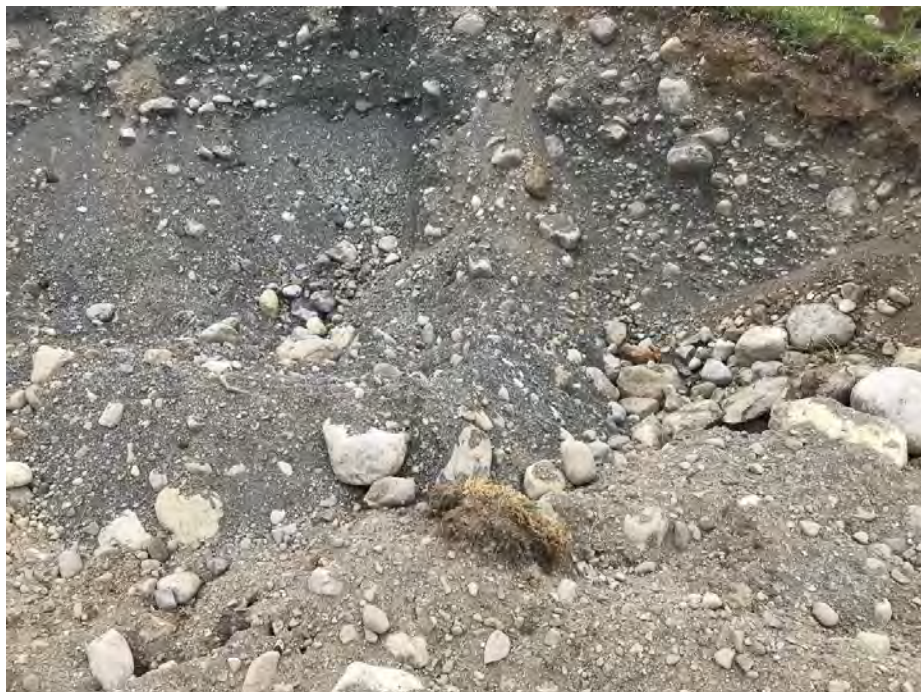
Photo No.
10

Natural sandy gravelly deposits, rounded boulders (fist sized)

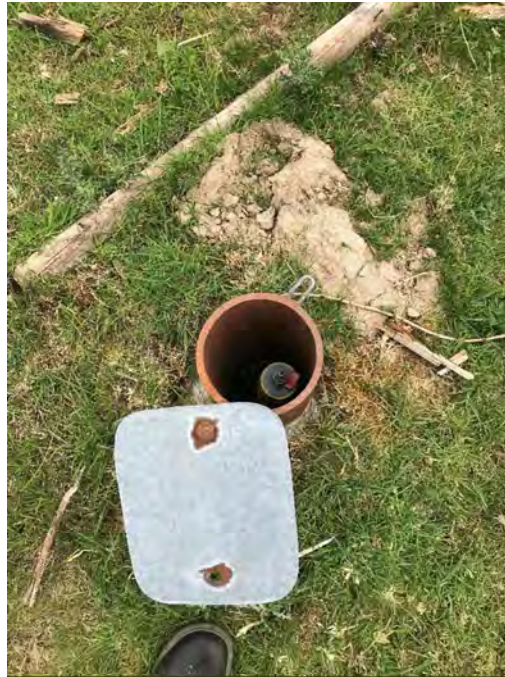
Photo No.
11

Landfill gas and leachate monitoring point of assumed landfill

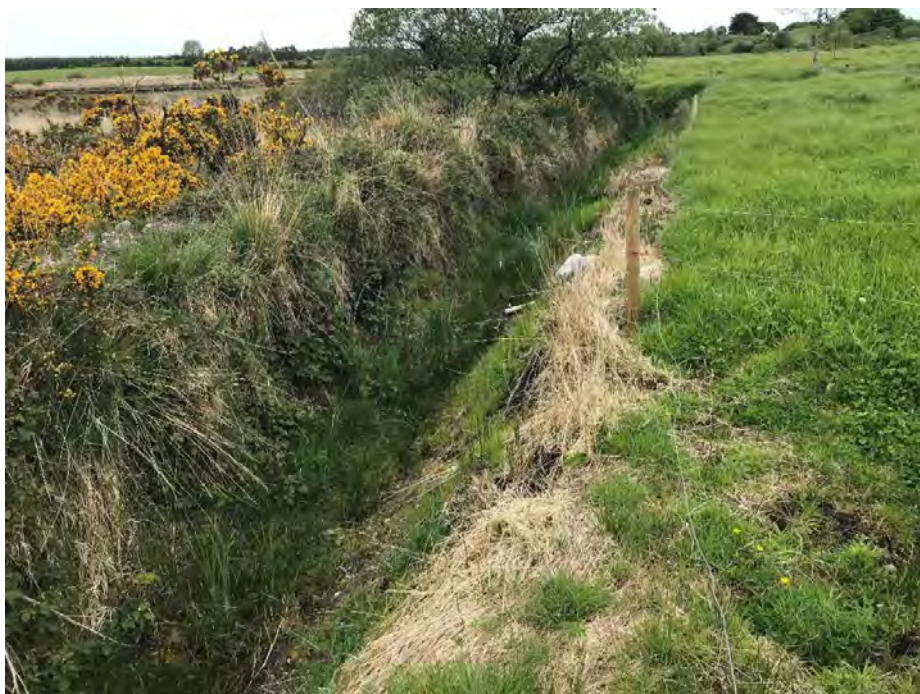
Photo No.
12

Closest field drain to landfill area, no direct connection.

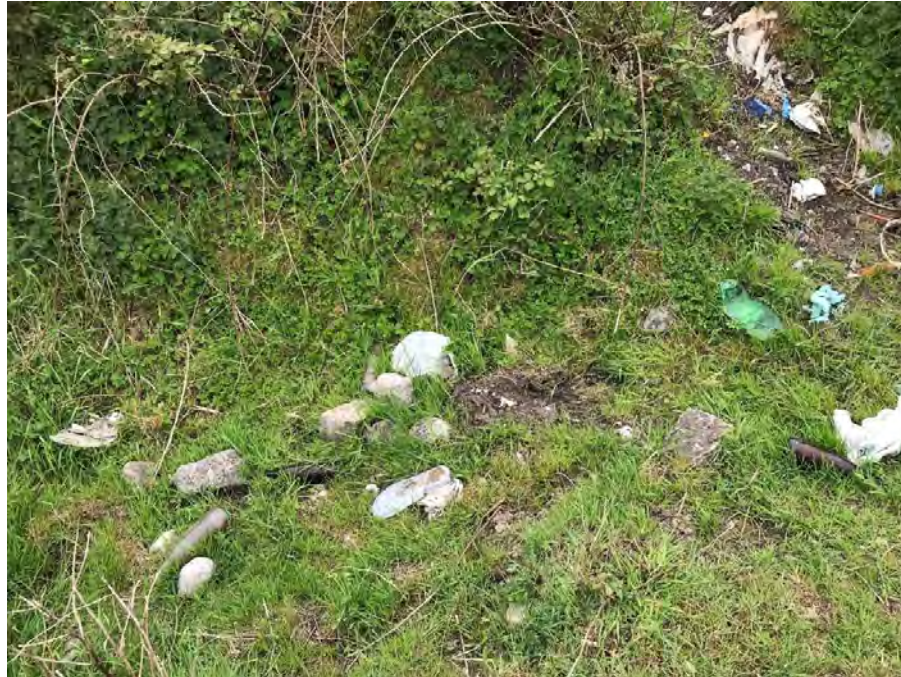
Photo No. 13

Description:
Exposed waste

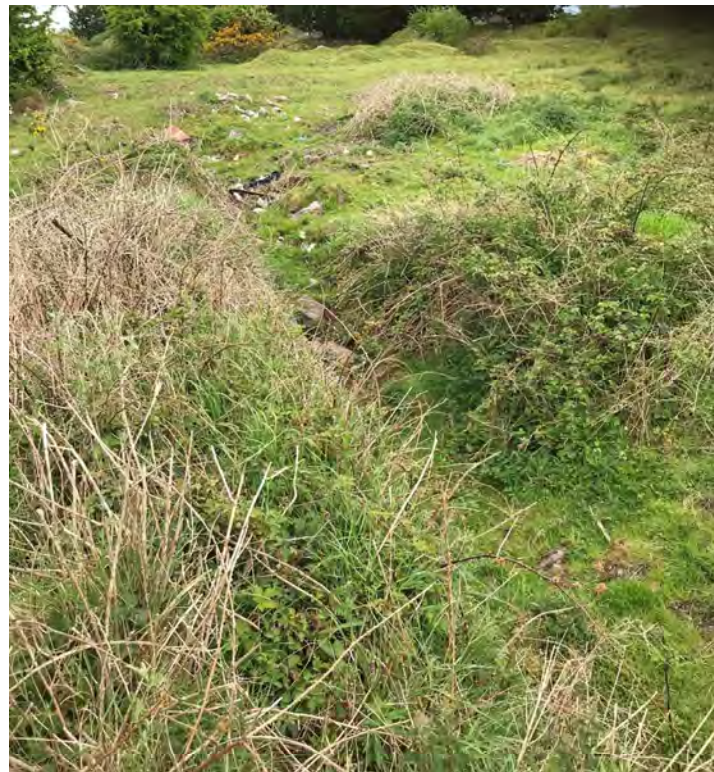
Photo No. 14

Assumed boundary trench between waste and natural ground
