APPENDIX 2

Site Walkover Checklist and
Photographic Log

Site Location: Tuam Historic Landfill

Project Number: P2282

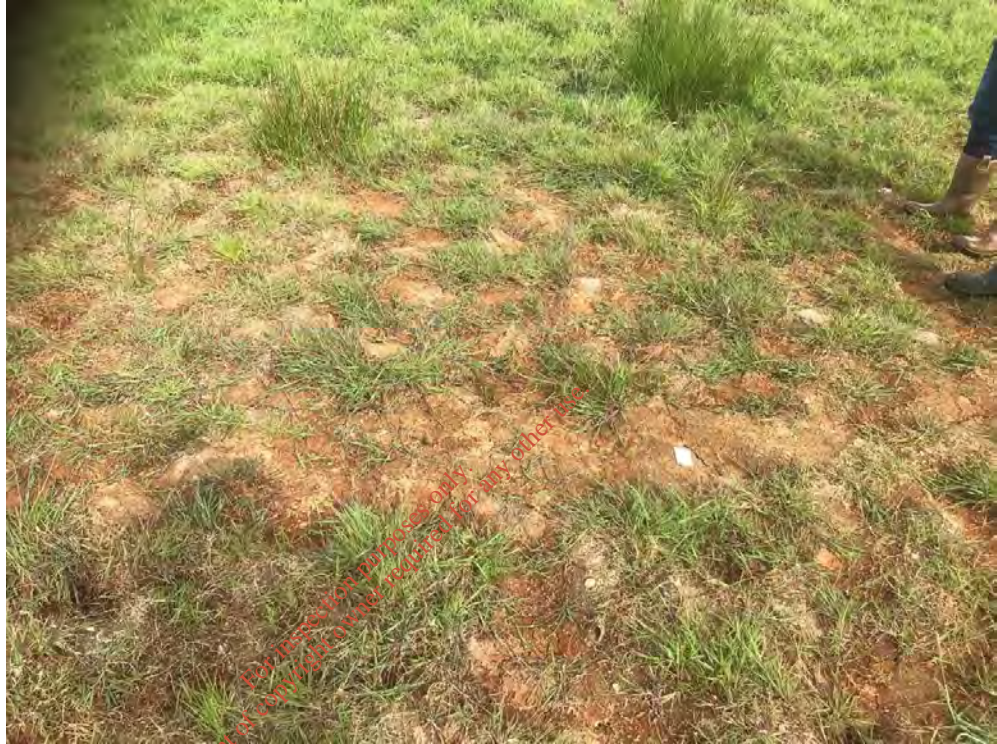
Photo No.
1

Evidence of possible leaching or seepage to localized flat area.

| Walkover Survey Checklist | | |
|---|---|---|
| Surface ponding of leachate | ✓ | Minor evidence of oxidation (no free water/leachate) to poorly drained/flat area on the landfill capping |

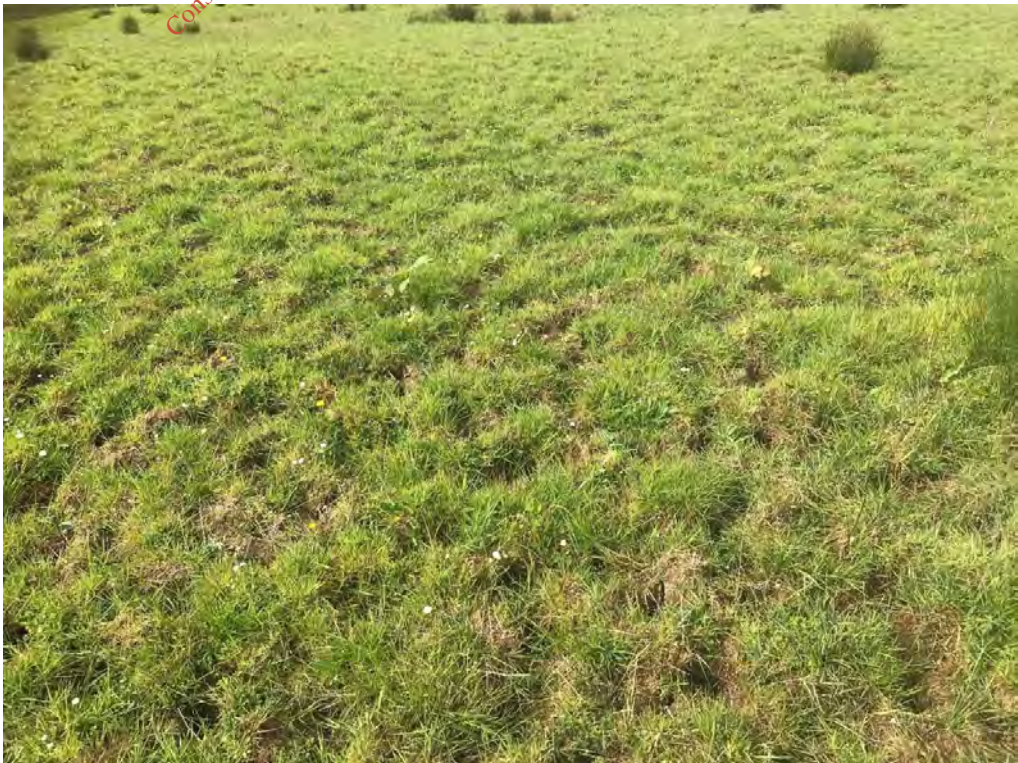
Photo No.
2

Heavy Poaching of Landfill Capping.

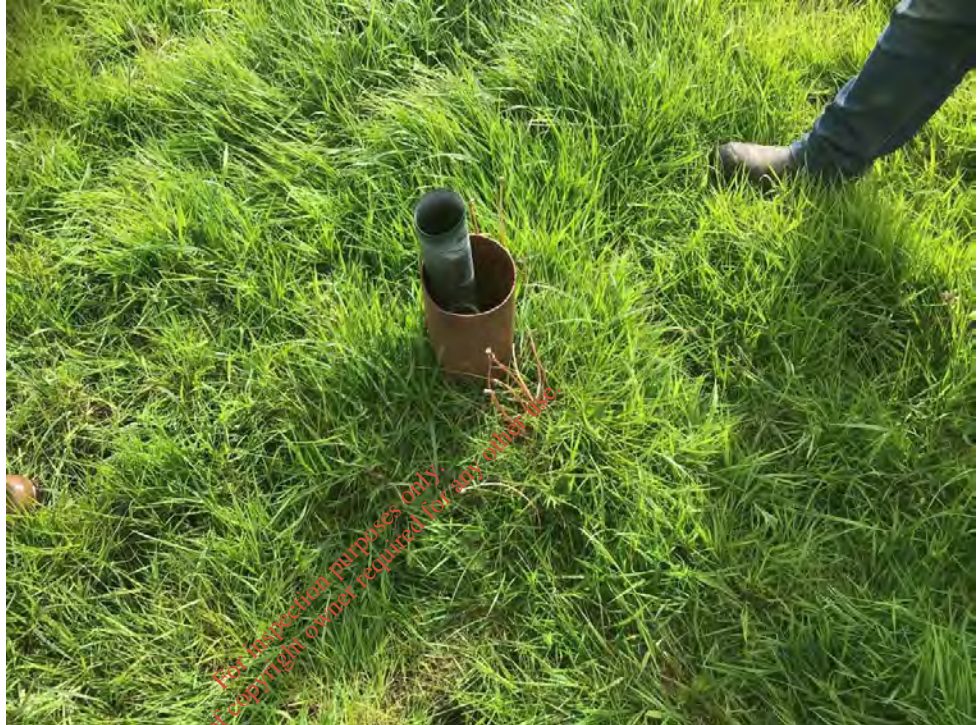
Photo No.
3

Leachate monitoring point to top of landfill

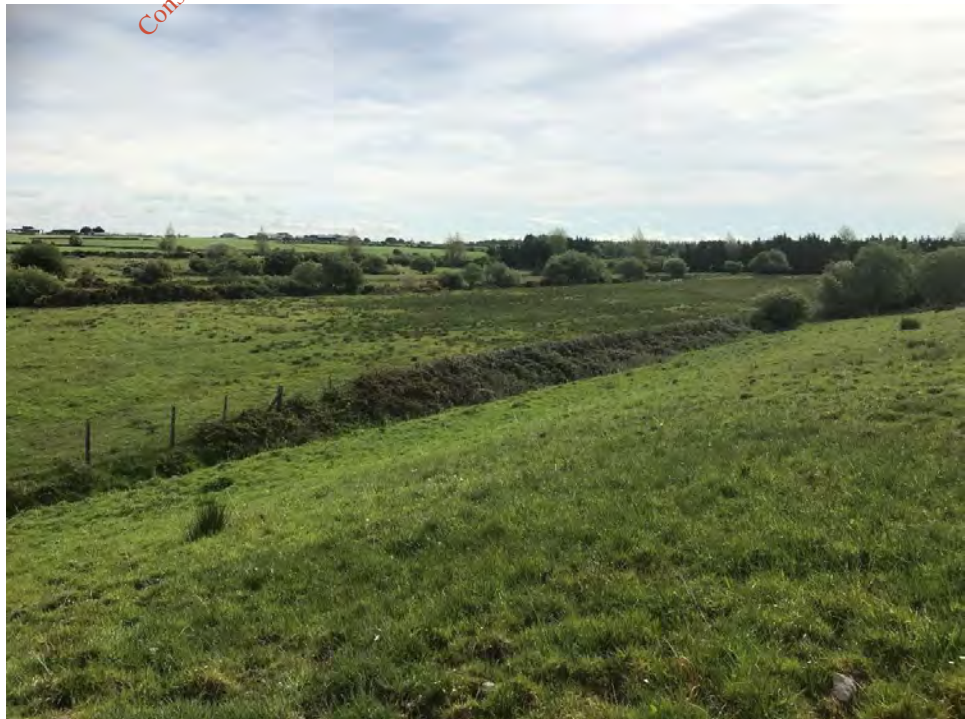
Photo No.
4

View looking North West from top of site, Western side.

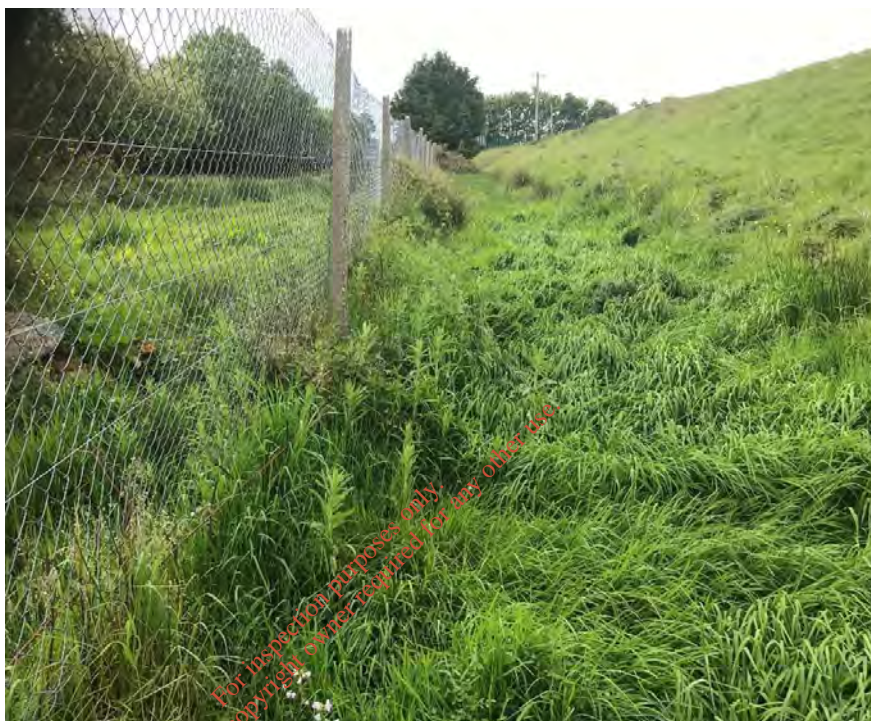
5

Surface water drain to landfill boundary, site fencing

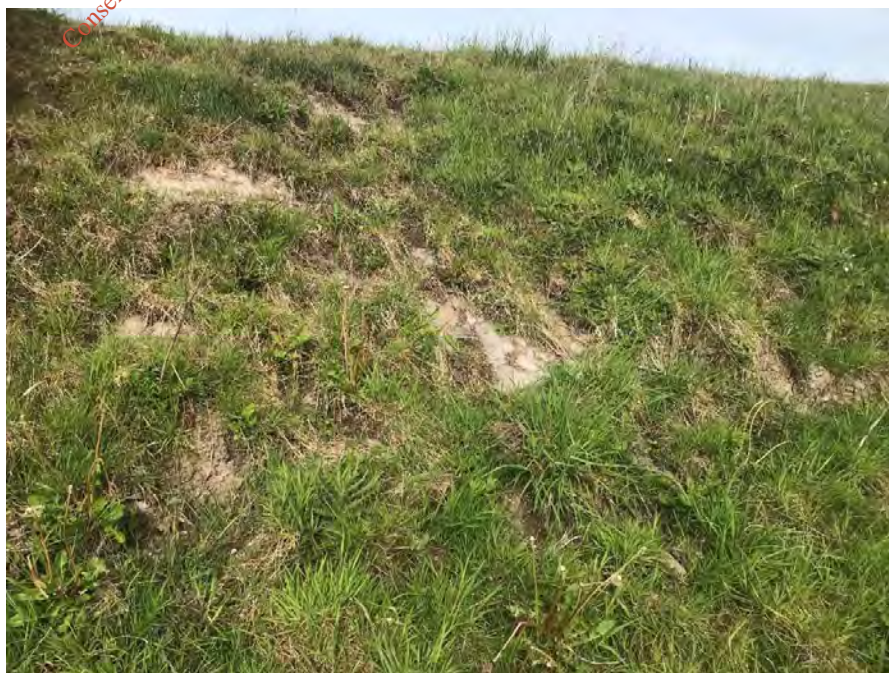
6

Evidence of slippage/erosion of landfill capping to side slopes, exposed geocomposite clay liner, evidence of animal damage and poaching

| Walkover Survey Checklist | | |
|---|---|---|
| Capping | ✓ | Site capped with soil and GCL, GCL visible in areas due to erosion/poaching by animals. Very shallow soil/topsoil layer to GCL. |

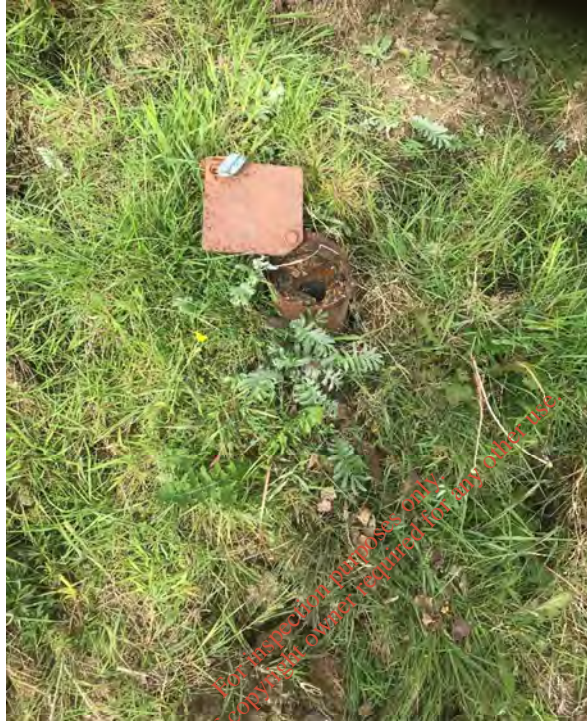
Photo No.
7

Leachate monitoring infrastructure (heavily corroded)

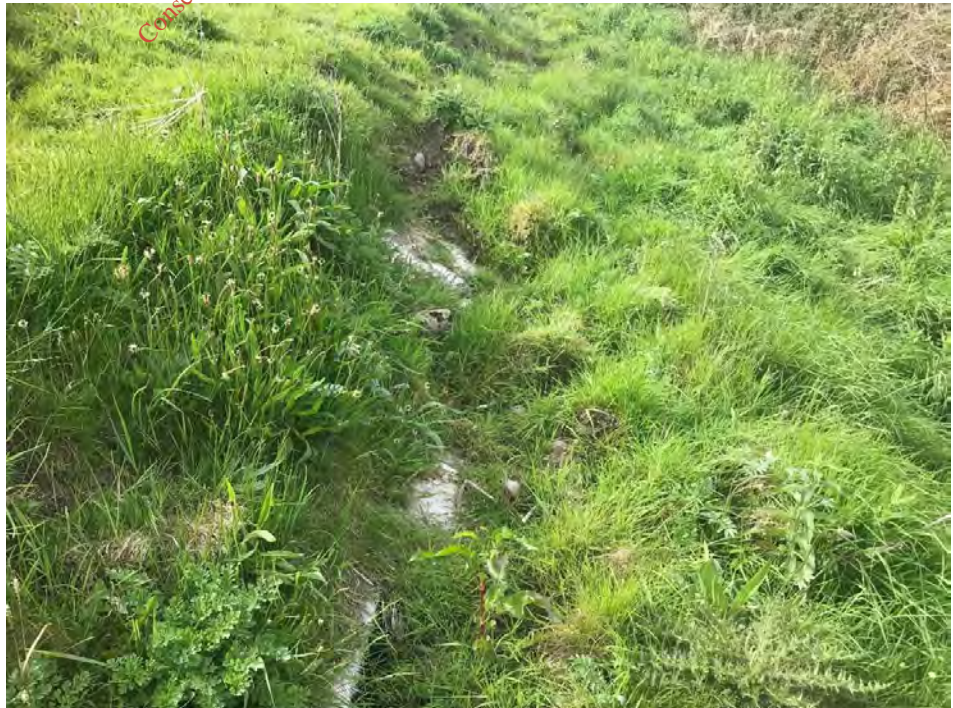
Photo No.
8

Further expose G.C.L. to side slopes

| Walkover Survey Checklist | | |
|---|---|---|
| Signs of settlement | ✓ | Area of poaching issues shallow GCL on side slopes of landfill |

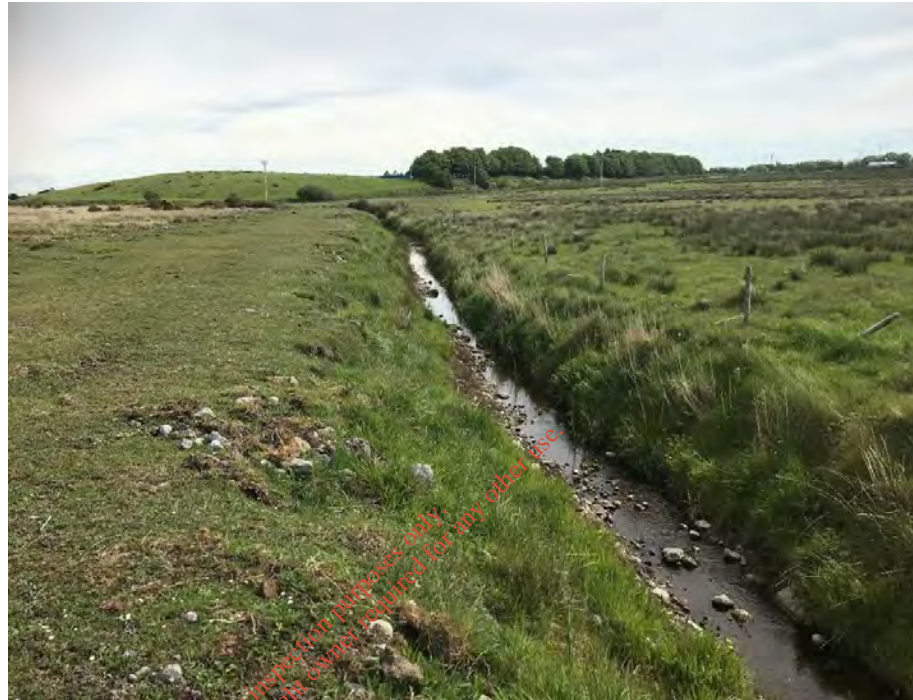
Photo No.
9

Surface water stream/bog drain, Flow to South West, linked to landfill surface water drains

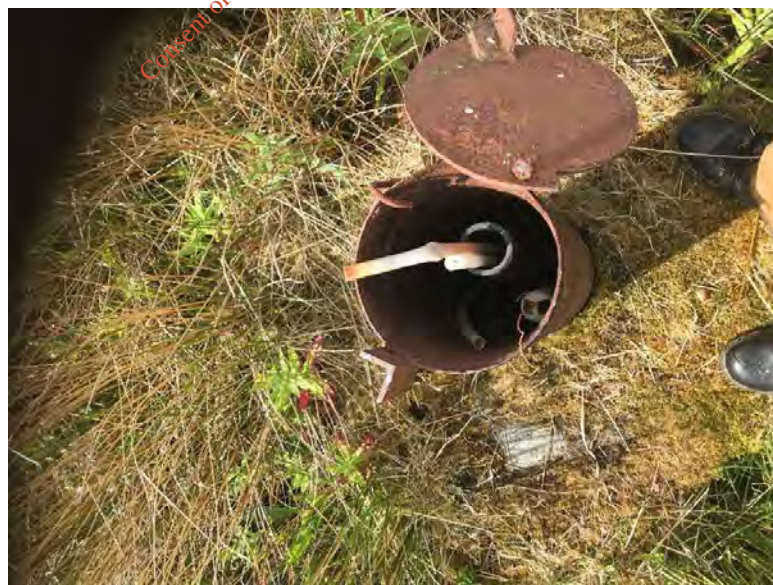
Photo No.
10

Groundwater monitoring infrastructure, offsite.

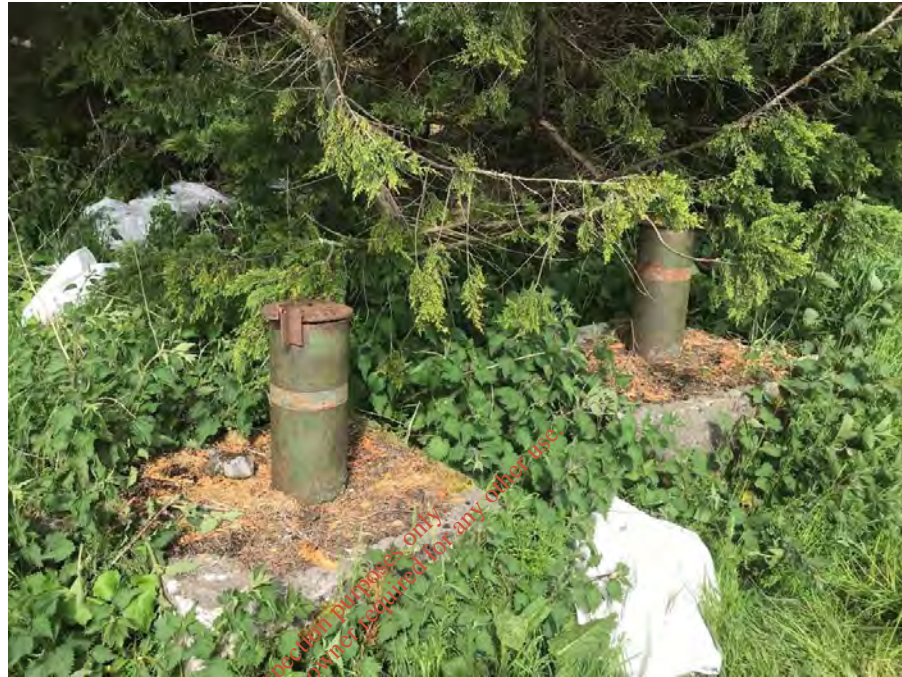
Photo No.
11

Groundwater monitoring boreholes at entrance to civic amenity

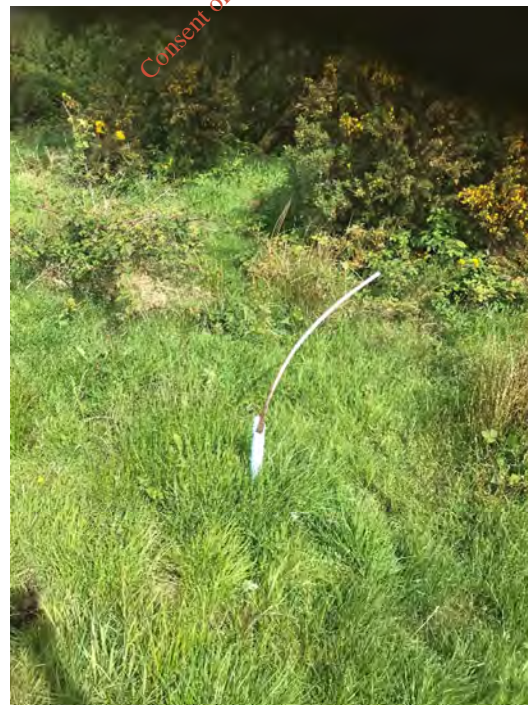
Photo No.
12

Groundwater monitoring boreholes
