APPENDIX 2

Site Walkover Checklist and Photographic Log

Site Location: Gort Historic Landfill

Project Number: P2282

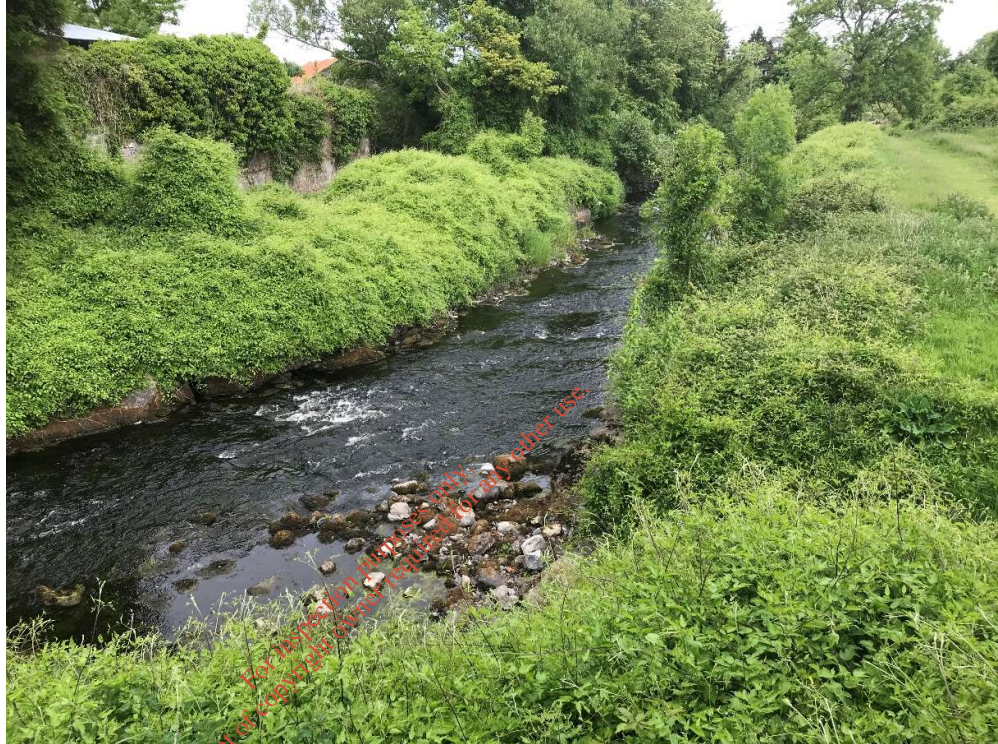
Photo No.
1

River upstream, near Holy Well, potential monitoring location

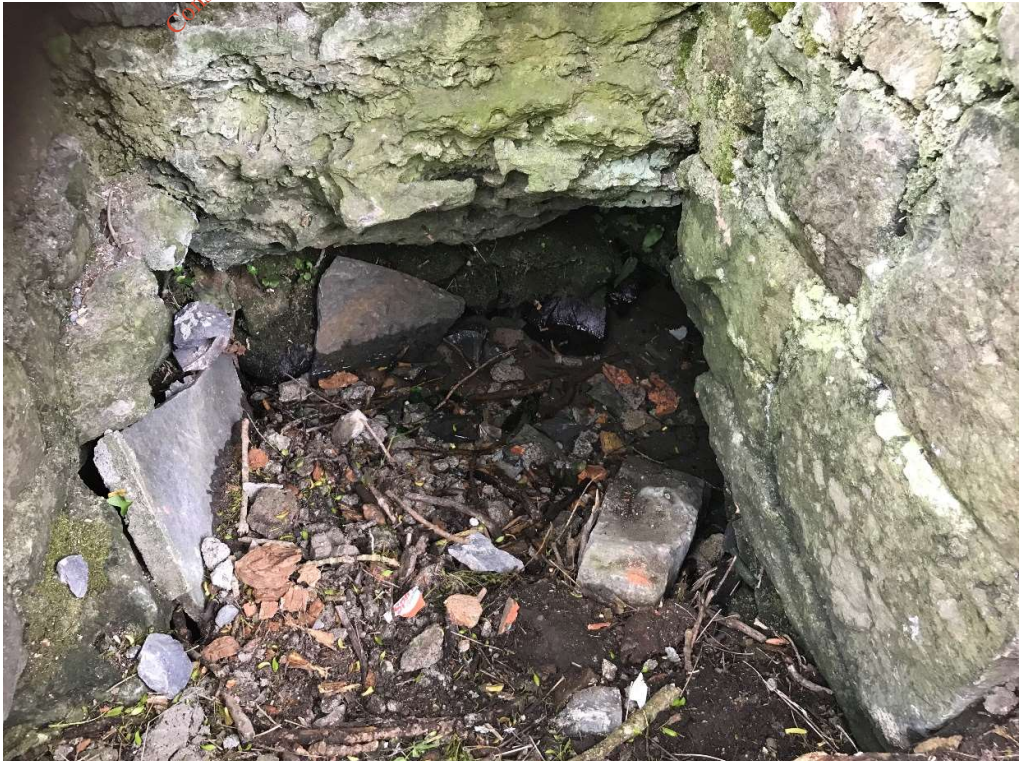
Photo No.
2

Holy Well, off-site St Machtans

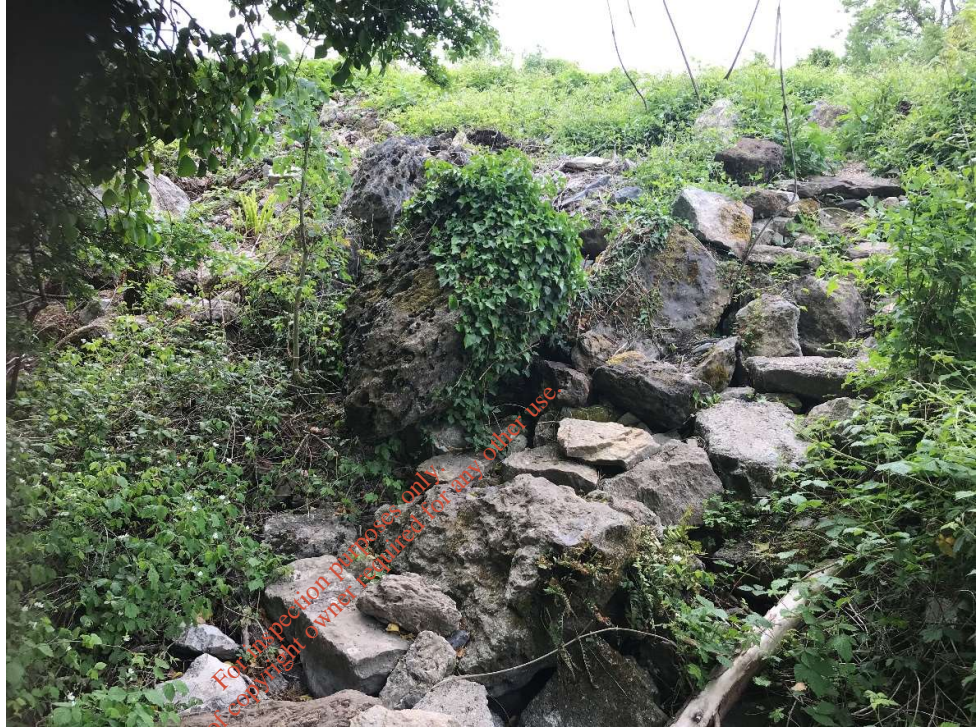
Photo No.
3

Deposition of stone/construction and demolition waste to land adjacent the landfill area

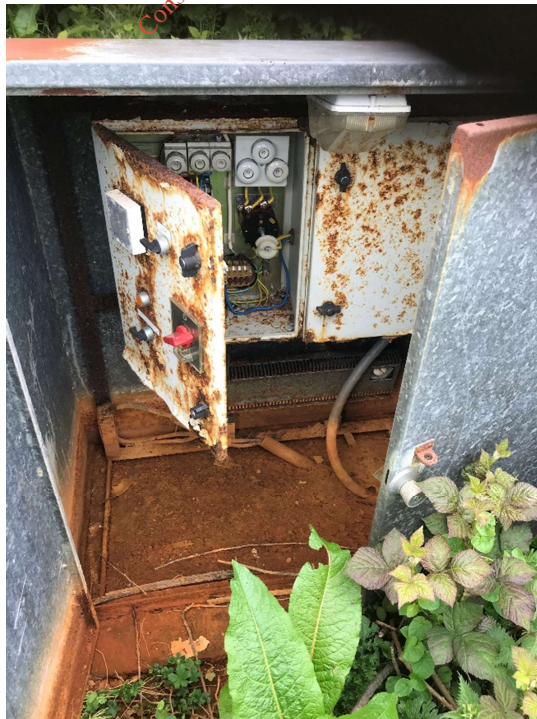
Photo No.
4

Control cabinet with ESB metered connection, assumed pump controller, ON Off Auto settings

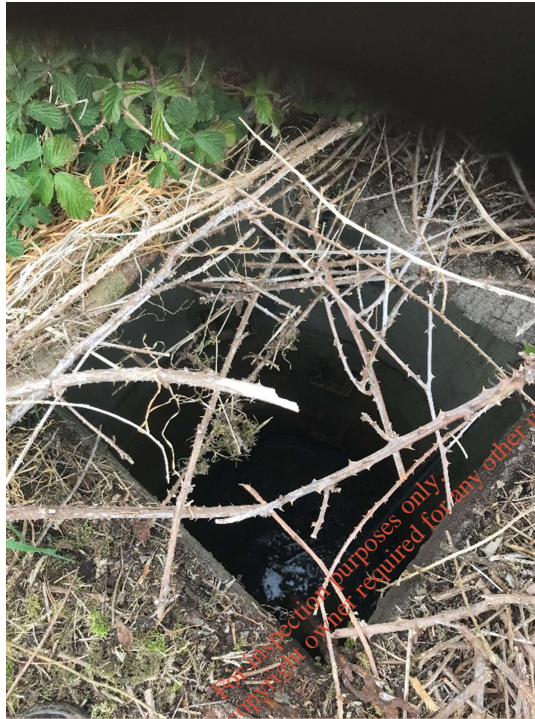
Photo No.
5

Pump sump (dilapidated), assumed leachate management system, note level sensor cable, gate valve non return valve.

9. Are there any indications of remedial measures? (Provide details)		
Capping	✓	Site capped with soil
Landfill gas collection	✓	No
Leachate collection	✓	Yes, abandoned leachate collection and pumping system, pump control unit, manhole, rising main see Photolog

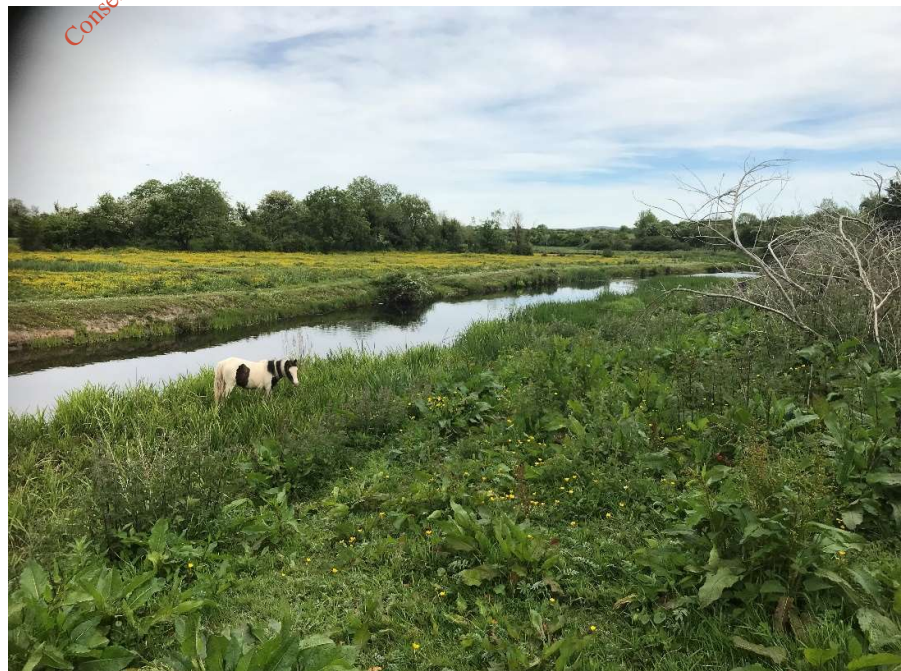
Photo No.
6

Landfill adjacent to river bank

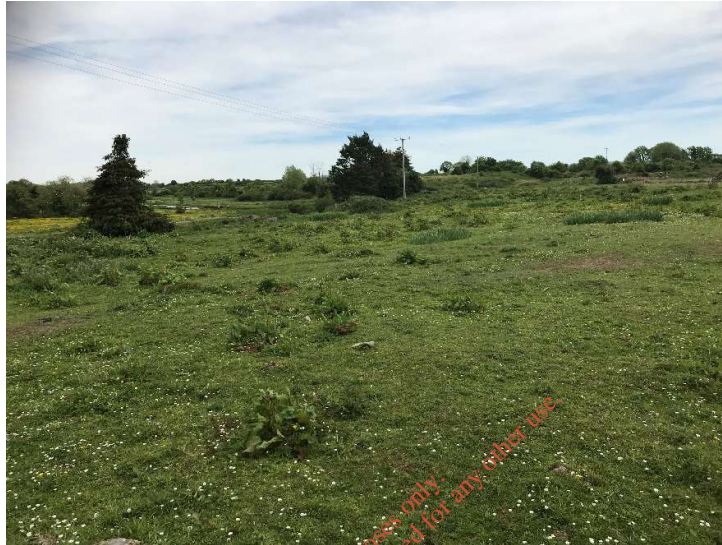
Photo No.
7

Description:
Landfill Area

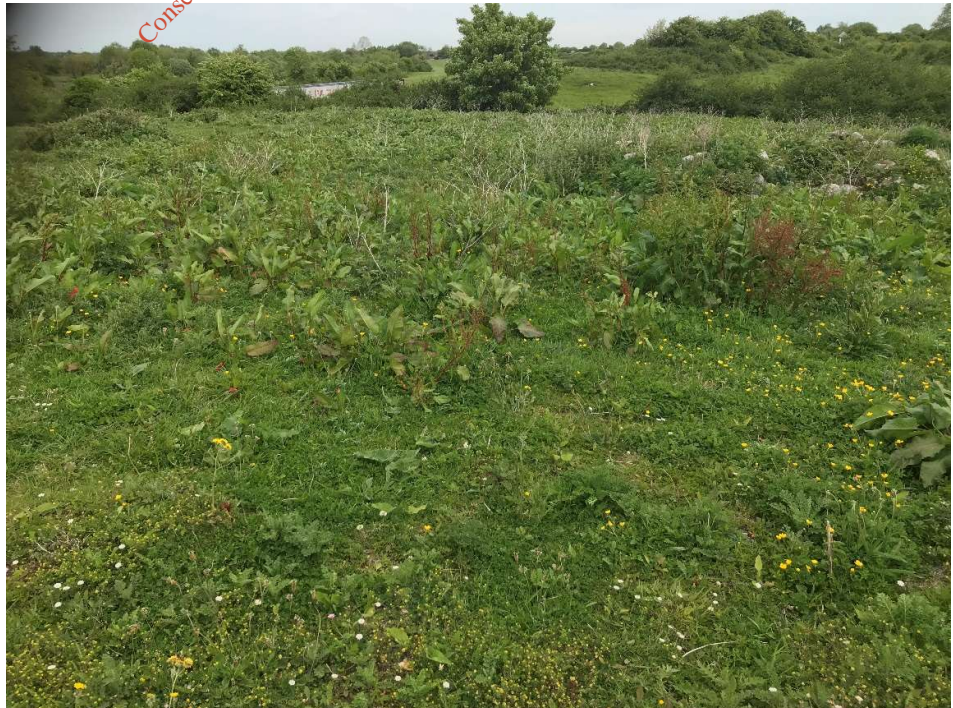
Photo No.
8

Description:
Landfill area

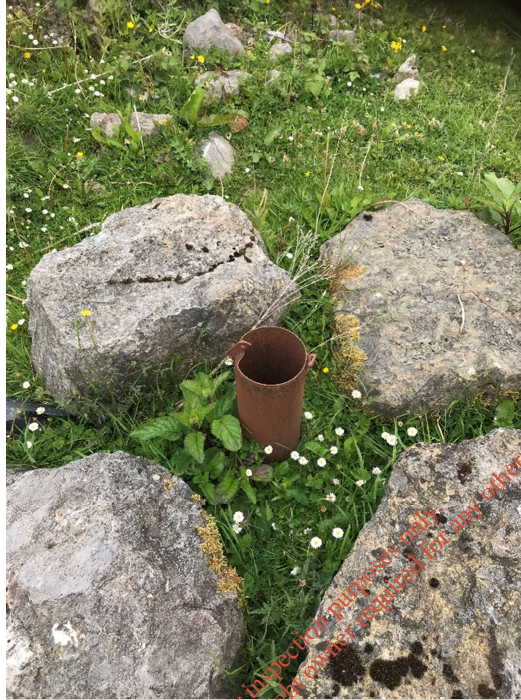
Photo No.
9

Groundwater monitoring infrastructure to North East of site

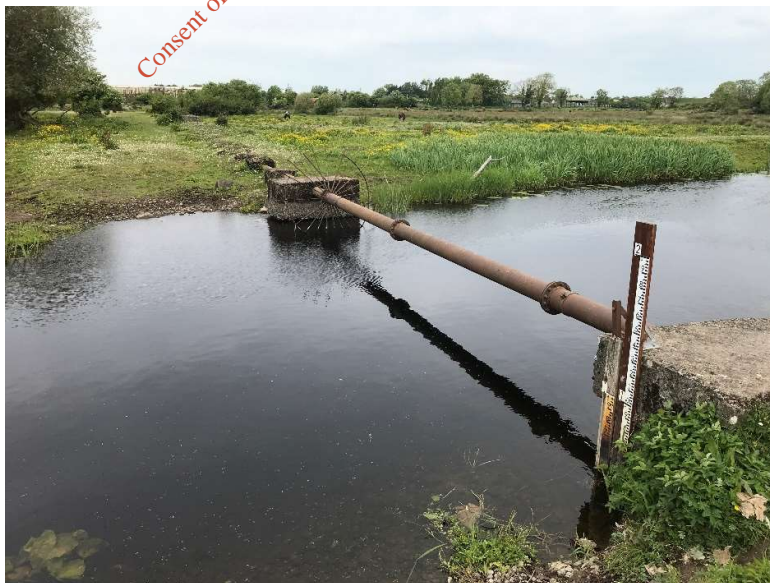
Photo No.
10

Foul water main river crossing – Potential downstream monitoring location

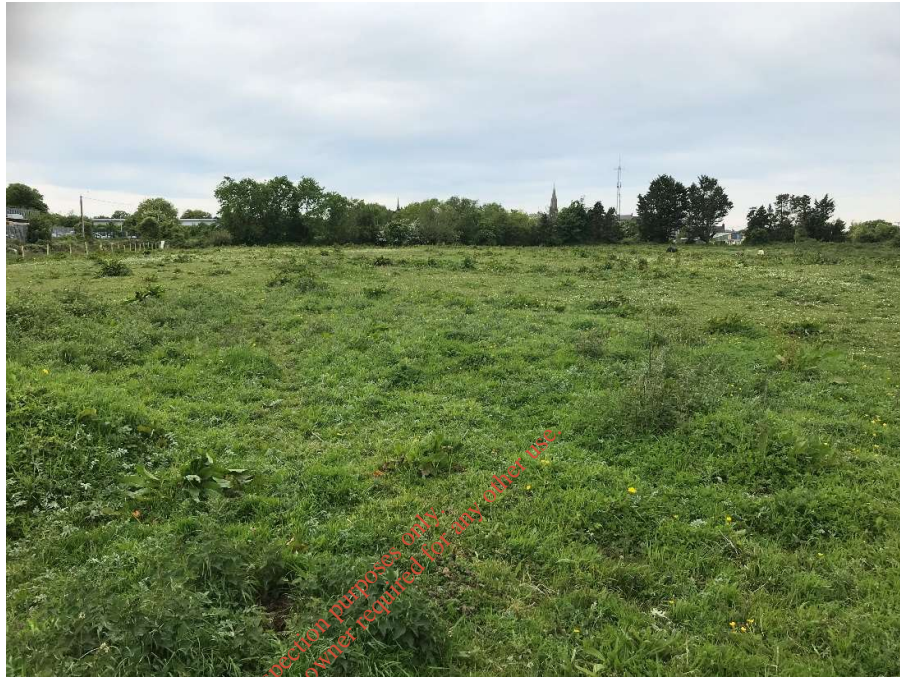
Photo No.
11

Description:
View of landfill

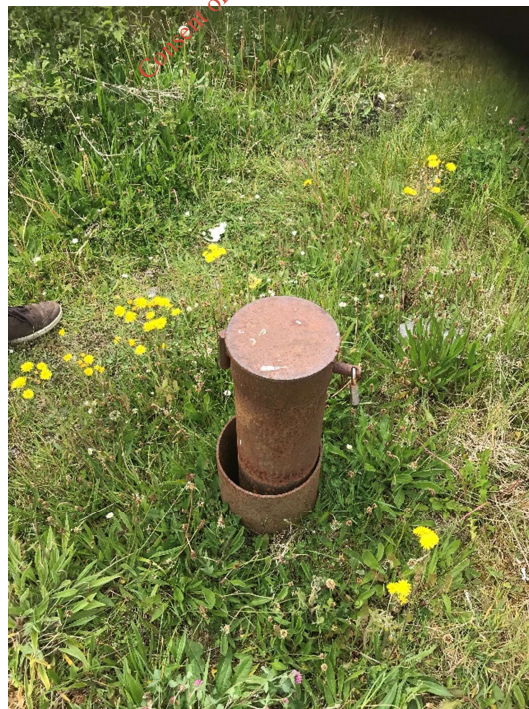
Photo No.
12

Description:
Groundwater monitoring
borehole at site entrance

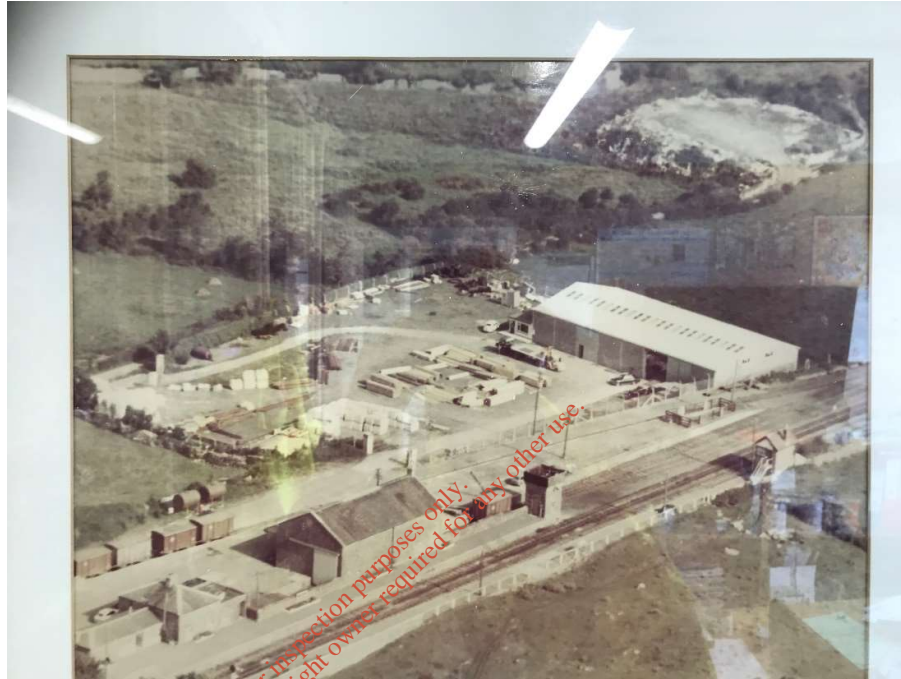
Photo No. 13

Historic Photo - 1973
Builders Providers

Landfill Operation in
Background
