# COMHAIRLE CHONTAE NA GAILLIMHE GALWAY COUNTY COUNCIL

## Closure & Remediation Plan for Tuam Landfill

October 1999

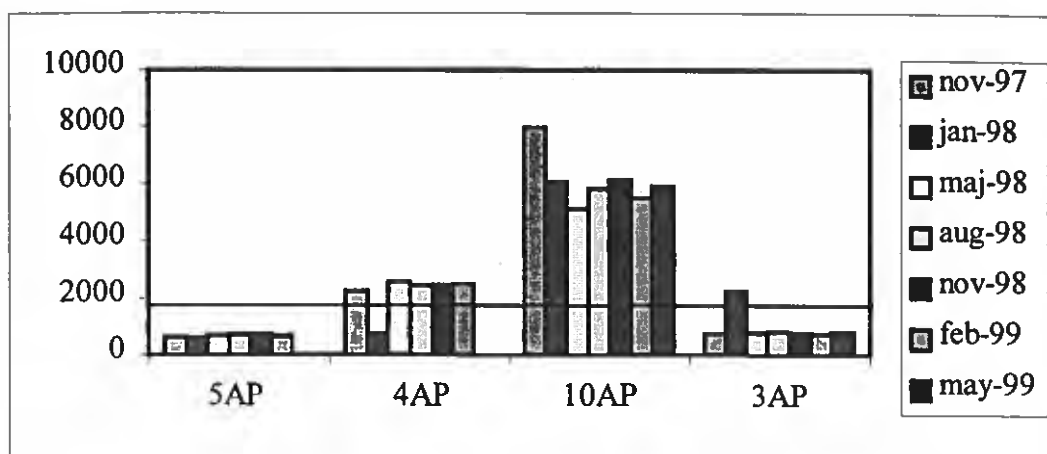
**Figure 4.1:** Conductivity measured in groundwater samples from the peat layer west and south-west of the landfill. 5AP is situated upstream of the landfill. 4AP, 10AP and 3AP are situated downstream. The horizontal line indicates the Maximum Admissible Concentration for water intended for human consumption.

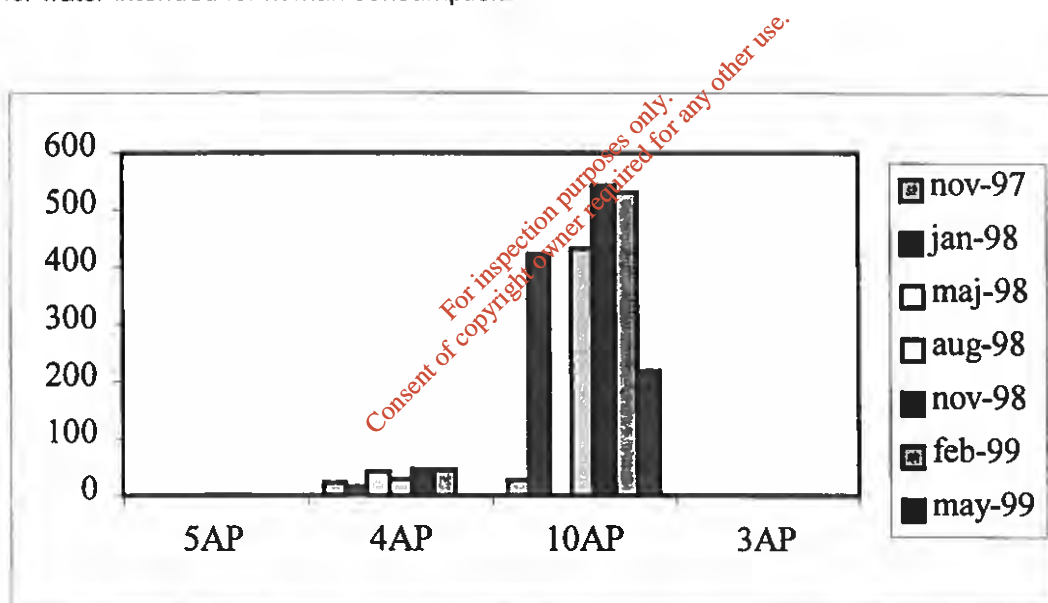
Stations 4AP and 10AP are also contaminated by ammonia, TOC, TON and phosphate from the landfill (**Figure. 4.2 and Table 4.3**). It should be noted that background concentrations of ammonia, violating the standards for drinking water were found in the area. This is probably due to the fact that the area is a bog with anaerobic conditions, where ammonia is the dominant inorganic nitrogen species.

**Figure 4.2:** Concentrations of ammonium measured in groundwater samples from the peat layer west and southwest of the landfill. 5AP is situated upstream of the landfill. 4AP, 10AP and 3AP are situated downstream of the landfill

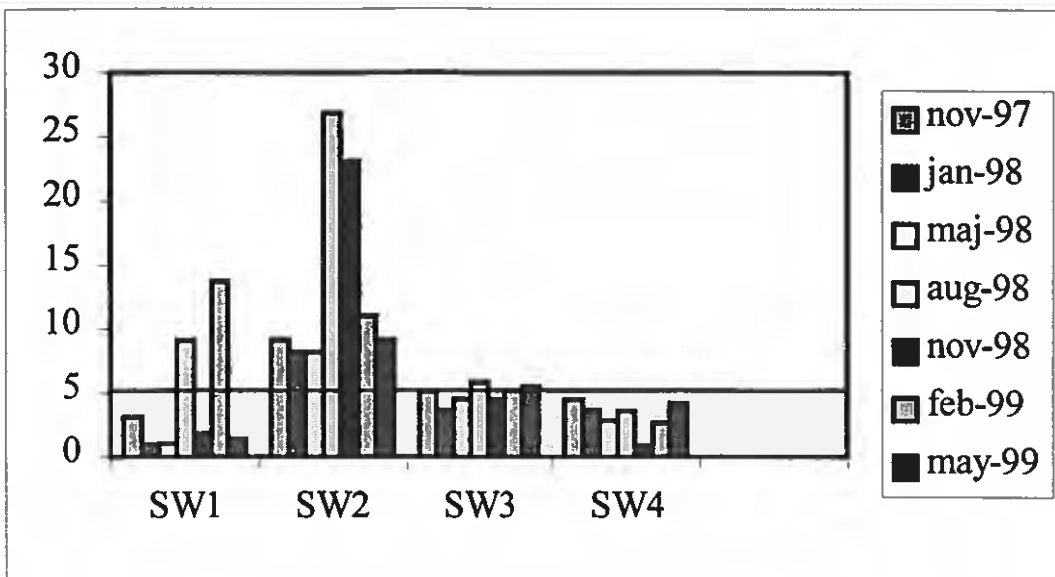
**Figure 4.3:** BOD measured in surface water samples. SW1 is situated upstream of the landfill. SW2, SW3 and SW3 are situated downstream of the landfill. The horizontal line indicates the EQS value for surface water.

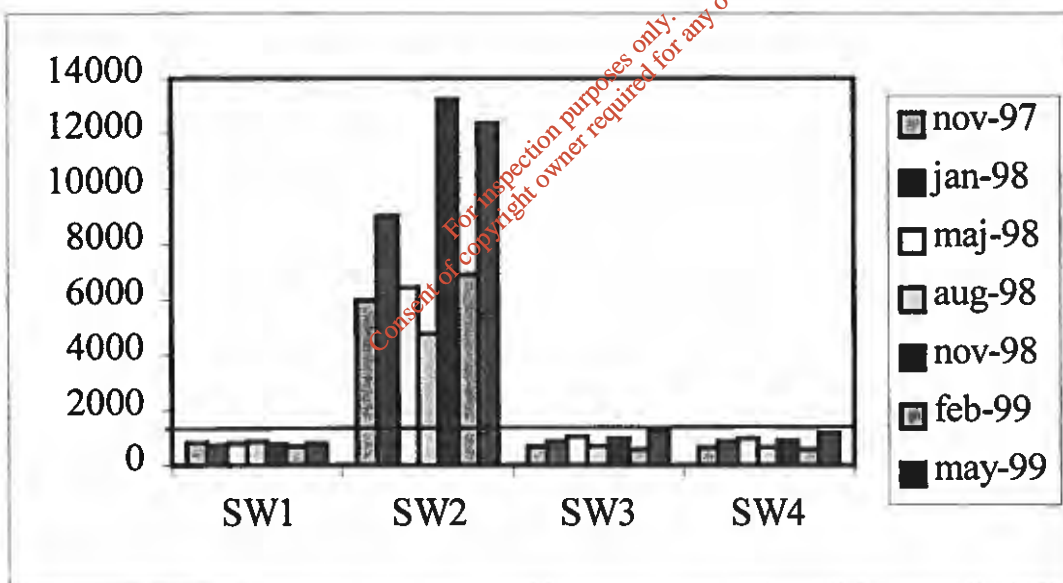
**Figure 4.4:** Conductivity in surface water samples. SW1 is situated upstream of the landfill. SW2, SW3 and SW3 are situated downstream of the landfill.
