TIER 3

ENVIRONMENTAL RISK ASSESSMENT

FORMER MUNICIPAL LANDFILL

WHITEGATE

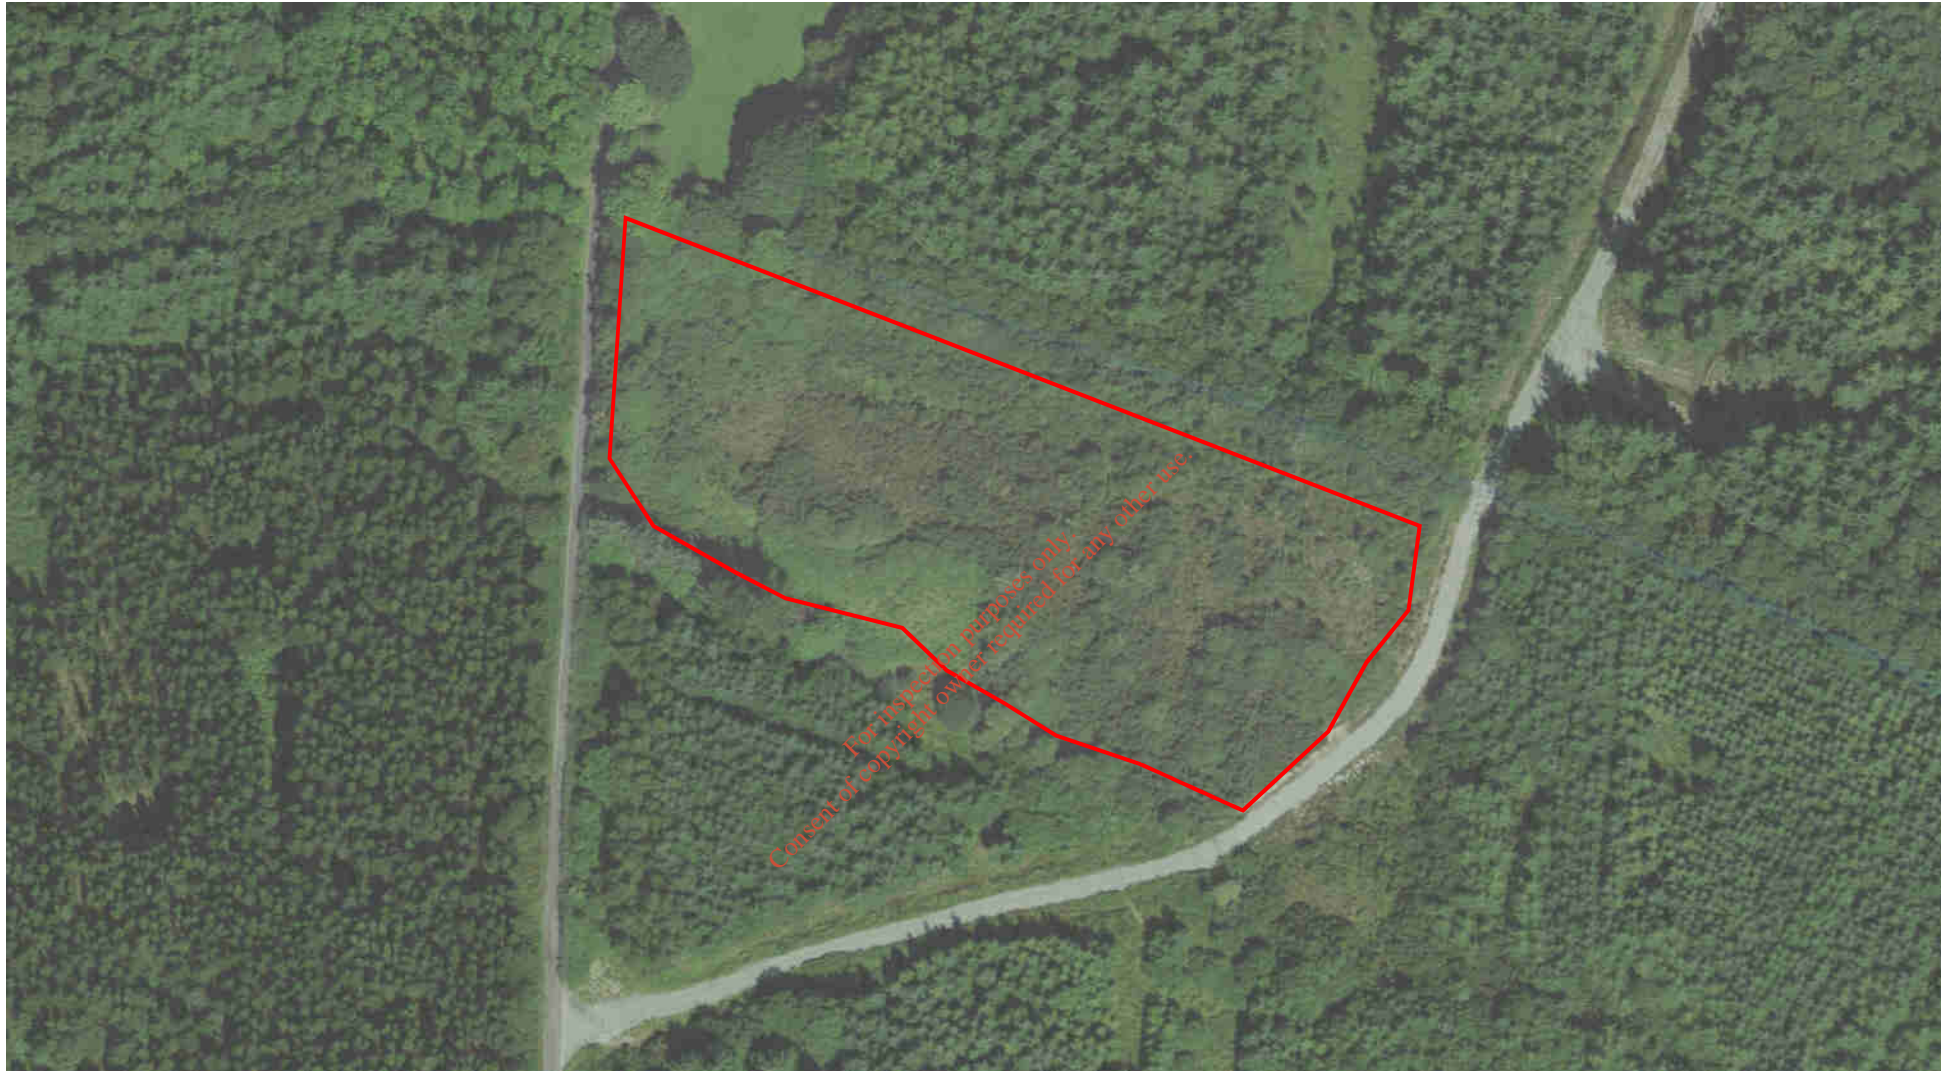
Figure 2.2 Site Layout

The site covers c8ha and is fenced off and are densely covered with gorse (Figure 2.2). The landfill is bound on all sides by forestry. The red line shows the property boundary, not the extent of waste present on the site. On the western boundary of the site there is a local road access from Whitegate village. This road forms part of the East Clare Way, and re-joins the R352 approximately 2km to the north of the landfill. The landfill area is raised c4-5m above the surrounding natural ground and slopes from west to east across the site.

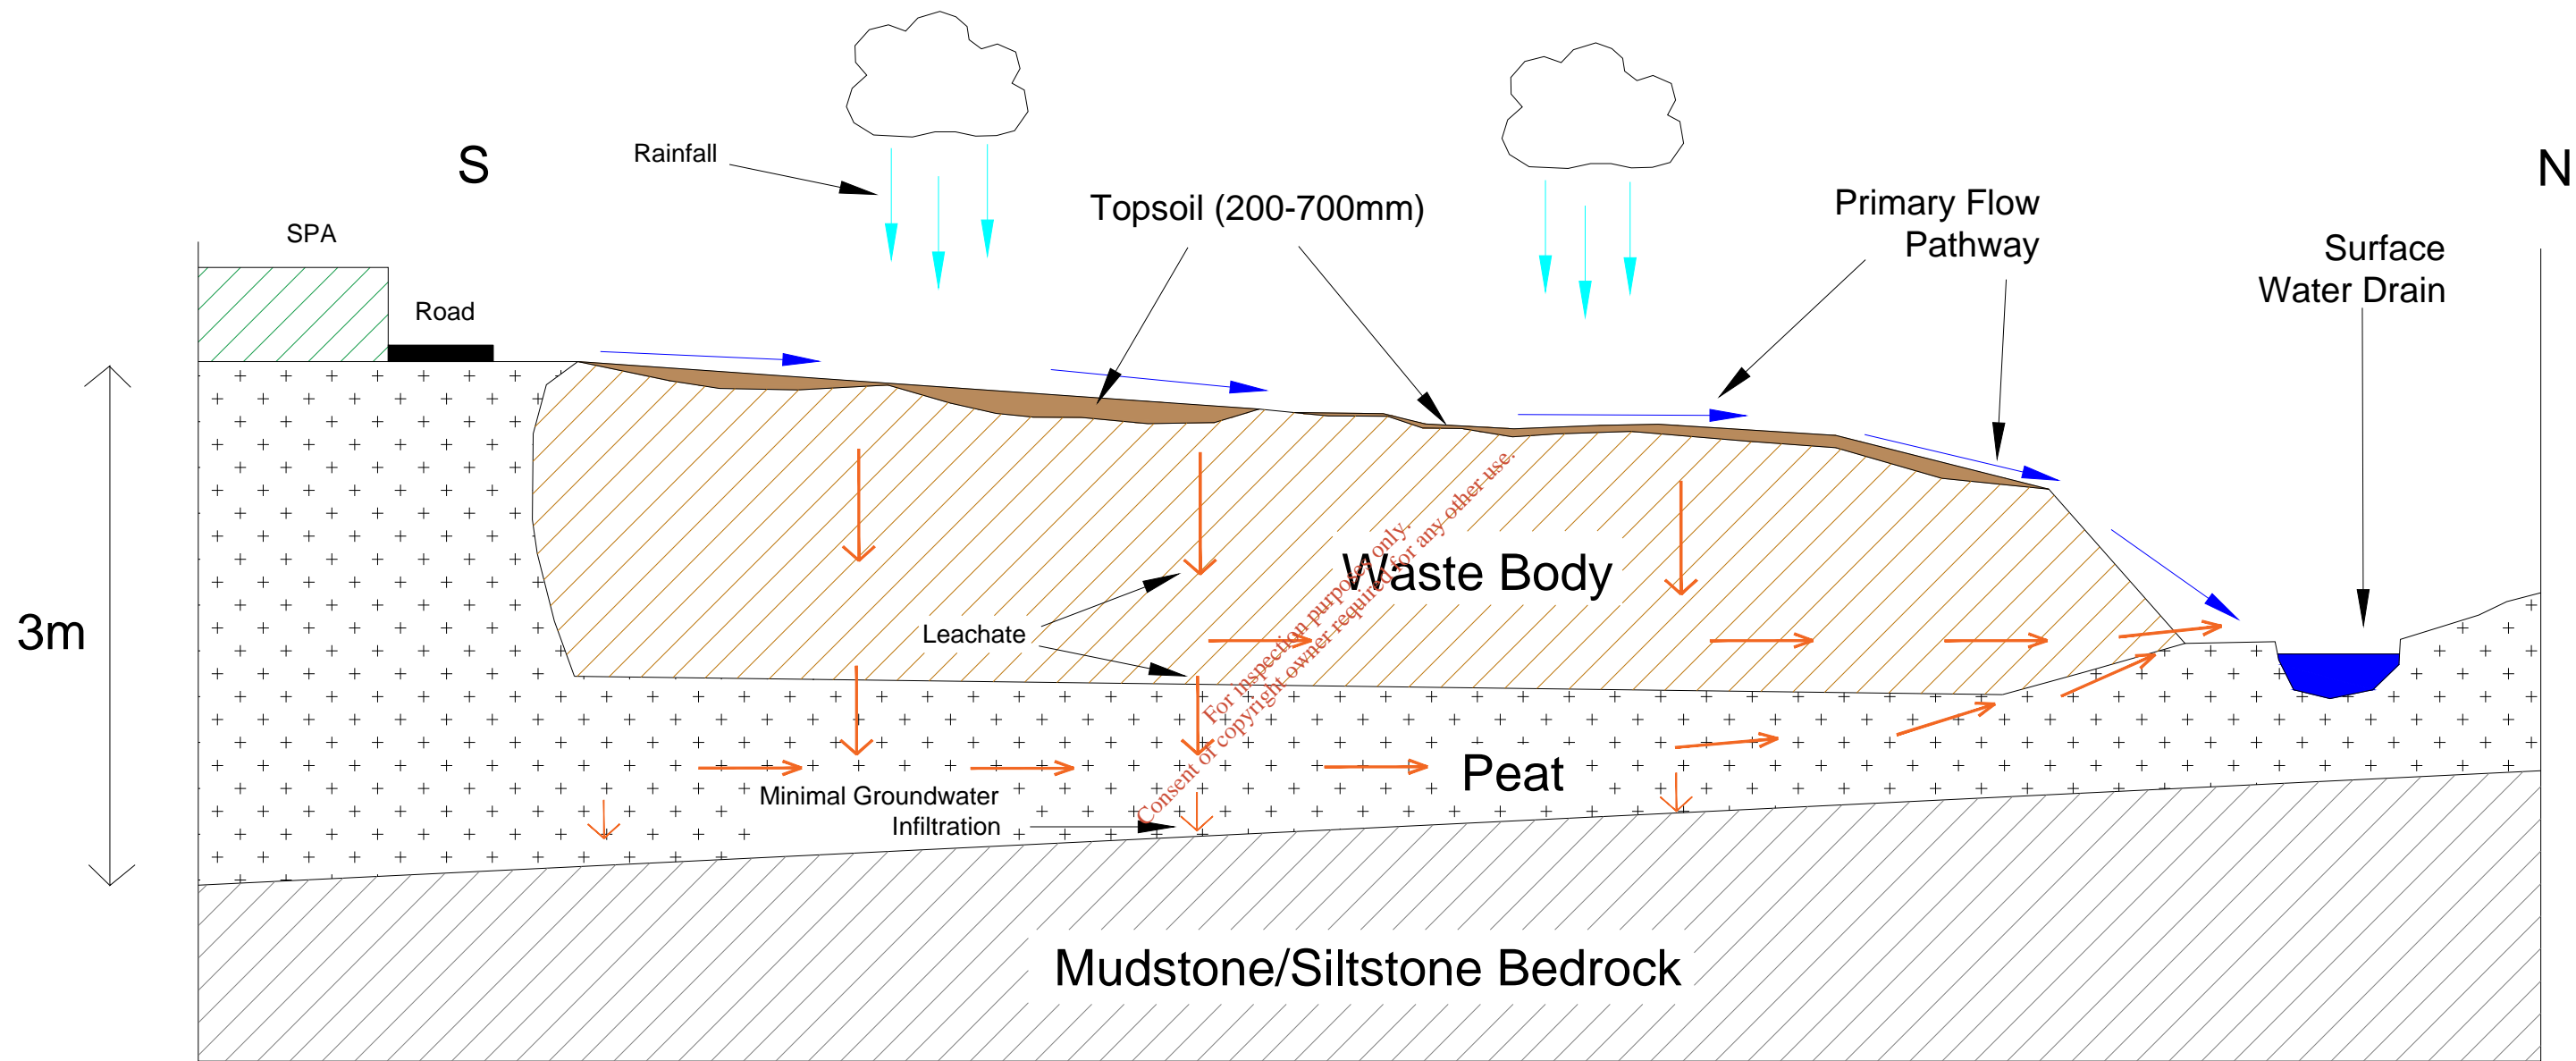
There is a thin layer of soils overlying the waste c200-700mm capping layer comprising top soil though it was not present continuously across the site. In some locations waste was visible at the surface. Waste is present across the entire 1.19Ha landfill area with a thickness of between 4-5m. It is underlain by peat. It is likely that rainfall recharge infiltrates the waste to its base. Because of the compaction of the waste on the peat the underlying peat layer is essentially impervious resulting in preferential discharge of leachate to the surface water drains around the site. Leachate migrates laterally to the drain along the north side of the landfill. It is likely that in the winter months there is substantial dilution of the leachate in the surface water courses downstream but in the drier periods of the year impacts will be more noticeable.
