FASSAROE INERT WASTE RECOVERY FACILITY

Fassaroe, Bray, Co. Wicklow

CLOSURE AUDIT REPORT

SLR Ref: 501.00180.00186
Version No: ISSUED
November 2020

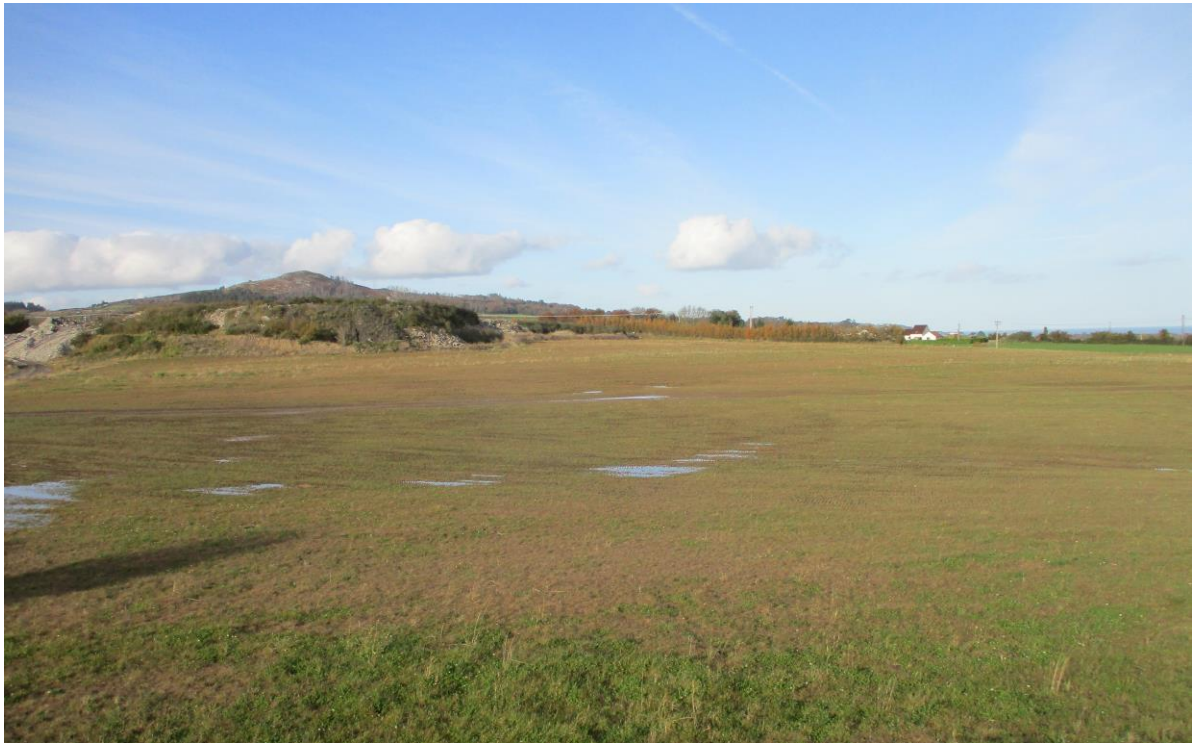
Plate 1 – General View North Across Backfilled / Restored Pit Area toward C&D Area

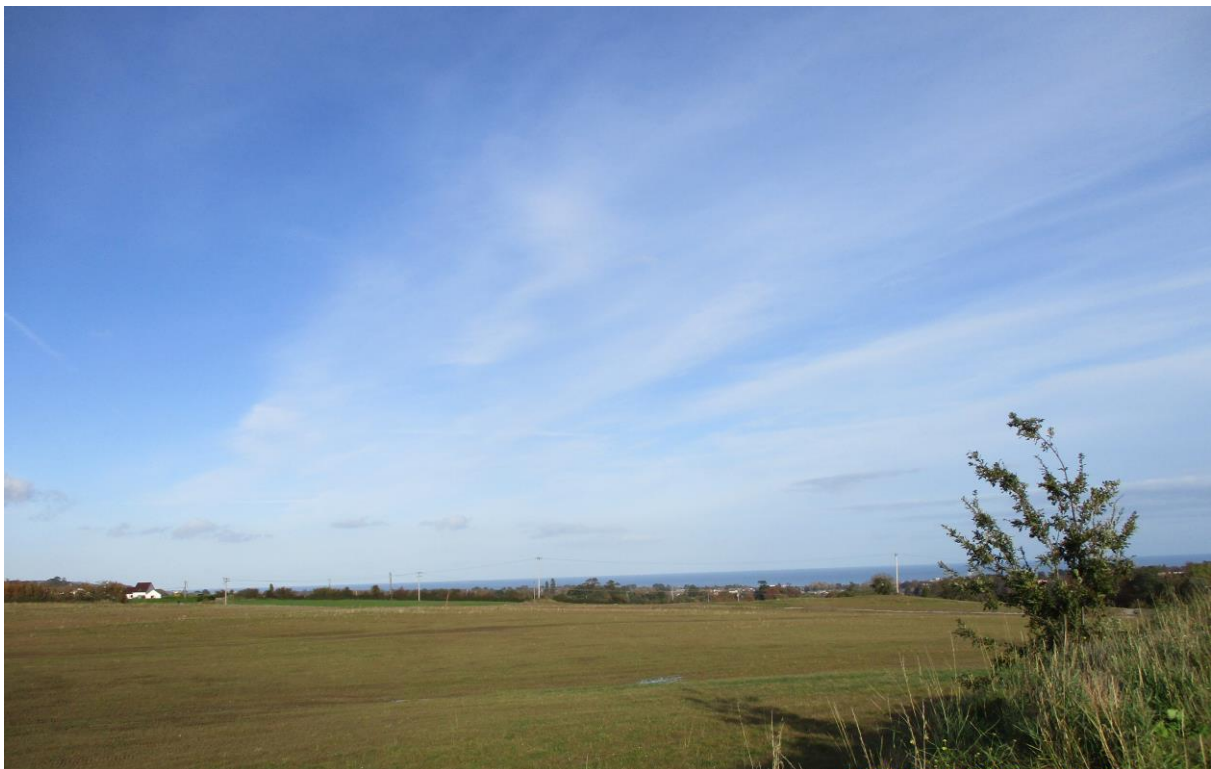
Plate 2 – General View North-East and East Across Backfilled / Restored Area

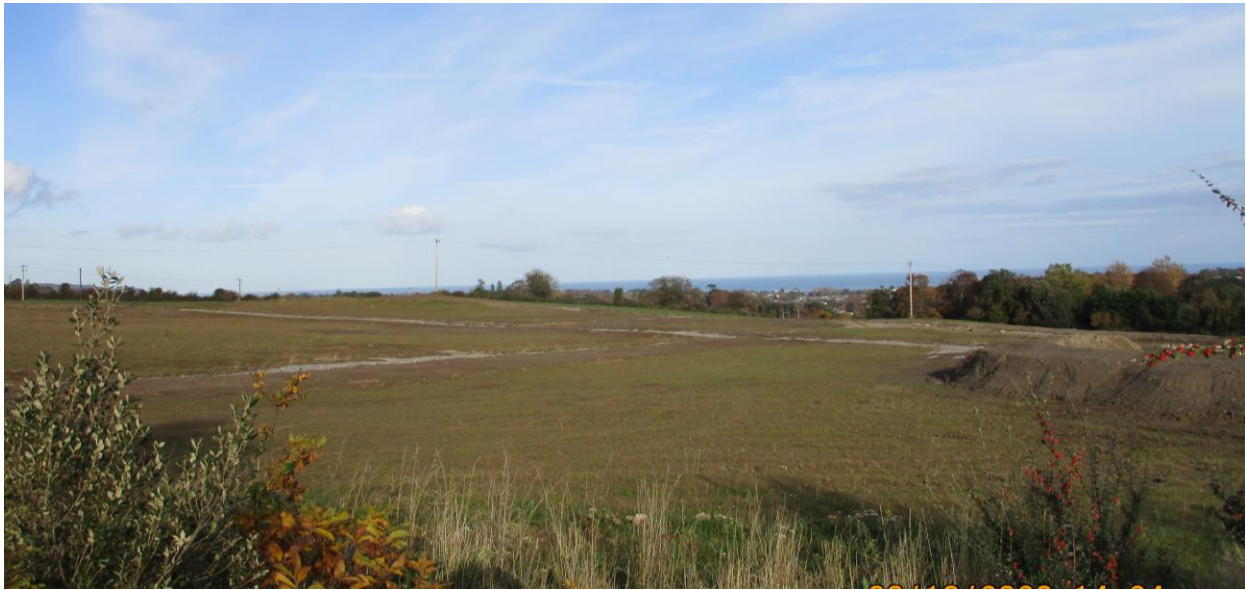
**Plate 3 - General View East across Backfilled / Restored Pit Area
with Land Drains in Centre Ground**

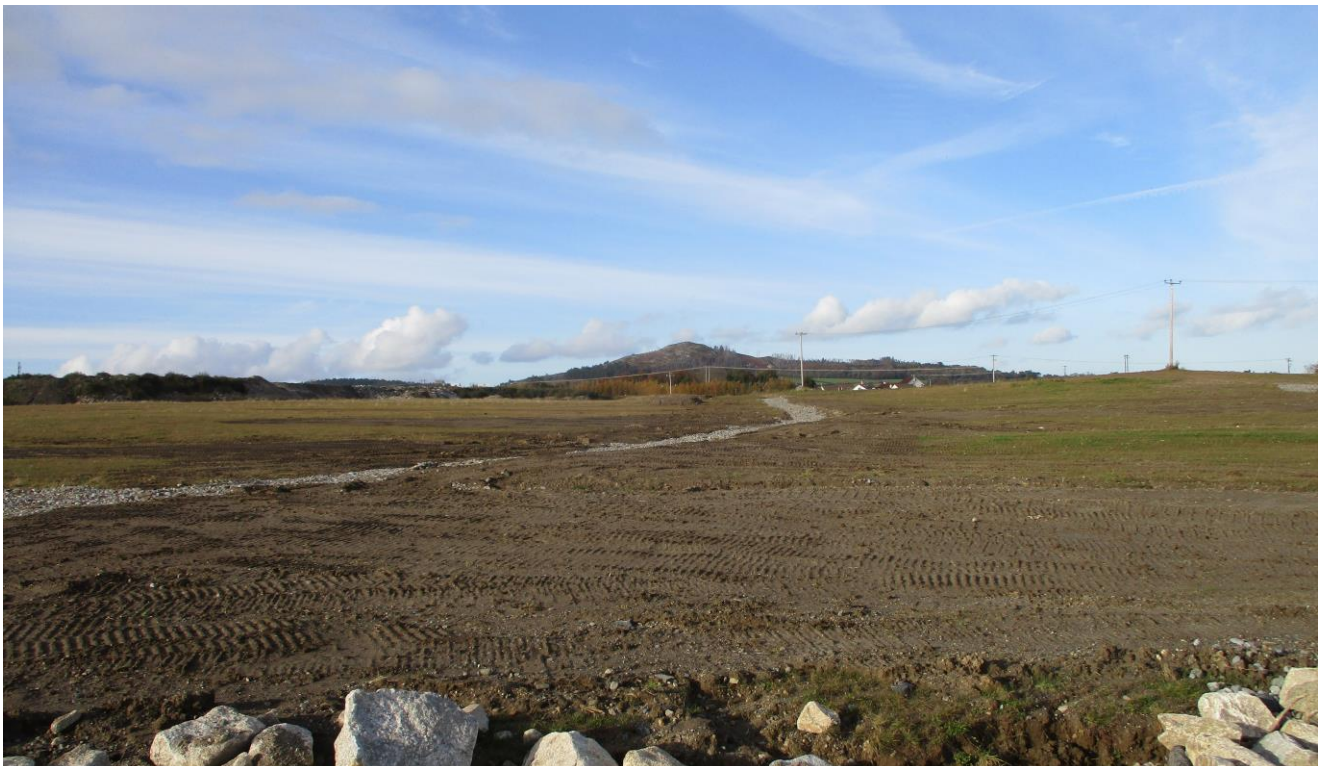
Plate 4 – View Looking North along Recently Completed Land Drain

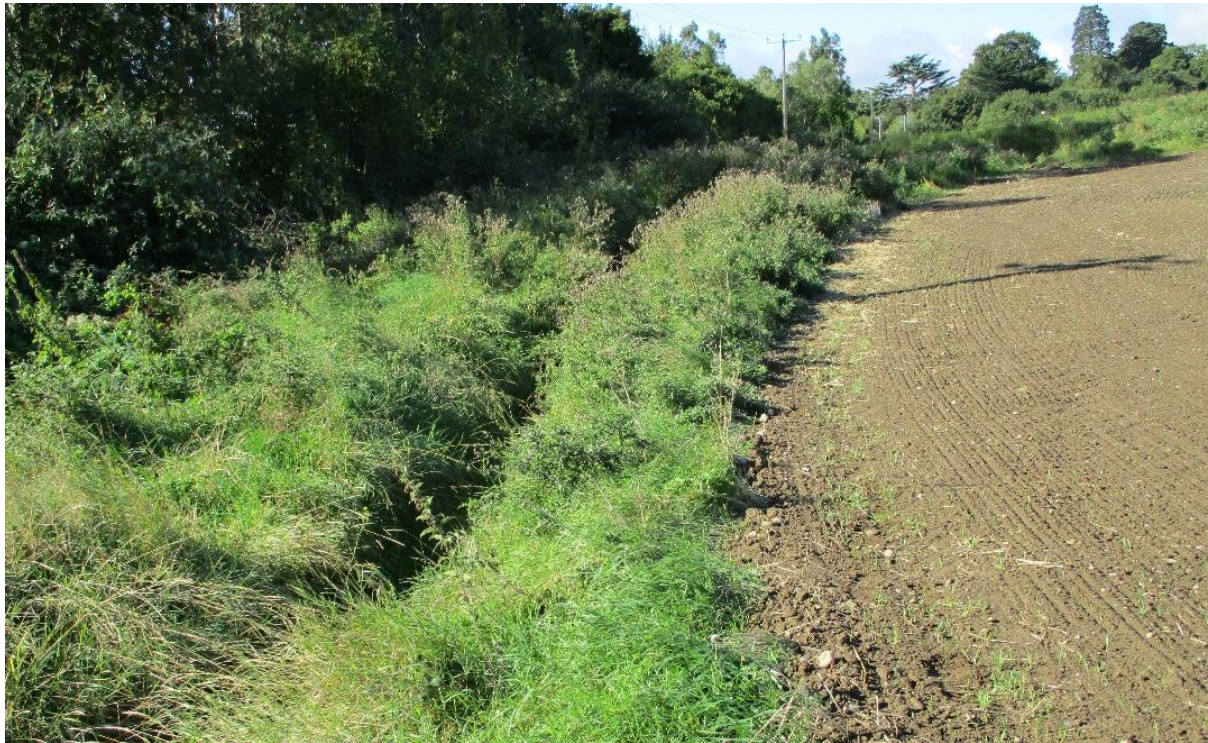
Plate 5 – View Along Existing Channel Leading from Backfilled Area to Manhole

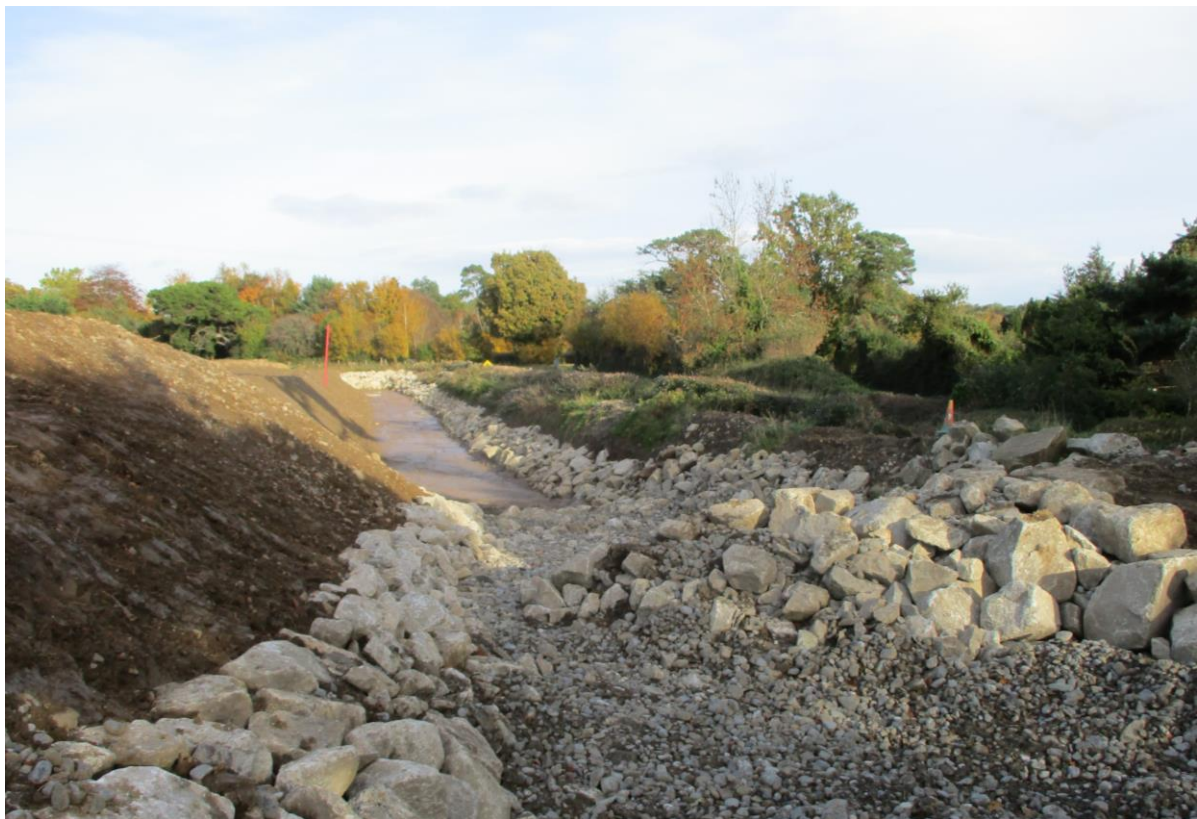
A 'baseline' model was run assuming that there was no holding pond in place and no flow restriction on the inlet to the existing 300mm diameter outlet pipe at the manhole. This model established that in the absence of the upstream holding pond, the recorded rainfall around November 2019 would have given rise to flooding upstream of the 300mm pipe, consistent with what was observed at that time.

Plate 6 – View from Existing Channel to Holding Pond Upstream of Manhole / Pipe Drain

The analysis also indicated that a 225mm diameter orifice plate (flow restrictor) should be placed upstream of the 300mm outlet pipe which crosses Fassaroe Avenue, to control flow and prevent pressure build-up in the pipe drain which runs at a relatively steep gradient downslope to the Cookstown River. In the absence of this control, the drainage analysis indicated that pressure build up could cause a manhole to lift and give rise to potential downslope / downgradient flooding.
