Cartron Big Landfill

Datagap Analysis & Tier 1 Assessment

Longford County Council

22 November 2017

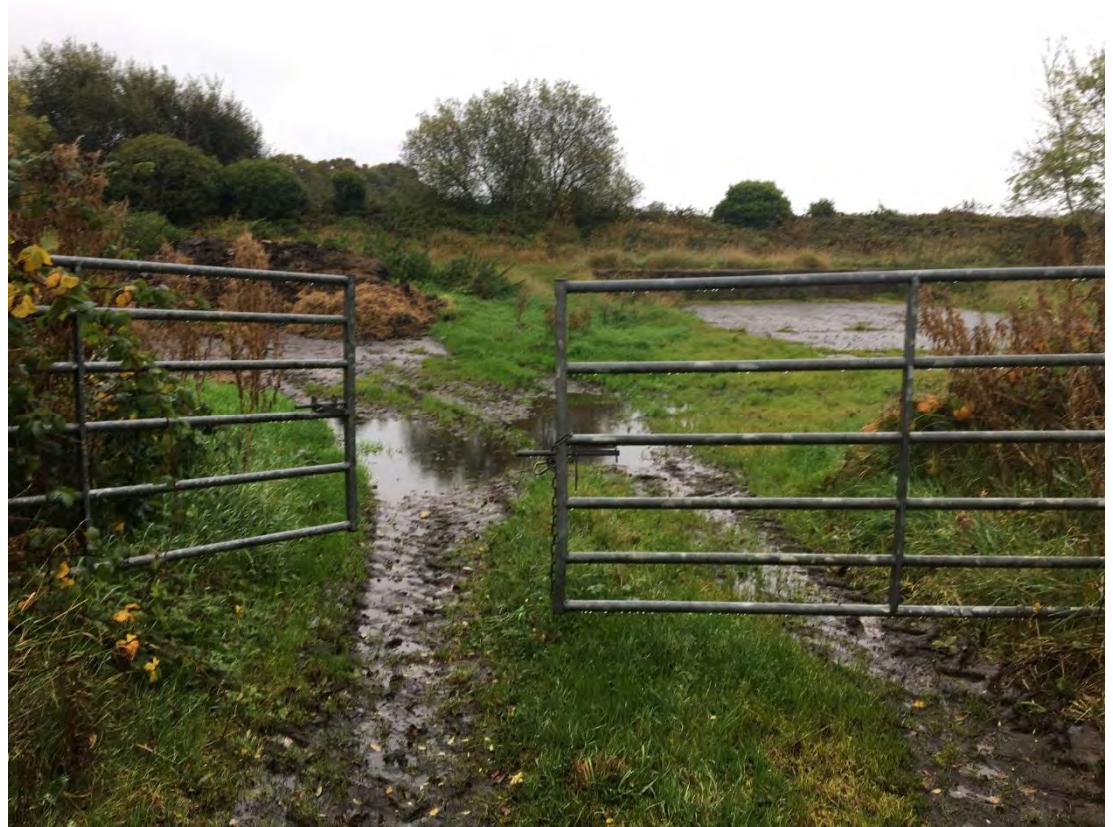
Main access gate to site from L3538 roadway.

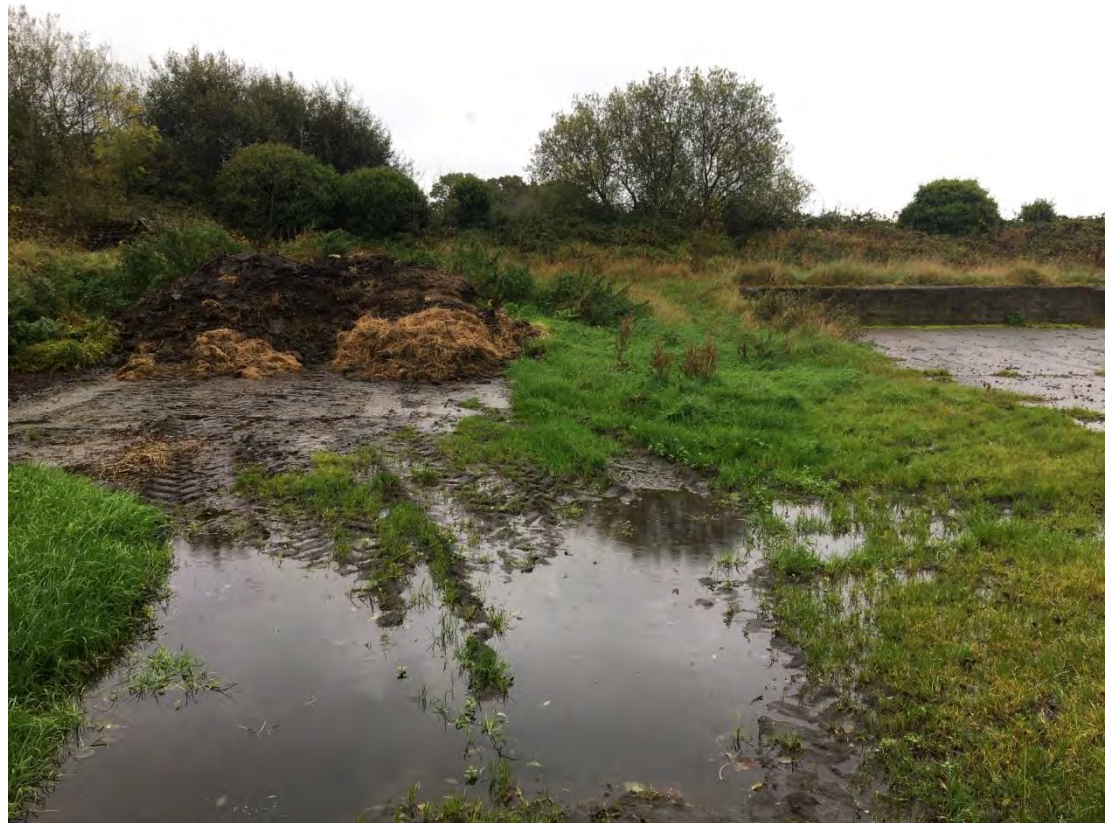
Concrete hardstand adjacent to main entrance gate, with surface ponding and farmyard manure.

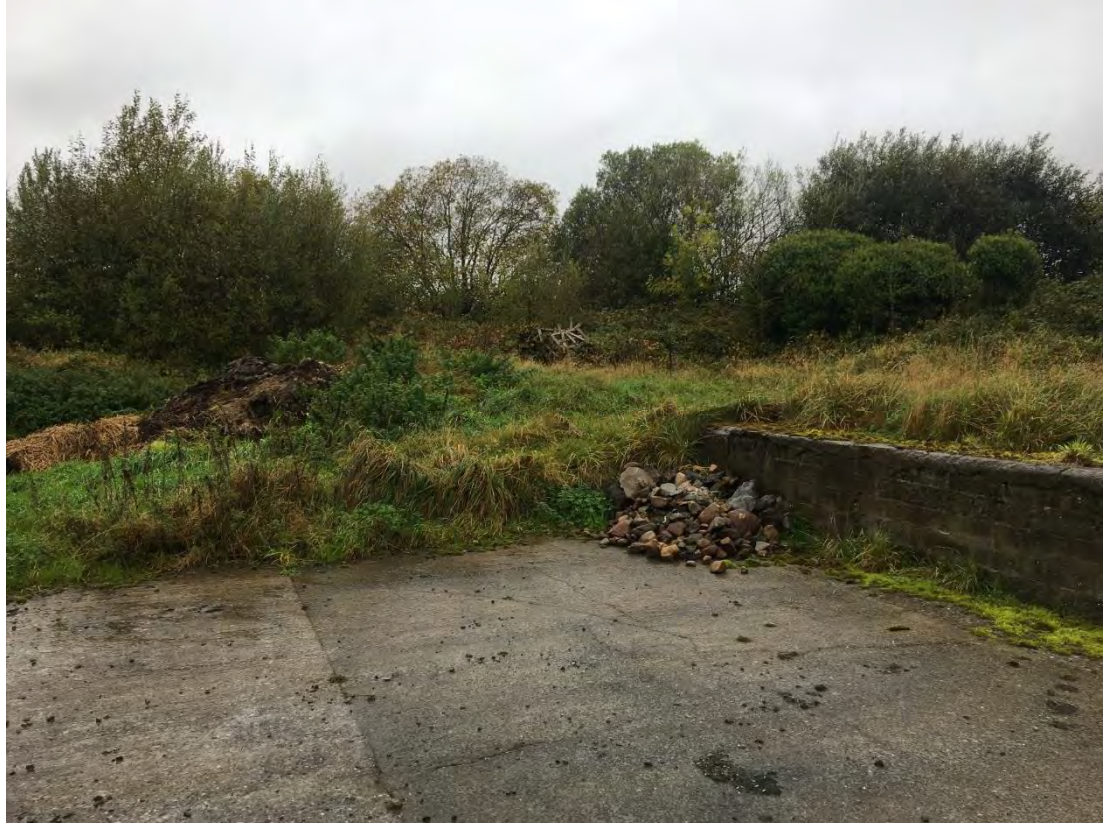
Debris and old wooden
pallets adjacent to concrete
hardstand.

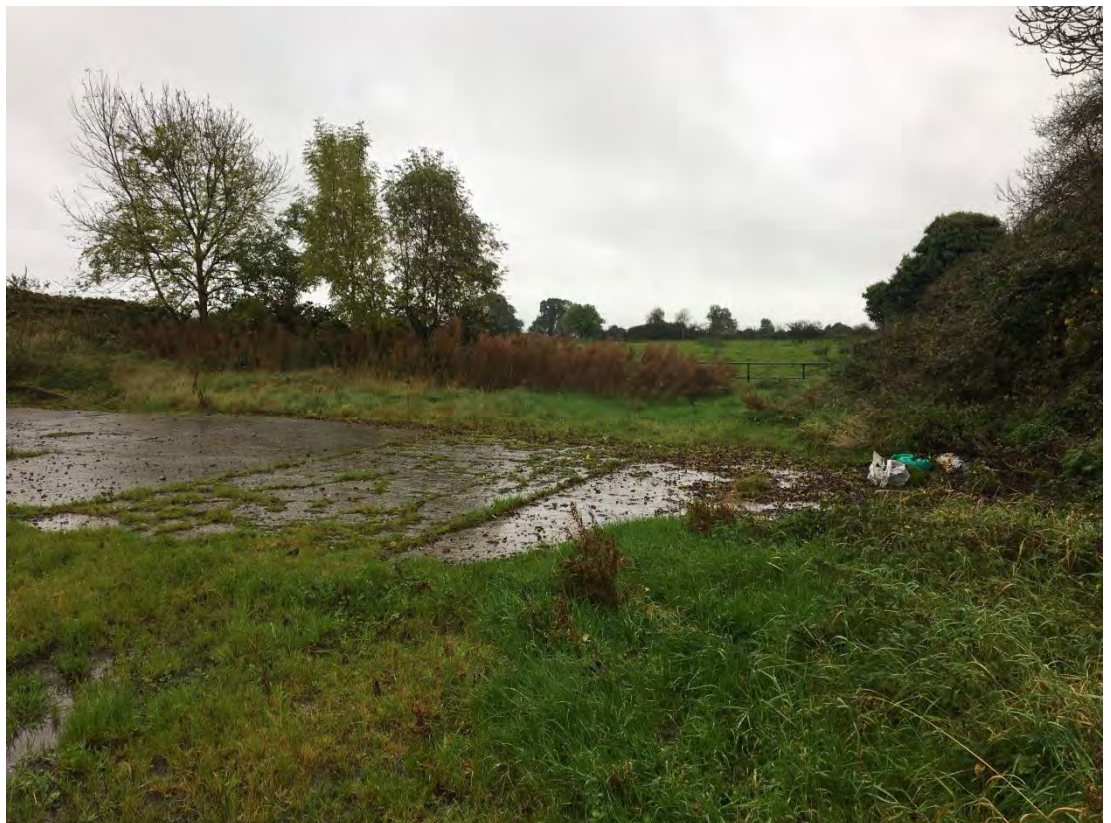
Rubbish bags adjacent to
concrete hardstand.

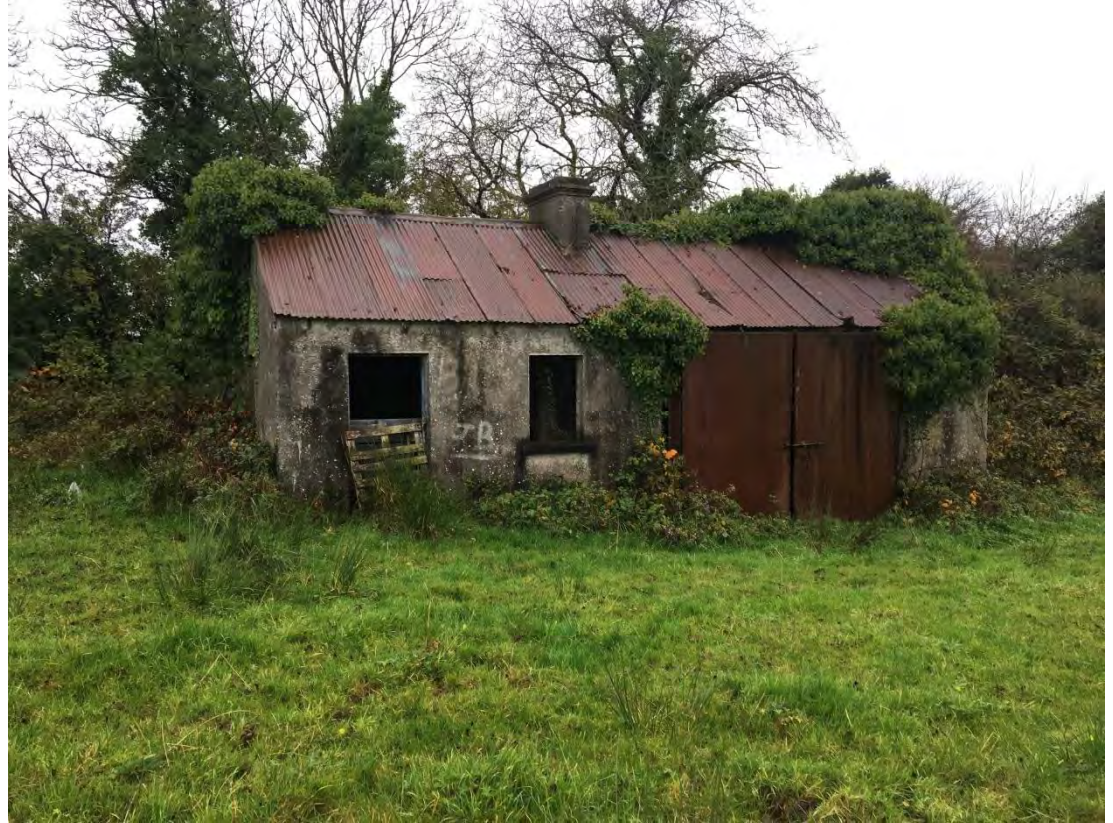
Derelict building adjacent to
main entrance.

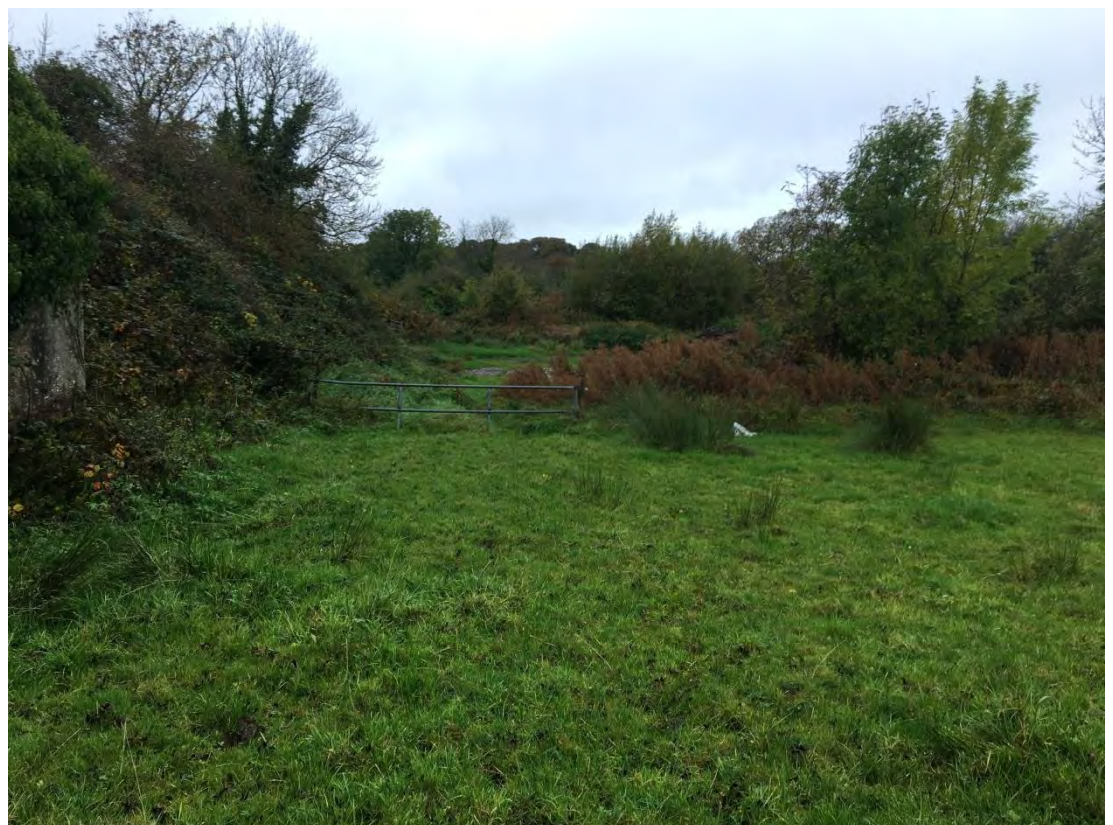
Internal access gate from
concrete hardstand to the
field.

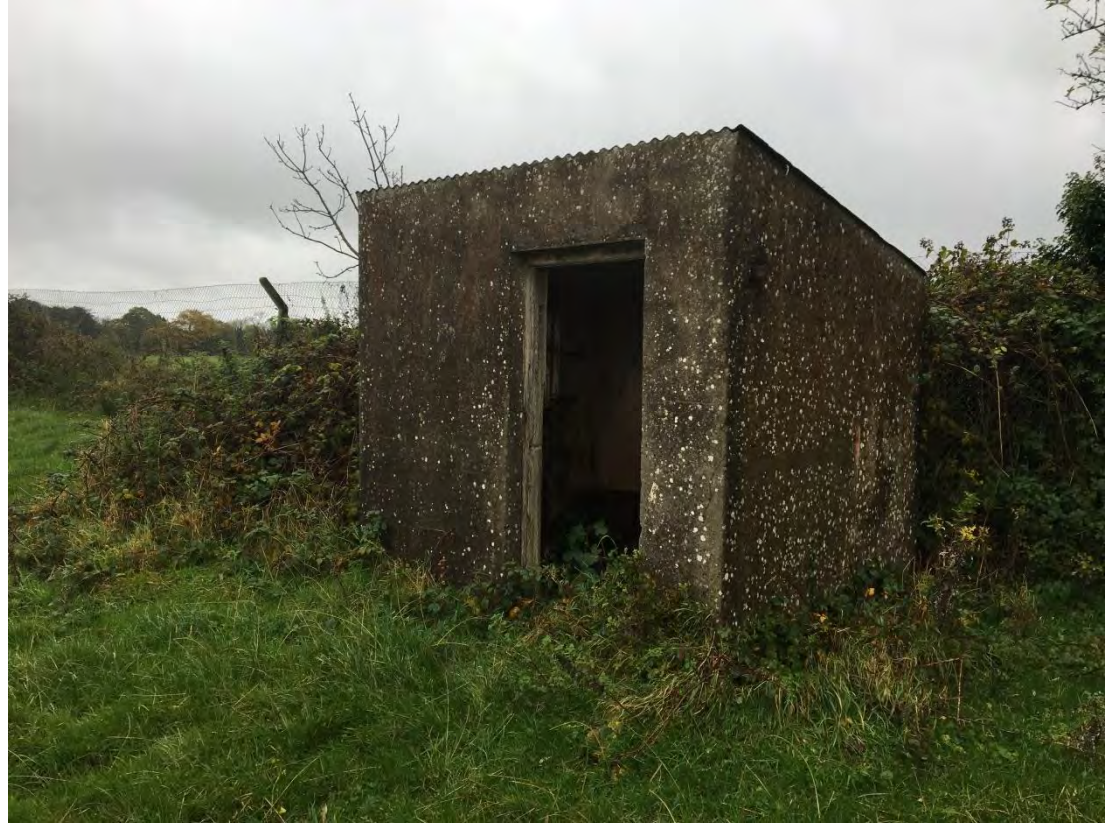
Derelict shed by second entrance in south-western corner.

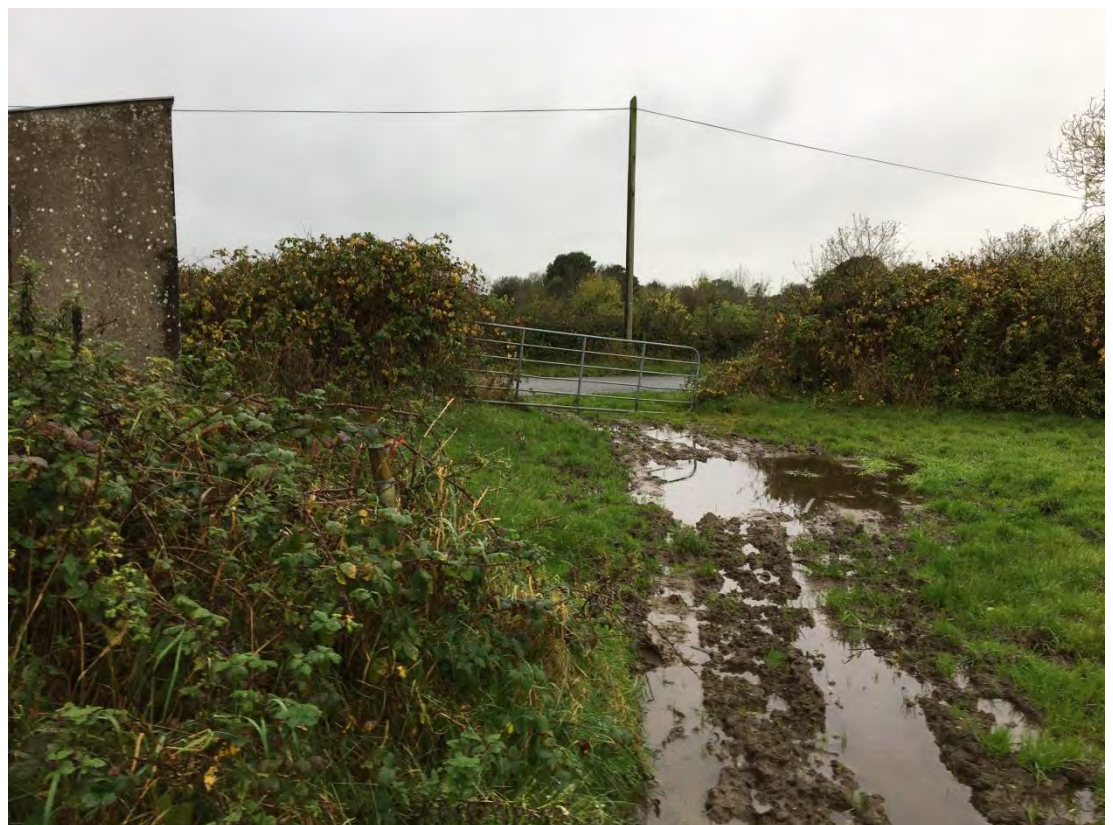
Entrance in south-western corner from L3538.

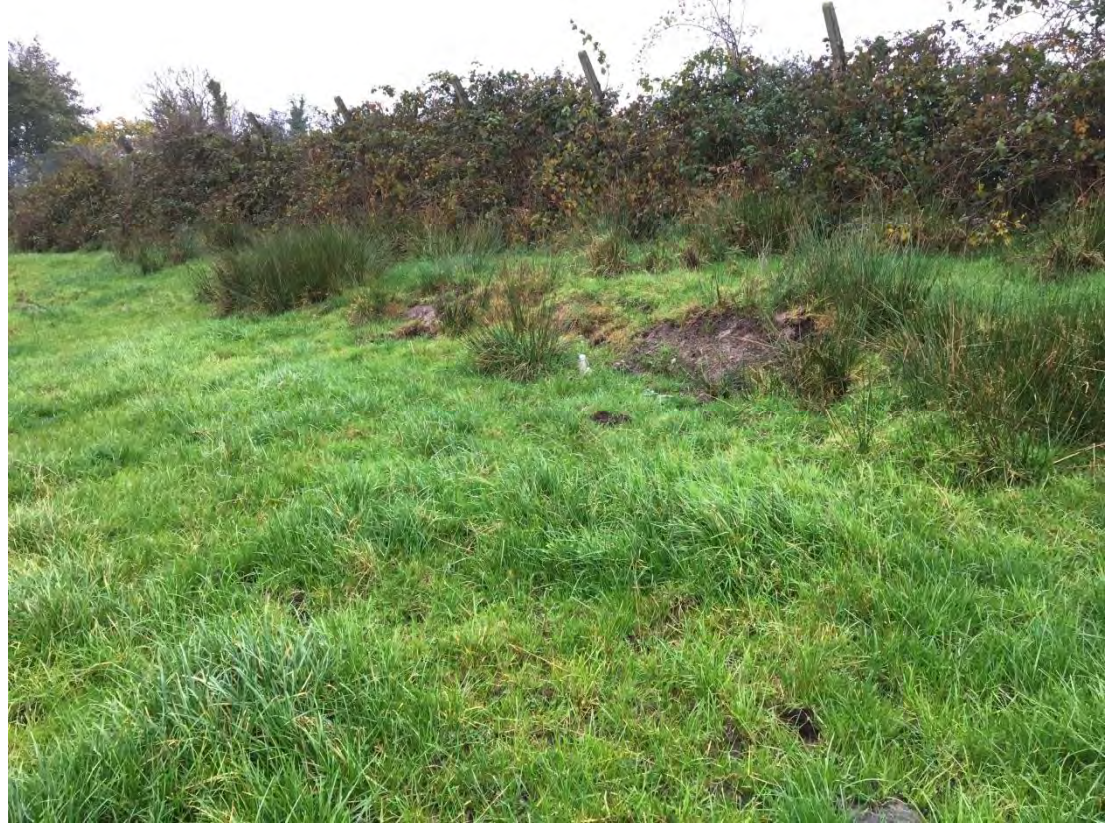
Evidence of subsidence along southern site boundary.

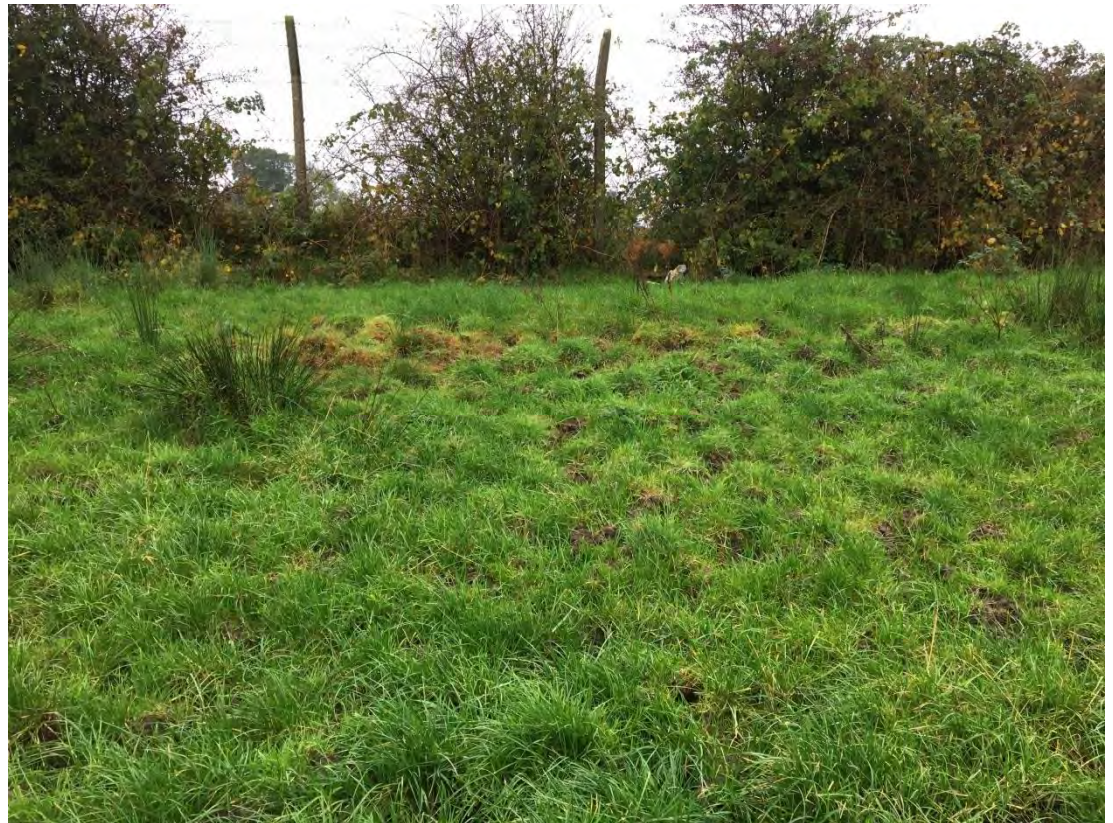
Evidence of subsidence along southern site boundary, 2 m high chainlink boundary fence.

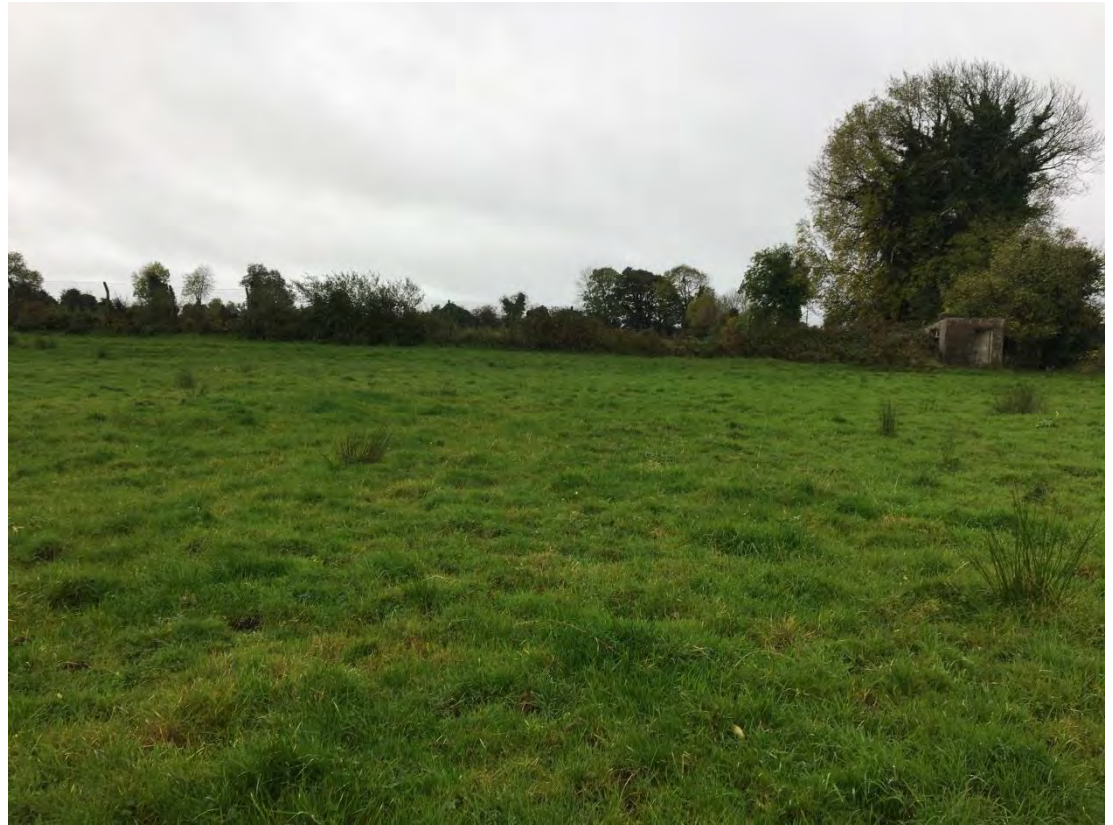
View of south-eastern
corner of field and southern
site boundary.

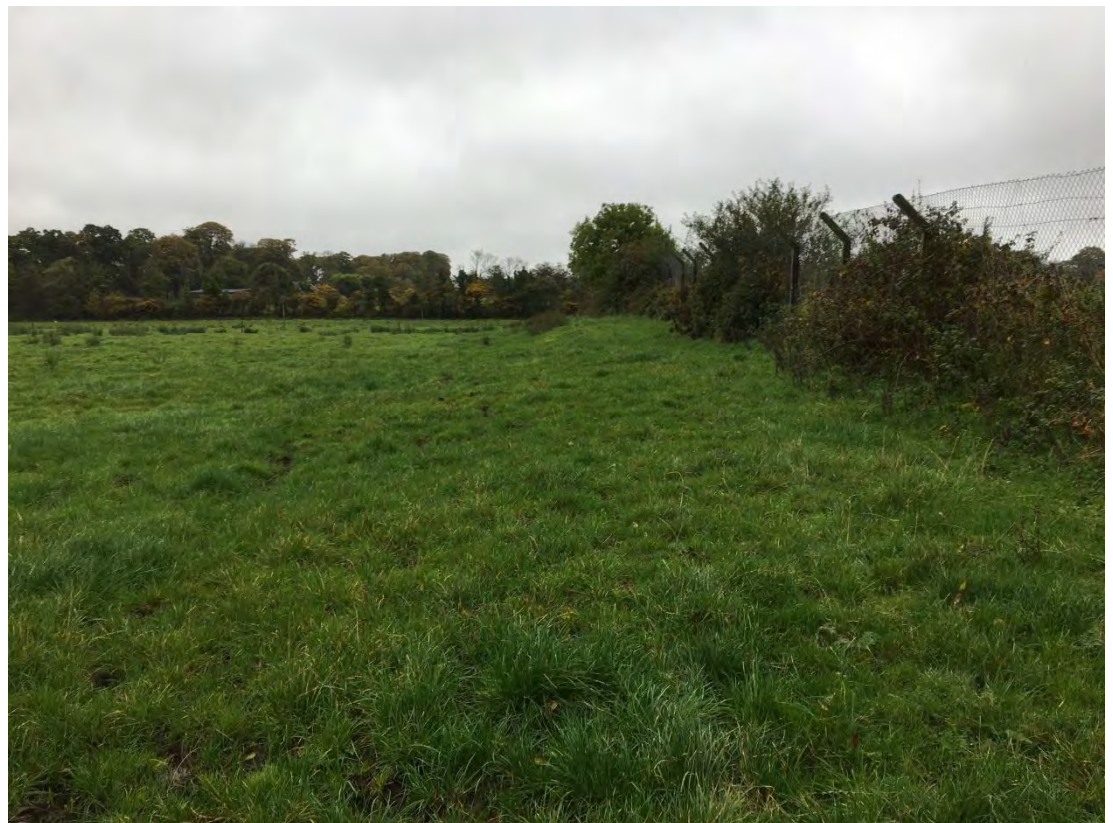
View along southern
boundary.

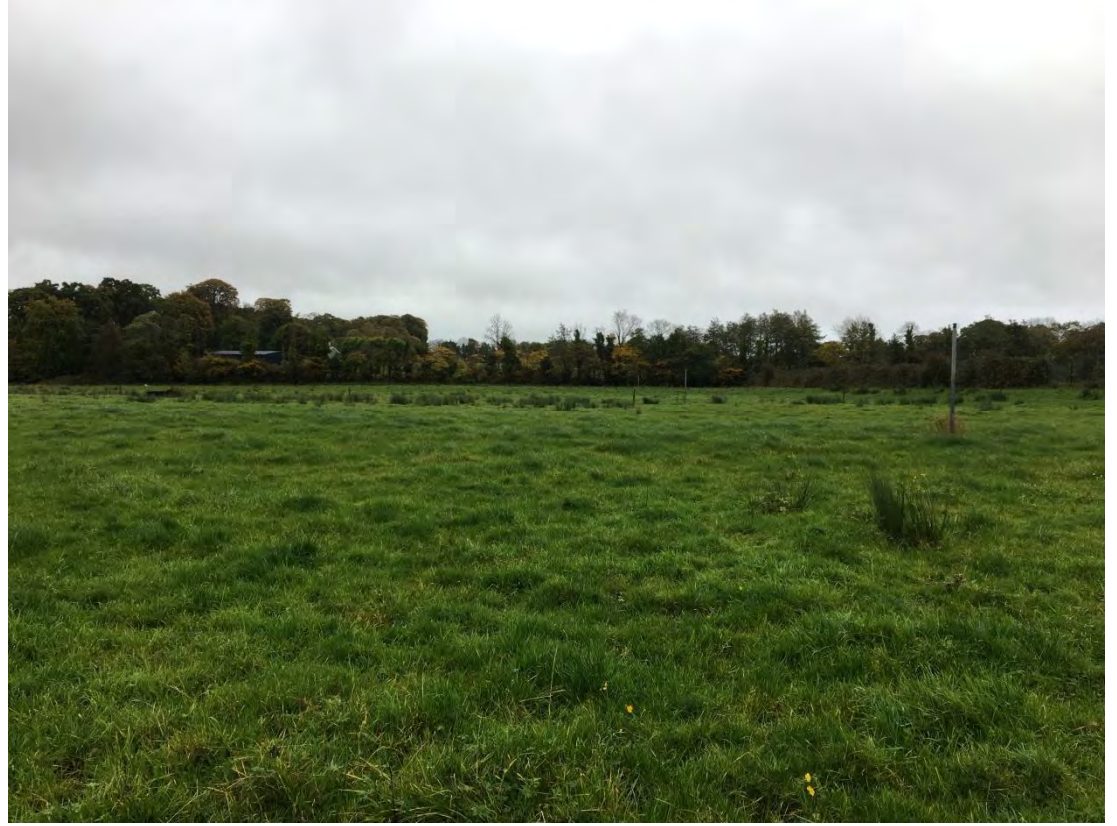
View across site from the east with landfill gas vent pipes visible.

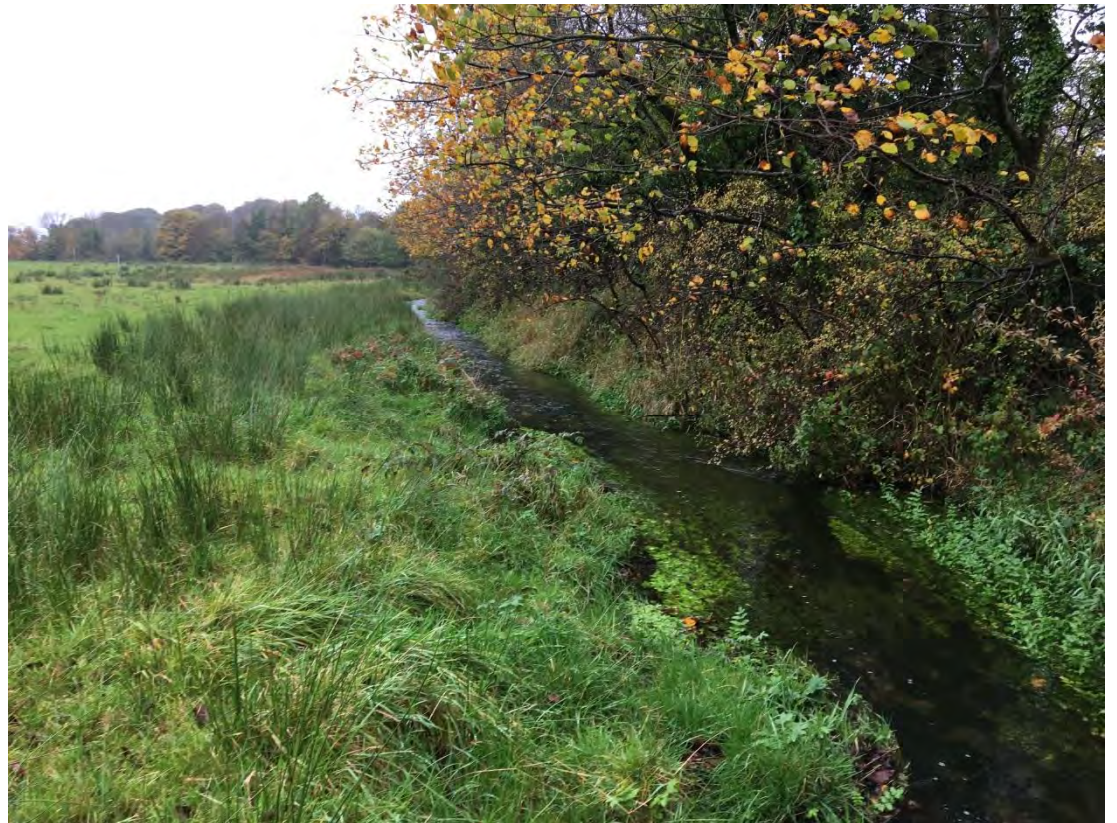
Clooncoose stream flowing along eastern boundary from south-east corner of site.

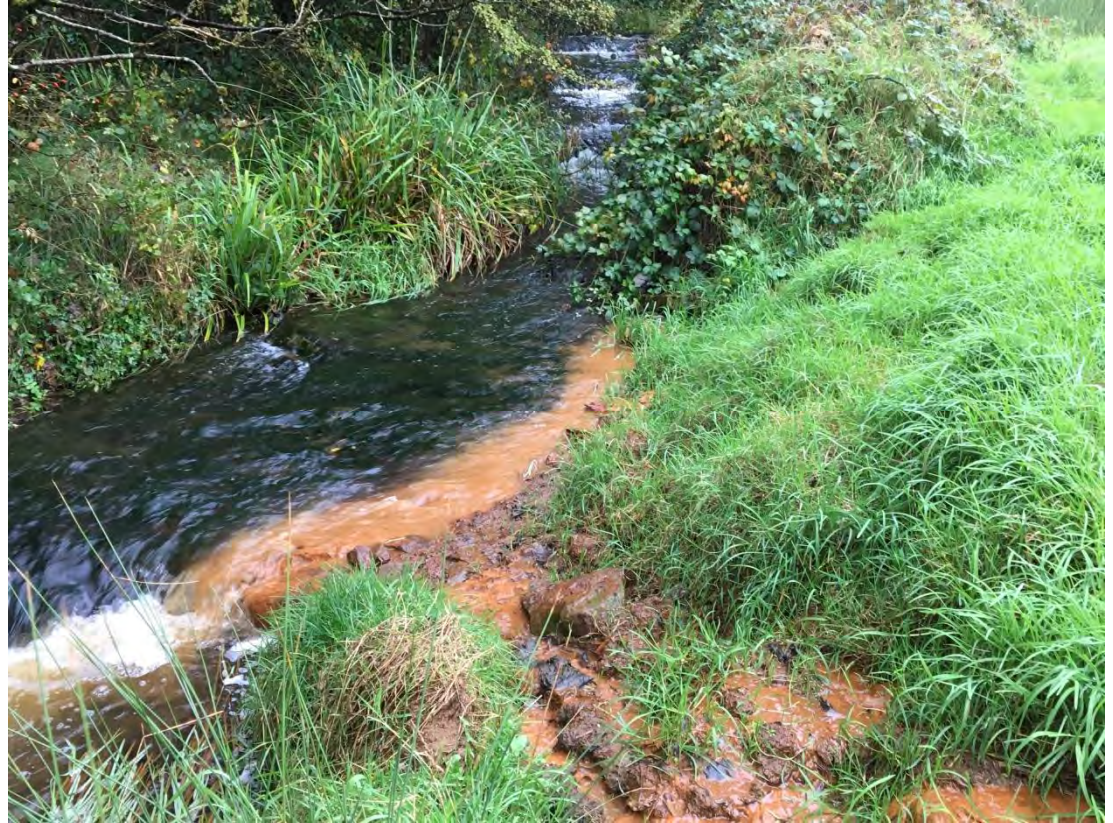
Leachate entering the stream, evidence of iron precipitate forming.

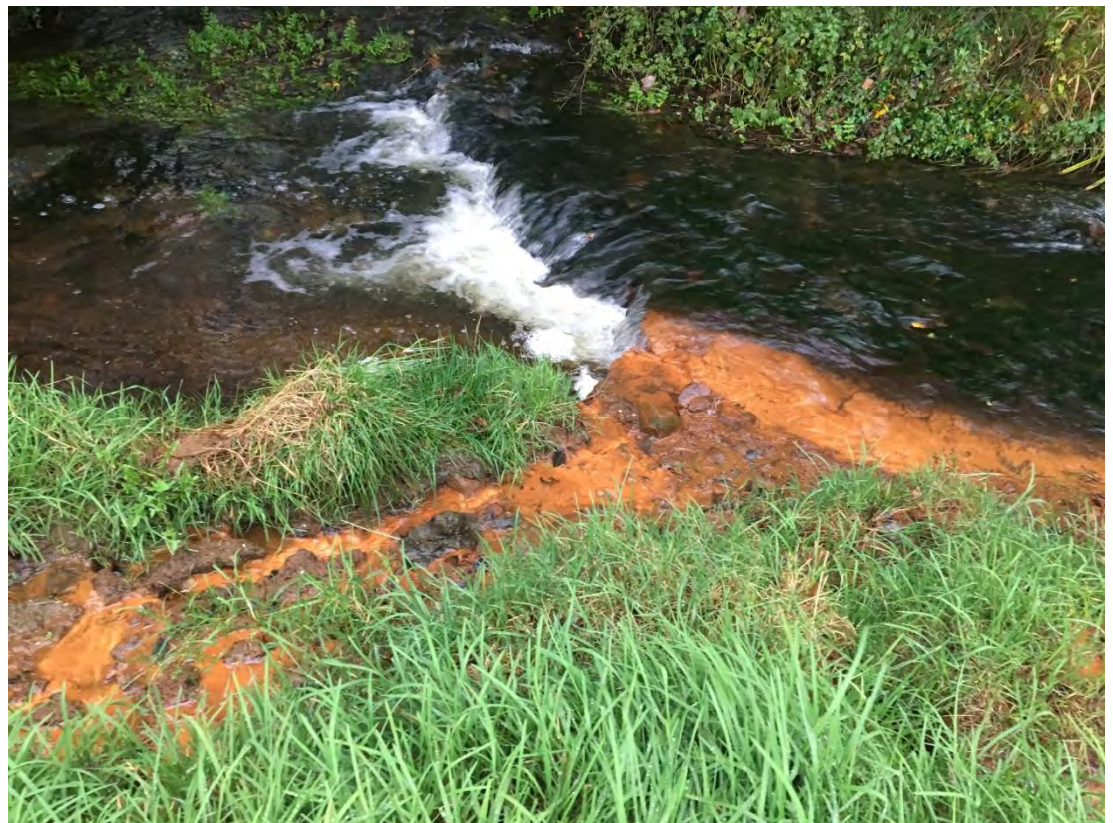
Leachate entering the stream, evidence of iron precipitate forming.

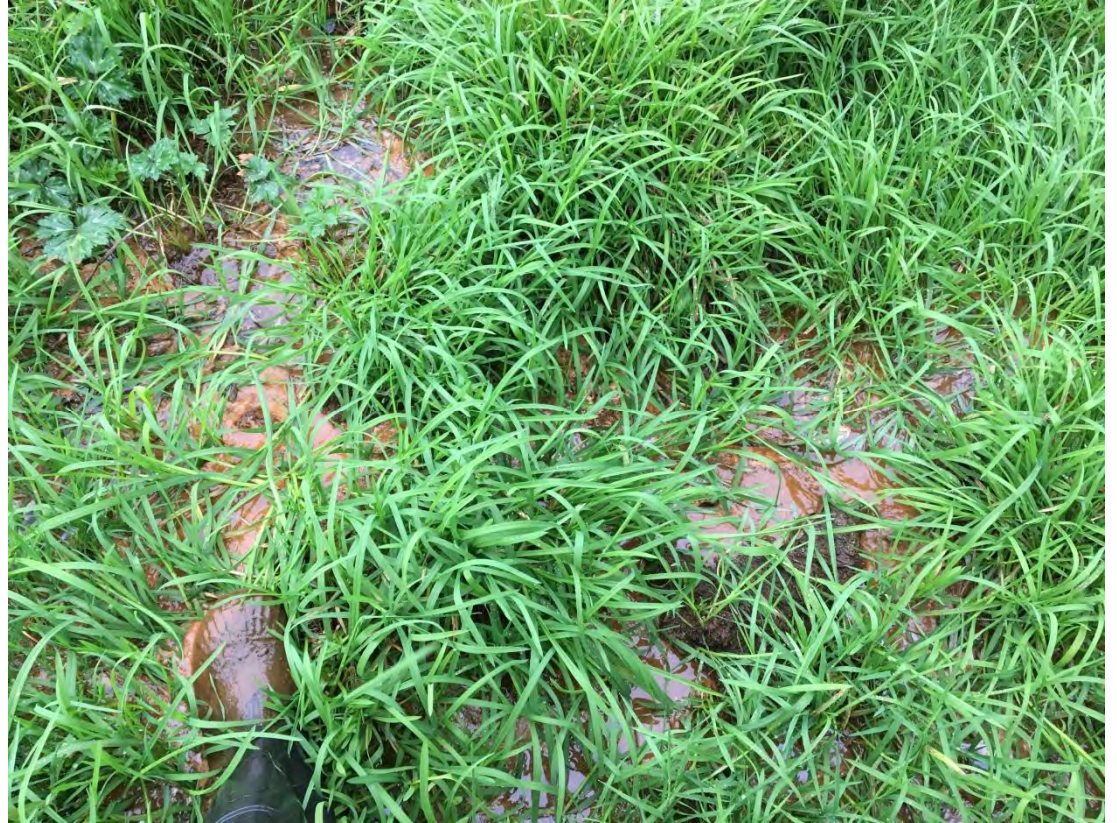
Waterlogged ground.

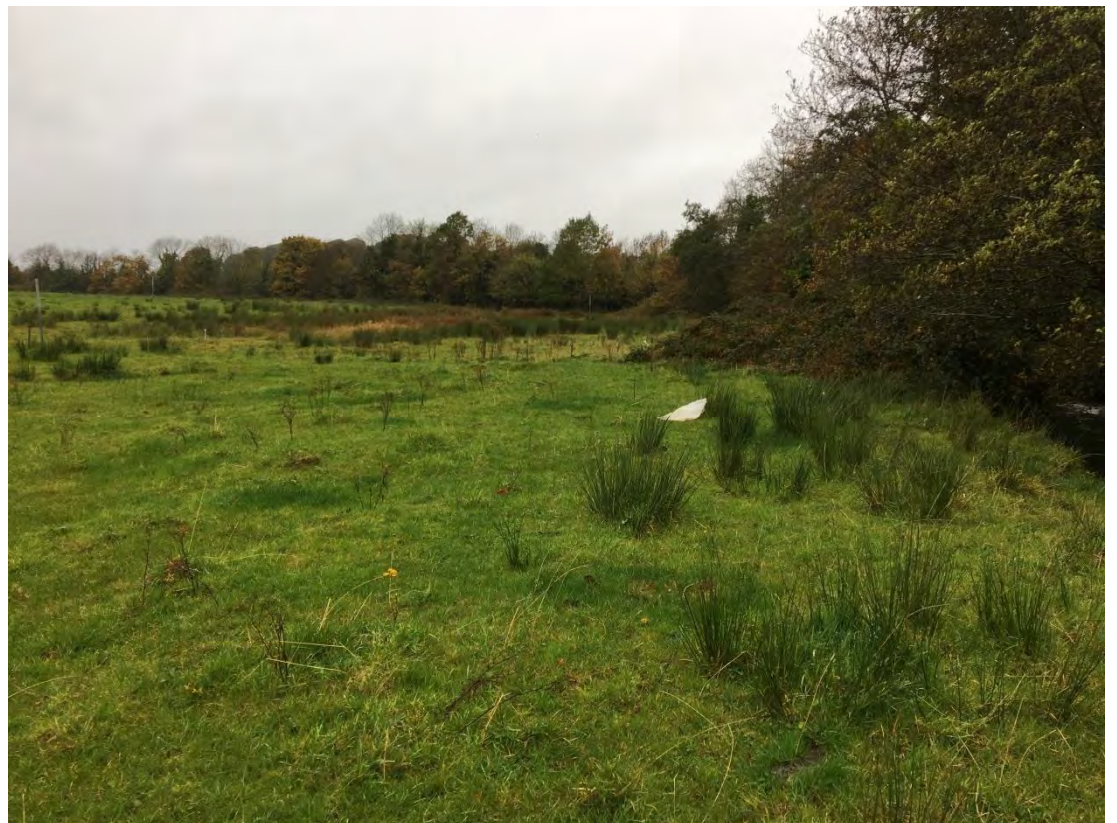
Change in vegetation where ground is waterlogged and leachate enters the stream.

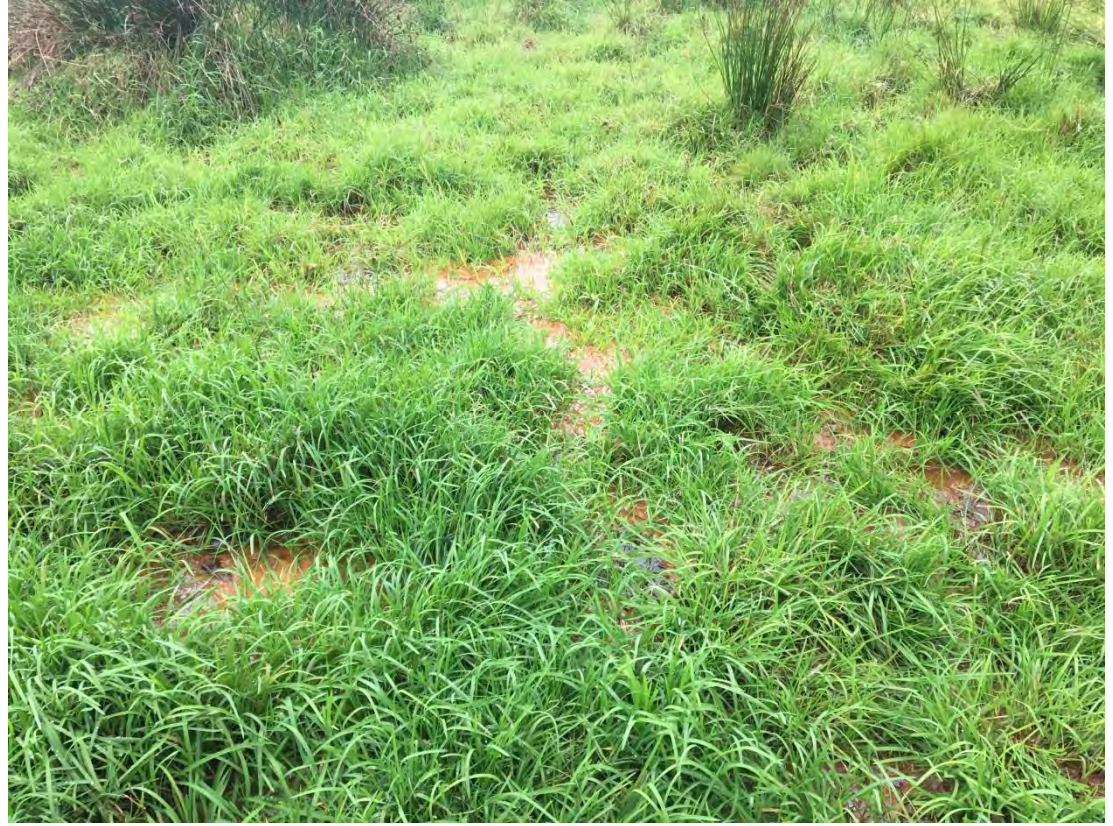
Waterlogged and boggy ground with leachate.

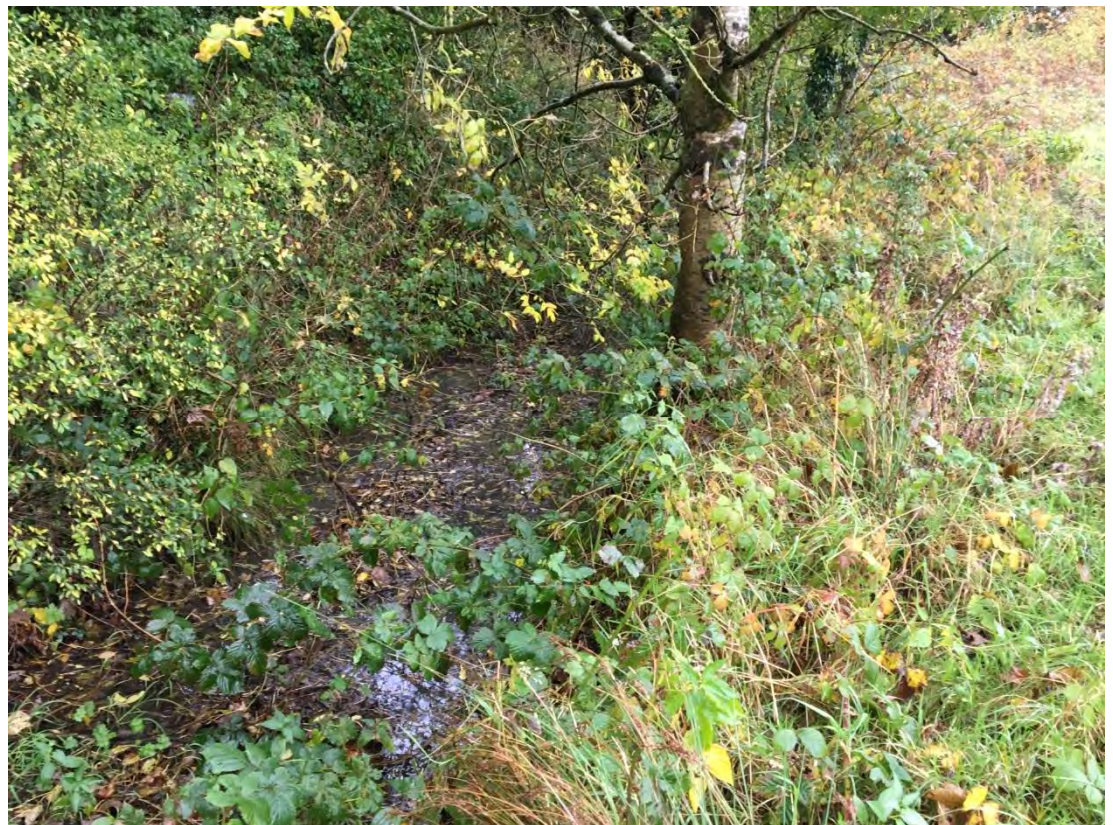
Drain along northern site boundary, low flow, and milky water.

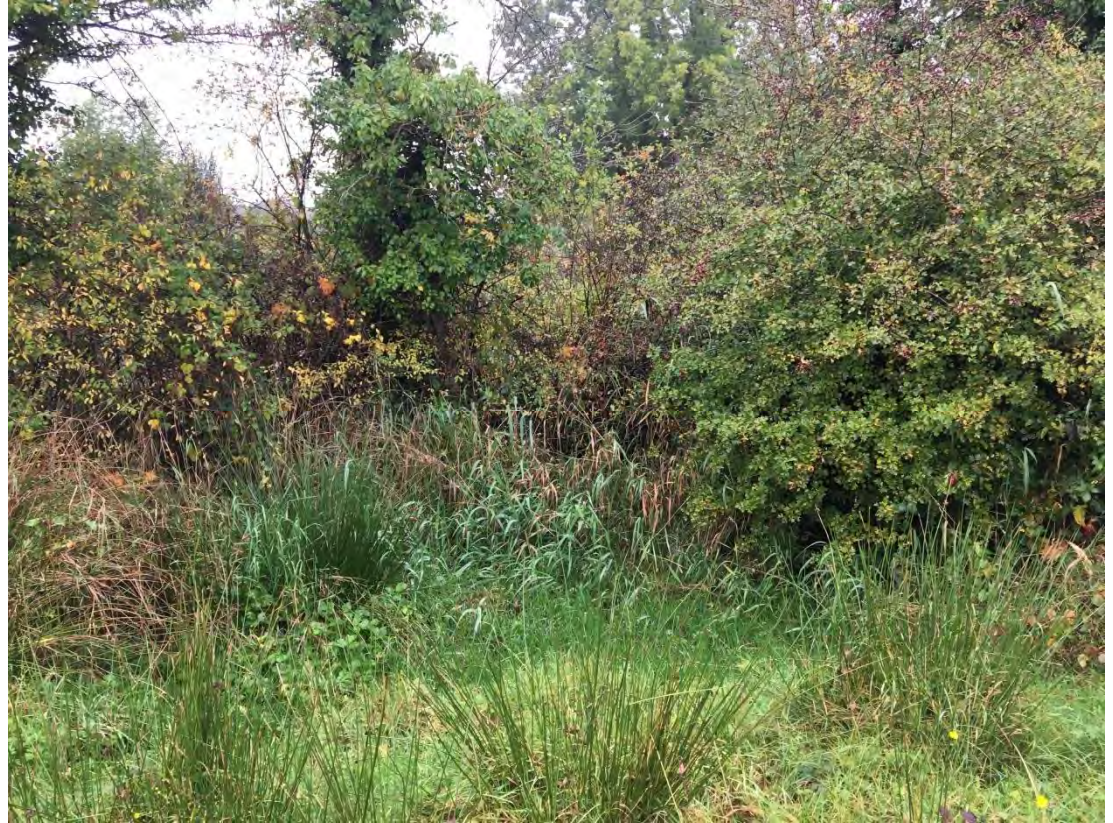
Boggy ditch in north-west corner of site.

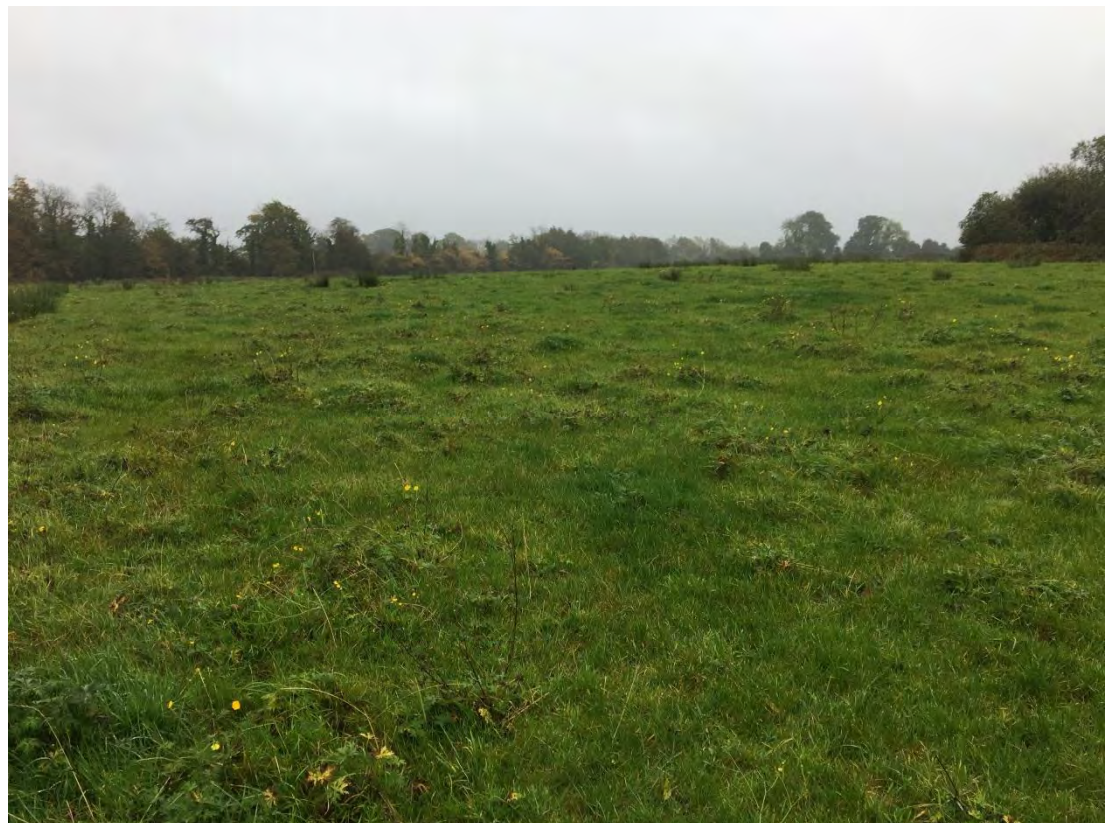
View of site from north-west corner.

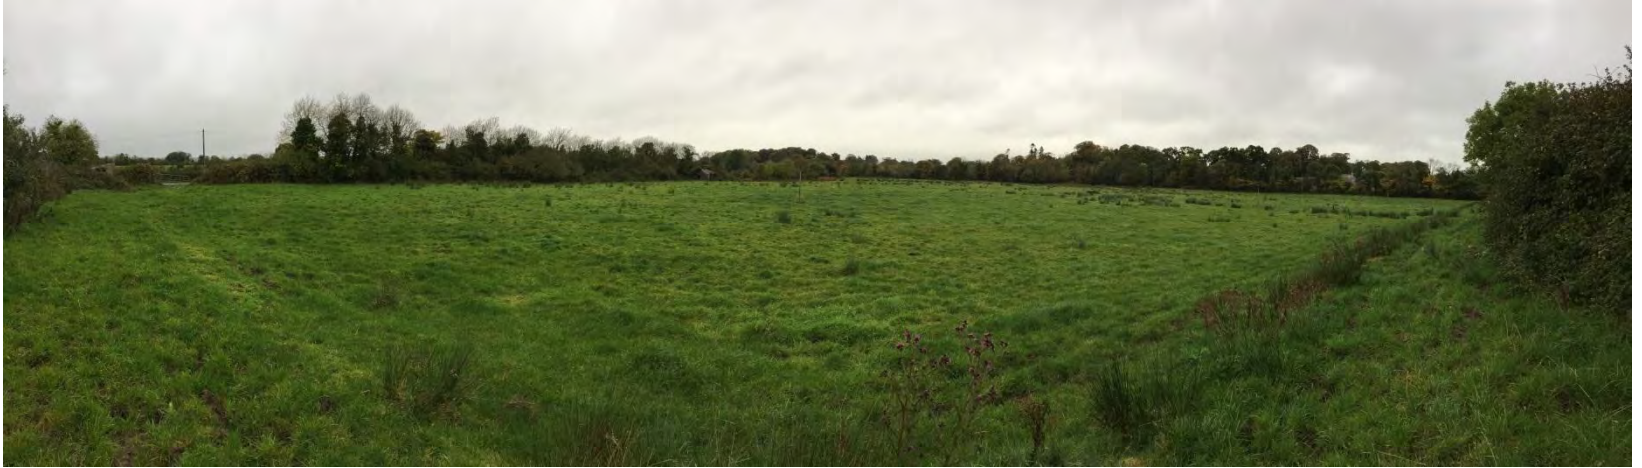
AECOM		PHOTOGRAPHIC LOG
Client Name: Longford County Council		Site Location: Cartron Big Landfill, Longford
		Project Number: 60549441
Photo No. 23	Date: 13/10/2017

Description: Panorama of site from southeastern corner.
