Saint Gobain Mining (Ireland) Ltd.,
Magheracloone, Carrickmacross, Co. Monaghan

Environmental Liabilities Risk Assessment

8th April 2021

Report No 2020/55/02

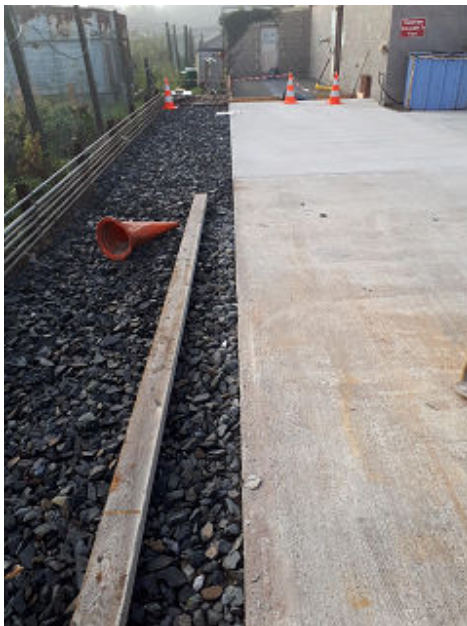
Sept. 2020: Concrete slab extended in front of oil pipelines – see photo below. This slab has a gradient that drains water from the slab to the existing wash bay drainage system on site. Water from the Washbay drain passes through the oil interceptor before entering the water settling lagoons on site.

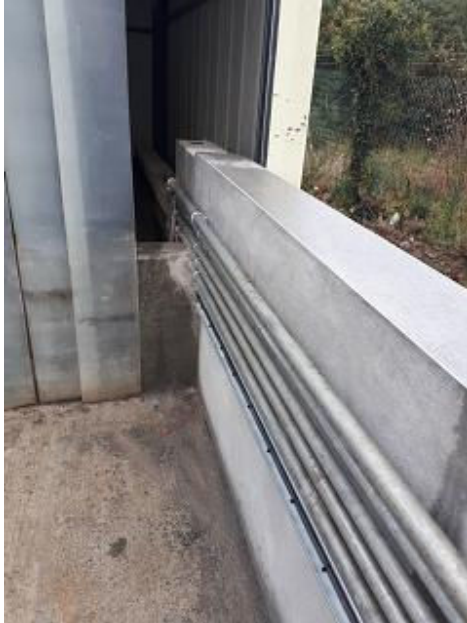
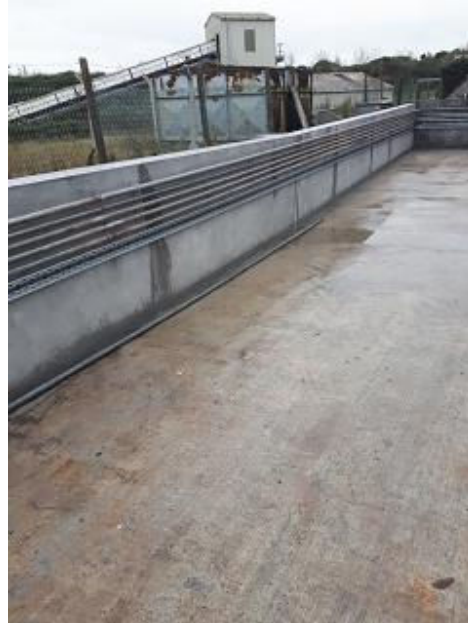
October 2020: A new wall was built along the boundary of this concrete slab to a height of approx. 1m. The oil pipelines were moved above the existing bund wall and be fixed to the inside of this new wall and the slab boundary. Any leaks or drips will therefore flow into the Washbay drain and on into the new Class 1 oil interceptor.

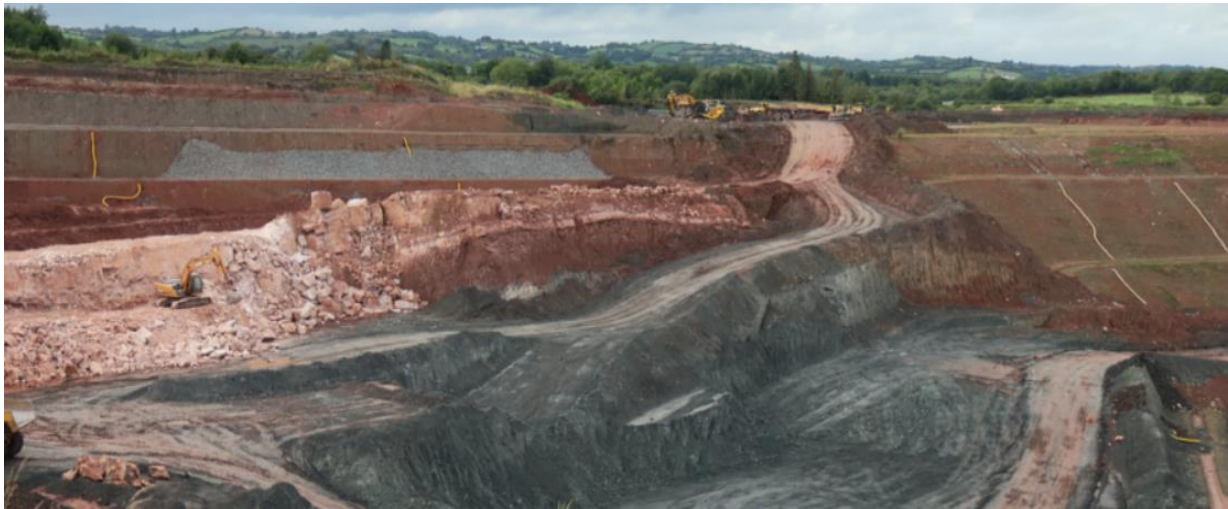
Figure 4.2: Good surface runoff management practices at the Knocknacran open cast, including plating of the bench faces and drainage of the benches
