CHURCHTOWN WASTE LICENCE REVIEW

Emission Compliance Report

794-NI-RWM-IBR1455
Final
12th February 2024

Donegal County Council

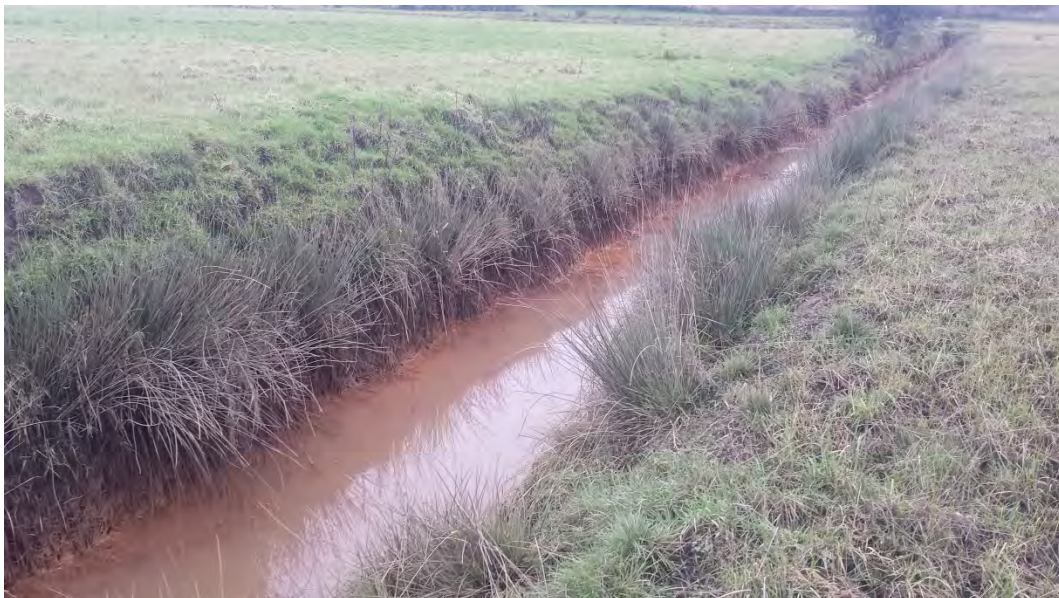
Photo 5.1 Surface water Drain to southwest of waste body

Visual evidence of potential leachate impact on the surface waters in the vicinity of the landfill was observed during the site walkover as is evident in **Photo 5.1**. However, this impact is likely to have been caused prior to current works being undertaken at the site with no observed leachate breakout from the site noted post completed capping works. As mentioned above, leachate will not be contained at the site until completion of the M&E works.

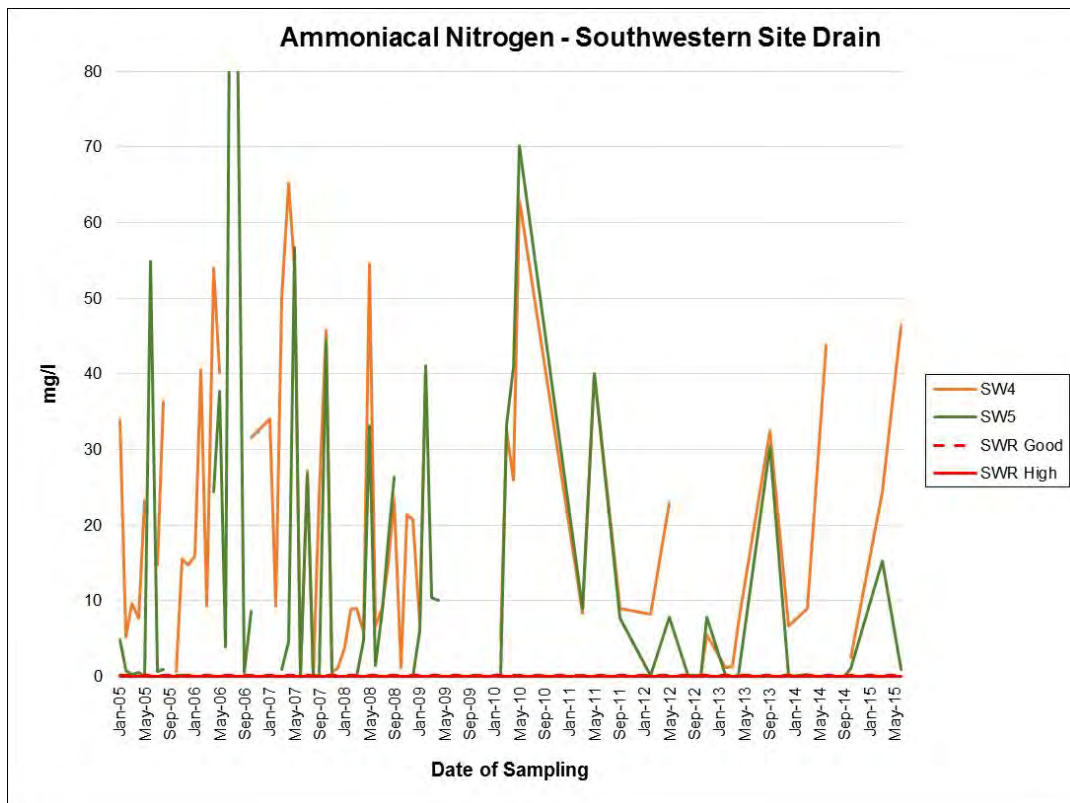
Figure 8.10 Southwestern Drain - Ammoniacal Nitrogen Levels

Elevated levels of Ammoniacal Nitrogen have been recorded within the southwestern boundary drain (see **Figure 8.10**) within samples **SW4** and further downgradient at **SW5**. The levels within SW4 range between 0.01 and 65.3 mg/l and within SW5 ranging between 0.01 and 151 mg/l. The levels recorded vary over time with broadly reducing levels noted between 2010 and 2014. However, increased levels have been noted in both locations since mid-2014.

The high levels of Ammoniacal Nitrogen in this drain are, similar to the northeastern drain, resultant from landfill leachate during a time when leachate was allowed to be dispersed to this drain from the flanks of uncapped landfill. These levels are expected to decrease significantly following completion of all remedial works at the site.
