Re: Application for review of IPPC Licence from Anglo American Lisheen Mining Limited, Killoran, Barnalisheen, Ballyerk ect. Moyne Thurles County Tipperary Licence Register P0088-03.

M E M O			
To:	John Hayes		
From:	Seán Power		
c.c.			
Date	26.09.2006		
Project:	Denis & Mary Sheehy	Project No.	01KK075
Subject	Site Inspection 21 <sup>st</sup> September 2006

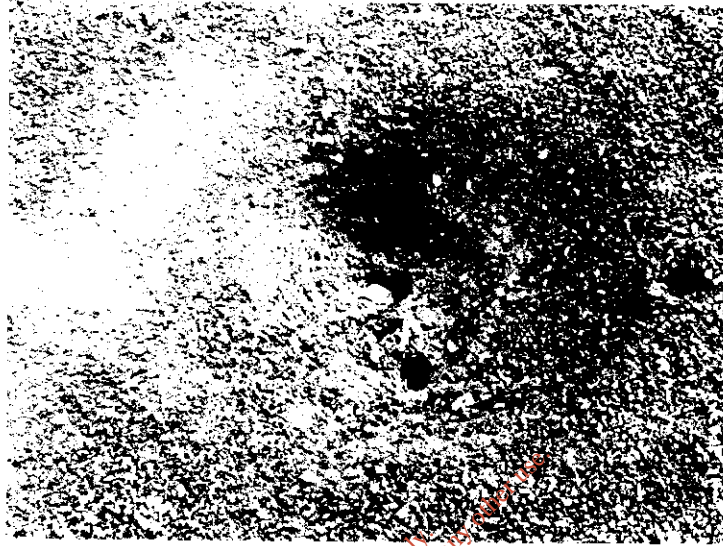
Prior to our inspection Mary Sheehy informed us that a circular hole approx 250mm (10') in diameter and 50mm deep appeared adjacent to the front entrance of the building on Monday 18<sup>th</sup> September. Mrs. Sheehy also informed HHP that a severe blast occurred at 5.30am on the 18<sup>th</sup> September.

Upon inspection of the hole a 2m GPS rod was pushed with relative ease into the hole. The rod was extended 2m vertically and approximately 0.5m horizontally into the fracture. The dimensions of the hole were approximately 450mm at ground level, 200mm deep and 200mm at the base of the hole.

5. It is the opinion of Lisheen Mines that the formation of the circular hole is due to funnelling of the weathered sand in the fault. Funnelling may have resulted as a result of drying of the sand due to lowering of the water table by a period of dry weather. In addition to this the vibrations caused by blasting may have accelerated the process.
6. Lisheen Mines recommend that a geophysical survey be carried out in the area surrounding the dwelling to determine the size and orientation of any faults in the area. Following this survey some excavations may also be carried out adjacent to the dwelling.
7. The geophysical survey should be carried out within 1-2 weeks of this inspection.
8. Denis and Mary Sheehy have requested that HHP be present during the geophysical survey.

Photograph No. 1: Hole to front of property
