I wish to present my findings stated below, to the IPPC Licence Review (P0012-05) by the Agency of my neighbour Roche Ireland Ltd, Clarenhill, Clarecastle Co. Clare, a subsidiary of Hoffman la Roche of Basel, Switzerland

My findings are based on factual evidence of HAZARDOUS WASTE buried in unlined pits named the H2 area, has been discovered.

## 2 H2 AREA LANDFILL

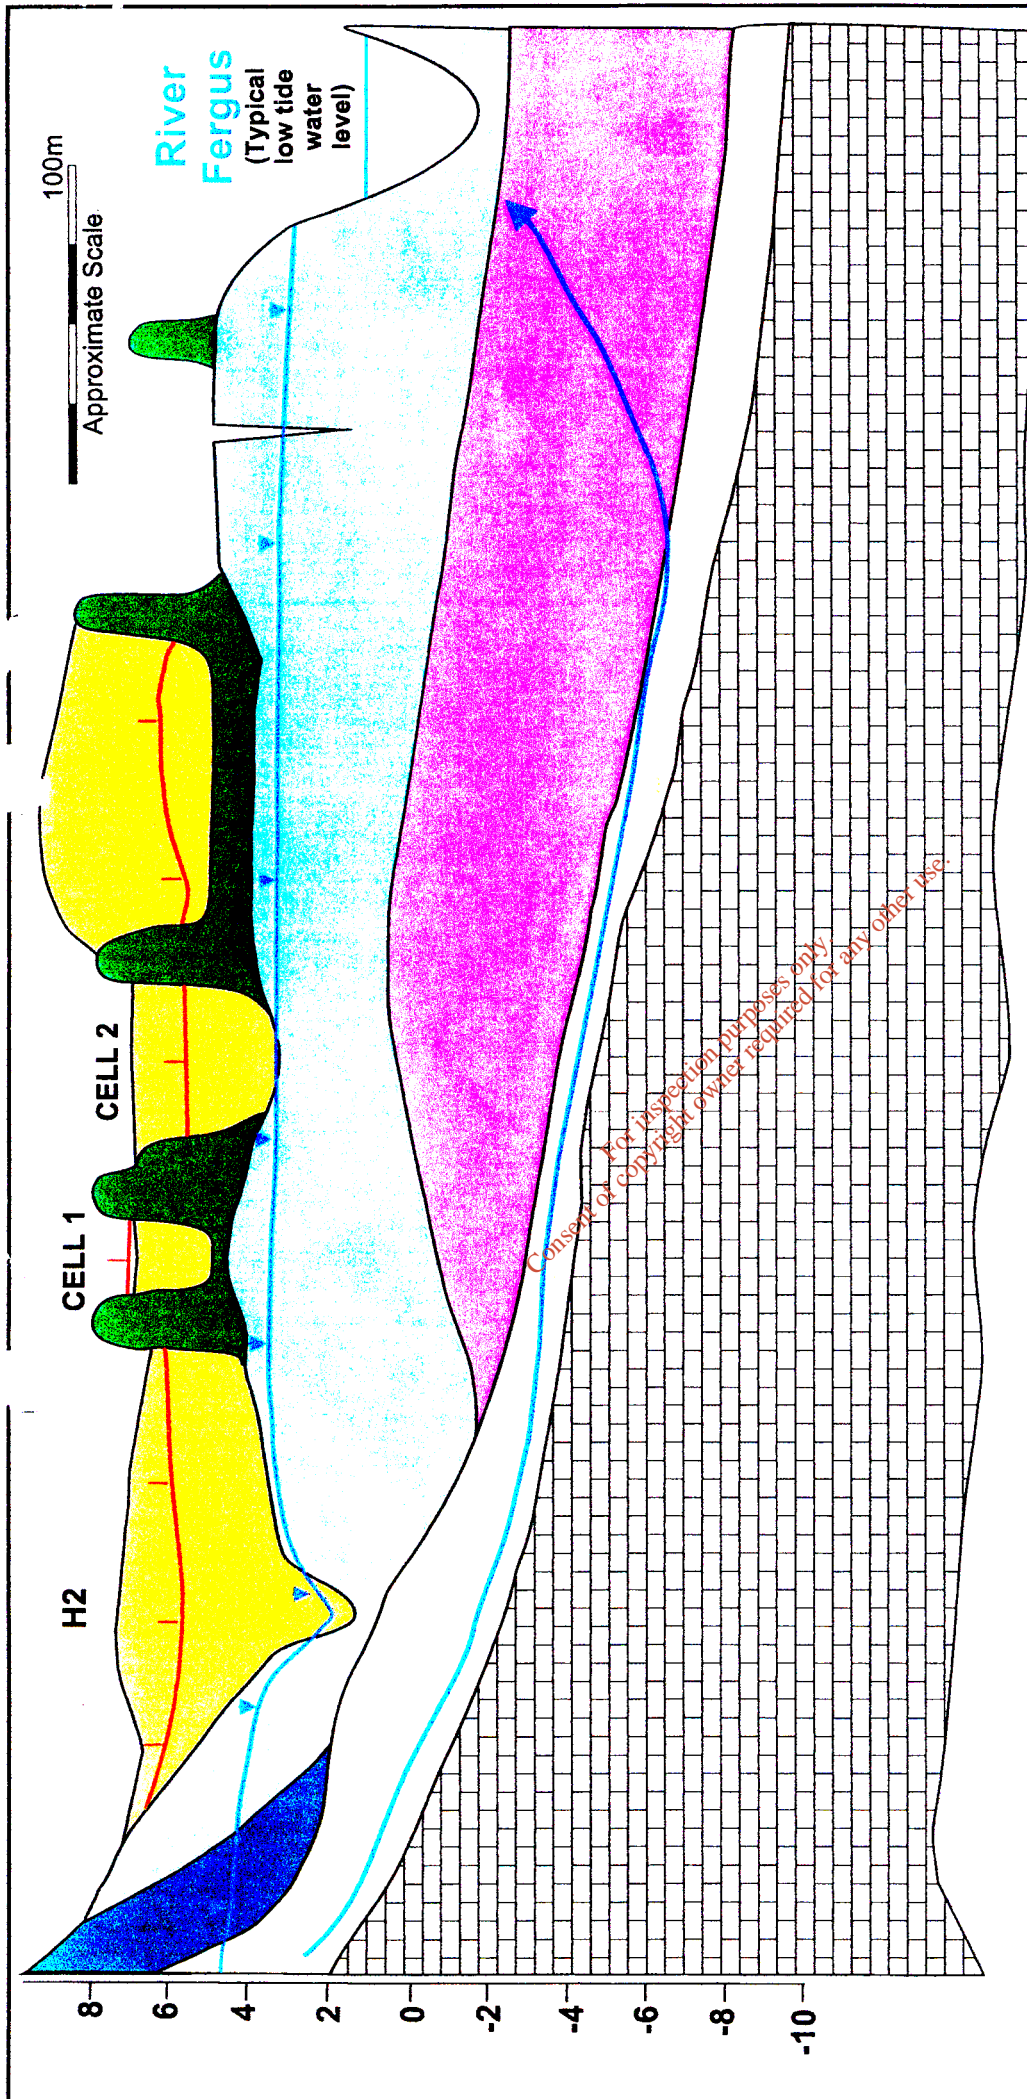
Title		SCHEMATIC HYDROGEOLOGICAL CROSS SECTION THROUGH LANDFILL CELLS H2, 1, 3 & 4	
Location		CLARECASTLE, CO CLARE	
Client		ROCHE IRELAND	
App'd	Reference	EO/H/COR	Date
TI App'd	Job No.	33748-024-447	AS SHOWN
Date		AUG 2004	
Scale		AS SHOWN	
URS		FIGURE 4

In summary, waste was initially landfilled into the H2 area between 1977 and 1980 with no control on filling processes, no lining, and no leachate control mechanisms. Waste disposal took place across a relatively wide area in numerous dispersed pits, including on land close to the artificially constructed Nature Area ponds. There was also a deep (5m deep, 750m<sup>3</sup> capacity) trench through the centre of the area, close to well H2, in which some drummed wastes were disposed of. The H2 area is underlain by soft silty clay, underlain by peat in places, overlying rock (weathered limestone) which is considered a shallow aquifer. URS determine that the clay layer is between 0.6 and 3.0 m thick in the H2 landfill area.

Leachate in the H2 cell is actively gassing (bubbling) in places (Dames & Moore 1997, URS, 2005). Trial pit grab samples of leachate/shallow groundwater in 2005 detected VOC compounds in the leachate of dichloromethane (DCM) (0.01- 110 mg/L), chloroform (0.012-5.4 mg/L) and toluene (0.098-857 mg/L). Leachate was extracted from two pumping wells within the H2 cell for several years in the 1990s, but this has now ceased. To the south of the H2 area, well 216 has historically shown elevated toluene (up to 38 mg/l in 1996) and THF (up to 54 mg/l in 1997). Drummed wastes were reported intersected during drilling of well 216 in 1996, which is screened in the shallow aquifer between 4.6 and 5.6 metres below ground.

Overall, the H2 area is a historic hazardous waste cell, is unlined, and is causing localised groundwater pollution on the Roche facility. URS estimate up to c.90,000 tonnes or 60,275m<sup>3</sup> of hazardous wastes lie in the H2 area. The H2 area constitutes a significant environmental liability for Roche. Hence a review of the risk assessment and a determination on remediation strategy and options is required.
