COC COC An Ginomheireacht um Chaomhnai Comhchaoil INSPECTORS REPORT O		OFFICE OF LICENSING & GUIDANCE	
To:	DIRECTOR. P LARKIN		
From:	MALCOLM DOAK	LICENSING UNIT	
Date:	3 NOVEMBER 2004		
RE:	APPLICATION FOR A WAS DONEGAL COUNTY COU BALLYNACARRICK LAND	ICATION FOR A WASTE LICENCE (REVIEW) FROM EGAL COUNTY COUNCIL, LICENCE REGISTER 24-2 , YNACARRICK LANDFILL.

SITE INSPECTION REPORT

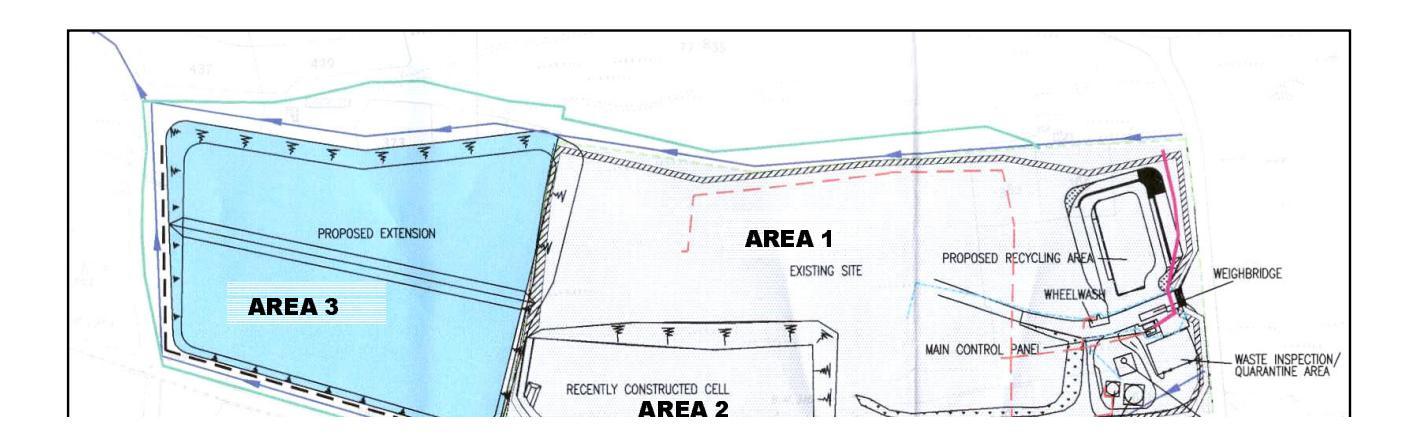
Donegal has operated a landfill at Ballynacarrick since 1980, originally filling into an unlined peat depression (Area 1), and expanding into a lined cell (Area 2) on issue of Waste Licence 24-1. Filling at Area 2 is near completion, to be finished by October 2004, although it was envisaged at the time of application that filling in Area 2 would occur into November 2005. The landfill can be split into three areas (*Figure 1* below outlines the landfill areas, existing facility and proposed extension).

- Area 1: original waste body, unlined, final capping/gas extraction commenced; *Area 2*: lined cell, to be filled by October 2004;
- *Area 3*: proposed site for extension and licence review application (225,000m³ capacity).
