SITE INVESTIGATION FACTUAL REPORT

**SITE INVESTIGATION FACTUAL REPORT,  
LABRE PARK, BALLYFERMOT, DUBLIN 10**

**JUNE 2005**

Project  
**LABRE PARK CIVIC AMENITY SITE**

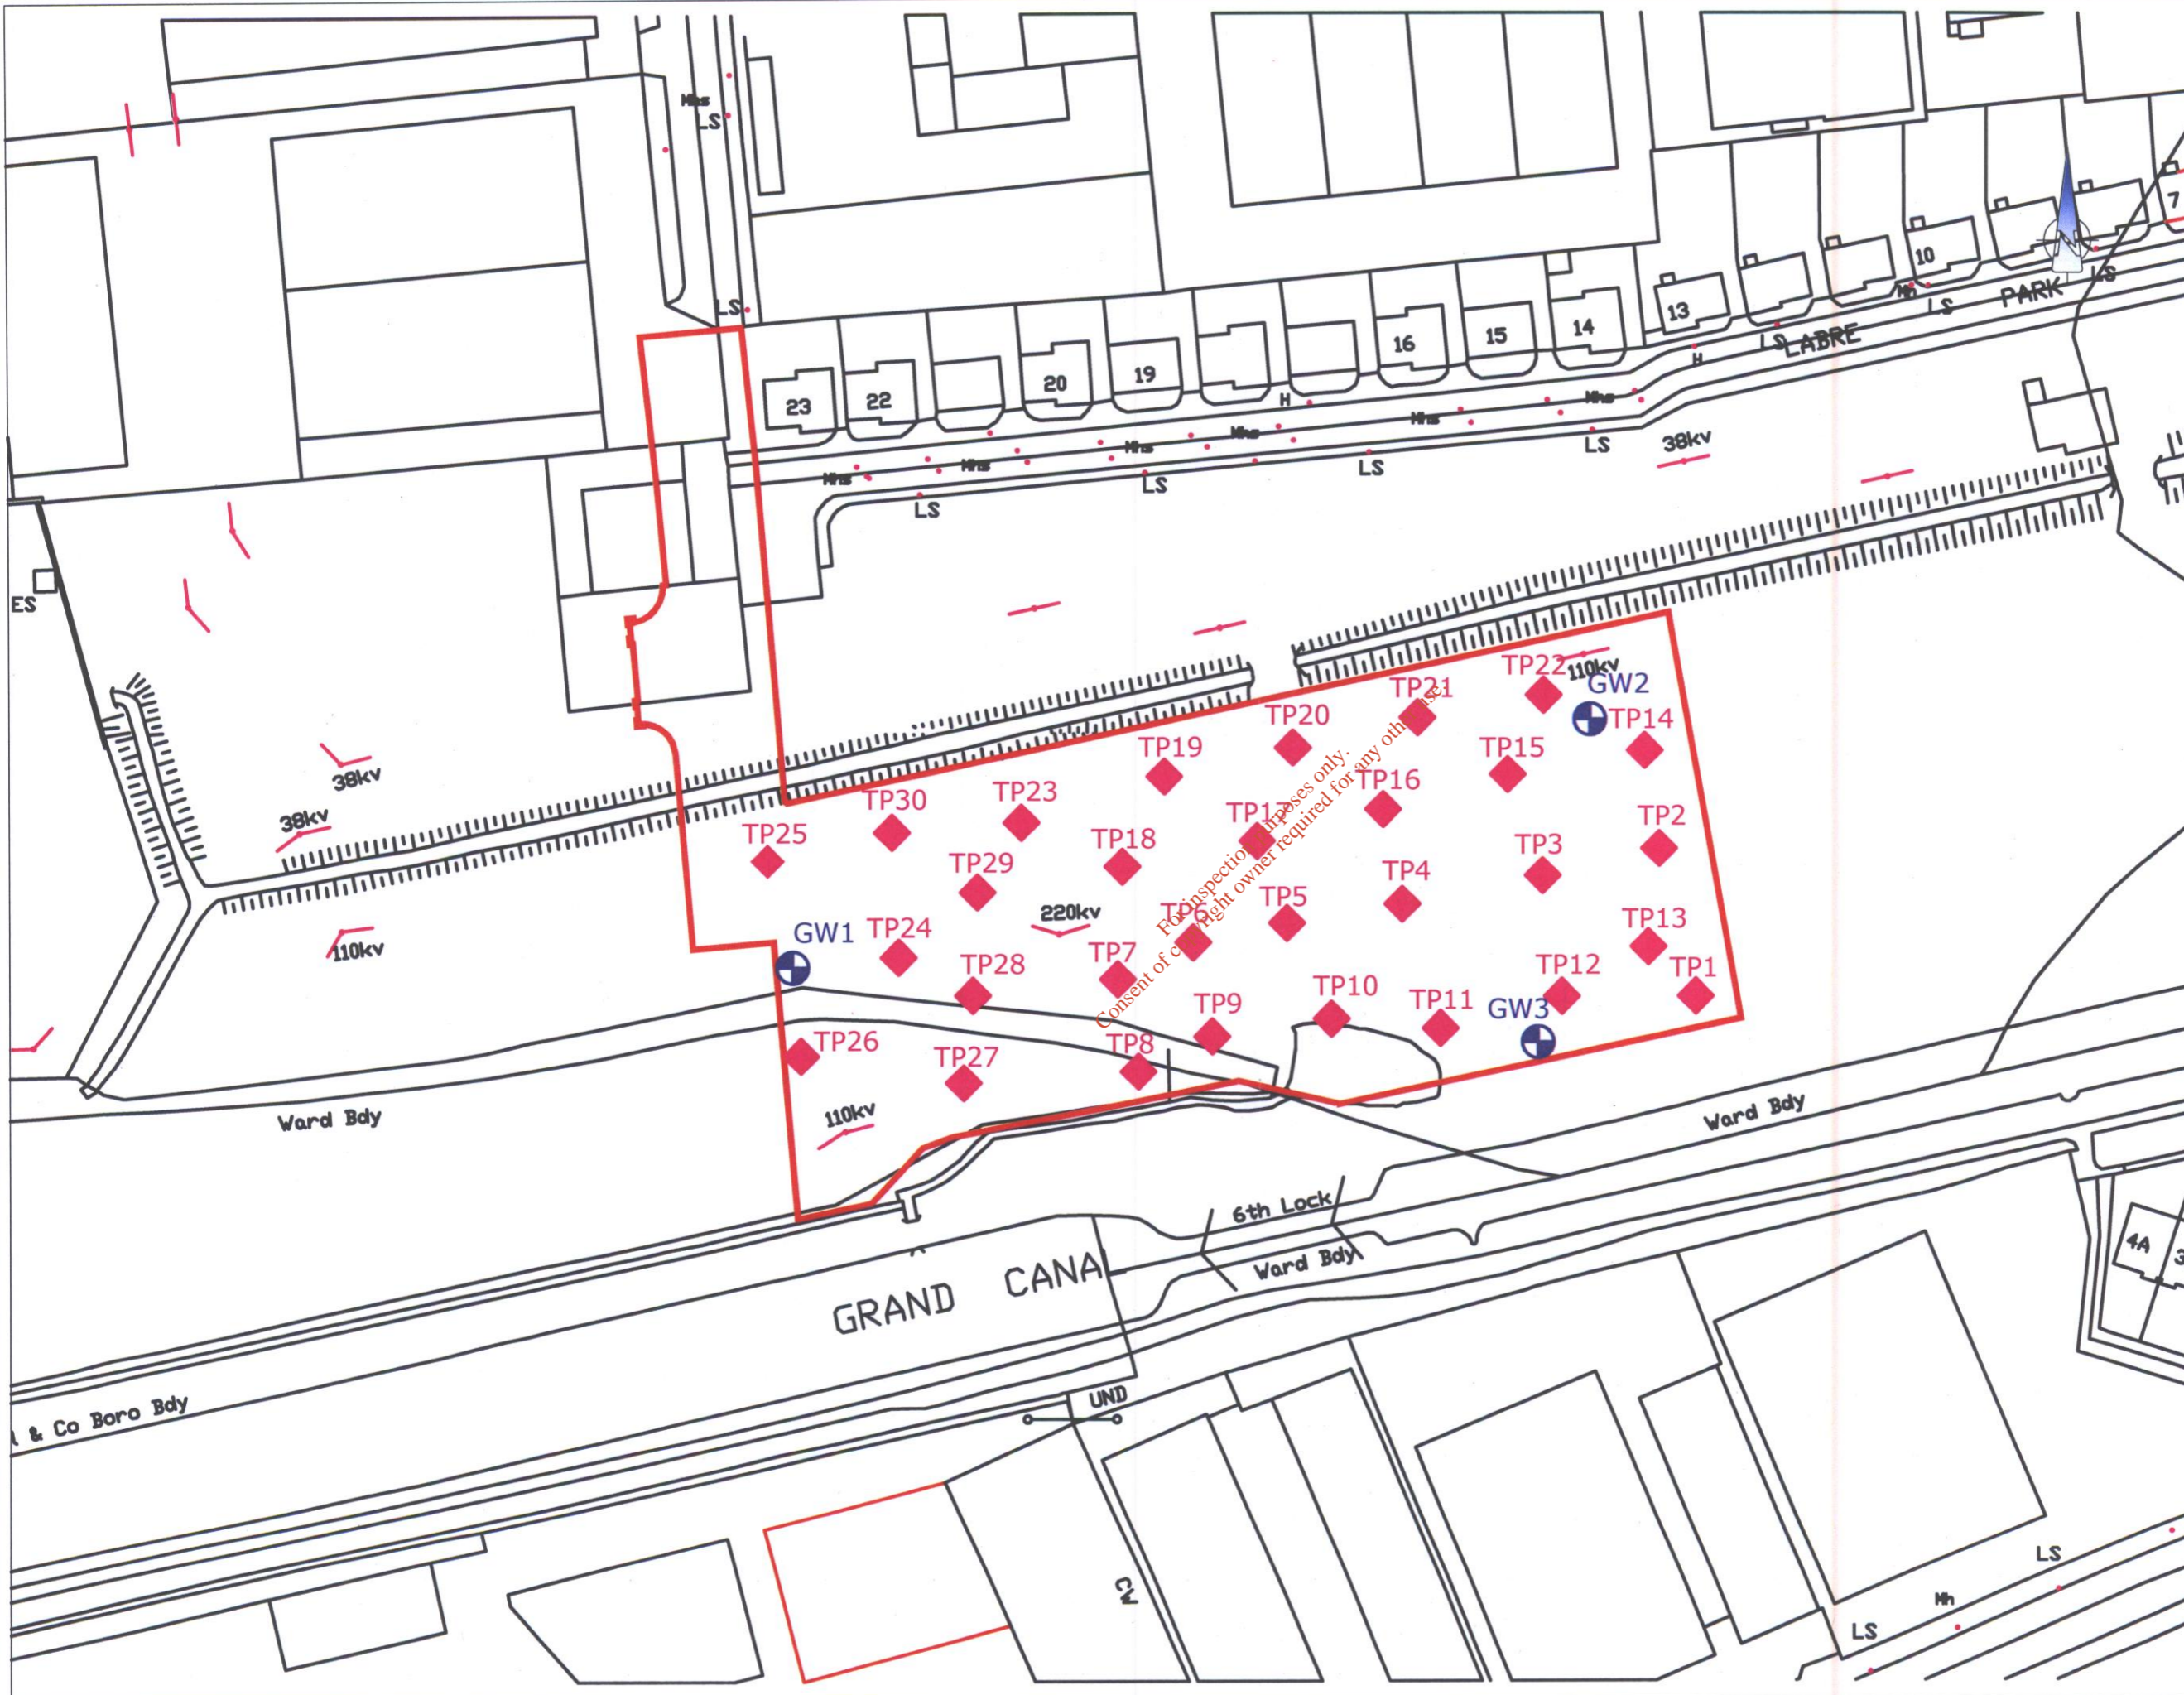
Drawing No. Figure 2

In total, 3 No. boreholes were drilled by Glover Site Investigations, to depths varying from 12m (GW3) to 18m (GW1) below ground level. The logs for each borehole are included in Appendix A, herein. The locations of these monitoring points are shown in Figure 2.
