Geophysical survey and archaeological assessment

**Proposed Abbotstown Business Park
Cappogue
Dublin 11**

Archaeological Licence Ref. 06E0228
Geophysical Licence Ref. 06R034
Planning Register No. F05A/1363

By
Joanna Leigh and Franc Myles
Margaret Gowen & Co. Ltd.
Job No. 0617-R1

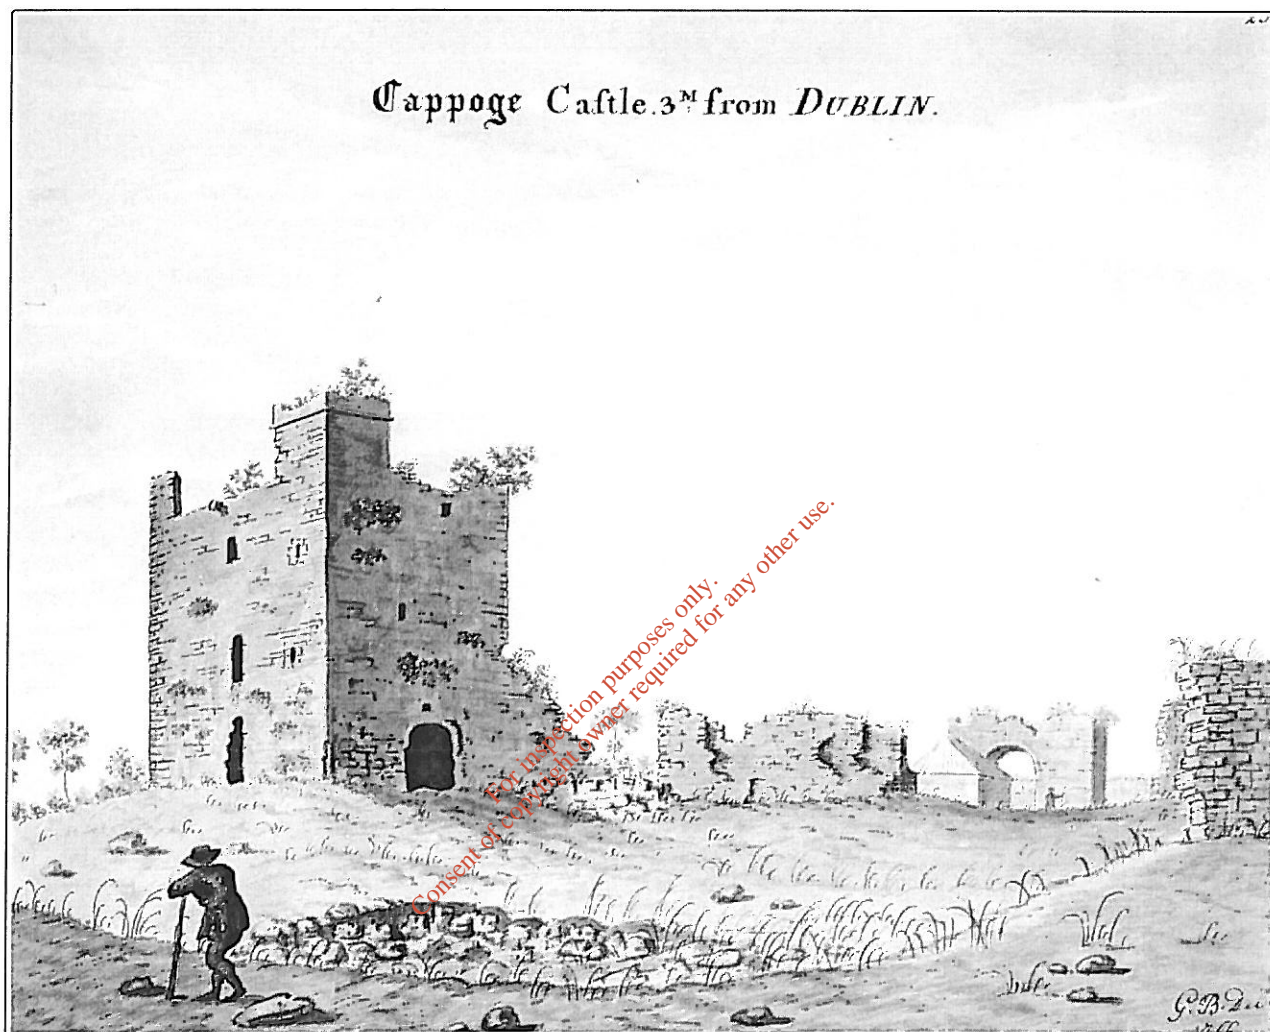
Job Proposed Abbotsdown Business Park, Cappoge, Dublin 11
Ref. 06017-R1
Date 04.04.06
Client Clifton Scannell Emerson Associates
Scale Not applicable
Fig. 2 Beranger, after Harbinson (1998), p. 69

Rocque however depicted the castle within the bawn and Beranger painted the ruin in 1766 (Fig. 2). Austin Cooper recorded a large crack down the southern side of the building in 1778 and by the early nineteenth century, according to Paddy Healy, its owner apparently used it as a quarry to build the present complex of buildings.

2.3 The best source for the building is Beranger's drawing of 1766 (NLI MS 1958 TX), which has been reproduced by Harbison (1998). Cappogue castle presents as a ruined three-storey tower within a bawn with an obvious gatehouse. What appears to be a second ruined structure is situated between the tower and the gate, with a smaller structure, possibly with a thatched roof located just inside the gate.

- 2.4 Of possible significance is a pond in the foreground of the drawing, at the base of a slope which may have had the bawn wall running along it (as evidenced by the stump of wall in the right foreground and the loose stone scattered around).

The accompanying text states that the tower was thirty feet high and located at the *southeastern corner* [my emphasis] of a walled enclosure. Beranger noted that Cappogue 'was a strong fortress formerly flanked by Towers of which only one remains' (NLI Ms 1415, 9). Two walls of the tower are evident, presumably the northern and eastern walls. The crack in the southern wall recorded by Cooper in 1778 is not evident and the visible walls appear structurally sound (Beranger was not adverse to depicting archaeological structures, cracks and all, as can be seen in his depiction of Simmonscourt castle or Danesrath near Clondalkin).

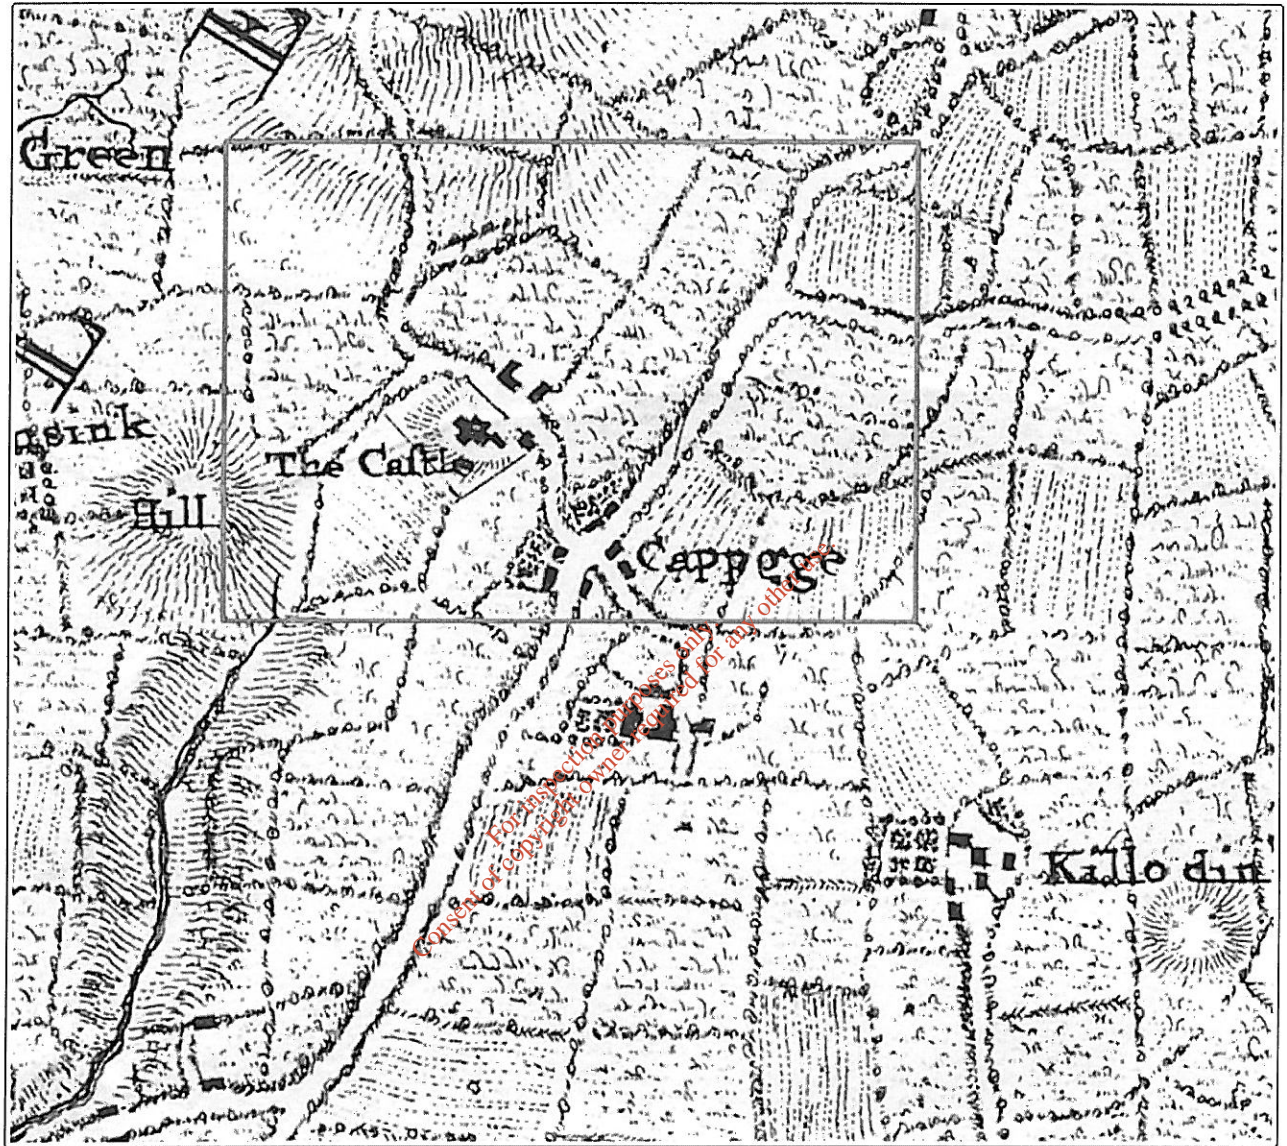
Job Proposed Abbotstown Business
Park, Cappoge, Dublin 11
Ref. 06017-R1
Date 04.04.06
Client Clifton Scannell Emerson
Associates
Scale Not applicable
Fig. 3 Rocque, 1762

- 2.6 When comparing Rocque and Taylor, the earlier map depicts the site in greater detail. The bawn is shown in the form of a straight-sided quadrilateral enclosure, with a field boundary closing the space to the northwest. *The Castle* itself is on a hummock, with no suggestion of the pond. It appears to have a cruciform shape, with the gatehouse on the roadside to the northeast. Although the scaling cannot be said to be absolute, the site's relationship with the obvious bend in the road would position it more towards the farmyard complex than its location on the RMP map.

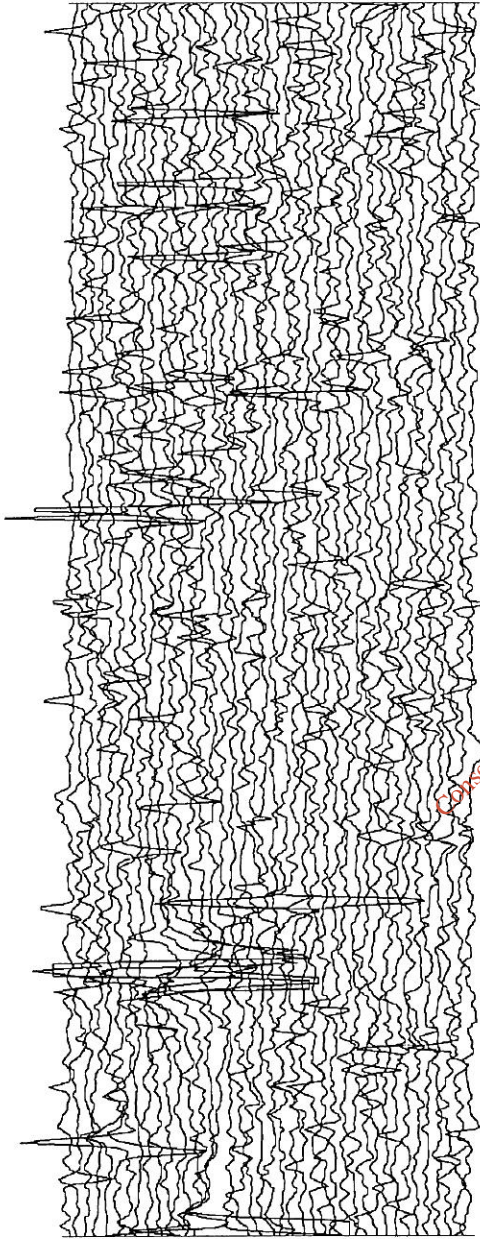
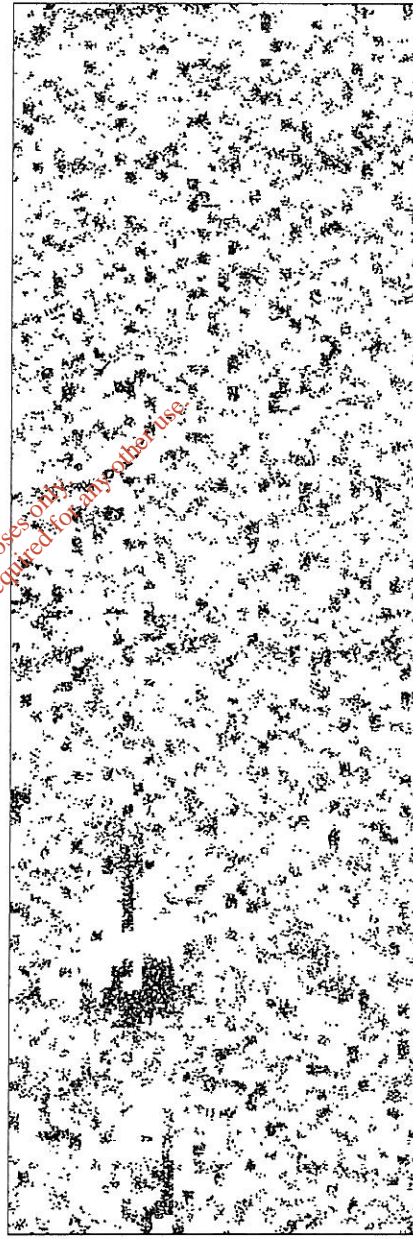
AREA 1: XY-TRACE & DOT DENSITY PLOT

- 6.4 In Area 1 a linear response appears to traverse the data set, orientated northeast to southwest. This response is suggestive of a former field division or boundary ditch.

- 6.5 Area 1 also contains linear trends orientated north south. These faint trends are most likely the result of modern ploughing activity.
- 6.6 Area 2 is dominated by modern ferrous responses and no archaeological interpretation of this data set can be made.

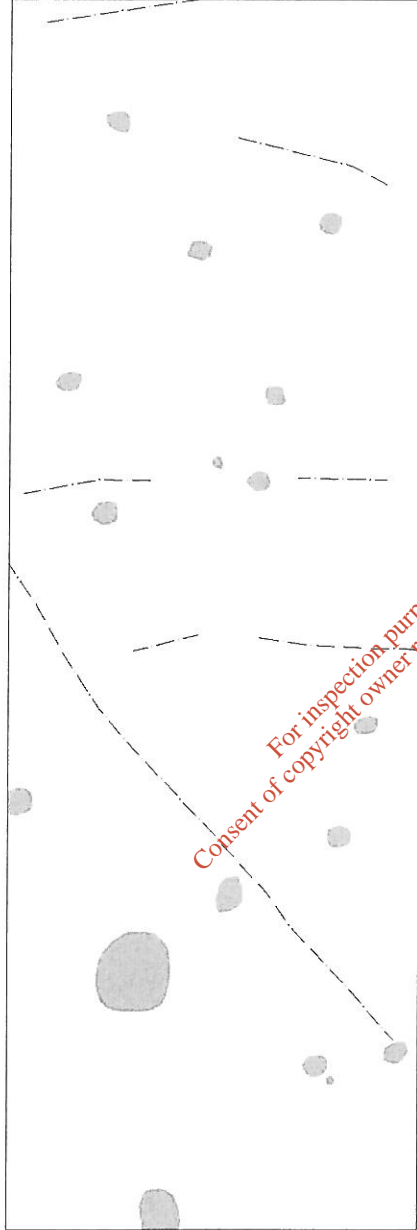
AREA 1: INTERPRETTION

- 7.3 A possible field division has been identified in Area 1, and faint linear trends here may represent ploughing activity.
- 7.4 The detailed survey in all areas is dominated by modern ferrous responses and archaeological interpretation of the data is tentative and no clear responses of potential archaeological origin were identified. Although no evidence for archaeological activity was identified, it must be noted that ferrous responses may mask more ephemeral archaeological responses.

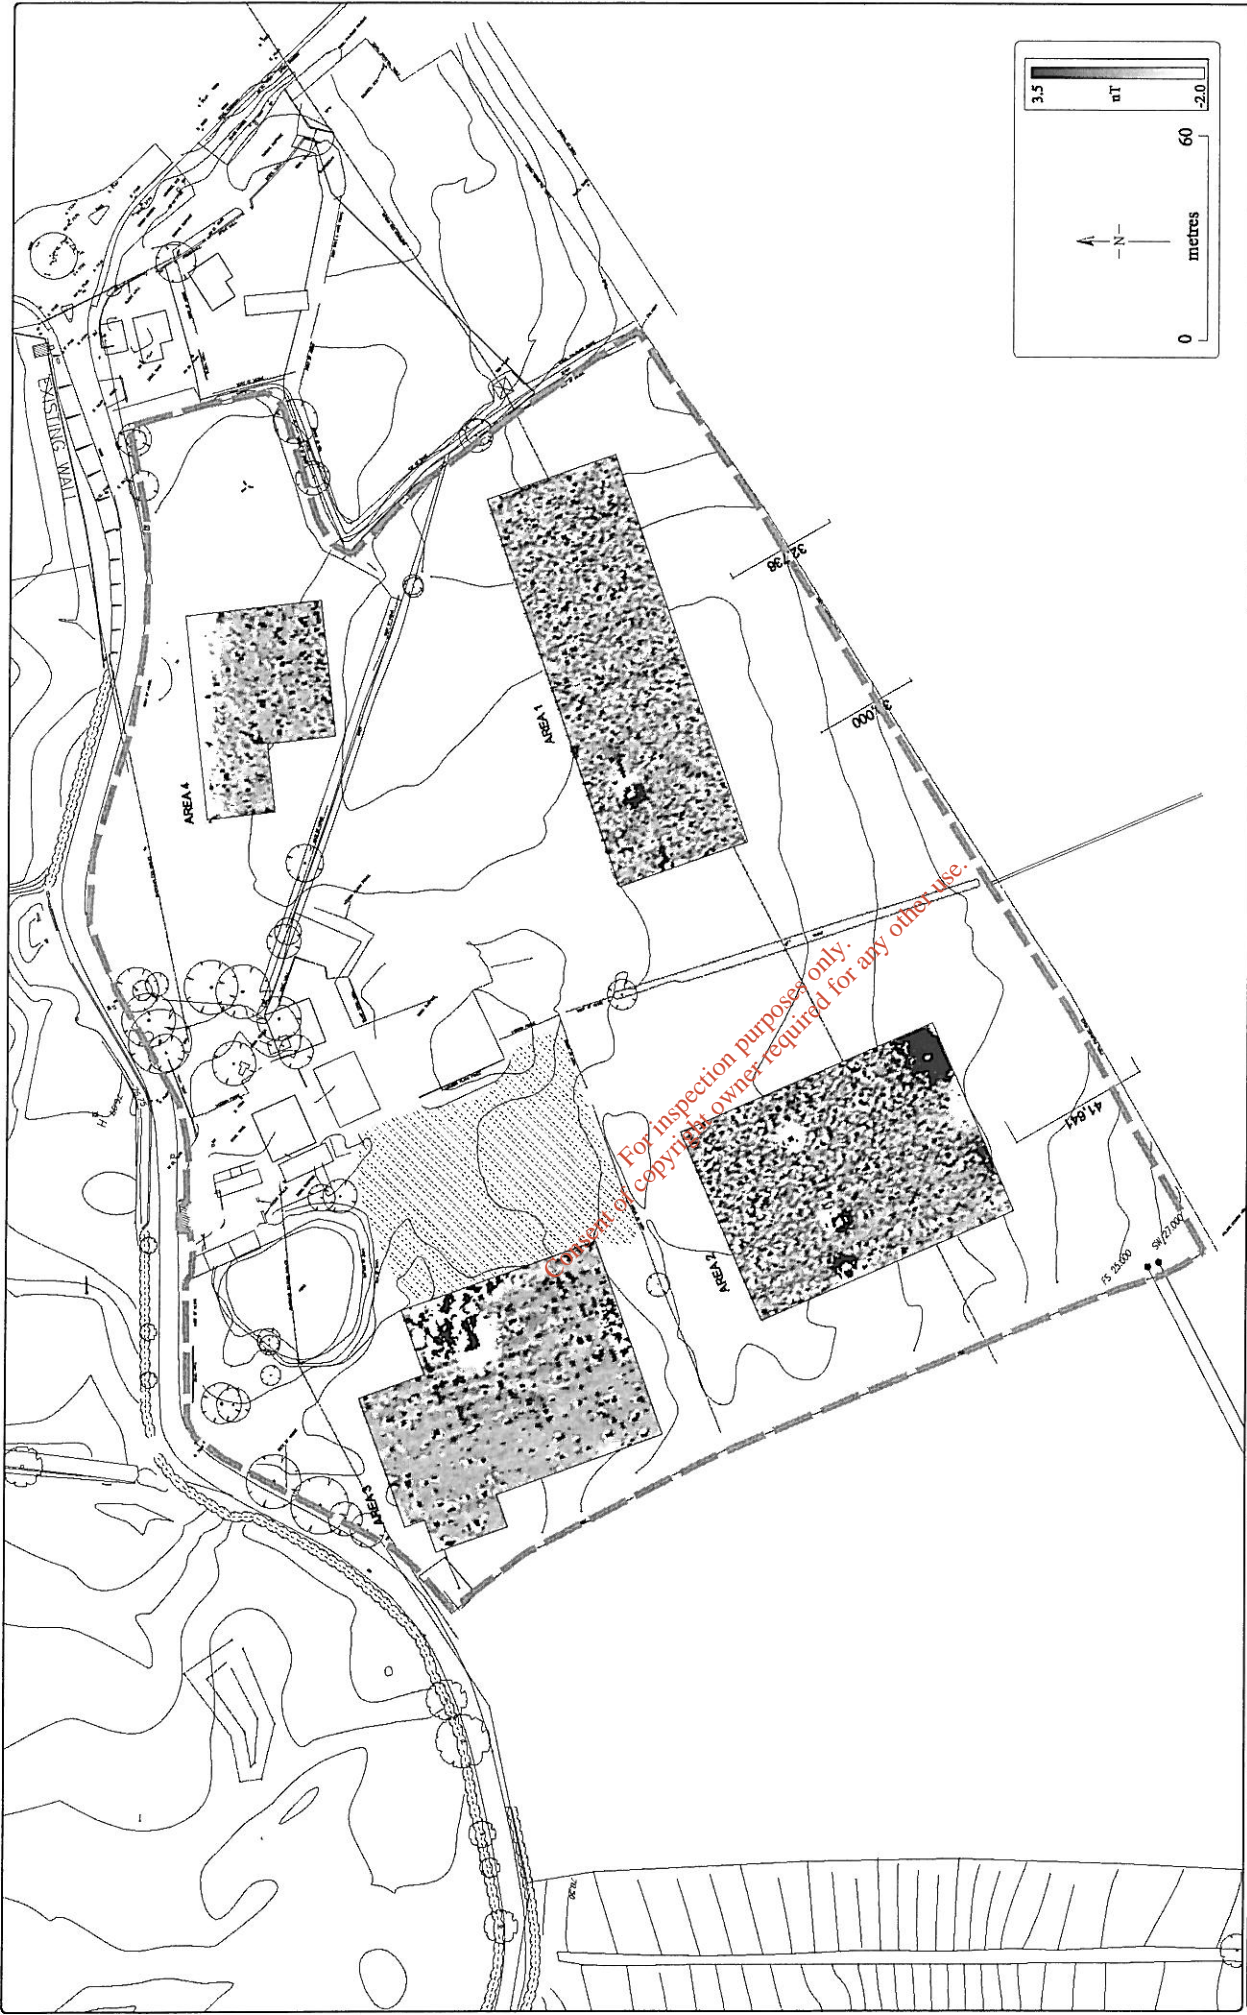
- 6.1 Detailed gradiometer survey has confirmed the results of the scanning. Survey Areas 1, 2 and 4 all demonstrate a broad background response ($\pm 2nT$). This is interpreted as modern in origin, suggesting these lands are significantly affected by modern disturbance.

- 6.2 Broad modern ferrous responses are evident in all areas, and probable service pipes have been identified in the south of Area 2 and the north of Area 4.

- 6.3 Modern disturbance is dominant in these data sets, and may mask responses of potential archaeological origin. However, some responses of possible interest are still evident in the data sets and are visible regardless of the modern disturbance.
