RE: IPC REG No PO 621-02

On behalf of my client Mr. Martin O' Donovan, of Cooligboy, Timoleague, Bandon, Co. Cork, I herein formally request clarification if the proposal to construct a new storm water monitoring point (SW2), can be accommodated by Technical Amendment, under his current IPPC Licence.

MARTIN O DONOVAN'S PIG FARM NMP 2010

ATTACHMENT NO 2

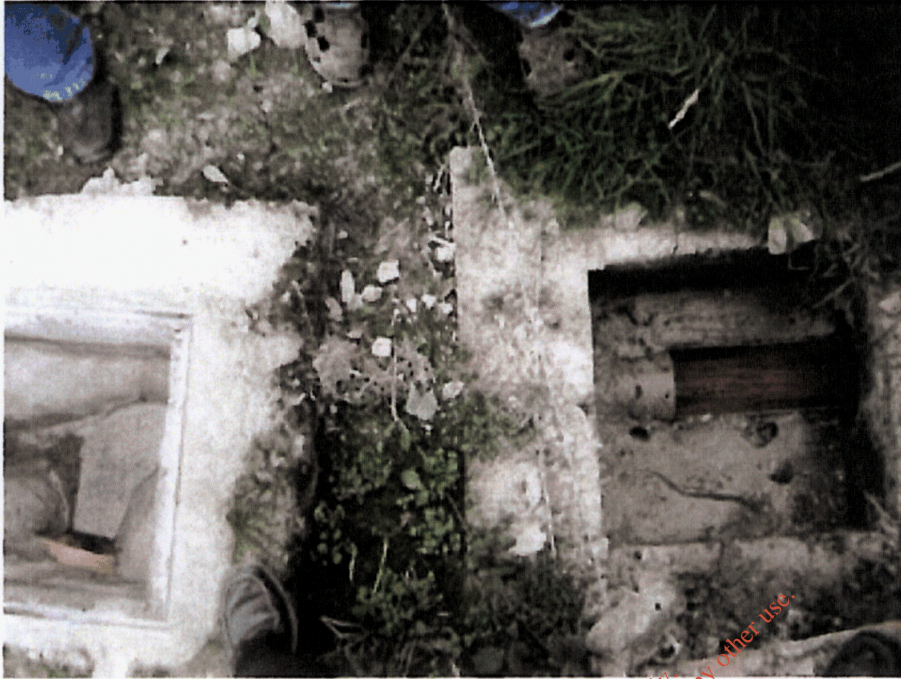
- The drain referenced in the photograph No 3 is a manhole to provide access to rod the drain under the adjacent earthen bank. It is linked directly to the monitoring point SW1 as shown in photograph 1 included in Attachment 2. The algae growth on the concrete walls is due to the fact that this manhole is mainly left uncovered, allowing debris, and decaying plant growth from the

adjacent earthen bank to fall in and decay. This manhole has now been cleaned, and will be kept covered at all times in future.

Photograph 1: Storm water monitoring point SW1, and adjacent manhole, at south eastern side of unit

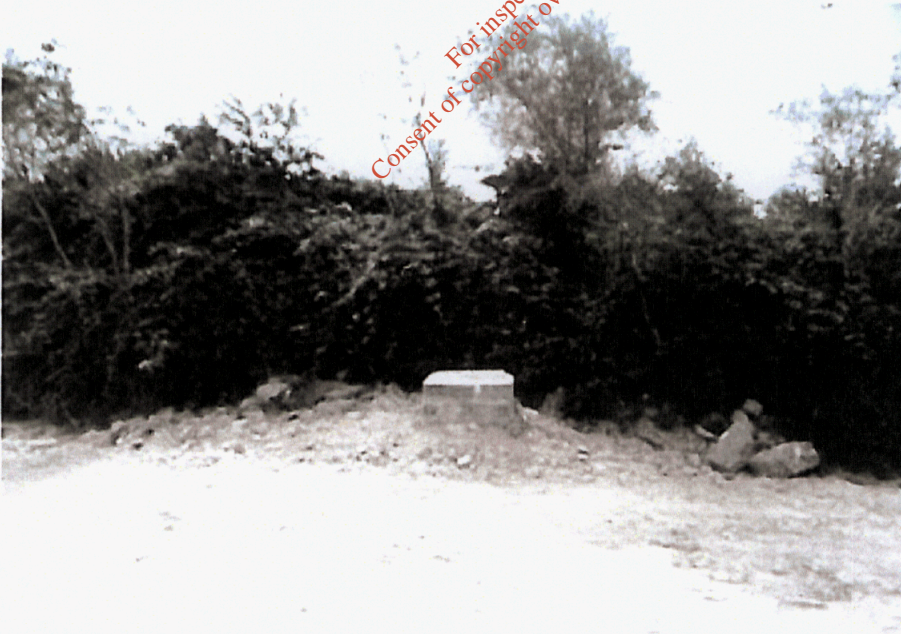
- The two pipes to the south of the main slurry collection point, divert storm water from the facility. The area from which it collects storm water is set out in Table 2 above, and their location is set out in the site layout plan included in Attachment 1. A new manhole has been constructed on this line (See photographs 2 and 3 in Attachment 2. It is proposed to monitor this in accordance with Schedule 3(i) of this IPPC License. In addition we are currently reviewing the possibility of upgrading the pathway of storm water flow from this facility through the forestry section to the south of the unit

Photograph 2: New storm water monitoring point SW2

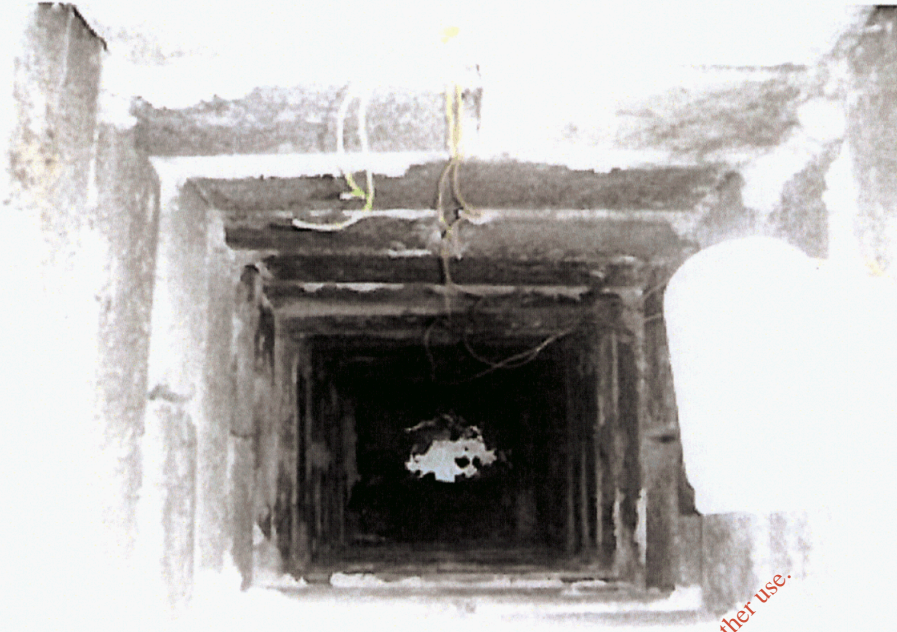
Photograph 3: Storm water monitoring point SW2, with internal dipper.

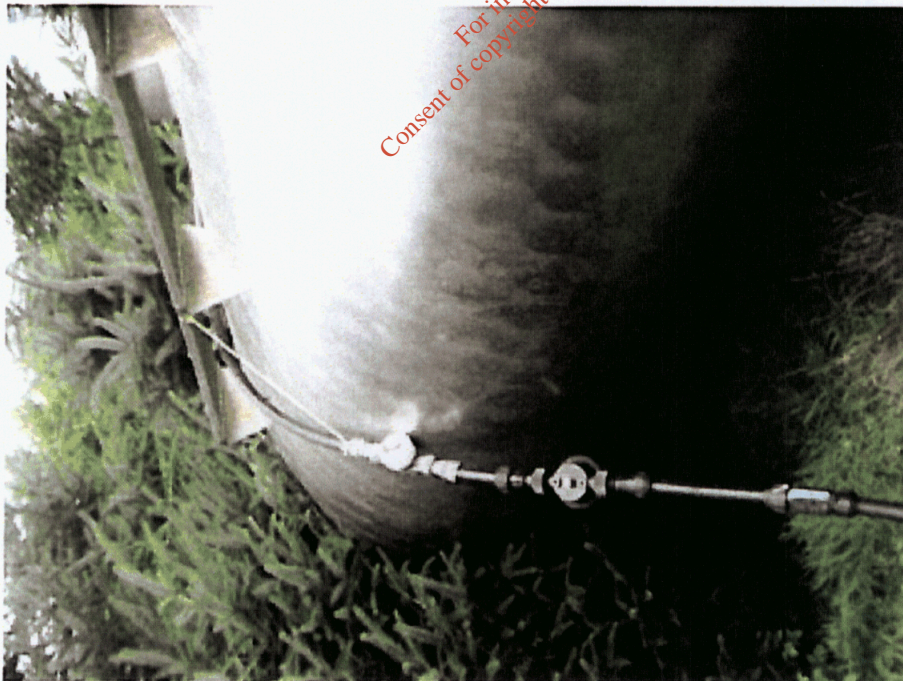
- There are two groundwater sources currently used to supply water to this facility. These are AGW2, and AGW4. The location of these wells is shown on the site layout plan included in Attachment 1. A water metre is fitted to both of these wells (See photographs 4 and 5, in Attachment 2). The meter readings will be recorded monthly, and a record of these readings will be maintained on site, in the register format included in Attachment 3.

Photograph 4: Water Meter for well AGW4

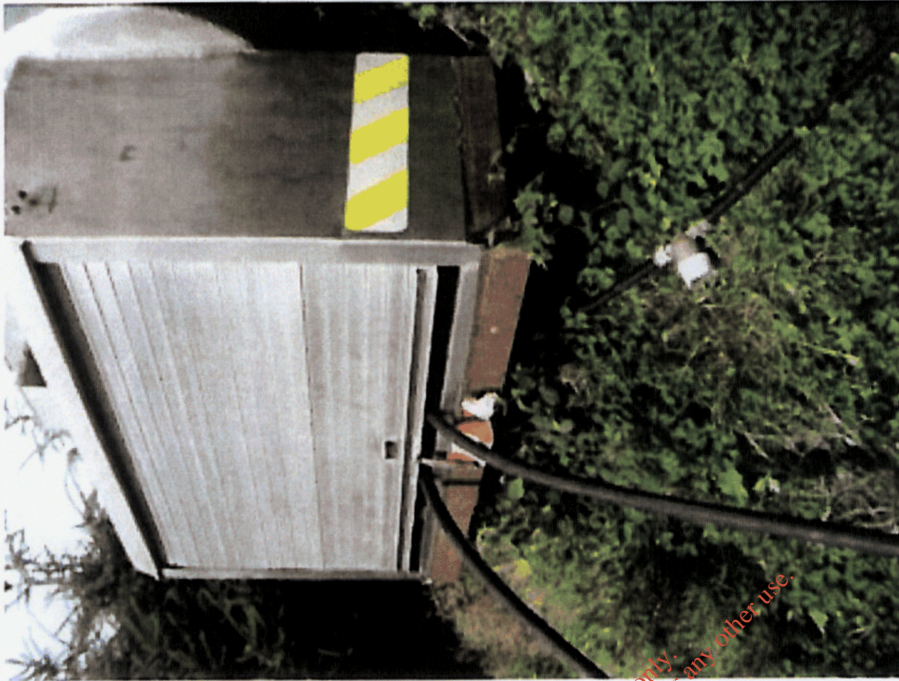
Photograph 5: Water Meter for well AGW2

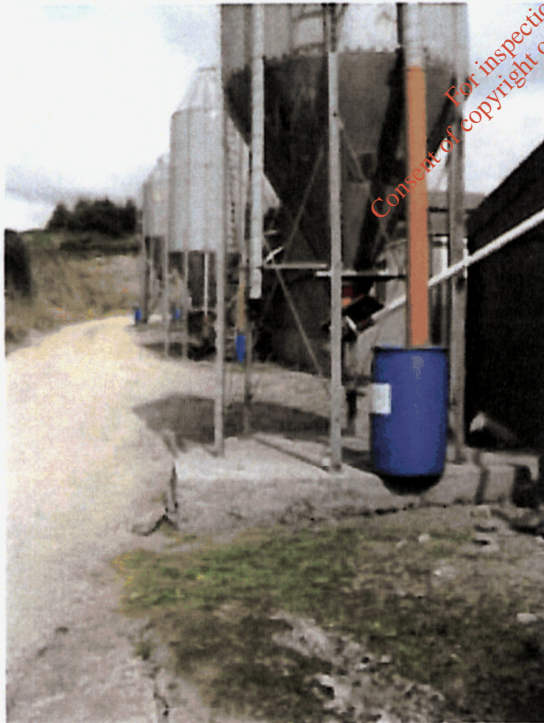
- The pipe at the south western corner of the facility was originally installed as a cable duct to run electric cables to the proposed mill, from the office area. It was put in place when this entrance area was being concreted, to negate the requirement to cut up the concrete yard later. It has not been utilised as the mill was not constructed. Following investigation it was determined that the only potential source of contamination that could enter this pipe, would result from the dust around meal bins on the western side of the unit. As a result a dust collection system has been installed under each of these meal bins, (See photograph 6 in attachment 2), and the entry and exit of this pipe have been sealed up.

Photograph 6: Dust collectors on meal bins on the western side of the unit
