Attachment E.1(iii): Site description of two potential sea disposal sites off Hook Head Report, Aquafact Ltd, November 1998

Site description of two potential sea disposal sites off Hook Head, Waterford Harbour

Attachment E.1(iv): Surveys of the Dredge Spoil Dump Site, Aquafact Ltd, 1996

**Photographic And Visual Survey Of The Seabed
In The Areas Of And Around A Dumpsite
In Waterford Harbour.**

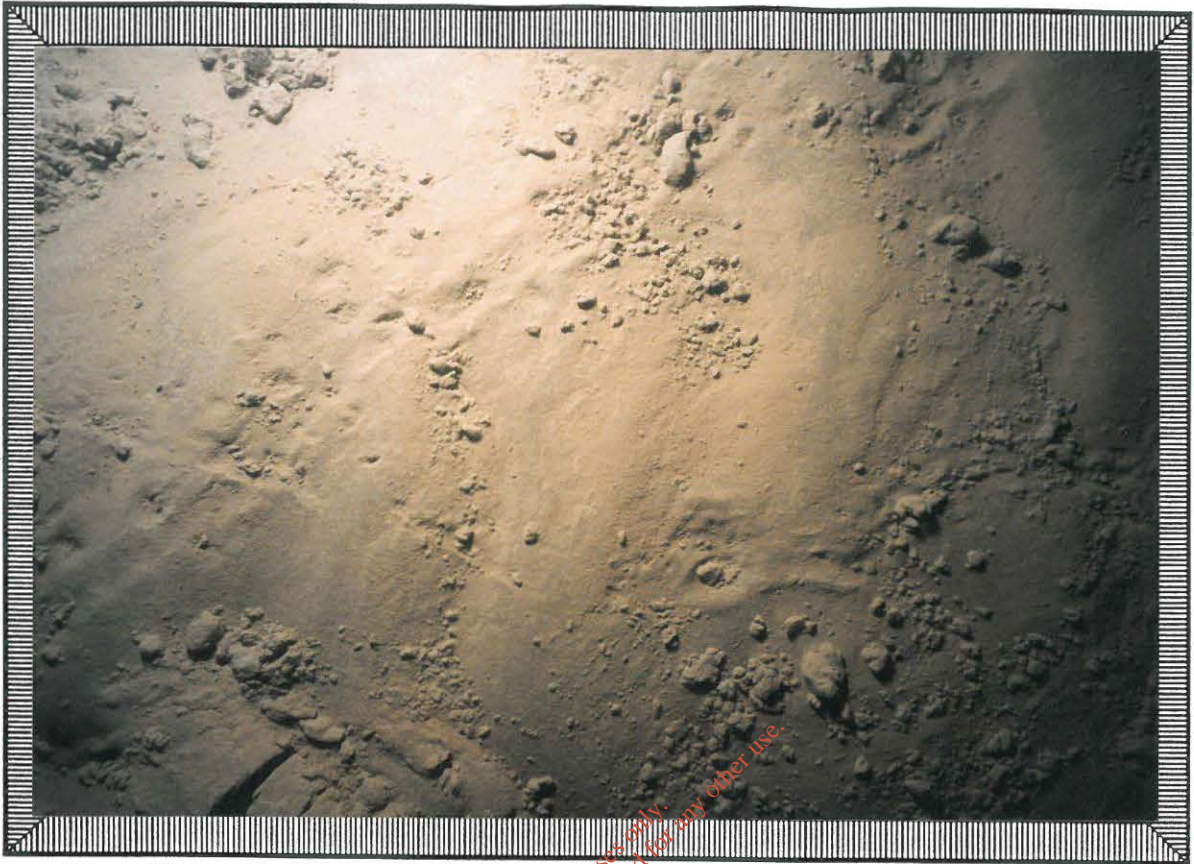
Photo No.:— 1

Photographs 1&2 record bottom conditions along the transects taken by the diver inside the north-eastern corner of the dumpsite (see Figure 1). The bottom is covered by a fine muddy sediment with no elements of the original seafloor apparent. No fauna were seen. Photo's 3-10 record conditions along the transect to the north-east of the site. The original coarse sand bottom was observed with a light layer of fine material covering it. Occasional blocks of dredged material were located (Photo's 4, 5, 8 & 10). Hermit crabs, *Pagurus bernhardus*, were common (Photo 3).

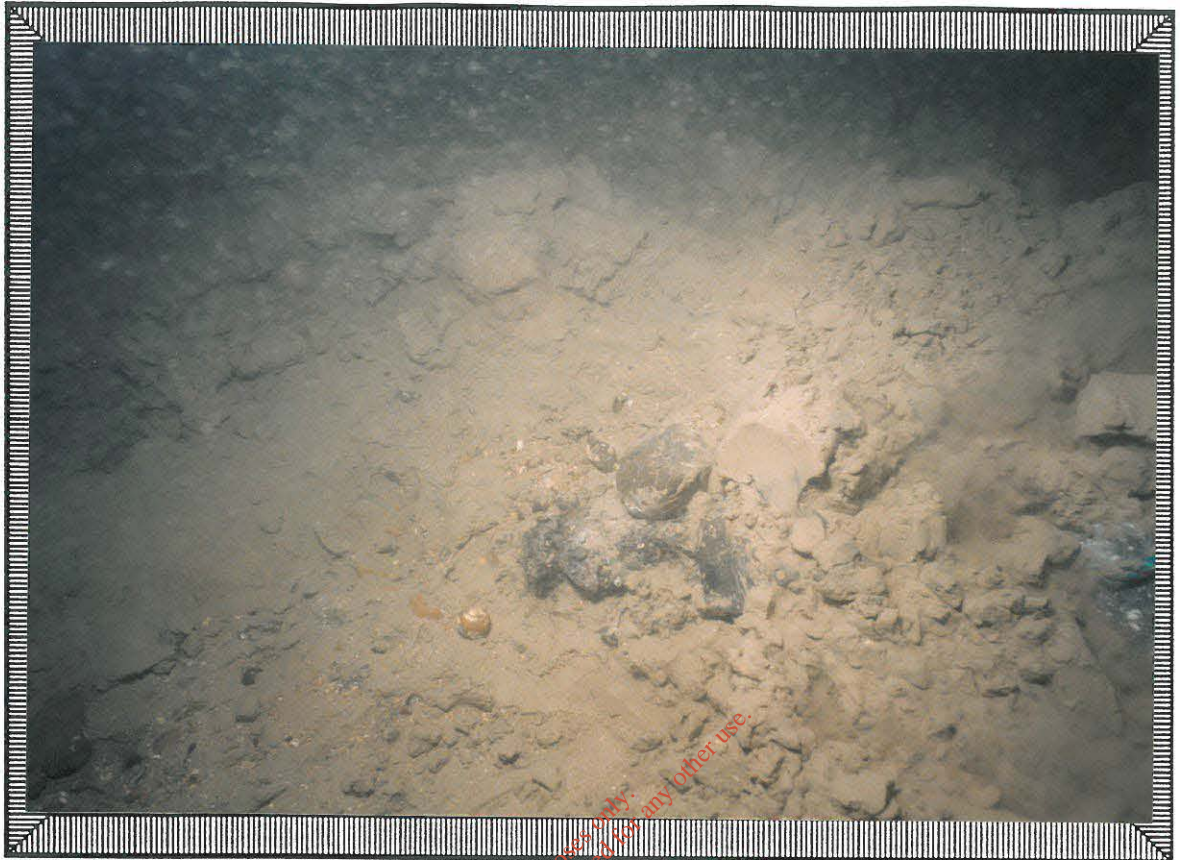
Photo No.:— 11

Photo's 11-14 show the depth of material deposited in the southern part of the site. The diver dug down approximately two feet to uncover rocks from the original bottom. The covering material is similar in composition as that recorded in the first transects. Again no fauna were observed.

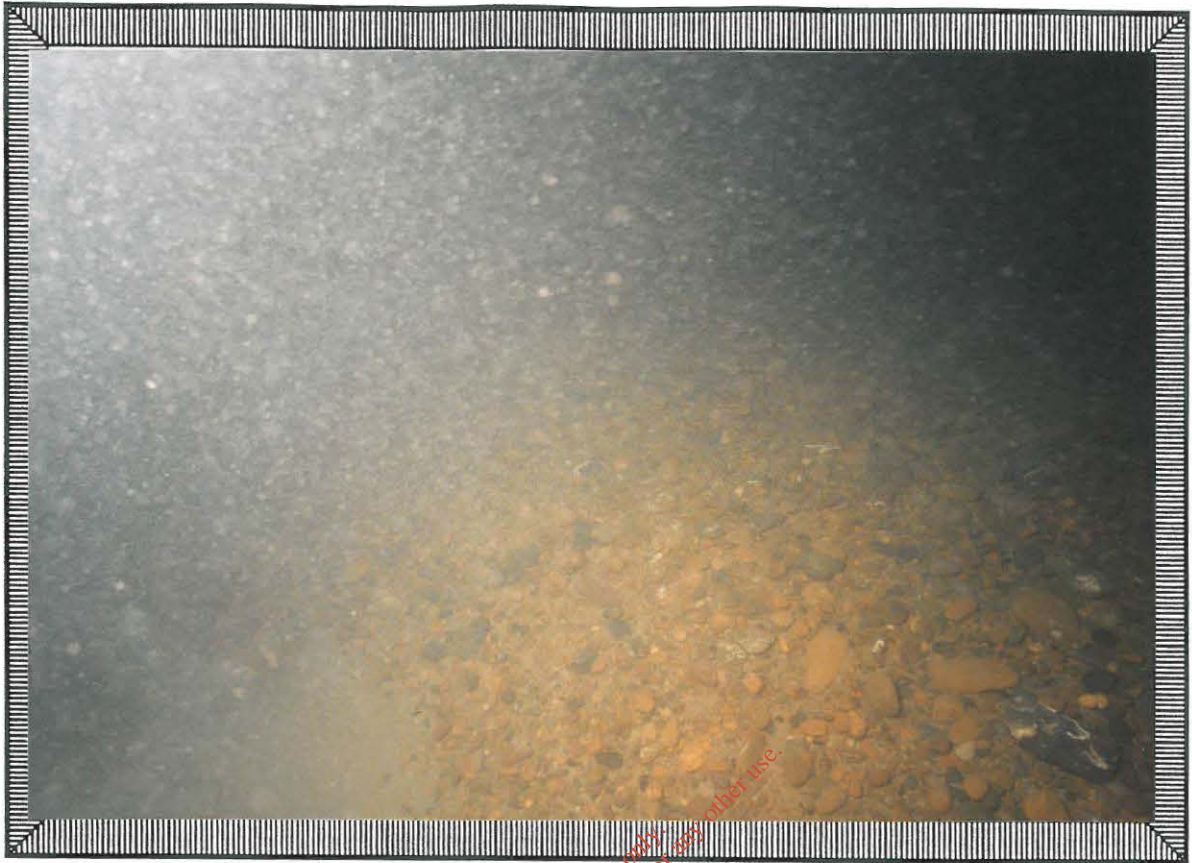
Photo No.:— 15

Photo's 15-18 record conditions seen during the transects in the western side of the site. There was a light covering of fine material covering the coarse gravel bottom. Starfish, *Asteries rubens* (Photo's 17 & 18), were common.

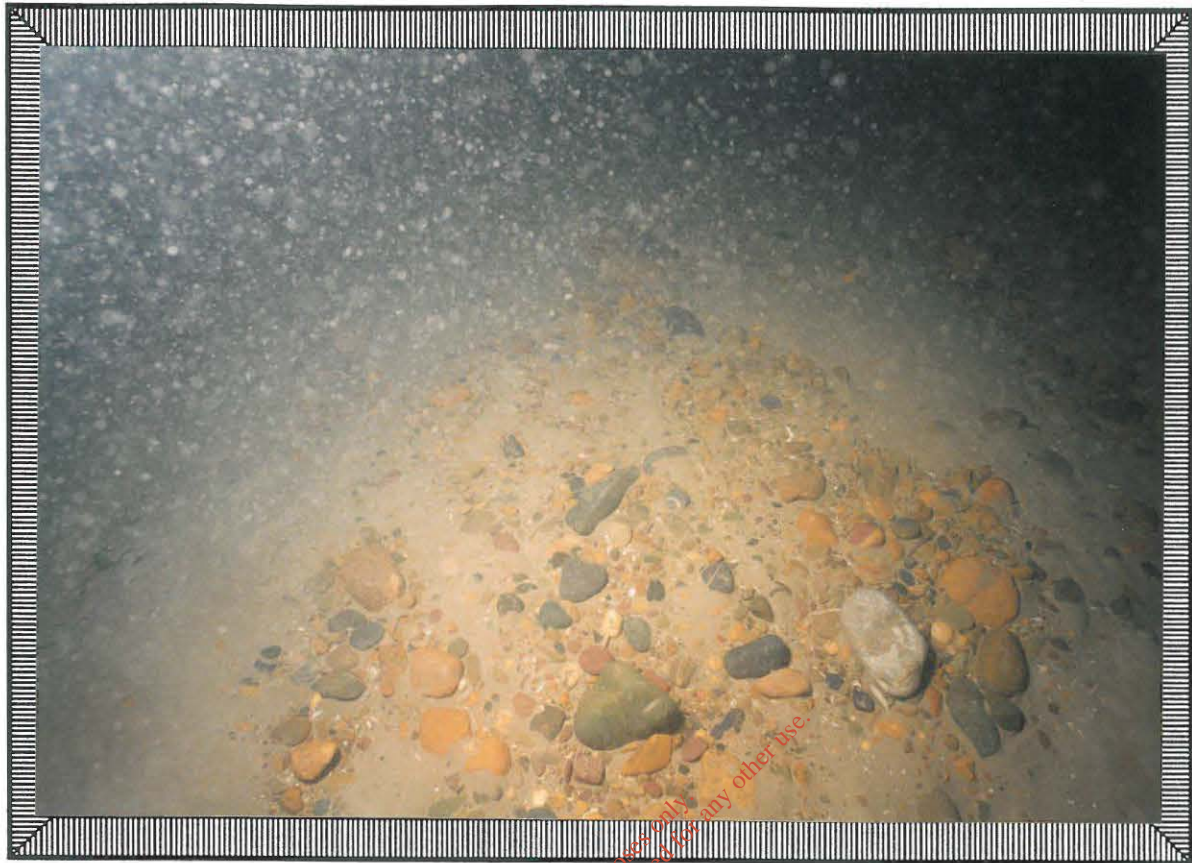
Photo No.:— 19

Bottom conditions prevailing to the extreme north of the dumpsite are seen in photo's 19-22. There was a extremely light, flocculent layer of fine material covering a

coarse gravel bottom. This fine material was easily displaced and in places was moving with the bottom current. No fauna were observed.
